Coal Hollow 5/13/2015 Inspection Report

Inspection Report

InspectionID Report Number: 4192

Permittee: **ALTON COAL DEVELOPMENT LLC**
 Operator: **ALTON COAL DEVELOPMENT LLC**
 Site: **COAL HOLLOW**
 Address: **463 North 100 West, Suite 1, CEDAR CITY UT 84720**
 County: **KANE**
 Permit Type: **PERMANENT COAL PROGRAM**
 Permit Status: **ACTIVE**

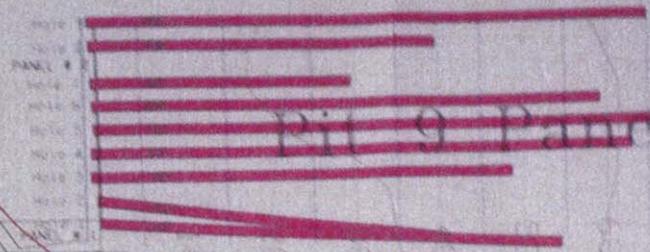
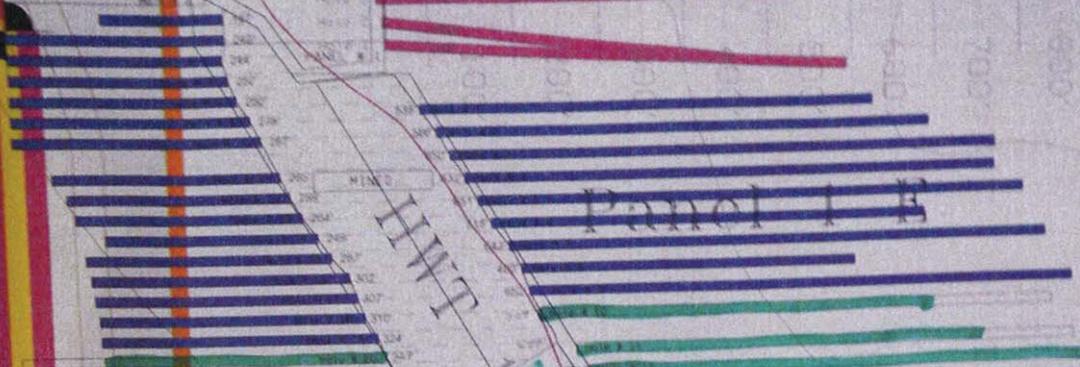
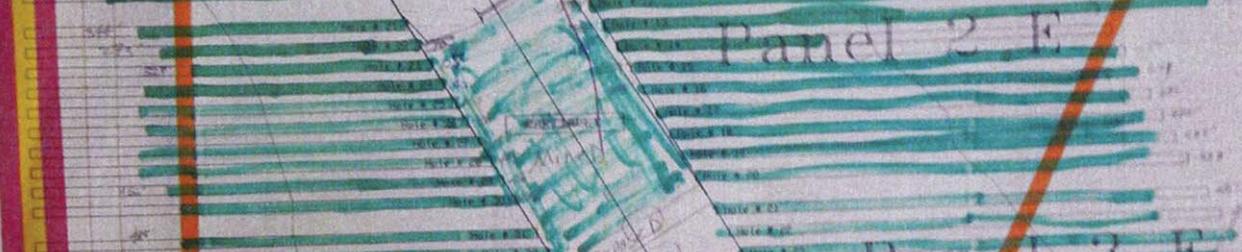
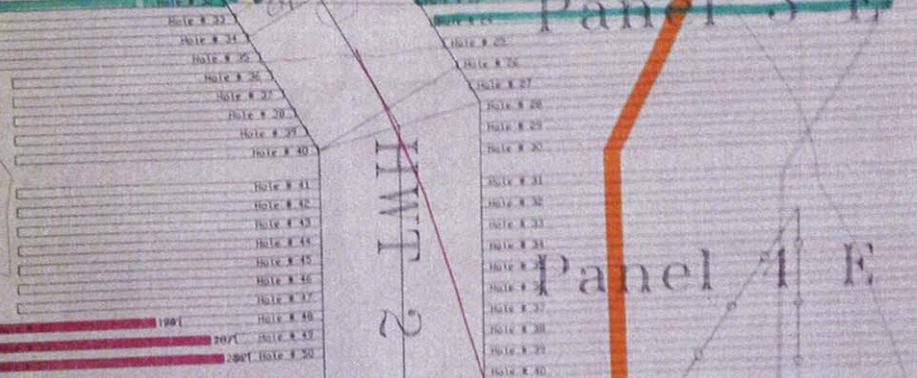
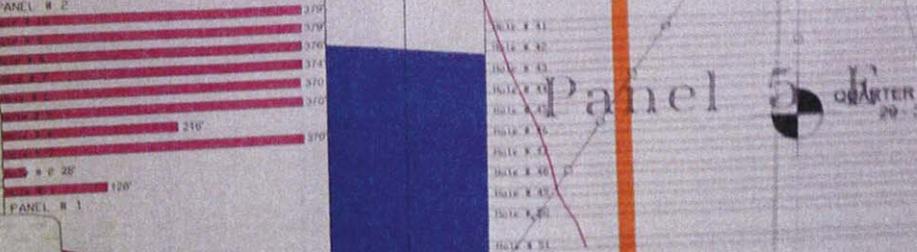
HWT 1 was backfilled above the coal. The haul road/entrance to the HWT 2 face was approximately 1,000 ft. long beginning in HWT 1. Mining activity was focused on construction and extension of HWT 2 where a blast was recently conducted and the overburden had been removed. (See the attached mining progress figure.) The alluvium above this section of HWT2 was being shaped to a 4h:1v slope. The coal in a 200 ft square block was being removed by an excavator and loaded onto haul trucks. This is the first coal to be loaded in a week. Mining activity also focused on construction and face-up of 3 portals in the UG Mine. Four coal haul trucks were running all day hauling gravel and cobbles from a gravel pit south of the mine on the County road to the UG mine/Pit 10 haul road. There was no backfilling occurring.

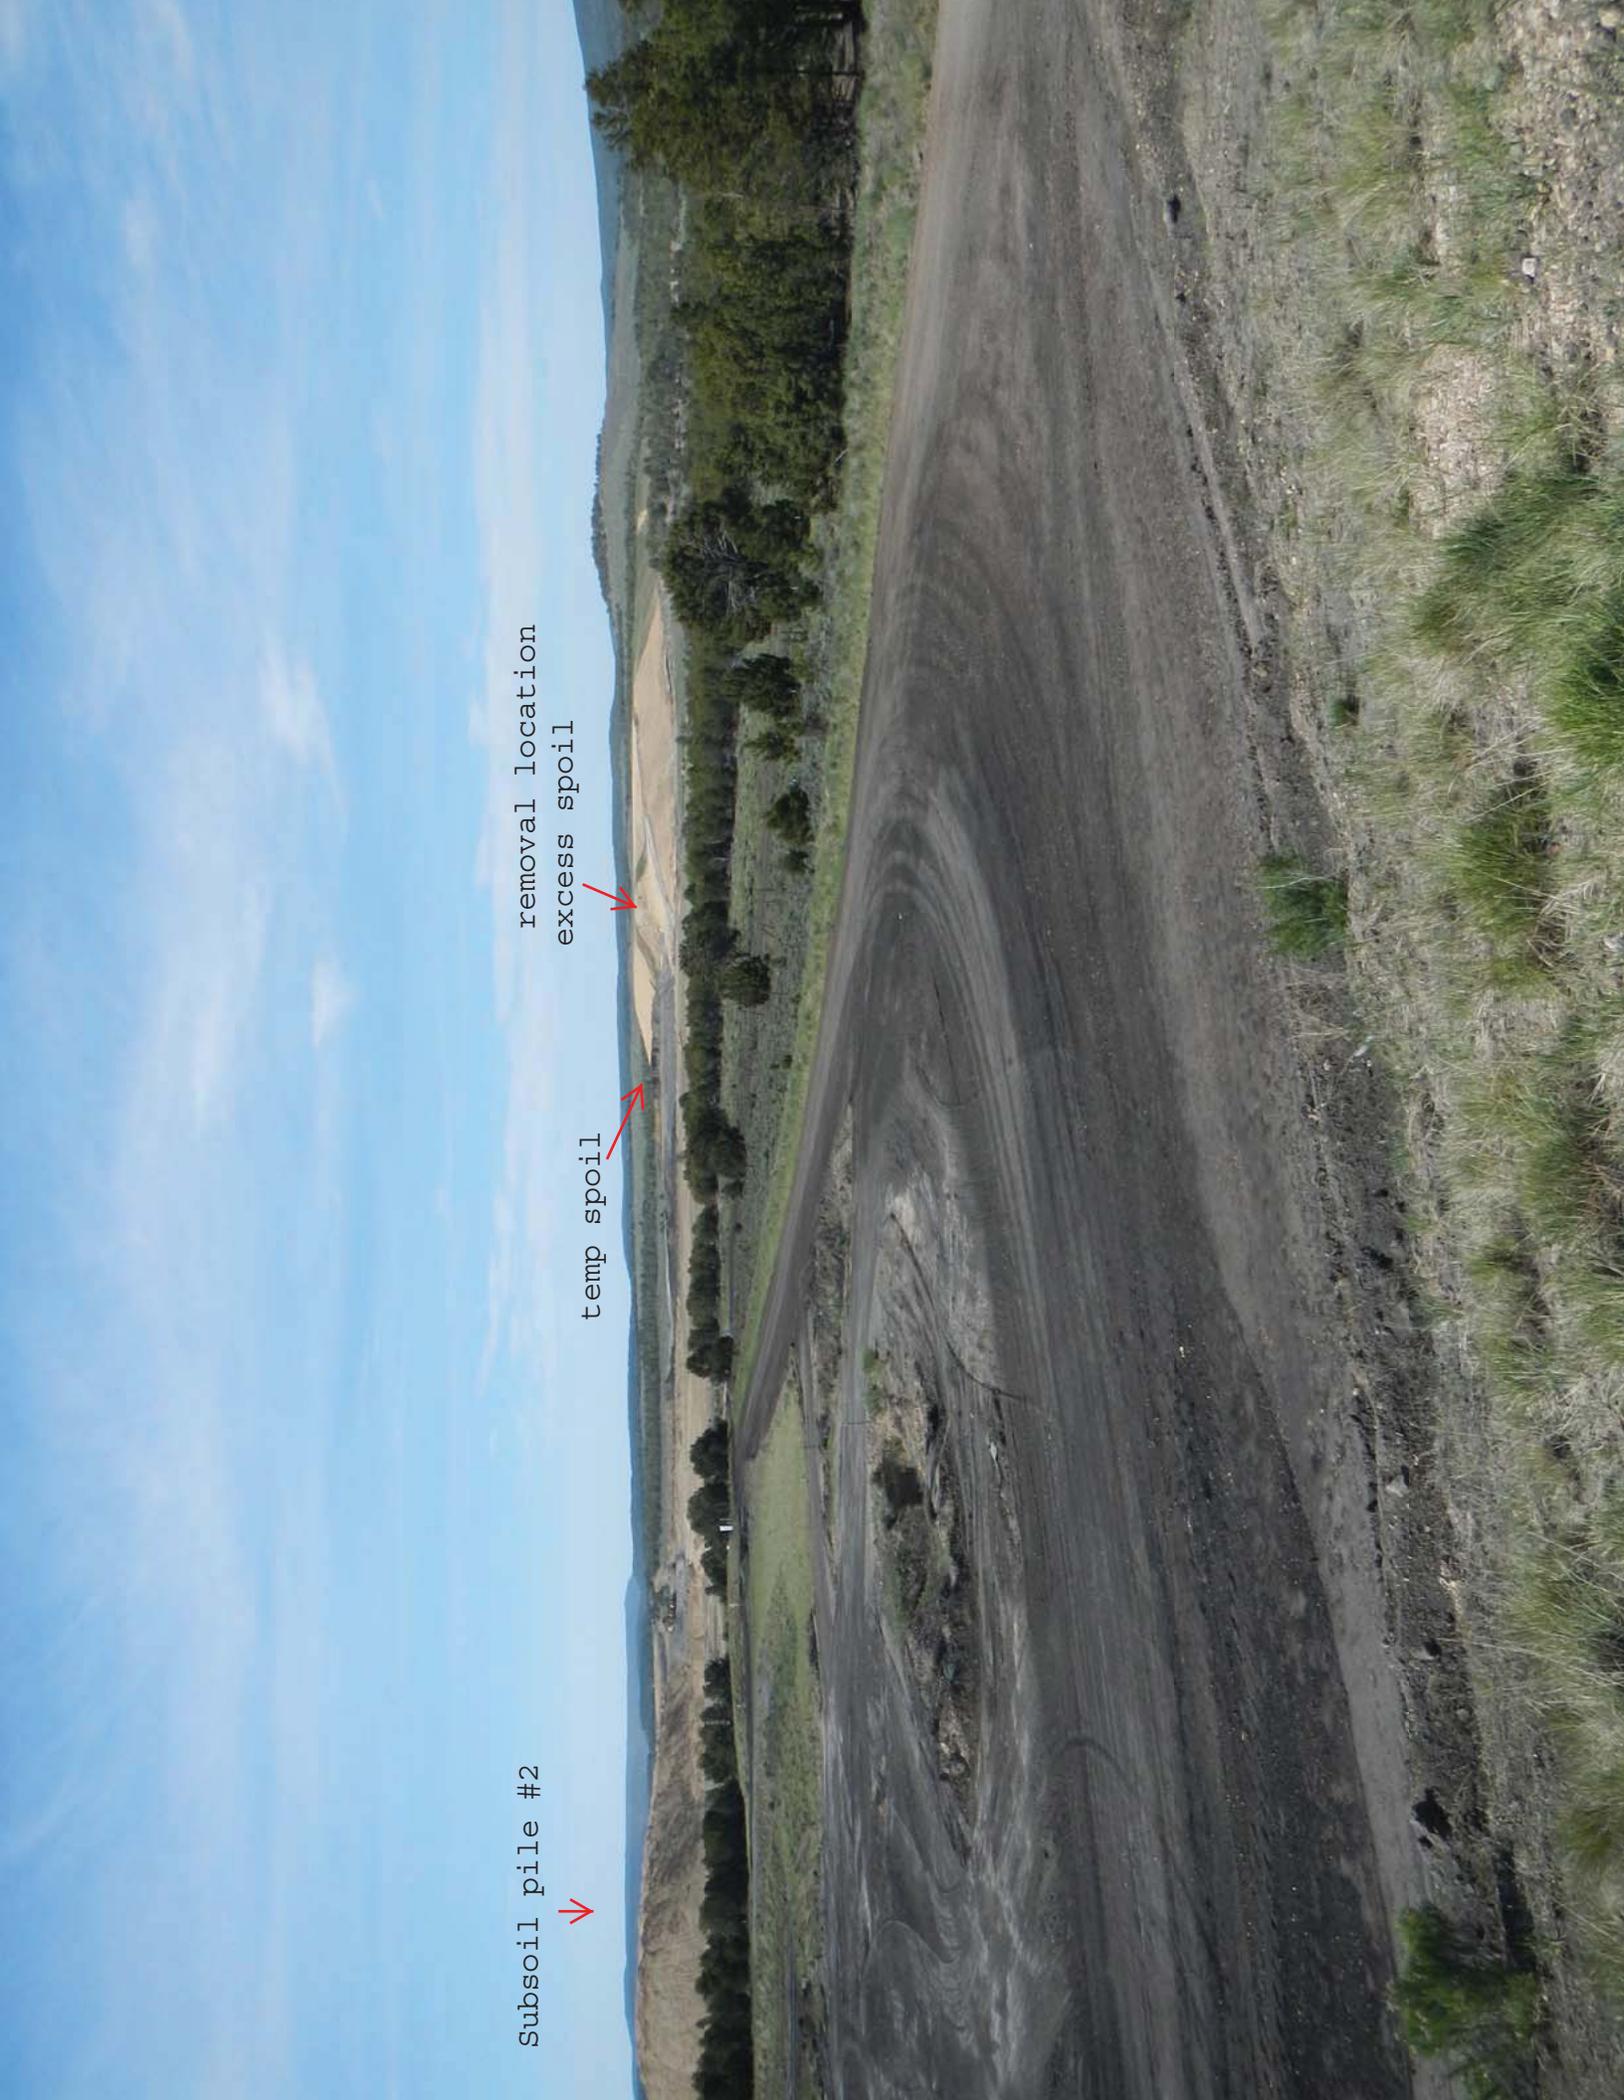
There was approximately 100,000 CY of formerly excess, now temporary, spoil remaining to be removed and used as fill in pits and trenches. There was one dozer ripping the temporary spoils, but no excavator was present to load trucks. There were no trucks hauling backfill.

The gully on the south side of the Excess Spoils pile was filled with pinyon tree branches. It is hoped that the branches will trap sediment and fill in the gully. This repair approach does not meet the requirements of R645-301-244.320. The Division staff will be asked to evaluate this approach and determine whether it will suffice, further work may be required. This location will be closely monitored for compliance with R645-301-746.221 and R645-301-762.100.

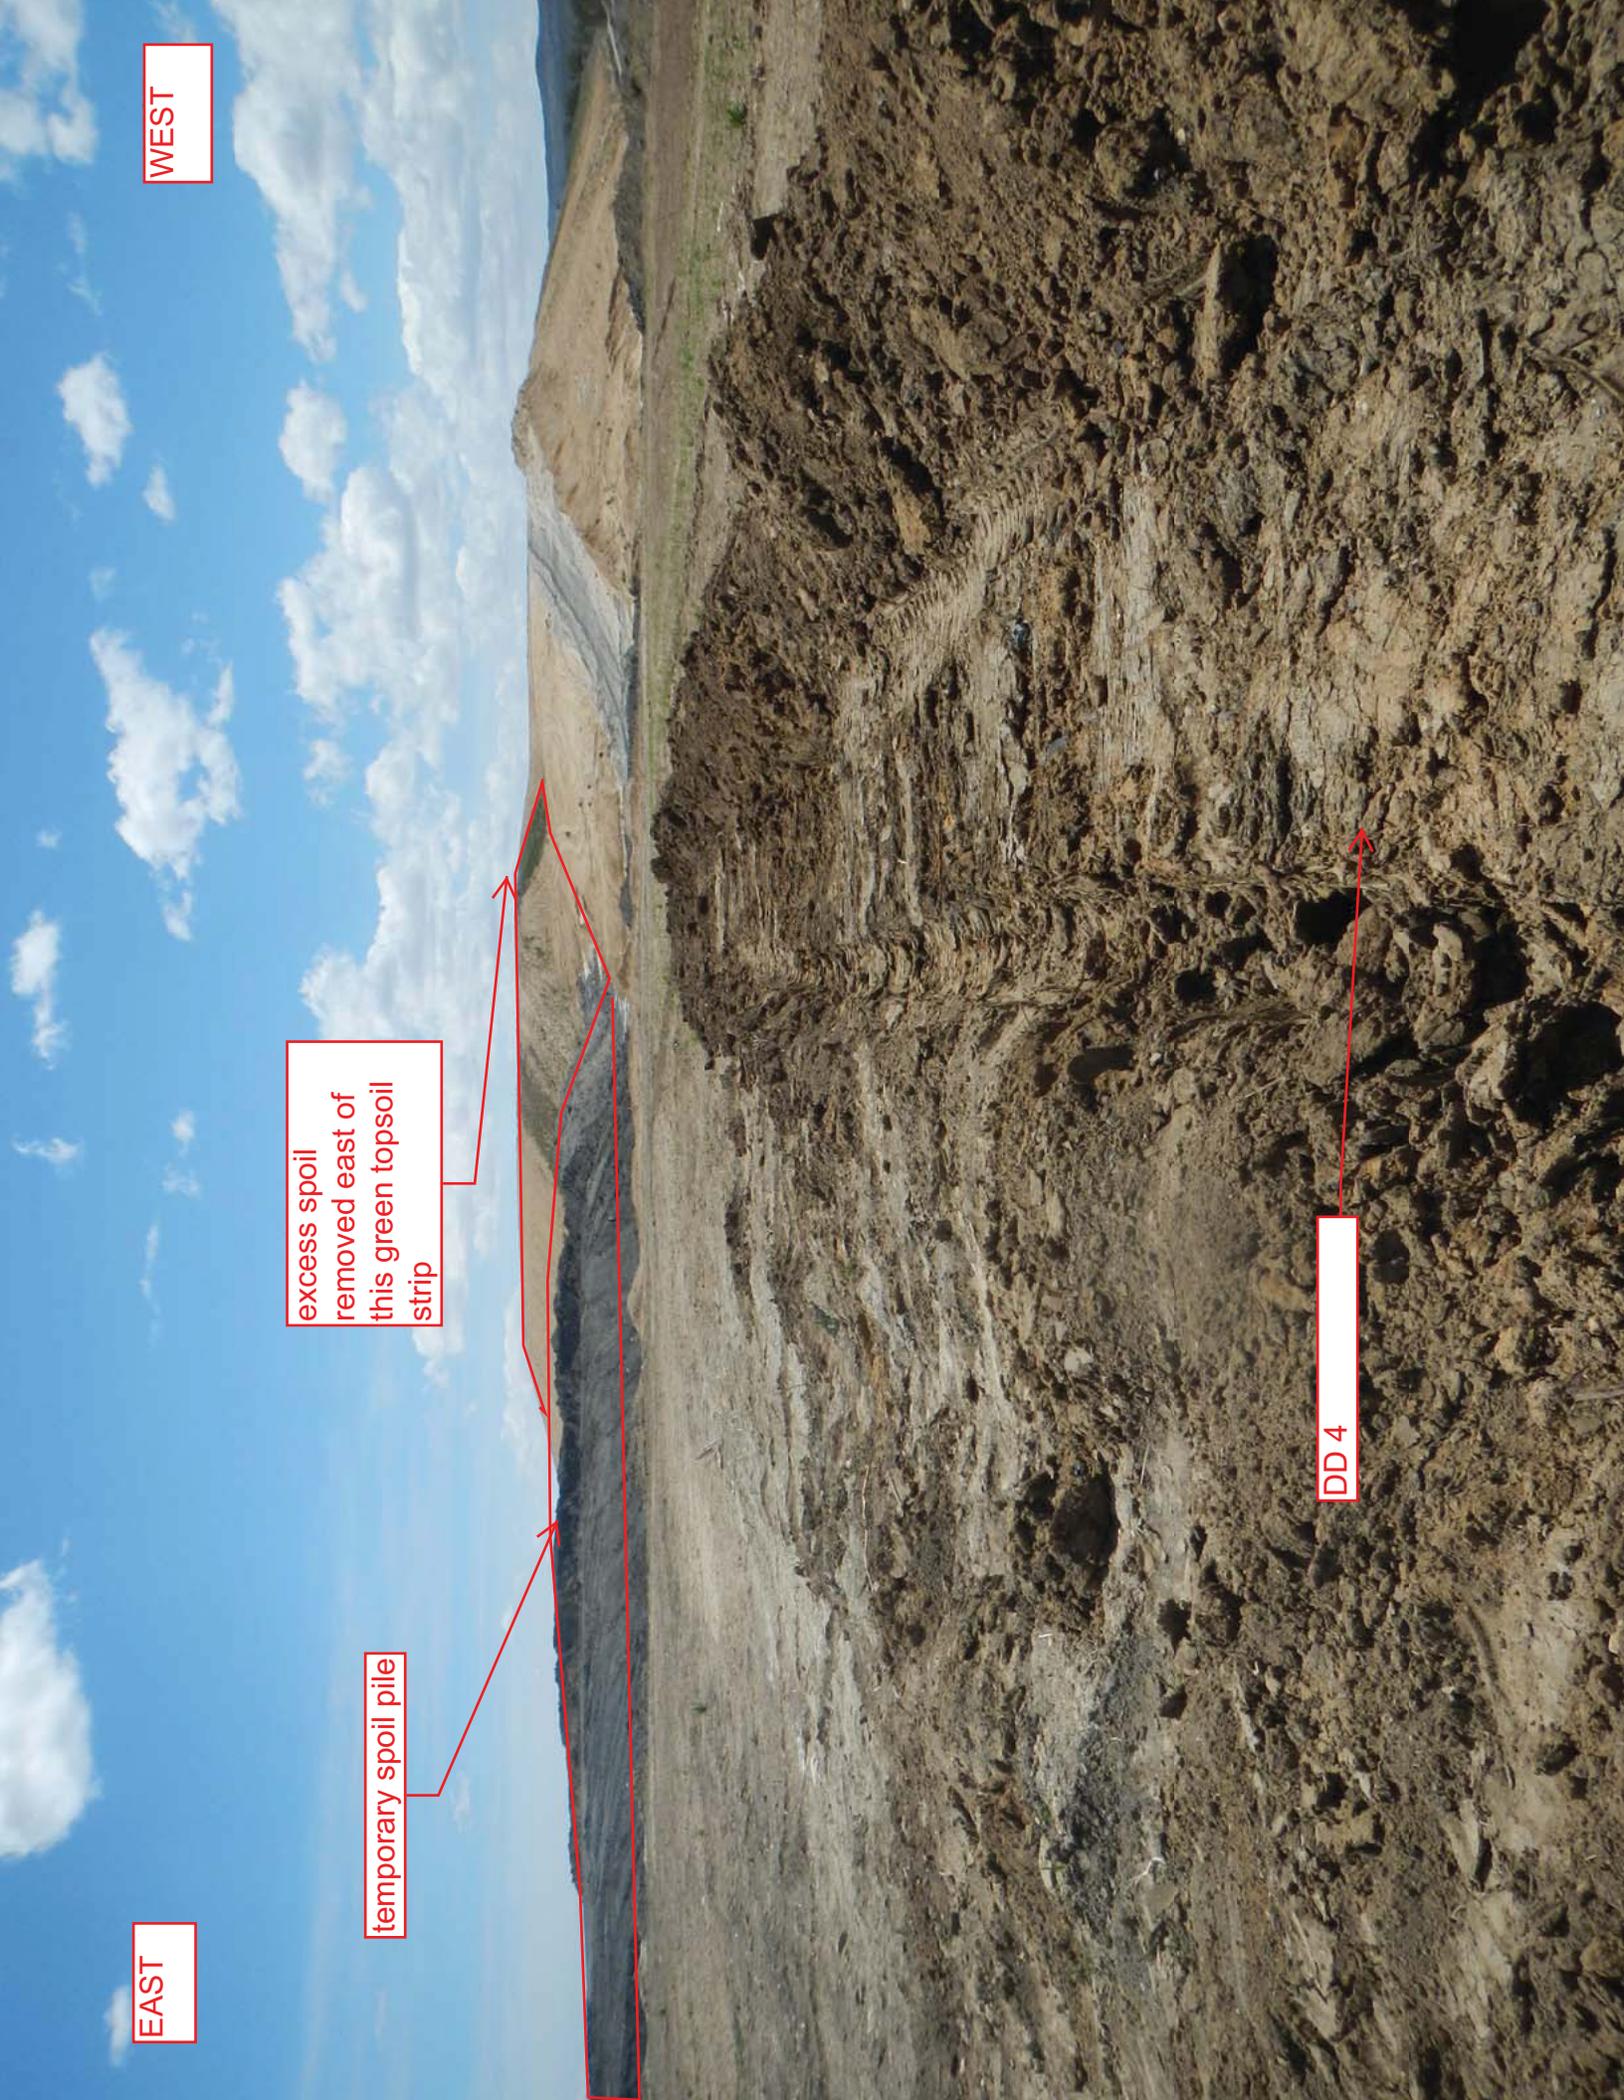
DD 4

DD#4 was under construction using a bobcat excavator. The ditch measured 5 ft wide with 2h:1v side slopes. The "borrow" from the ditch was being placed on the uphill side of the ditch (that is the side near Robinson Creek). When it comes time to reclaim, the ditch will be filled in with this soil. Designs for DD #4 are found in Dwg 5-34. Seed was on hand to seed the new ditch DD#4 and to seed the location of the old ditch, that has now been filled in.
