Coal Hollow Inspection June 16, 2015

Inspection Report

Permit Number:	C0250005
Inspection Type:	COMPLETE
Inspection Date:	Tuesday, June 16, 2015
Start Date/Time:	6/16/2015 9:00:00 AM
End Date/Time:	6/16/2015 3:00:00 PM
Last Inspection:	Tuesday, June 09, 2015

Permittee: **ALTON COAL DEVELOPMENT LLC**
 Operator: **ALTON COAL DEVELOPMENT LLC**
 Site: **COAL HOLLOW**
 Address: **463 North 100 West, Suite 1, CEDAR CITY UT 84720**
 County: **KANE**
 Permit Type: **PERMANENT COAL PROGRAM**
 Permit Status: **ACTIVE**

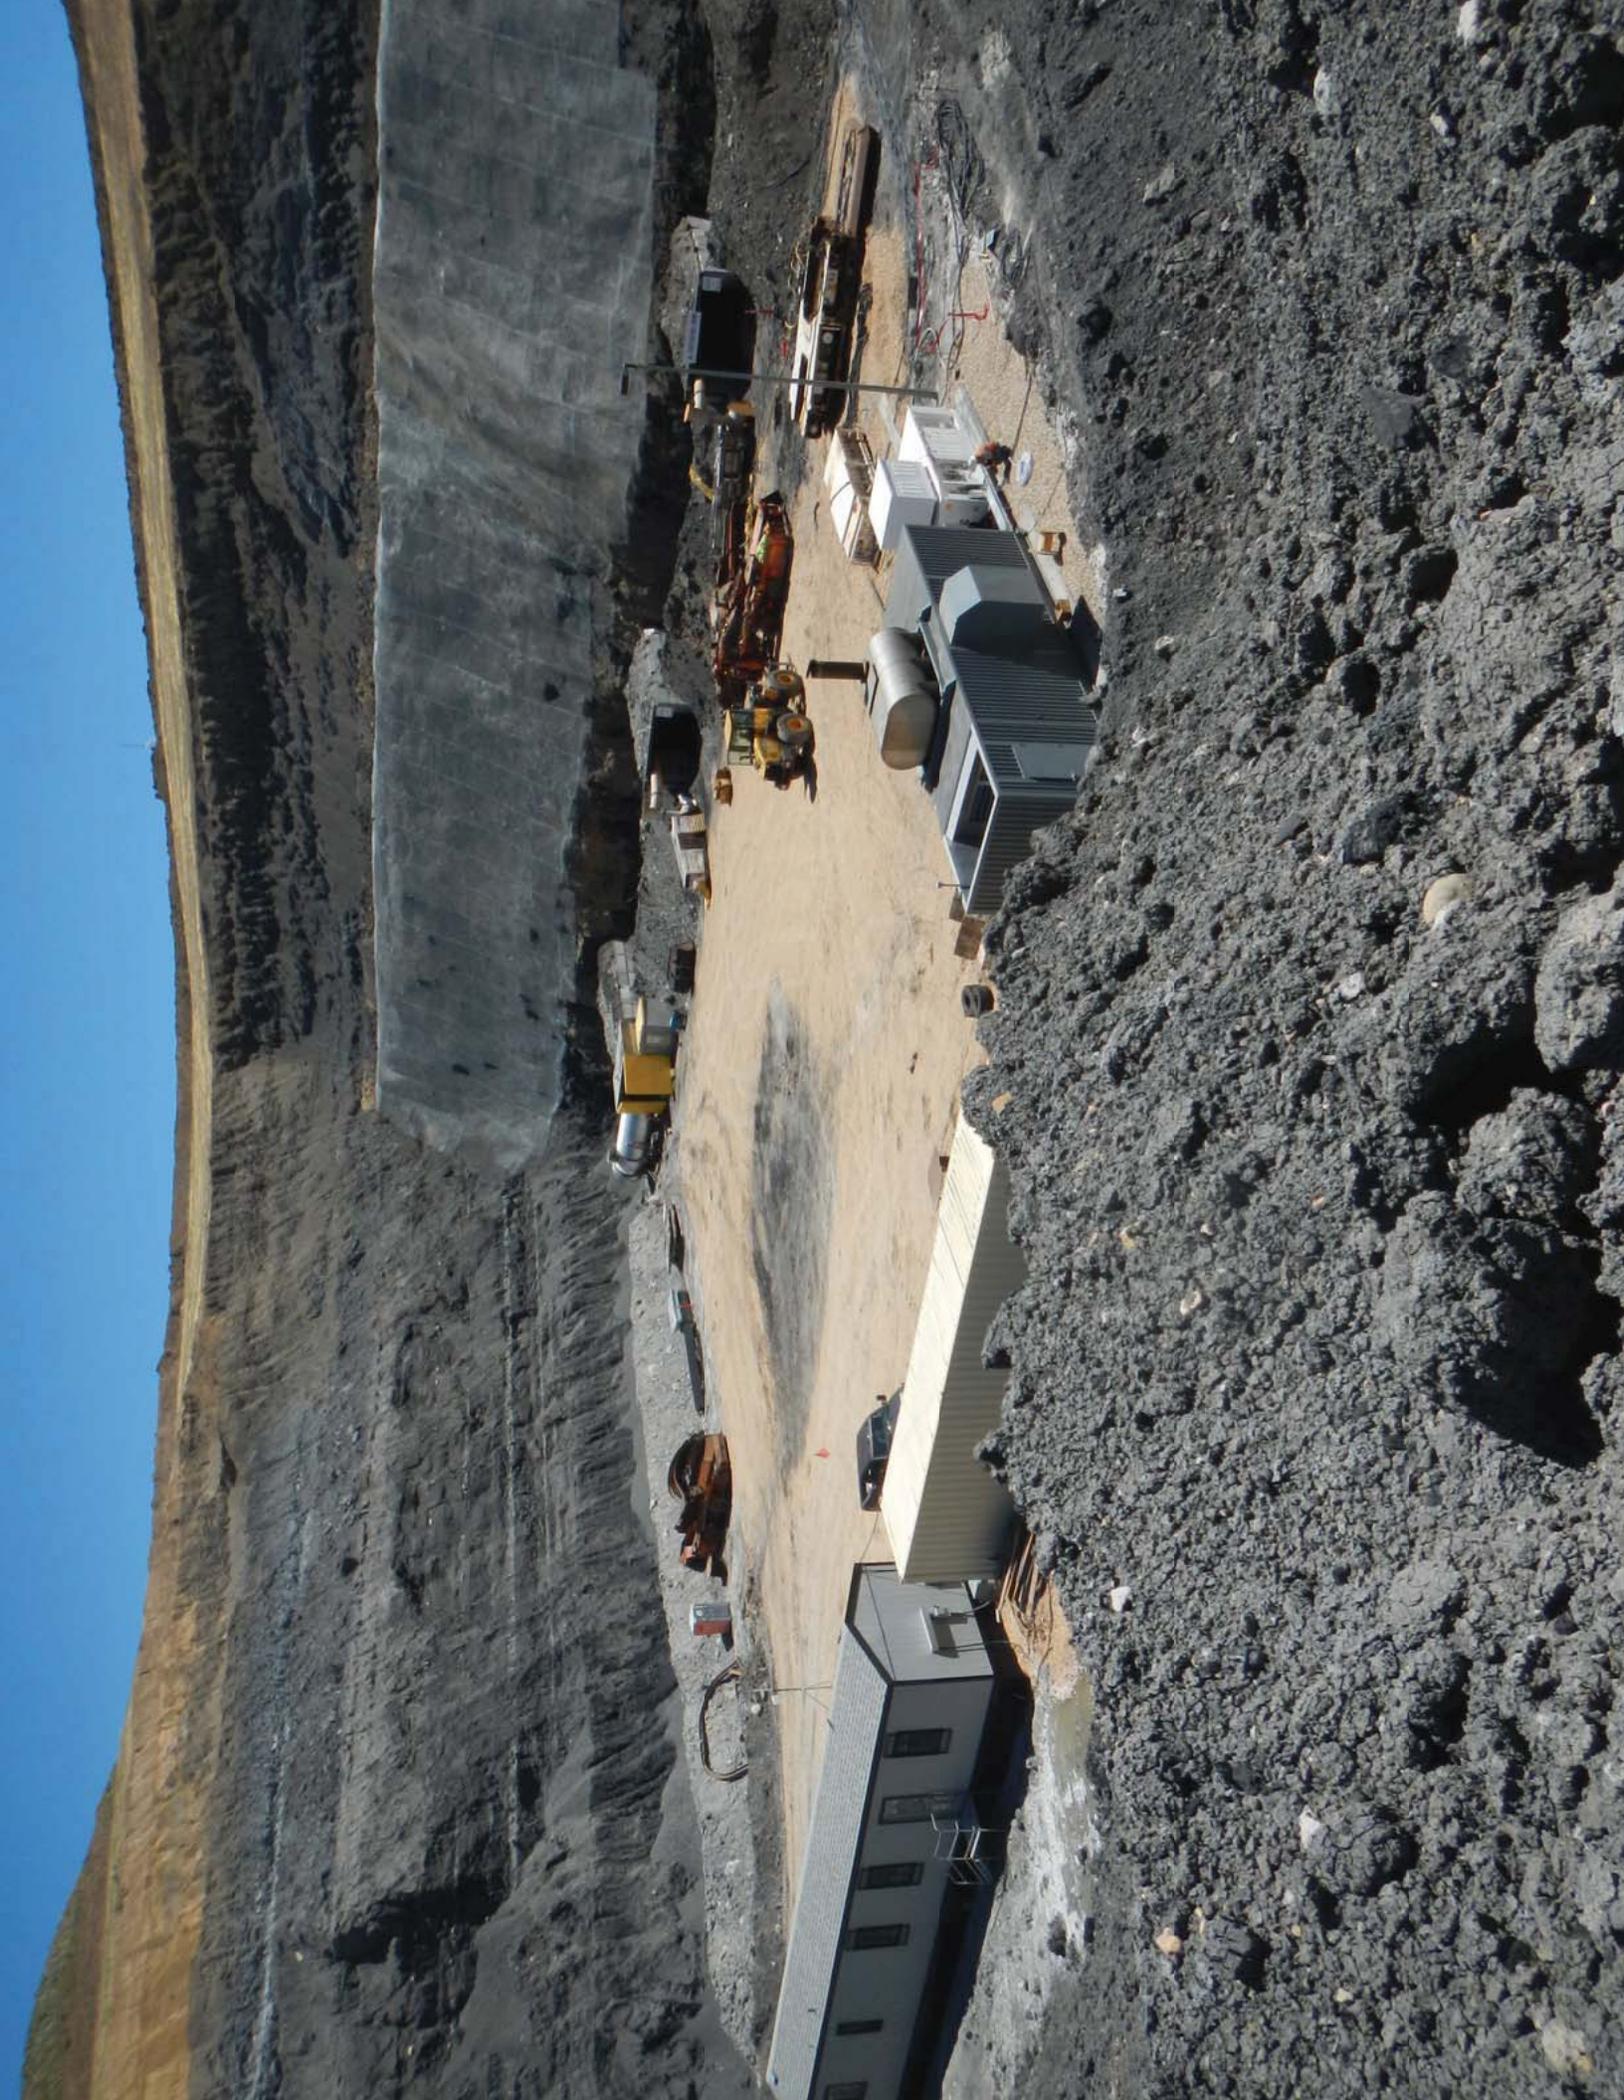
Seeded slope above the Burton #1
Mine (Pit #10) highwall
