Coal Hollow, NOV #20153, Task ID #4949

**Citation for Non-Compliance
Utah Coal Regulatory Program**

Inspection Report

InspectionID Report Number: 4234

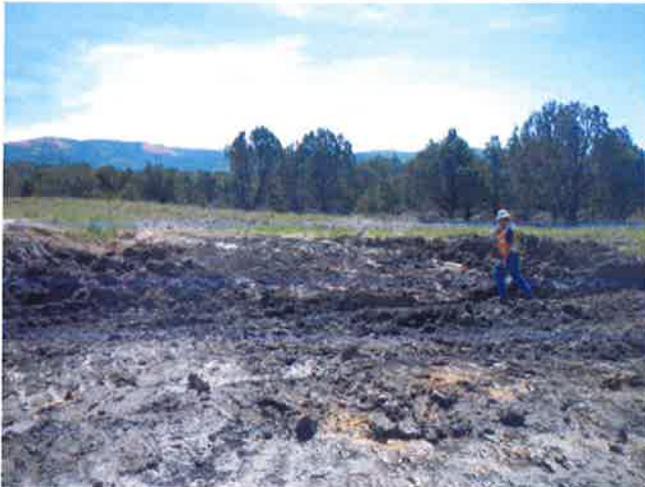
Maintenance was completed on a leaking valve at the water tanks located on the far east side of the facilities area. The area around the south side of the water tanks was saturated and had clearly been worked by equipment. In the process of the repairs to Ditch C7 a stockpile of saturated soil sits south of the tanks. The June 16th inspection requested that the weeds and sediment be cleared from C7. While some work was clearly done, the area still requires some fine grading to establish flow to ditch C7. The Permittee was told to move the stockpiled soil south of the water tanks to the appropriate stockpile area and to stabilize it. See photos 1 through 6 for details.

3. Wet material still present where pipe was repaired

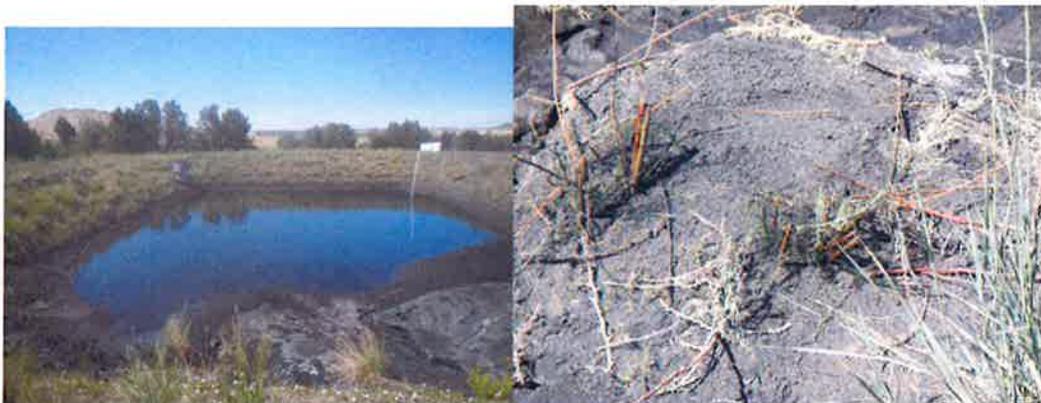
Tamarisk plants at all the ponds one through four were cut and treated with Garland on 6/25/15. This action meets the requirements stated in the June 16th inspection and R645-301-742.123. See photo 10 for example of treatment at Pond 1B.

10. Pond 1B with Tamarisk cut

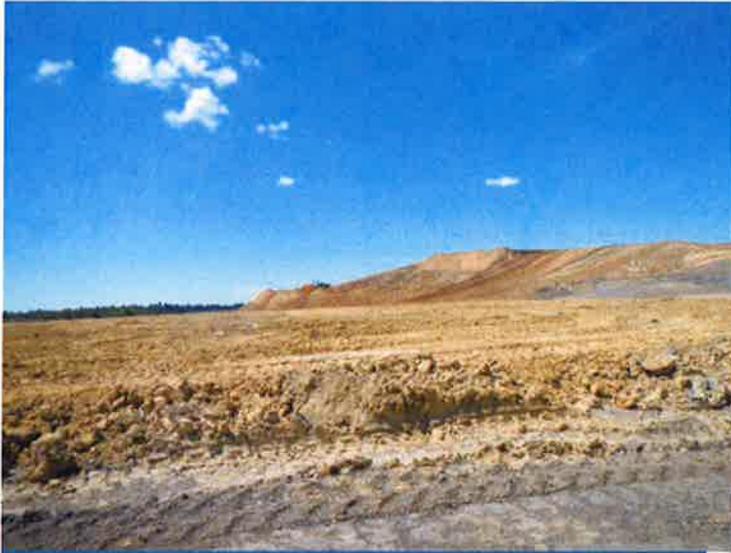
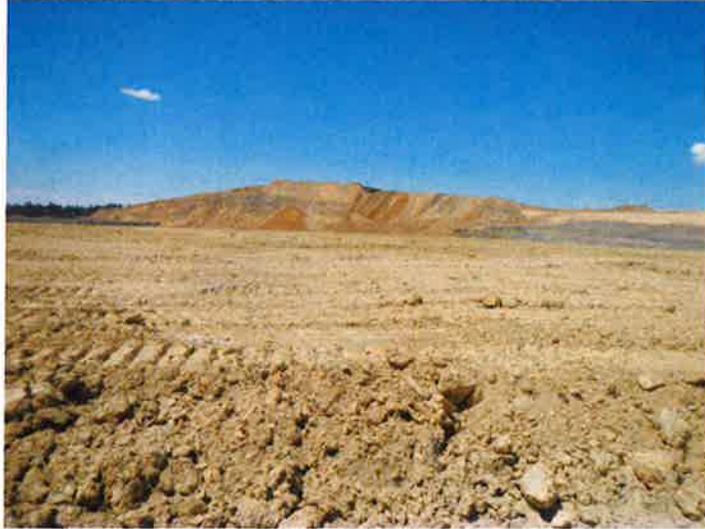
20. Working face of excess spoil pile

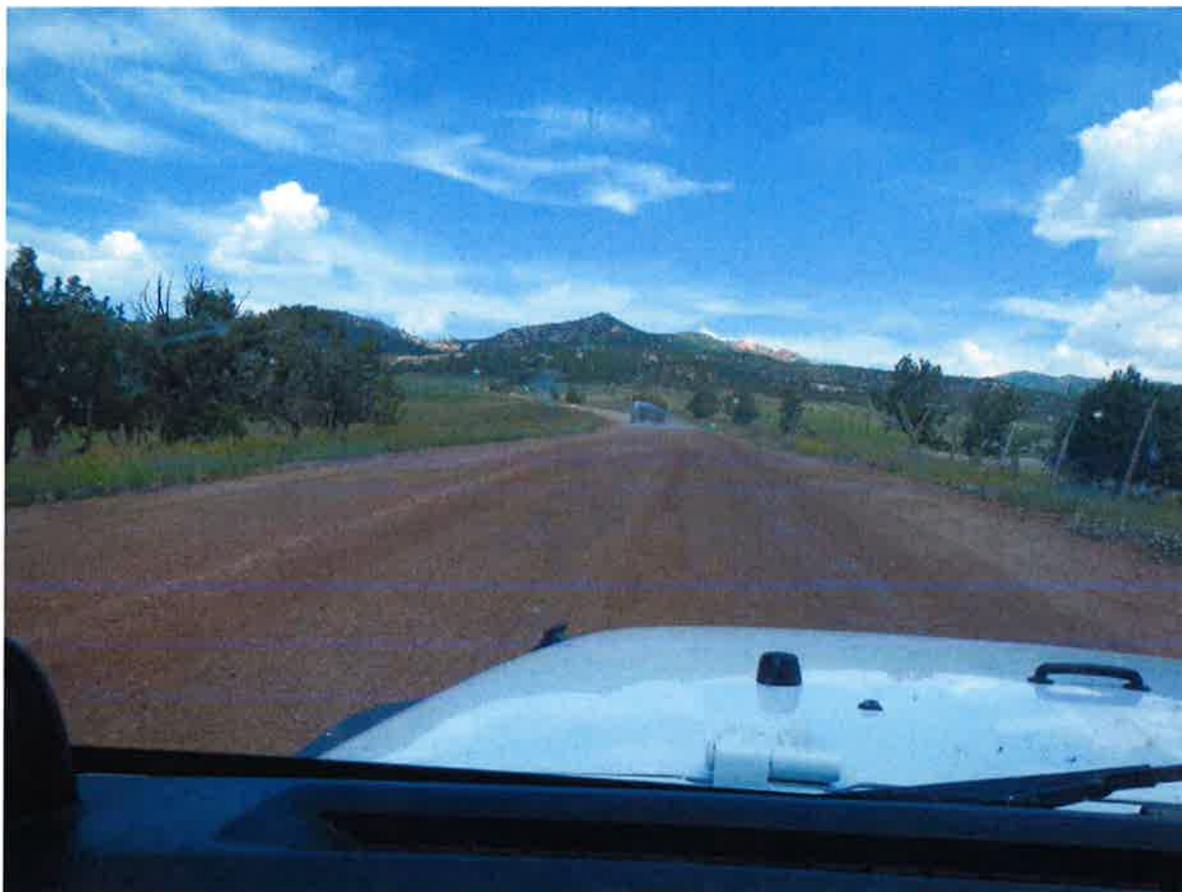
The grader was witnessed surfacing the current haul road. The water truck was also witnessed maintaining dust control. See photo 26.

26. Water truck watering the mine access road
