**Citation for Non-Compliance
Utah Coal Regulatory Program**

Citation #: 20153

Inspection Report

InspectionID Report Number: 4234

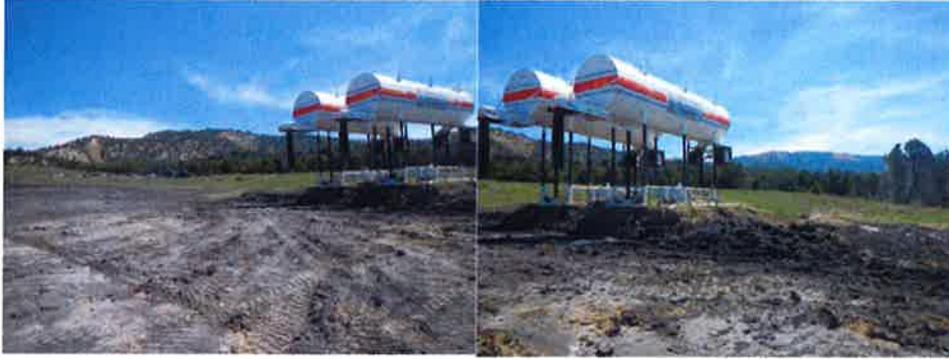
Maintenance was completed on a leaking valve at the water tanks located on the far east side of the facilities area. The area around the south side of the water tanks was saturated and had clearly been worked by equipment. In the process of the repairs to Ditch C7 a stockpile of saturated soil sits south of the tanks. The June 16th inspection requested that the weeds and sediment be cleared from C7. While some work was clearly done, the area still requires some fine grading to establish flow to ditch C7. The Permittee was told to move the stockpiled soil south of the water tanks to the appropriate stockpile area and to stabilize it. See photos 1 through 6 for details.

1. Water tanks on East side of the facilities area

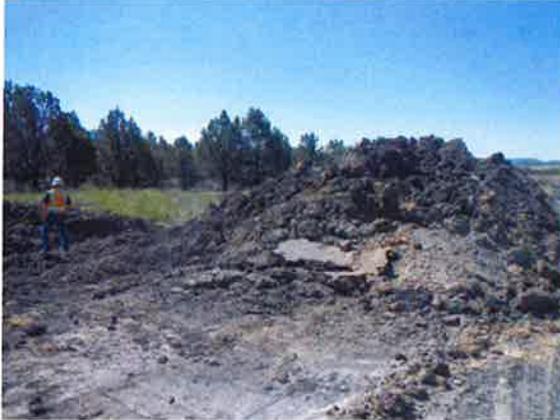
2. Soil pile from maintenance work completed at water tanks

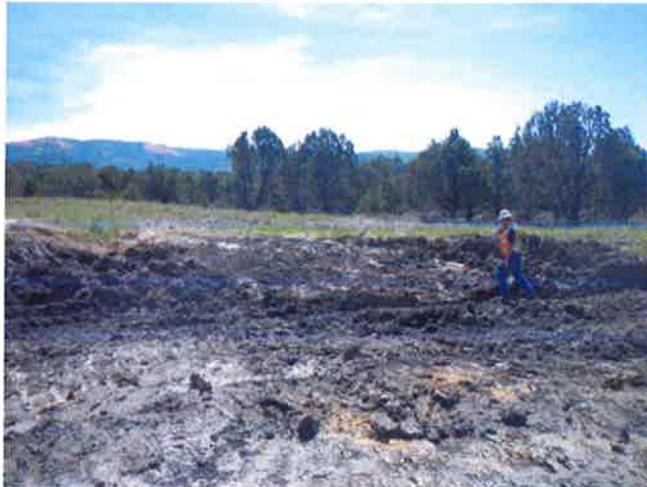
3. Wet material still present where pipe was repaired

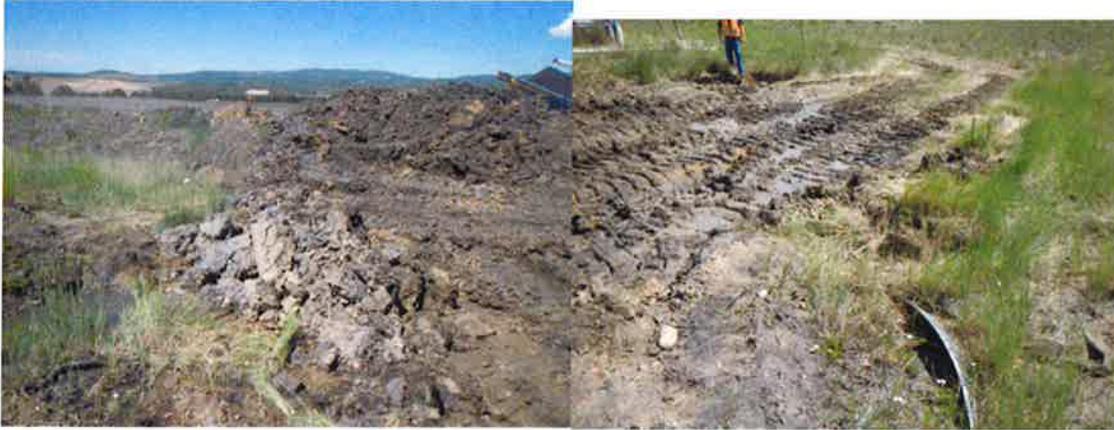
4. Material pushed onto undisturbed area

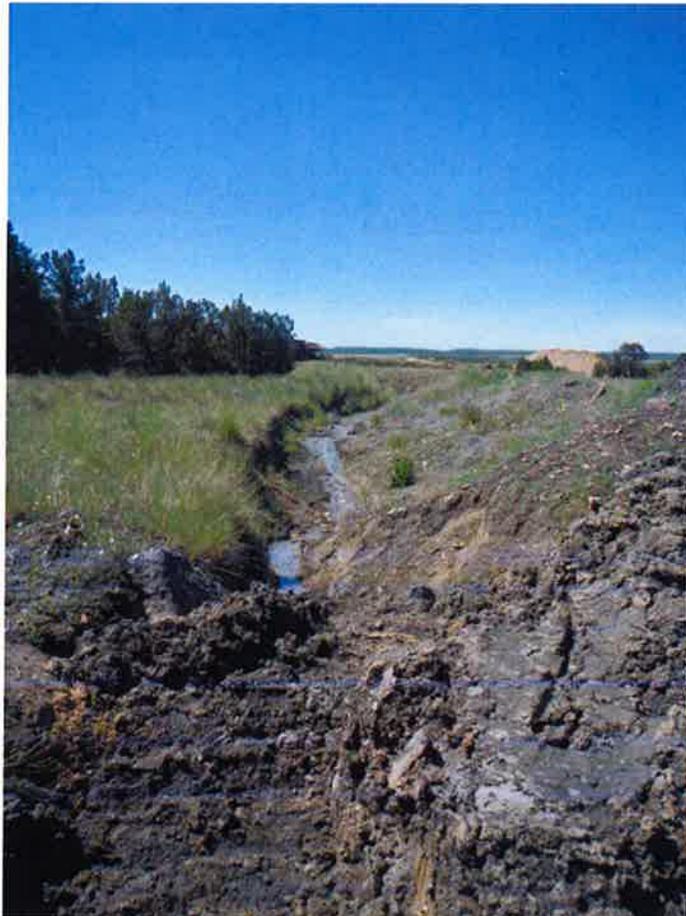
5. Flow from water tanks into ditch C7

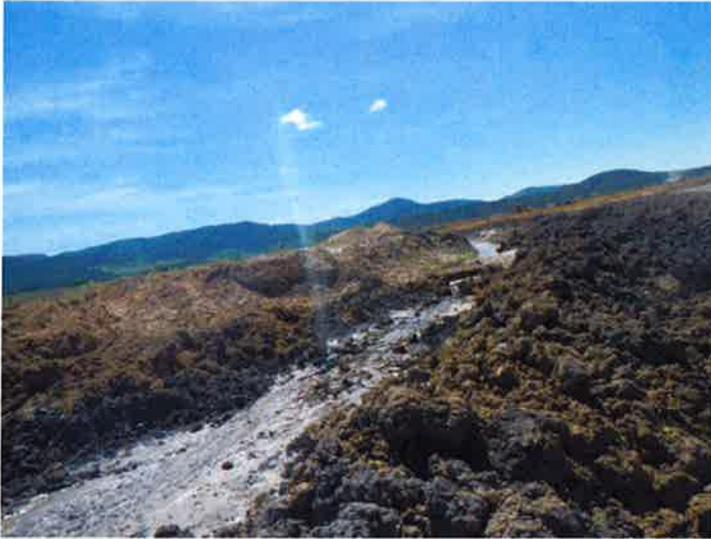
6. Road drainage before junction with DD#4

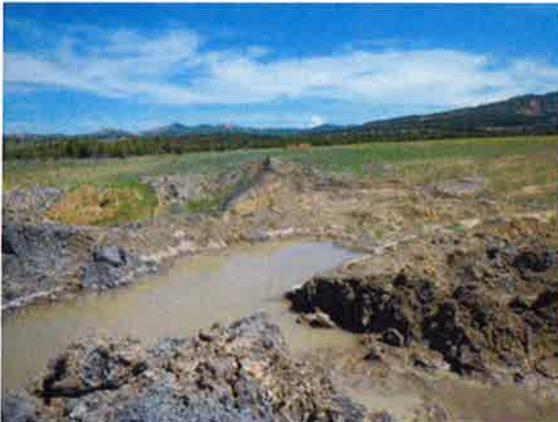
Diversion Ditch DD#4 berms had been recently worked. A high spot still remains just south of where the road drainage ditch connects with the newly constructed DD#4. The area is still ponding water but is dry enough that equipment should be able to clear the high spot so that drainage may free flow to Pond 3. The Permittee was told to remove the final high area within DD#4 that is acting like a plug in the flow of the ditch. See photos 7 through 8 for details.

7. Junction of Road drainage and DD#4

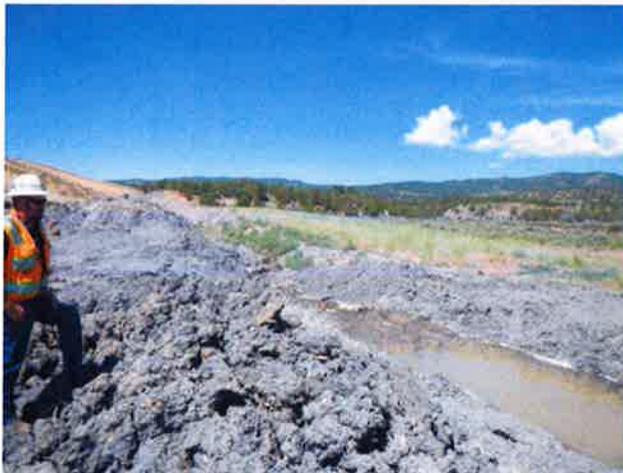
8. Flow West of DD#4 after junction to Pond 3

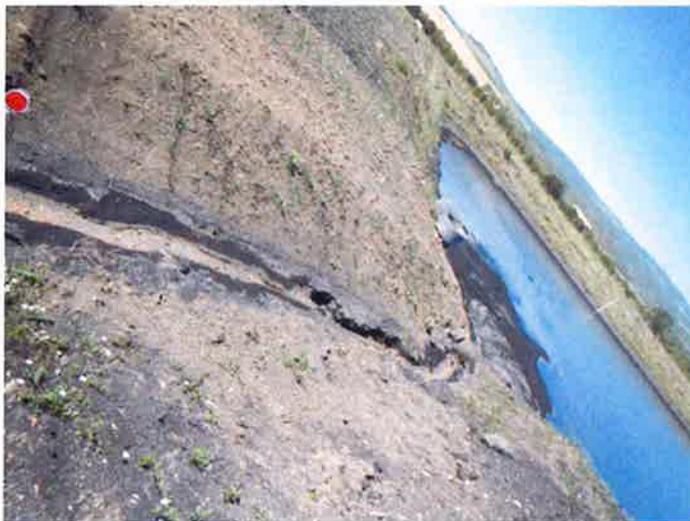
The Permittee stated that the second quarter certified pond and spoil inspections were completed the previous week and the final copies had yet to be received. The water truck was pulling water from Pond three at the time of the inspection. All ponds were inspected and found that the levels were relatively low with sediment levels below all the clean out marks. See Photos 12 for an example of water level height. Pond 1 has a gully on the east bank that still needs repairing along with riprap placed in the outlet. These maintenance tasks were required to be completed in the June 16 inspection by June 30. The Permittee submitted a design to modify the current inlet to Pond one. The Modification showed that the stated maintenance will be repaired during the construction of the modifications. The Pond one amendment was sent back deficient, Task 4894, on 6/9/15 and the Division has yet to receive the amended application. In the meantime, the maintenance needs to be completed before the rain season starts so riprap should be placed no later than 7/13/15, per as build drawing C9.0 for pond 1 attached. If the intent is to complete the required maintenance during the amendment's construction, Task 4894, the Permittee needs to resubmit the plans by 7/13/15. See photo 9.

9. Pond 1 inlet

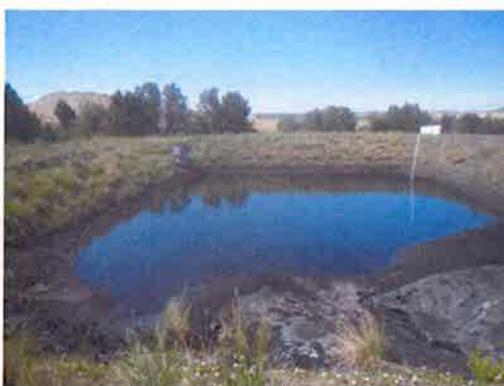
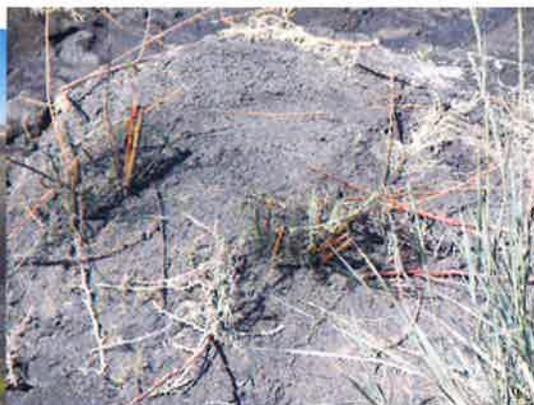
Tamarisk plants at all the ponds one through four were cut and treated with Garland on 6/25/15. This action meets the requirements stated in the June 16th inspection and R645-301-742.123. See photo 10 for example of treatment at Pond 1B.

10. Pond 1B with Tamarisk cut

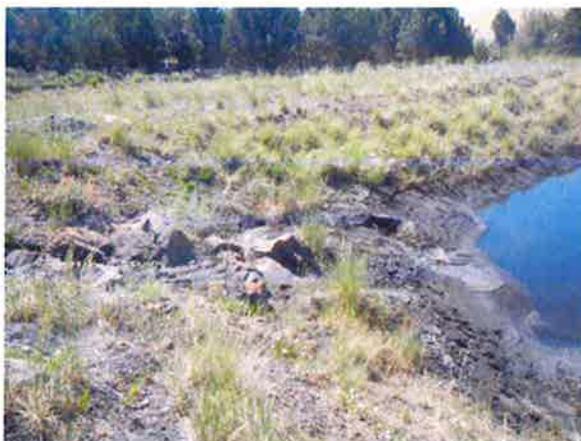
11. Pond 1B inlet

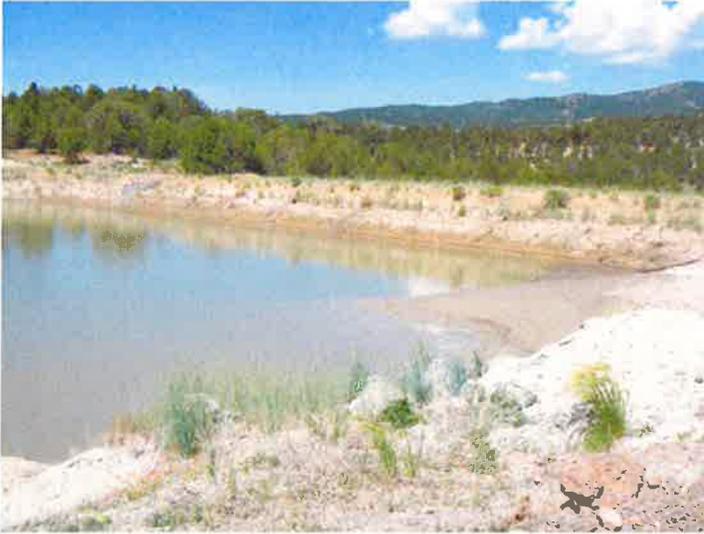
Pond three still requires maintenance on the inlet armoring. The June 16th inspection stated the need for maintenance on the inlet to repair the pond to the Asbuilt design. The water level of the pond is low creating an opportune time to make said improvements.

12. Sediment deposit fan at Pond 3 inlet

There was a discussion with the Permittee for upcoming amendments that would include improvements to Pond 3. The Permittee should submitted amendments to the Division on or before July 21st. See Photos 12 through 14.

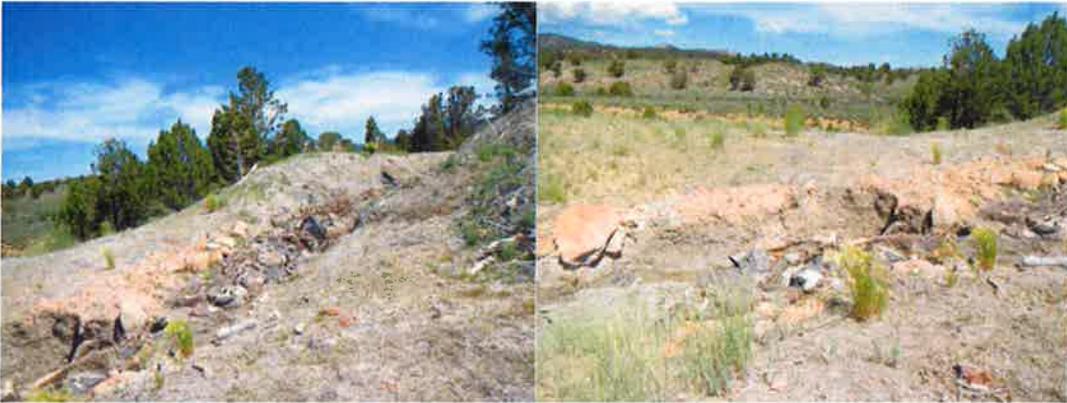
13. DD#4 armoring at inlet to Pond 3 were maintenance is required

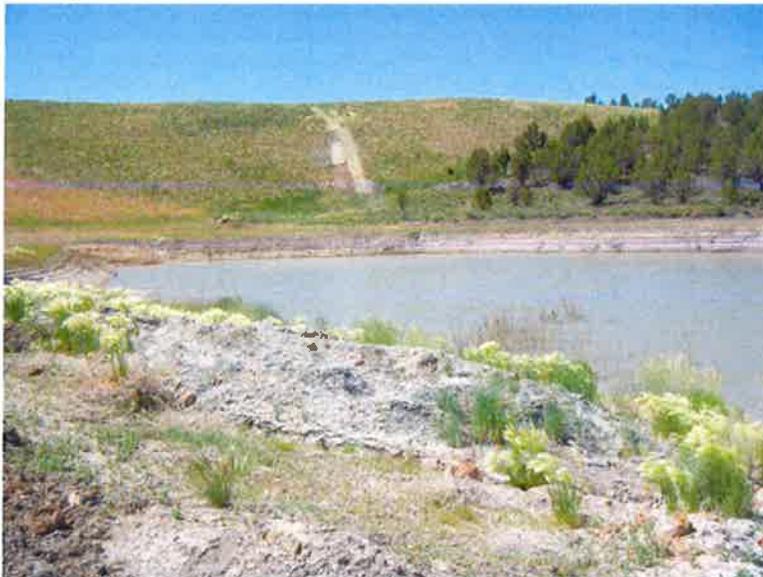
14. Exposed Tamarisk within Pond 3 that were not treated due to limited access

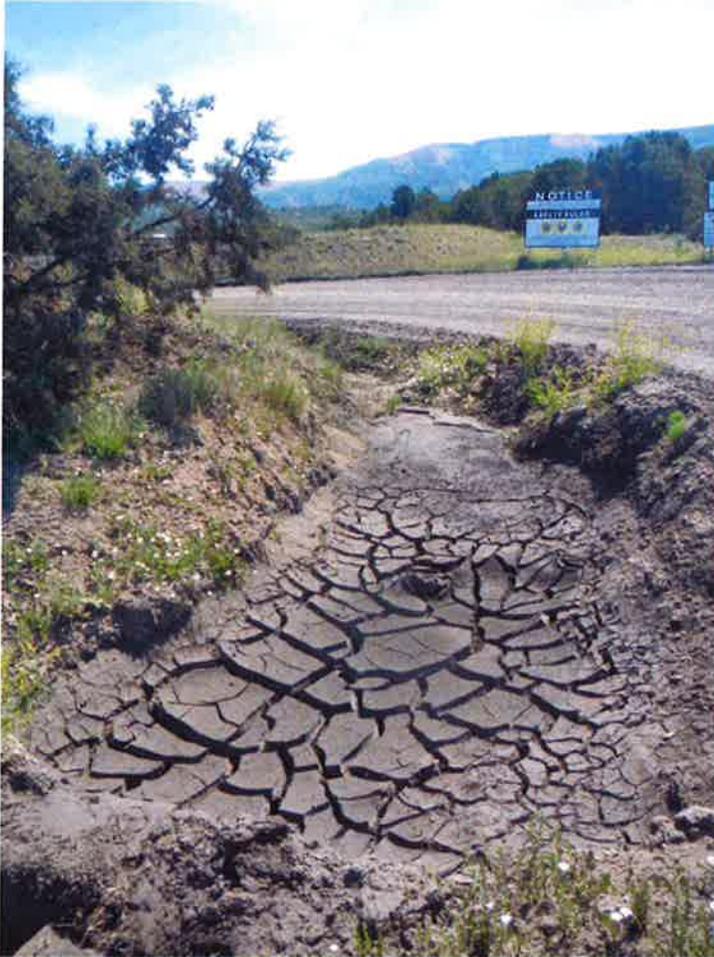
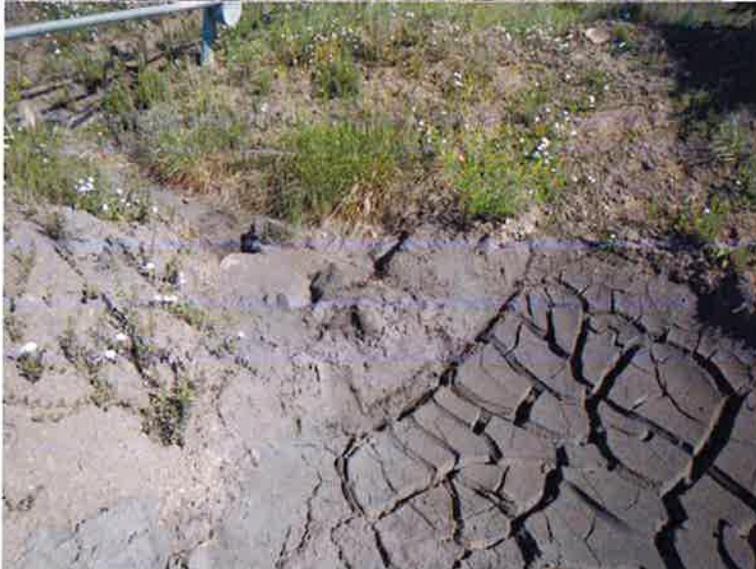
Failure to maintain ASCAs on either side of the mine entrance and failure to maintain the inlet to culvert at the Mine entrance. The inlet to the culvert at the entrance is at least half full, see photo 17 of Inspection Report #4234. The ASCA on the north and south side of the entrance are more than two thirds buried by sediment, see photo 15 and 16 respectively of Inspection report #4234 for more details.

The main entrance ASCA and culvert were inspected, see photos 15 through 17 for details. The June 16th inspection report 4219 detailed that the area has been sufficiently dry for some time and that maintenance needed to be completed prior to the next inspection. NOV 20153 is being issued for failure to maintain this ASCA and the entrance culvert.

15. Main entrance North side ASCA sediment and straw bales.

Establish drainage in the entrance culvert and ASCAs as originally designed and approved in the Mining and Reclamation Plan. The maintenance work will be completed by July 13, 2015.

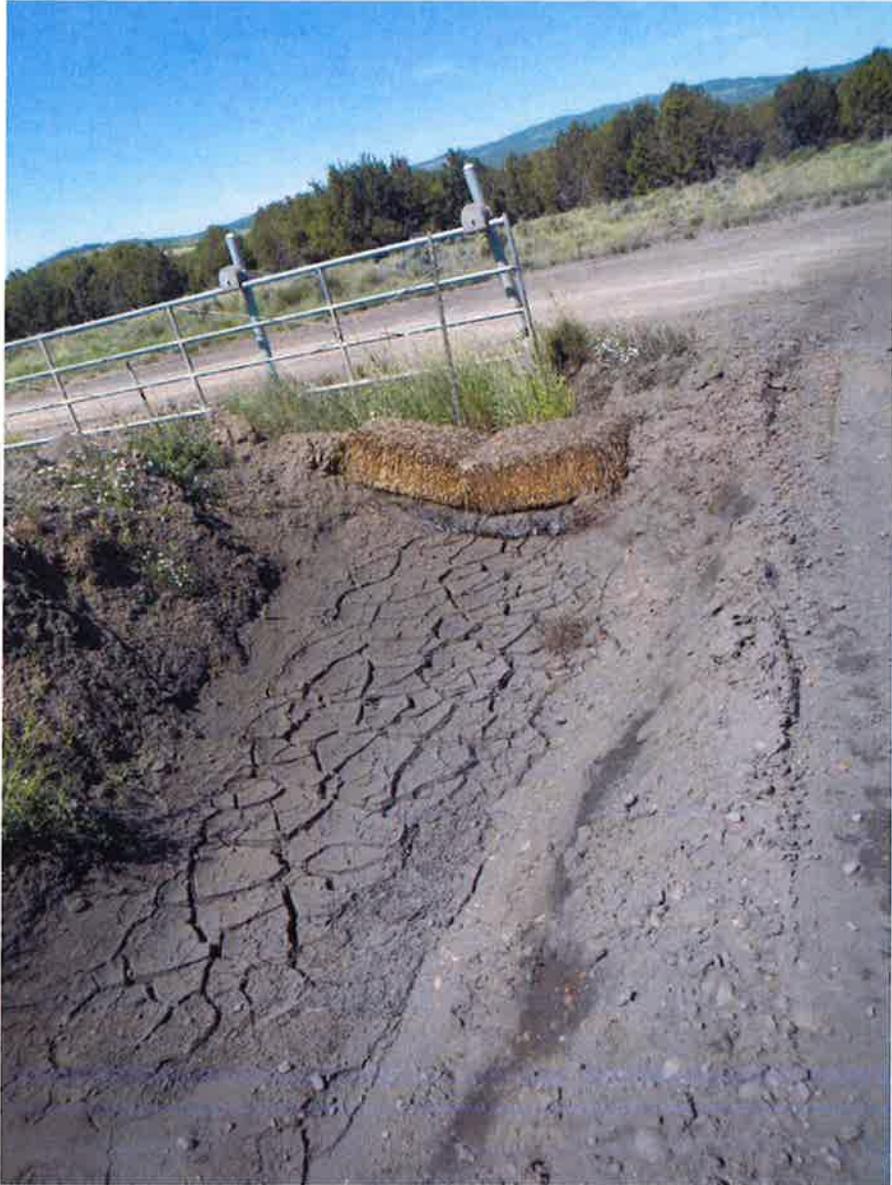
16. Main entrance South Side ASCA

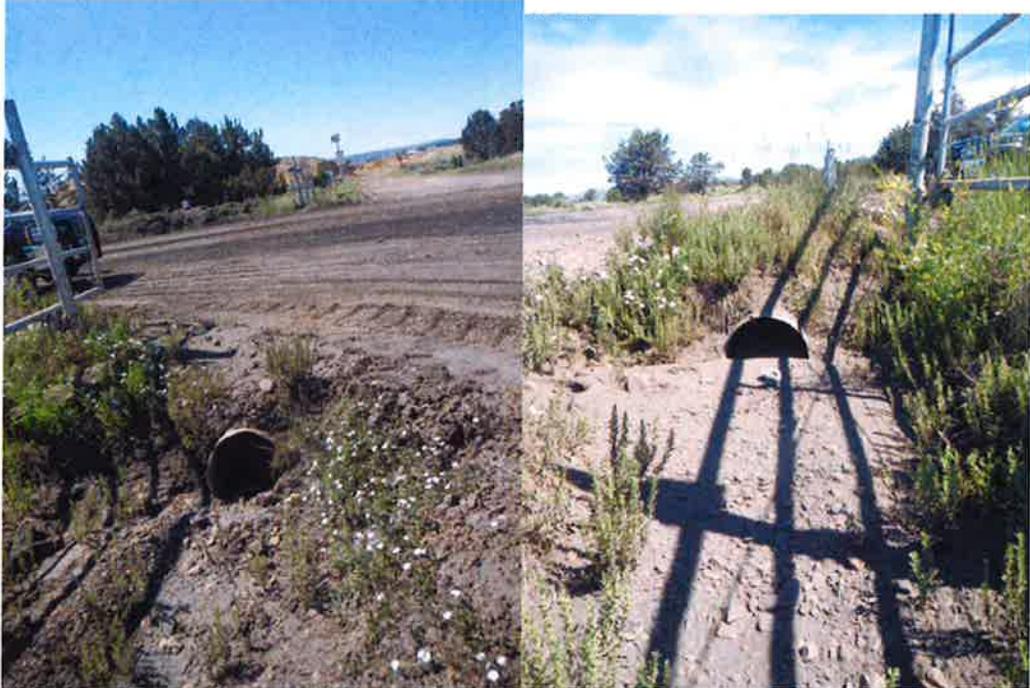
17. Main Entrance Culvert

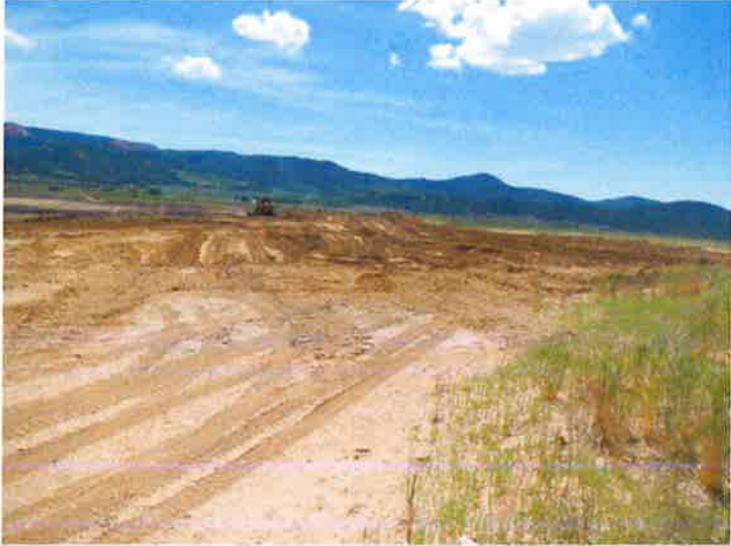
18. Dozer pushing subsoil off excess spoil pile.

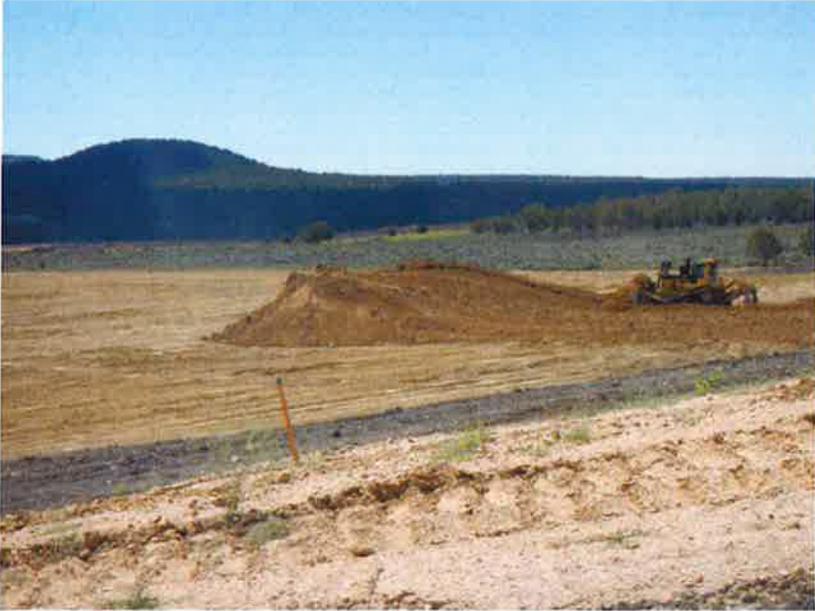
19. Subsoil Pile at base of excess spoil pile

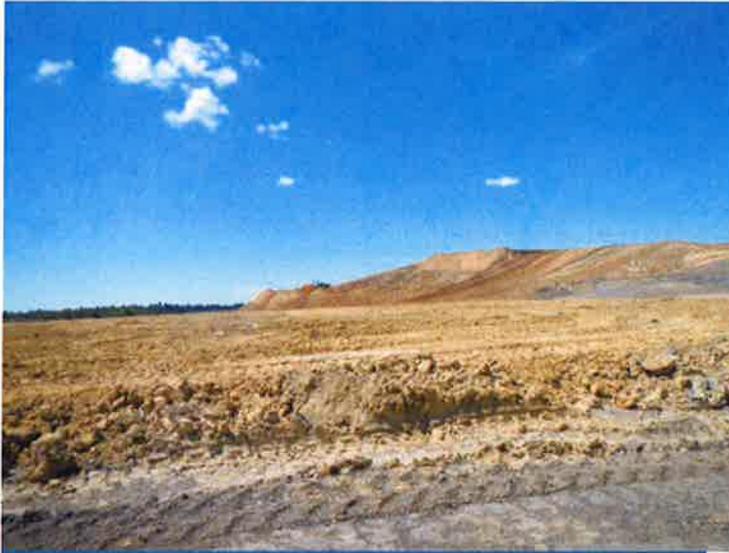
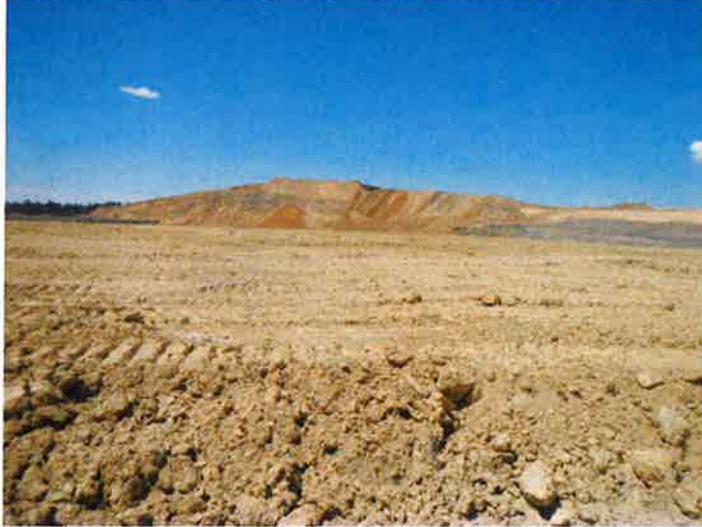
20. Working face of excess spoil pile

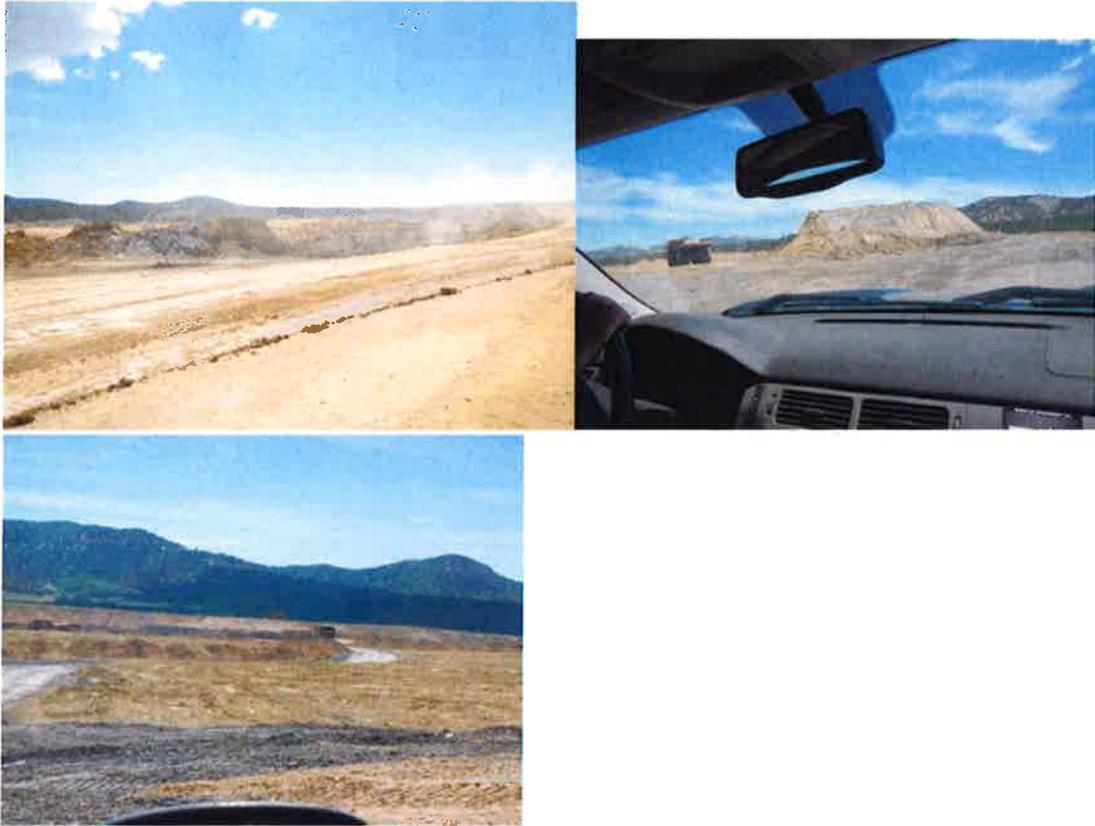
21.Trucks hauling sub soil to HWT 1

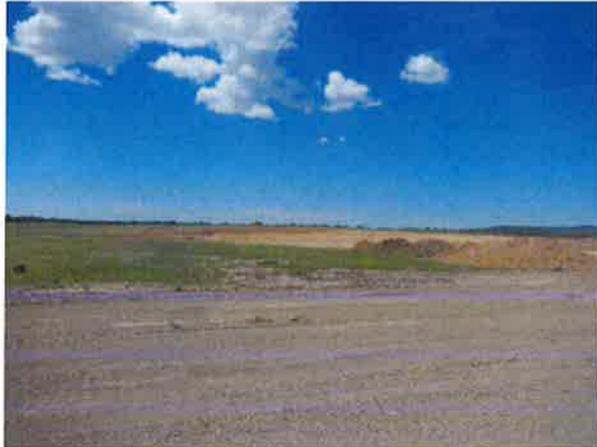
22. Topsoil being stockpiled for dozing in southern area.

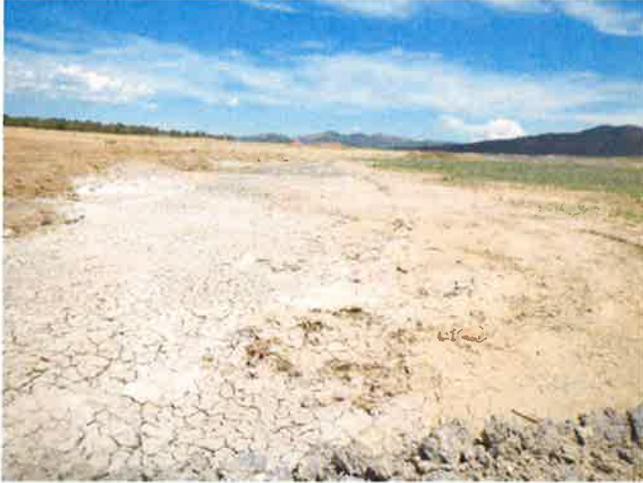
The ponding area adjacent to the reconstruction of Dames access road was witnessed during inspection. Top soil piles were witnessed in the vicinity to be placed shortly over the area north of the Dames's access road. The Permittee was advised to grade the area to drain so as to avoid salt pooling at the site that would hinder vegetation growth. As discussed, a culvert should not be placed due to the continuing maintenance required. With proper grading the area will drain to the south and flow through the gravel surface which will be placed on the Dames's access road. See Photo 23. The Division wishes to reiterate that top soil should not be used for grading. The Division will conduct tests to verify the topsoil depth in bond release areas during a bond release inspection.

23. Dames Access low spot

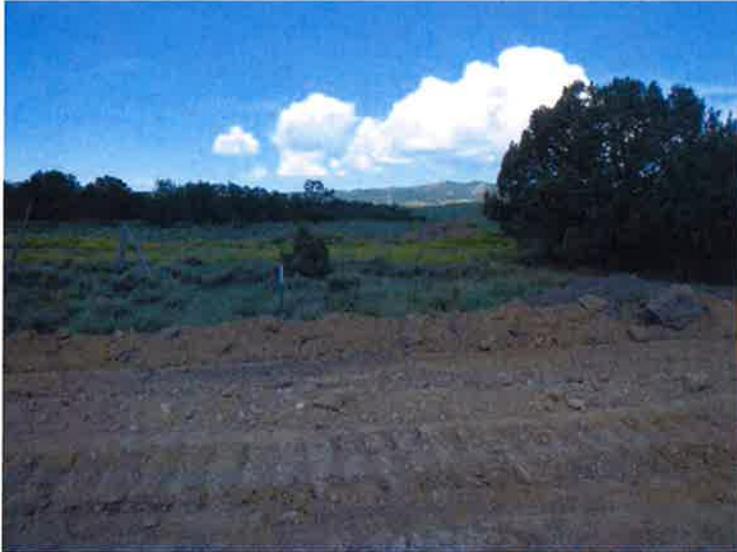
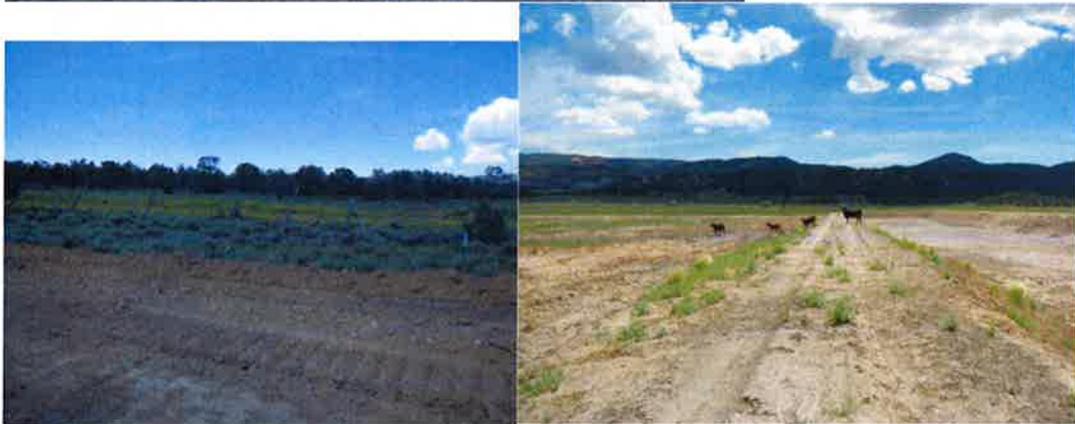
A section of fence was broken during reclamation activities around Pit 21. The fence is now laying down and requires maintenance. Photo 24 shows how the fence is on the ground. Cattle have been entering the mine site due to the broken fence. The cattle were witnessed at Pond 4 during the time of this inspection as well as the previous July 16th inspection. The Permittee has contacted the rancher and will follow up with fence maintenance.

24. Fence down around Pit 21 and cattle at Pond 4

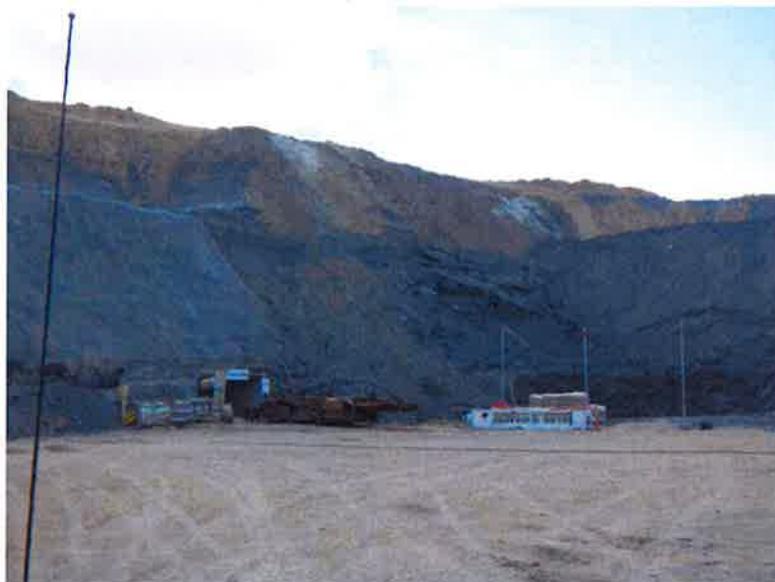
Within Pit 10 along the south slope there has been a series of sloughing as the slope is sloughing back. The Permittee stated that the area is no longer receiving water and is expected to remain stable now. See photo 25.

25. Pit 10 southern slope sloughing

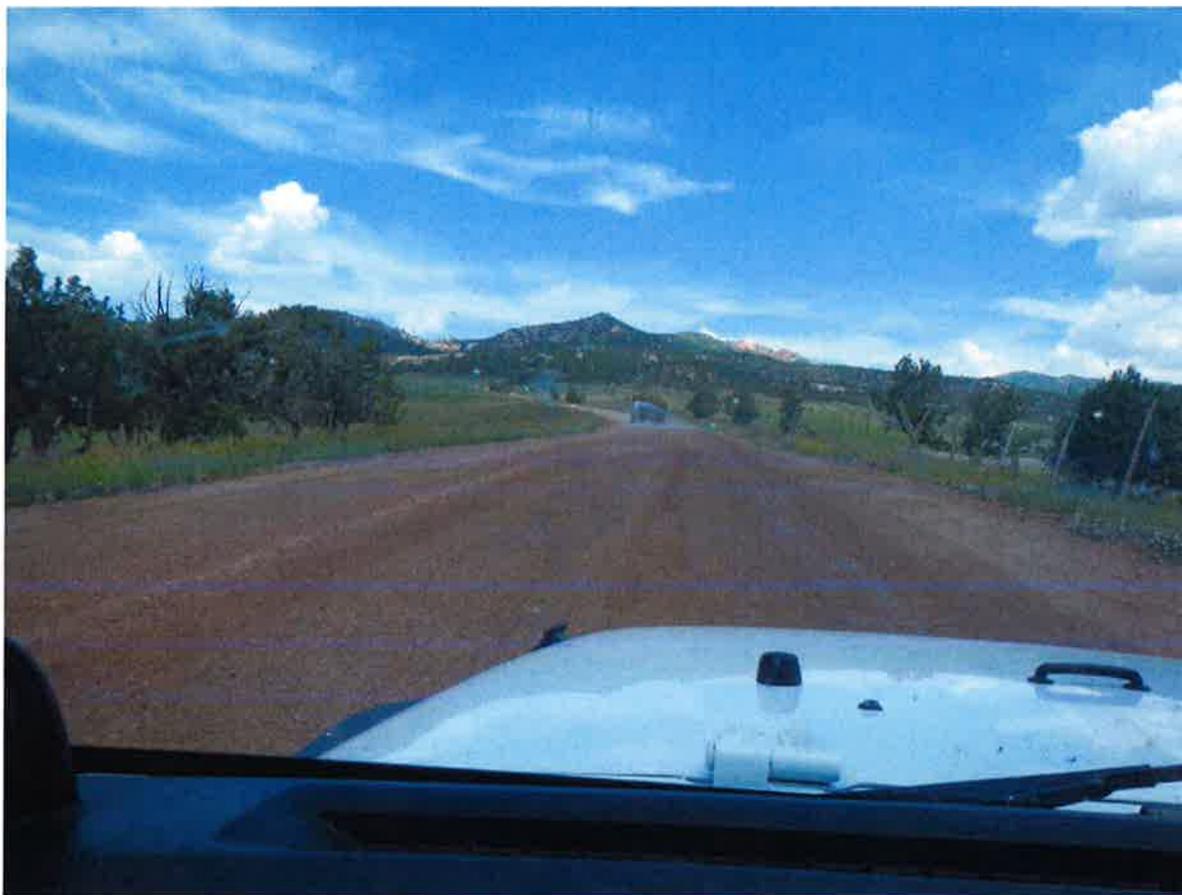
The grader was witnessed surfacing the current haul road. The water truck was also witnessed maintaining dust control. See photo 26.

26. Water truck watering the mine access road

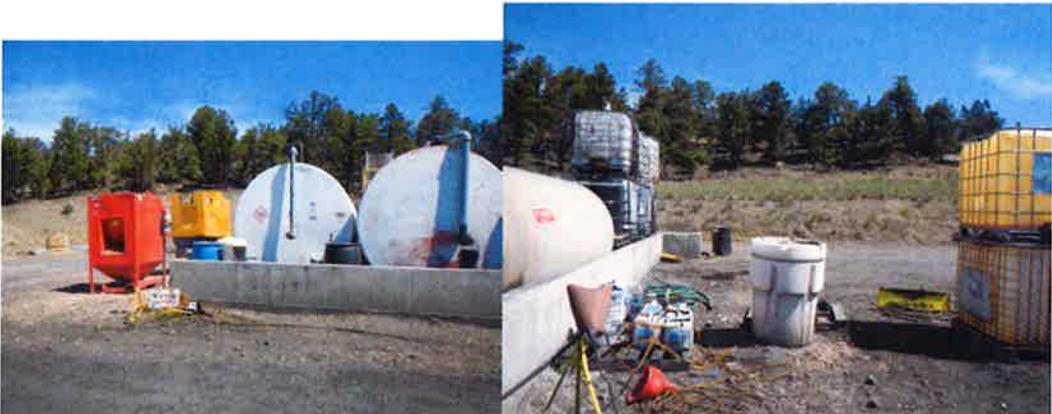
The secondary containment area was inspected to insure that the SPCC plan was being followed. See photo 27. Approximately 2 inches of water was observed within the fuel containment structure.

27. Spill containment Area
