## Coal Hollow Inspection 11 24 2015

# Inspection Report

Permit Number:	C0250005
Inspection Type:	PARTIAL
Inspection Date:	Tuesday, November 24, 2015
Start Date/Time:	11/24/2015 10:00:00 AM
End Date/Time:	11/24/2015 3:00:00 PM
Last Inspection:	Wednesday, November 18, 2015

Permitee: **ALTON COAL DEVELOPMENT LLC**  
 Operator: **ALTON COAL DEVELOPMENT LLC**  
 Site: **COAL HOLLOW**  
 Address: **463 North 100 West, Suite 1, CEDAR CITY UT 84720**  
 County: **KANE**  
 Permit Type: **PERMANENT COAL PROGRAM**  
 Permit Status: **ACTIVE**

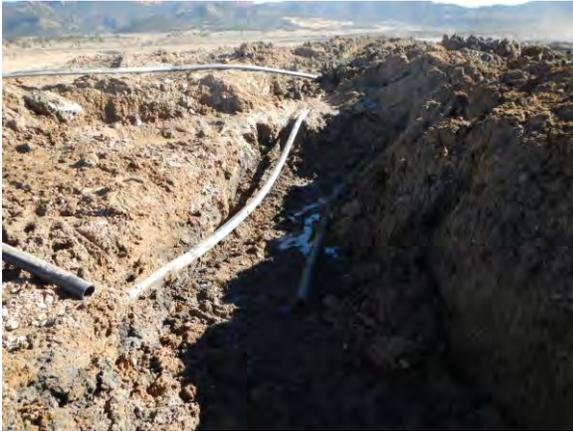
Appendix 5-13 was recently approved to allow the discharge of 100 gpm (0.22 cfs) into Pond #3 for a period up to 14 days. Two pipes have been laid from Pit 10 to Pond #3, however one pipe is severed at the transition zone where it is discharging greater than 2 gpm into DD4. Water pumped from the sump in Pit #10 is collected from in mine roof bolting and from boot cleaning station and from a catch basin collecting alluvial water from the surrounding disturbed area. Whether two pipes will remain buried or one pipe would remain was not clear. Clark Atwood, the underground mine foreman indicated that both pipes were functional.

Pit t0 to Pond 3 pipe recently approved. Two polypipes partially buried along DD4.

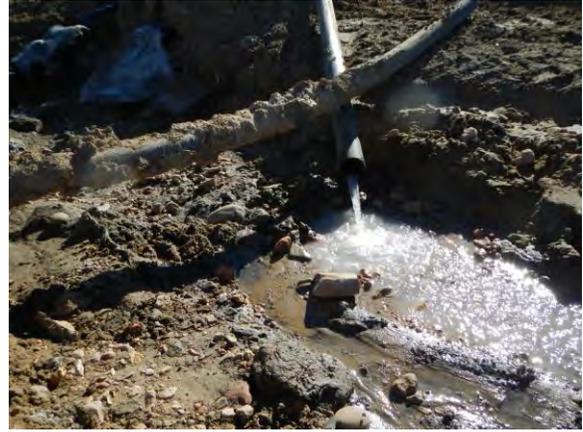
Temporary discharge from UG mine to DD4 through polypipe during installation of pipe.

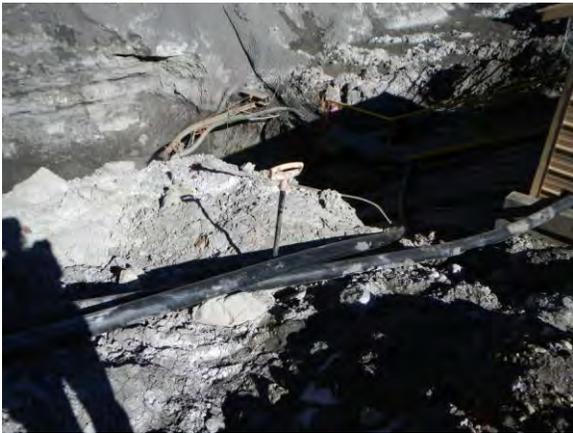
Two pipes can remove water from UG sump. One pipe is currently active.

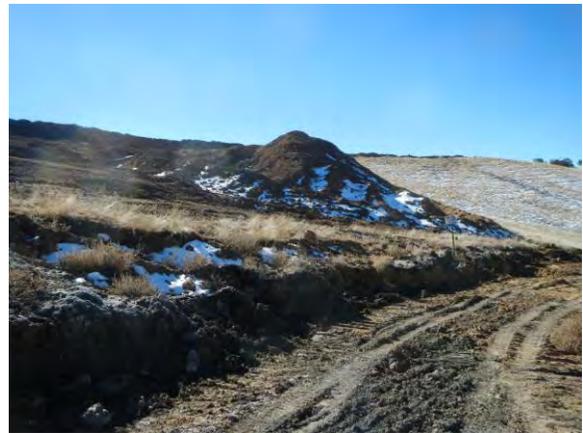
Temporary topsoil stockpile #1 has been consolidated and bermed along the west side of the excess spoil pile. (This topsoil stockpile was the subject of NOV 21157, which will now be terminated). Three other temporary topsoil stockpiles are bermed along the south side of the excess spoil pile. I refer to them (from west to east) as temporary topsoil stockpiles 2, 3 and 4. Temporary topsoil stockpile 4 is signed and bermed. Temporary topsoil piles 2 and 3 require signs. The berm between temporary topsoil stockpiles 2 and 3 requires repair. This work is high priority and will be completed promptly, by the end of the week, November 27. These temporary topsoil stockpiles were created early this fall for contemporaneous reclamation use.

Bermed temporary stockpile 1 on the West side of the excess spoil pile, undisturbed topsoil on far slope (NOV 21157 terminated).

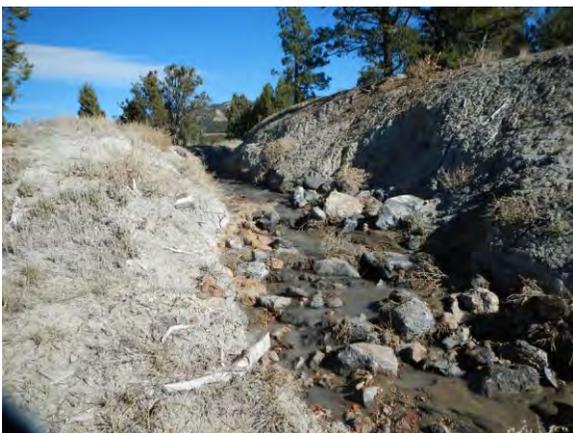
Pond 3 inlet flowing from DD4. Inlet requires riprap repair to design specifications.

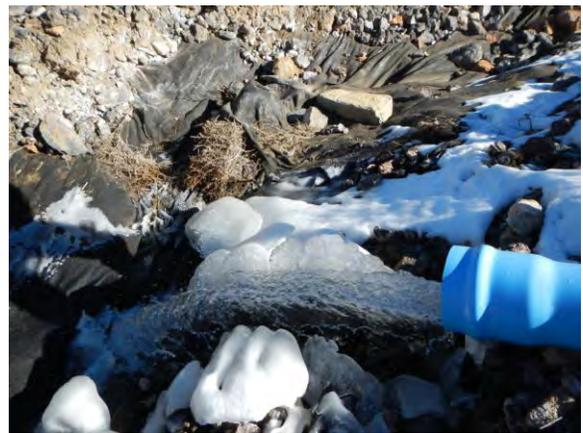
Pond 3 discharge from decant pipe.

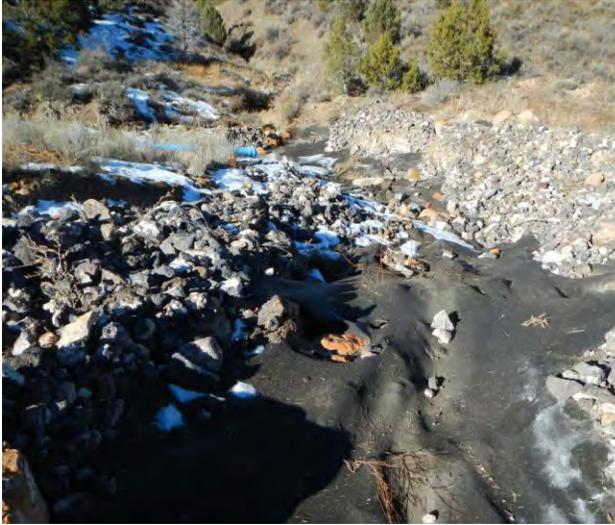
Pond 3 overflow requires riprap repair to design standard.

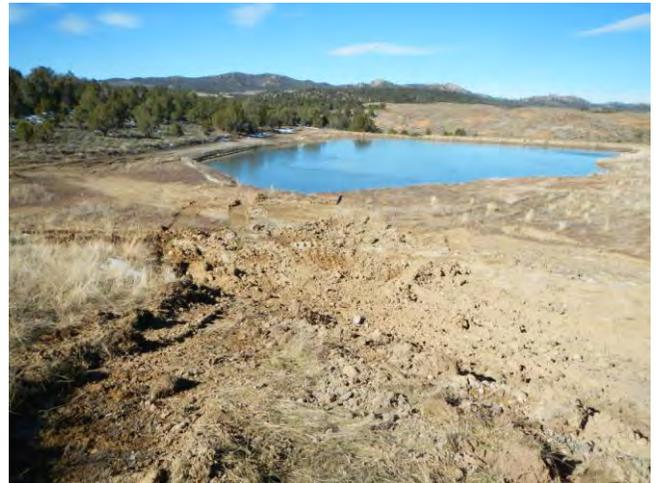
Polypipe is just short of Pit 10. Installation in pond requires riprap to design standard.

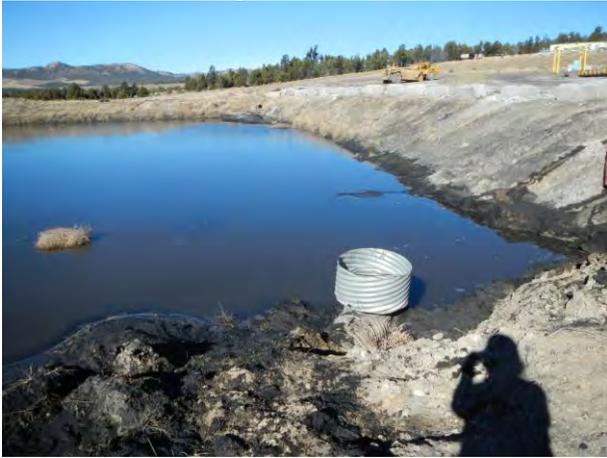
Pond 1 inlet construction was recently approved and will get underway. This work requires surveying in a ditch, shortening Culvert 6 and placement of riprap. This work is a high priority and will be completed promptly and prior to December 11. Pond 3 has been discharging for about a month through the decant. Pond 3 also has been receiving flow through DD4 from Pit 10 for some time. The pit 10 pipe is about 20 feet short of the pond and needs to be extended. Pond 3 requires riprap at its outlet and inlet and at the Pit 10 pipe inlet. This work is high priority and will be completed promptly and prior to December 11.

Far side of the pond will be new inlet (requires riprap to design standard).

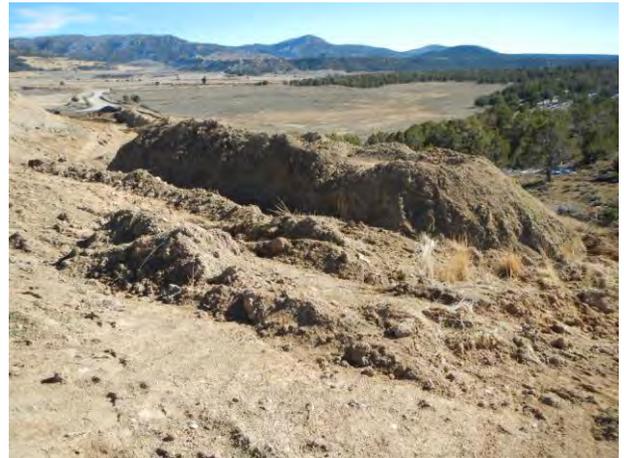
Temporary topsoil stockpile 2. Temp pile 3 & 4 in distance.

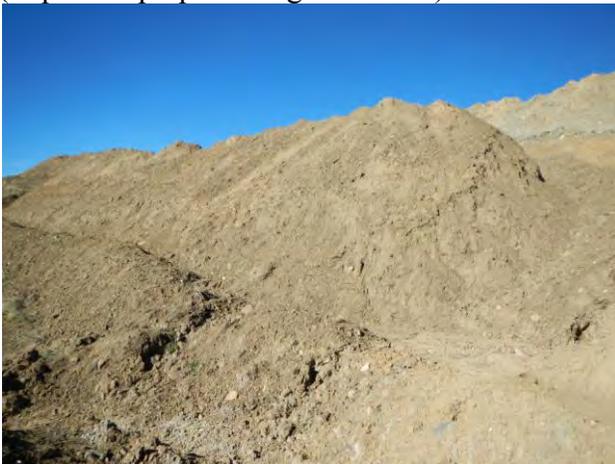
Repair of breached berm at junction of Temporary topsoil stockpile 2 and Temp pile 3 needs immediate attention.

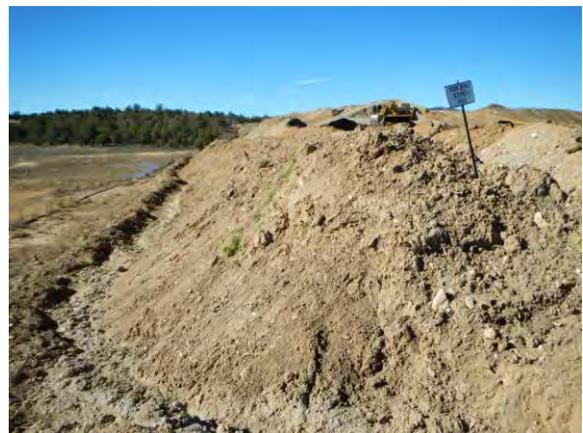
Temporary stockpile 4 is bermed and signed.

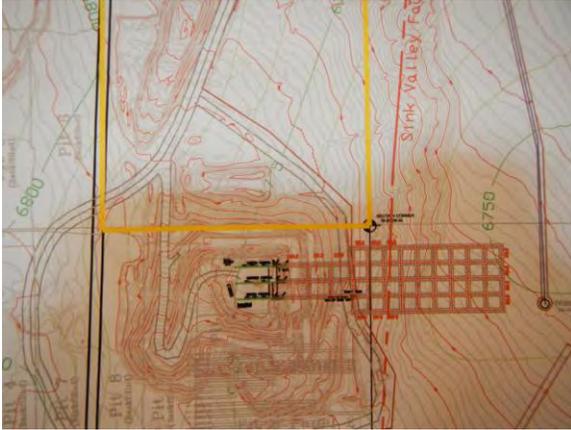
Pit 10 UG mining area, see also Dwg 5-3B

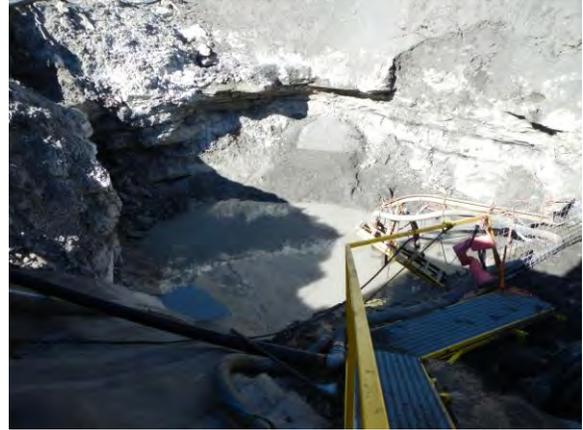
Sump water is currently pumped to Pond 3 via DD4.

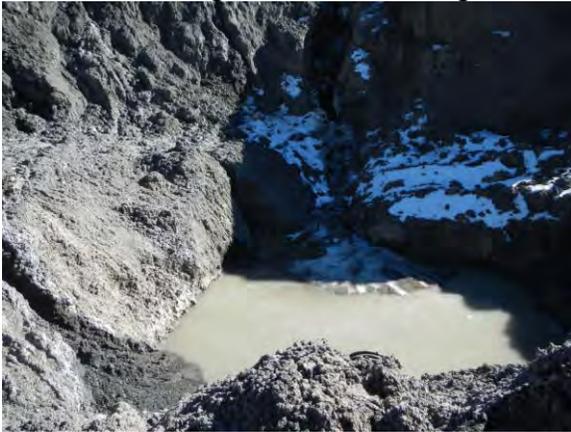
Water carrying sediment is entering the Pit 10 sump from the alluvium above Pit 10. There is no current sediment control in place to treat several acres of drainage. A ditch allowing flow into pit 10 and a catch basin on the bathhouse pad is not shown on Dwg 5-3B. Culverts at the mine entrance and along the haul road are not shown on Dwg 5-3B.

Catch basin on bathhouse pad collects alluvial drainage.

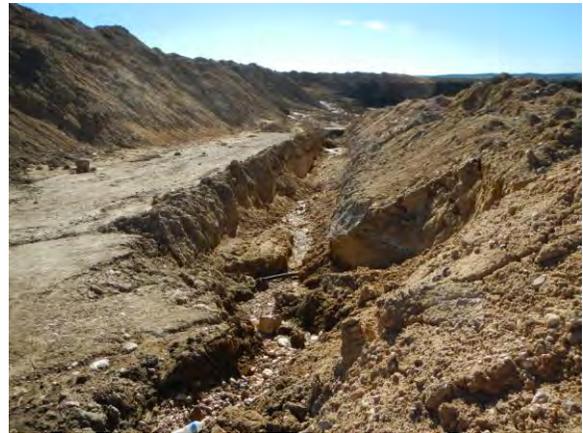
Ditch above pit 10 with buried waterline leads to un-reclaimed area shown

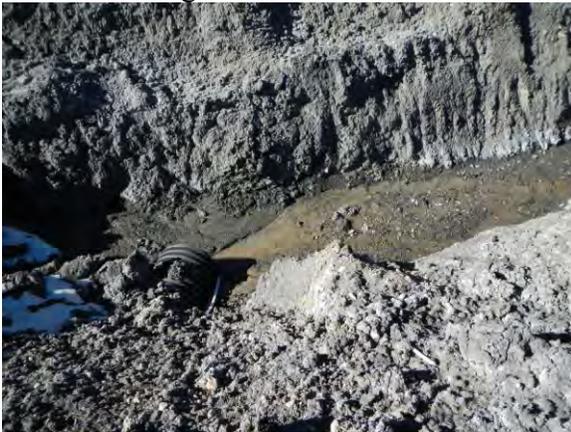
Culvert carries alluvial drainage across the road to sump

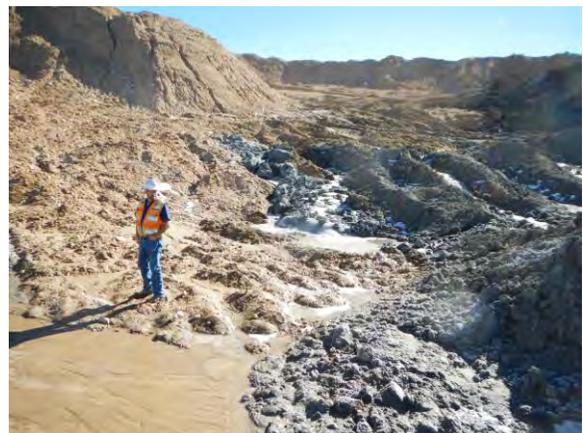
This un-reclaimed area is the source of the flow into Pit 10

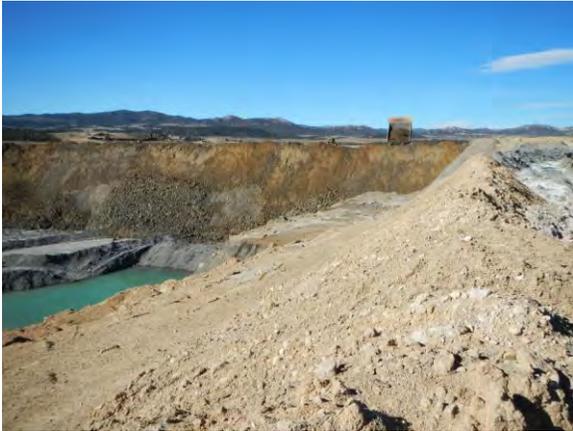
HWT 1 is being backfilled with spoil from the excess spoil pile.

Backfill into HWT 1. Note location of truck in photo above and below.

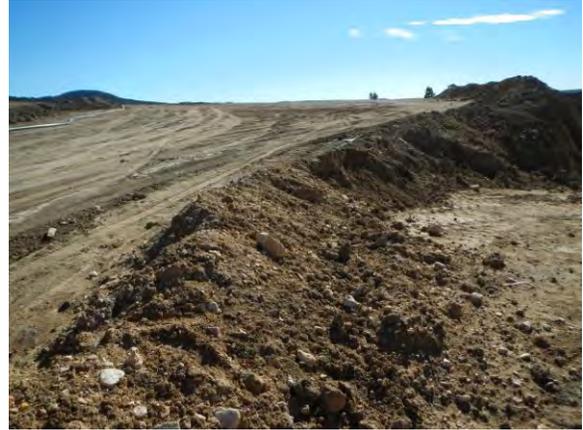
Excessively large roadway un-reclaimed above Pit 10.

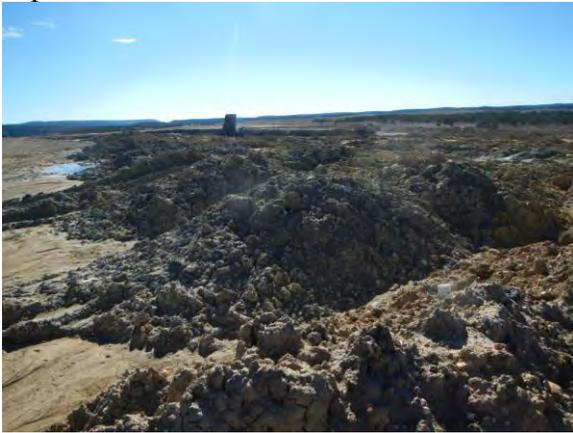
Backfill of Pit 9

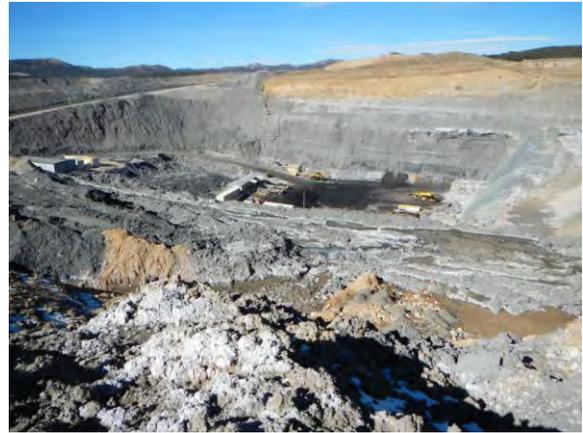
Water collects on un-reclaimed area above Pit 10.

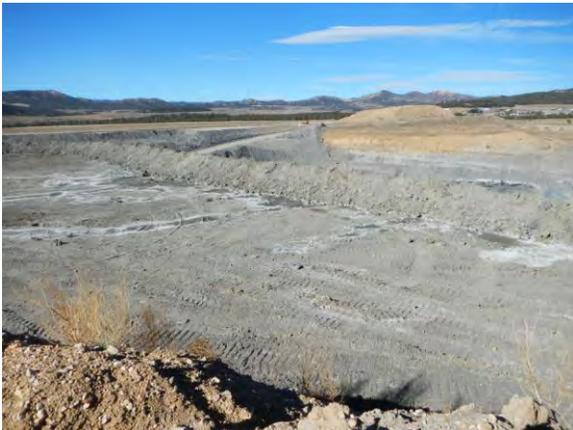
Backfill of Pit 9 on left Pit 10 in farground.

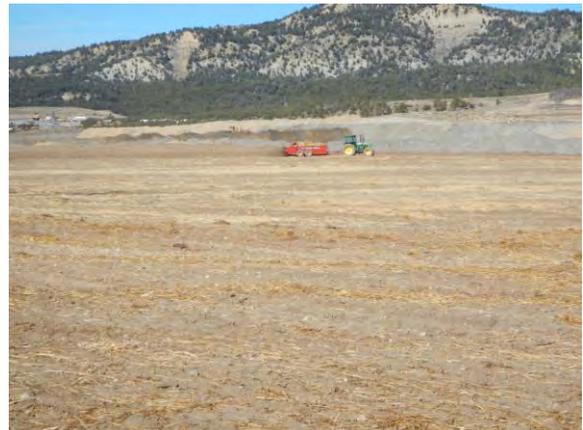
Pits 20 - 24 had received topsoil and were being mulched and seeded during the inspection. Kevin Heaton reported that 3 bales of straw @ 700 lbs ea and 6 CY of nutrimulch are applied to each acre. A photo of the seed mix is attached to this report.

Topsoil, mulch, nutrimulch and seed applied to backfilled and regraded Pits 20 – 24 (Ph 1 bond release areas 4 and 5).
