State of Utah

Division of Oil, Gas and Mining

Inspection Report

Permitee: **ALTON COAL DEVELOPMENT LLC**
 Operator: **ALTON COAL DEVELOPMENT LLC**
 Site: **COAL HOLLOW**
 Address: **463 North 100 West, Suite 1, CEDAR CITY UT 84720**
 County: **KANE**
 Permit Type: **PERMANENT COAL PROGRAM**
 Permit Status: **ACTIVE**

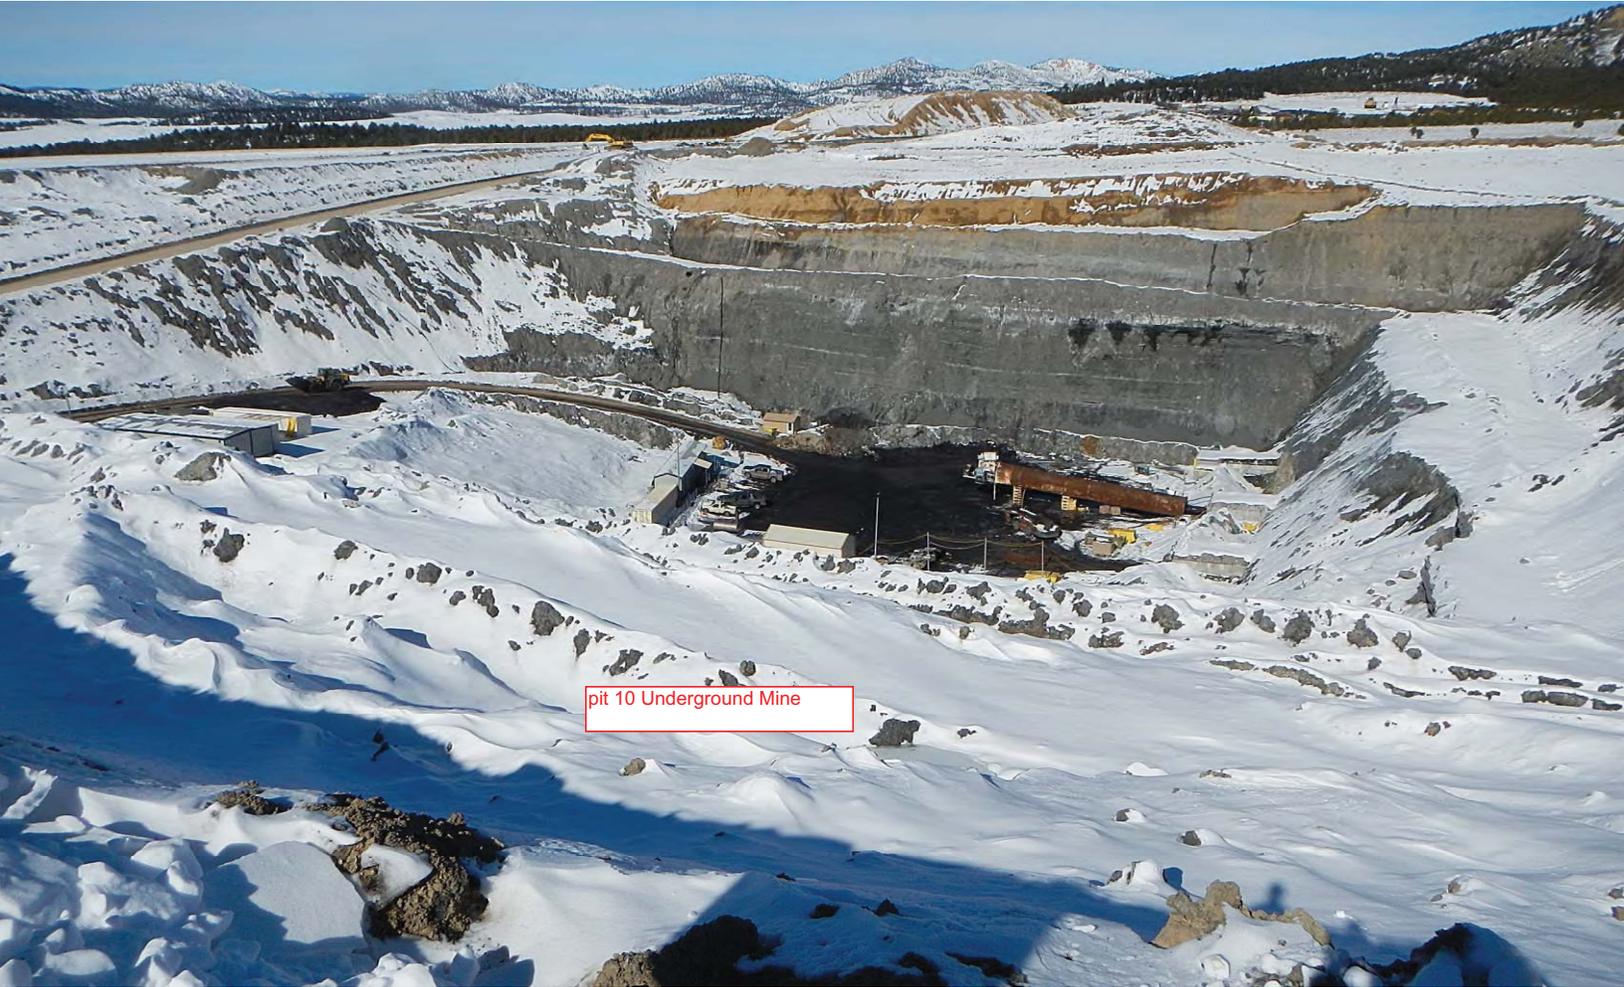
pit 10 Underground Mine

The drainage from the slopes surrounding pit 10 is accumulating in the facilities yard of the underground mine portal. This drainage either reports to a catch basin or drains to the portal yard. Water collected in the catch basin flows down a ditch to the sump where it is piped to pond 3. The timing of this pipe installation corresponds to the November pond 3 discharge which exceeded Utah water quality limits. This is a violation of R645-301-731.611 which is related to drainage control.

Water is accumulating in front of the Burton #1 mine portal entrance. This is a potential violation of R645-301-731.511. Future plans to direct the drainage towards the sump were discussed with Adrian Childs, Underground mine foreman. The Permittee was reminded that drainage control must be shown on a map.

A sludge of coal fines and mud was being removed from the Burton #1 mine portal entrance during the inspection. It is being placed on the bathhouse pad above the portal in Pit 10, where it will drain back down to the underground mine facilities yard. This coal mine waste location storage location is not shown on the facilities Dwg 5-3B. Neither is the catch basin, the roadside ditch, or the culverts in front of the portal or the second pipe to pond 3. This is a violation of R645-301-731.720 which must be corrected with an as-built drawing by February 1, or said violation will be issued.

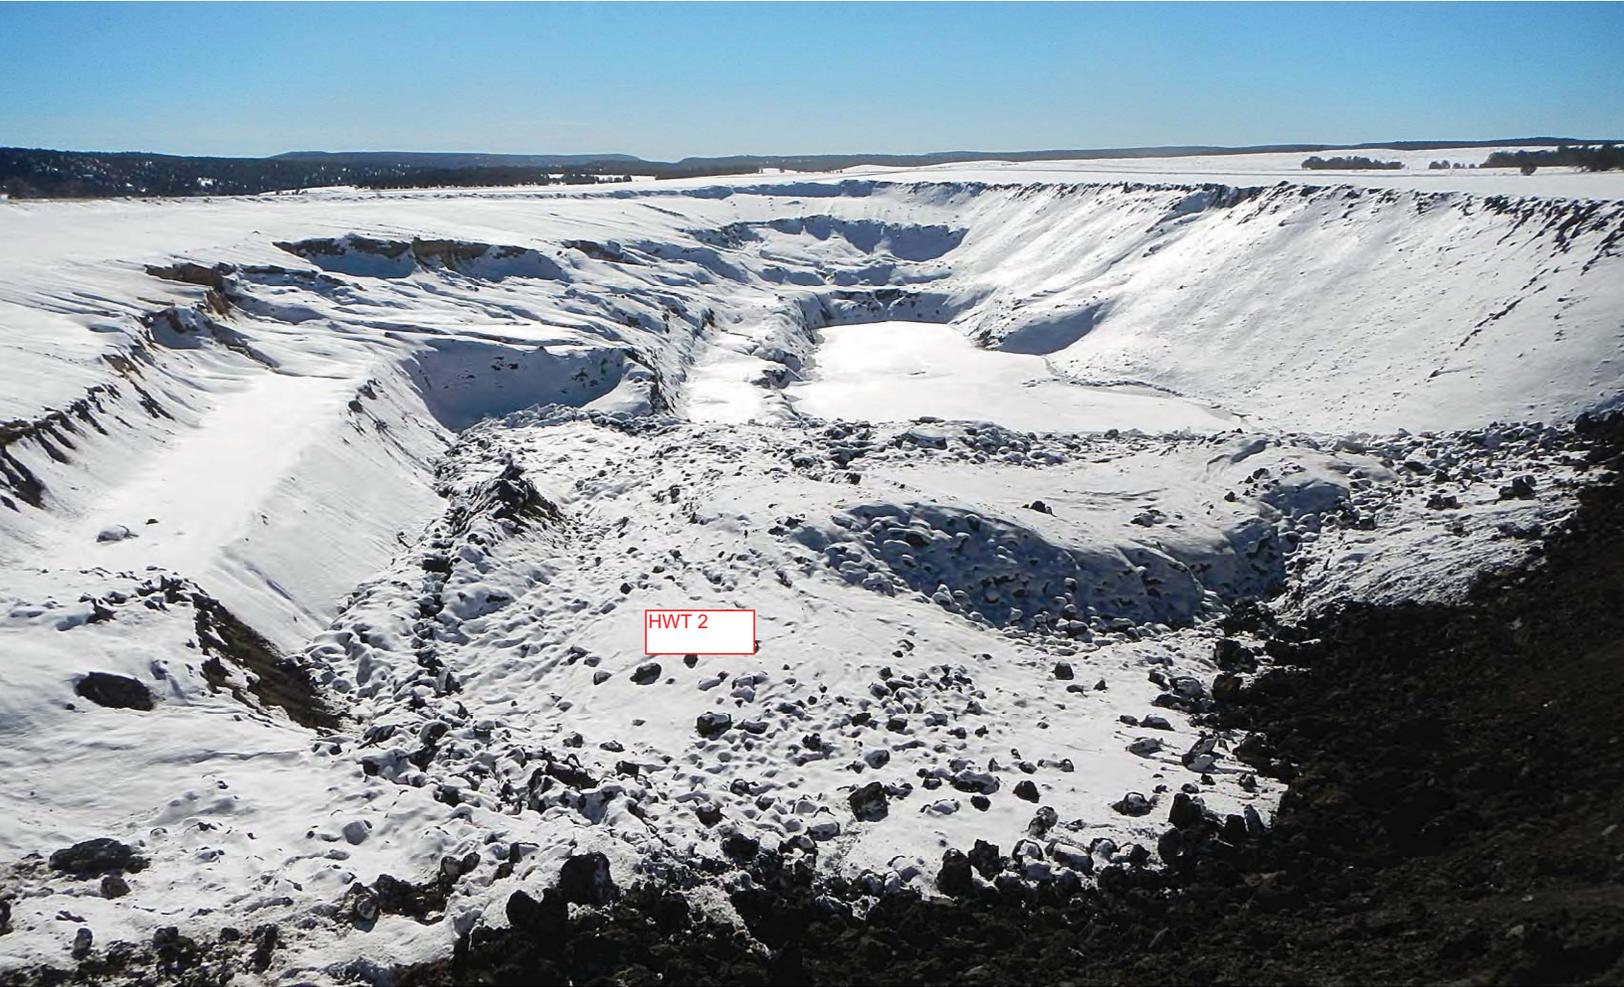
Five haul trucks were running spoil from the Excess spoil pile to backfill HWT 2. Mining ceased in HWT 2 with Panel 4E in July 2015, see Inspection report # 5246. The final panels in HWT 2 are submerged below an estimated seventeen feet of water, but are not backfilled. Drawing 5-38 shows rough backfilling and grading of HWT 2 in the next twelve months, but does not provide a specific timetable for completion. NOV 21163 has been issued for failure to have rough backfilling and grading follow coal removal by not more than 60 days in accordance with R645-301-553.

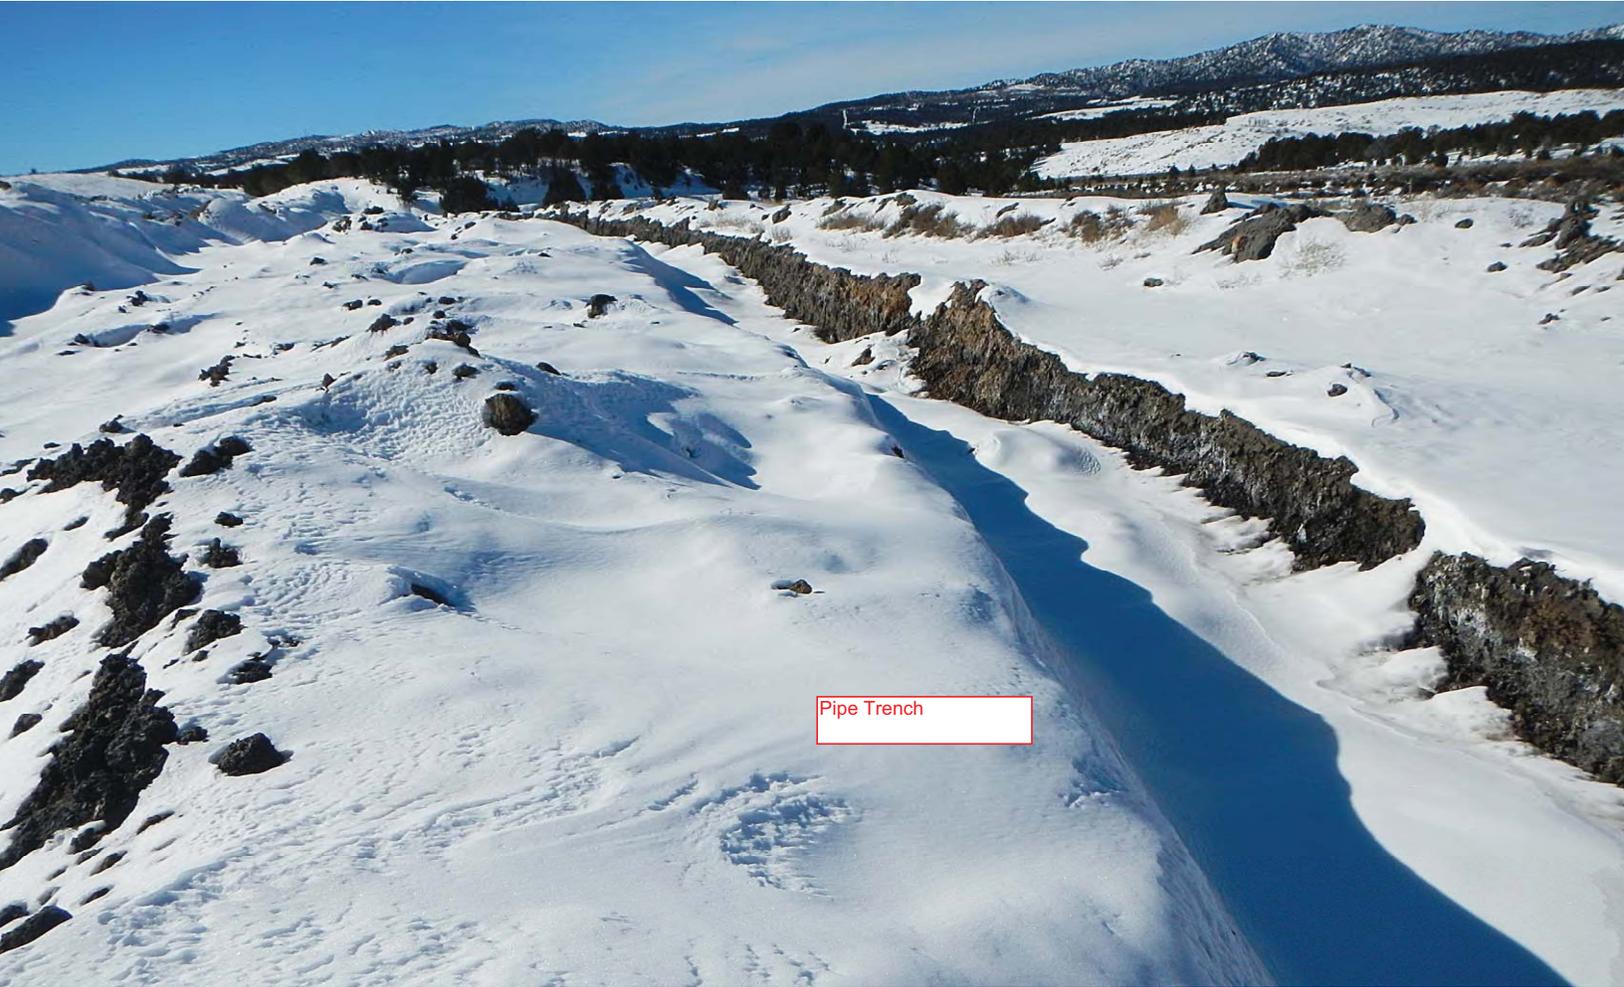
Pipe Trench

Appendix 5-13 containing plans for the pipeline to Pit 10 was approved November 13, 2015. Two pipelines were observed partially installed during the 11/24/2015 inspection. A kink in the pipe had stalled the installation temporarily and discharge from the Pit 10 sump was directed to DD4 through a second pipe. This source of sediment to pond 3 contributed to the exceedence of water quality discharge limits in November. During this January inspection, it was discovered that the second pipe was still positioned in DD4; and although a functioning pipeline is buried within the pipeline trench, the installation is not according to design. Figure 1 in Appendix 5-13 notes that an apron of riprap will be placed at the point the pipeline enters pond 3. Mr. Nichols stated that this apron was not installed and the pipeline was extended into the pond with a hose. Mr. Childs stated that the second pipeline (discharging to DD4) was not being used, due to a broken pump, and that it will be buried in the trench when the snow melts and will be serviceable at some point in the future. NOV 21162 has been issued for failure to comply with R645-301-752.100, R645-301-732.300 and R645-301-744.100.

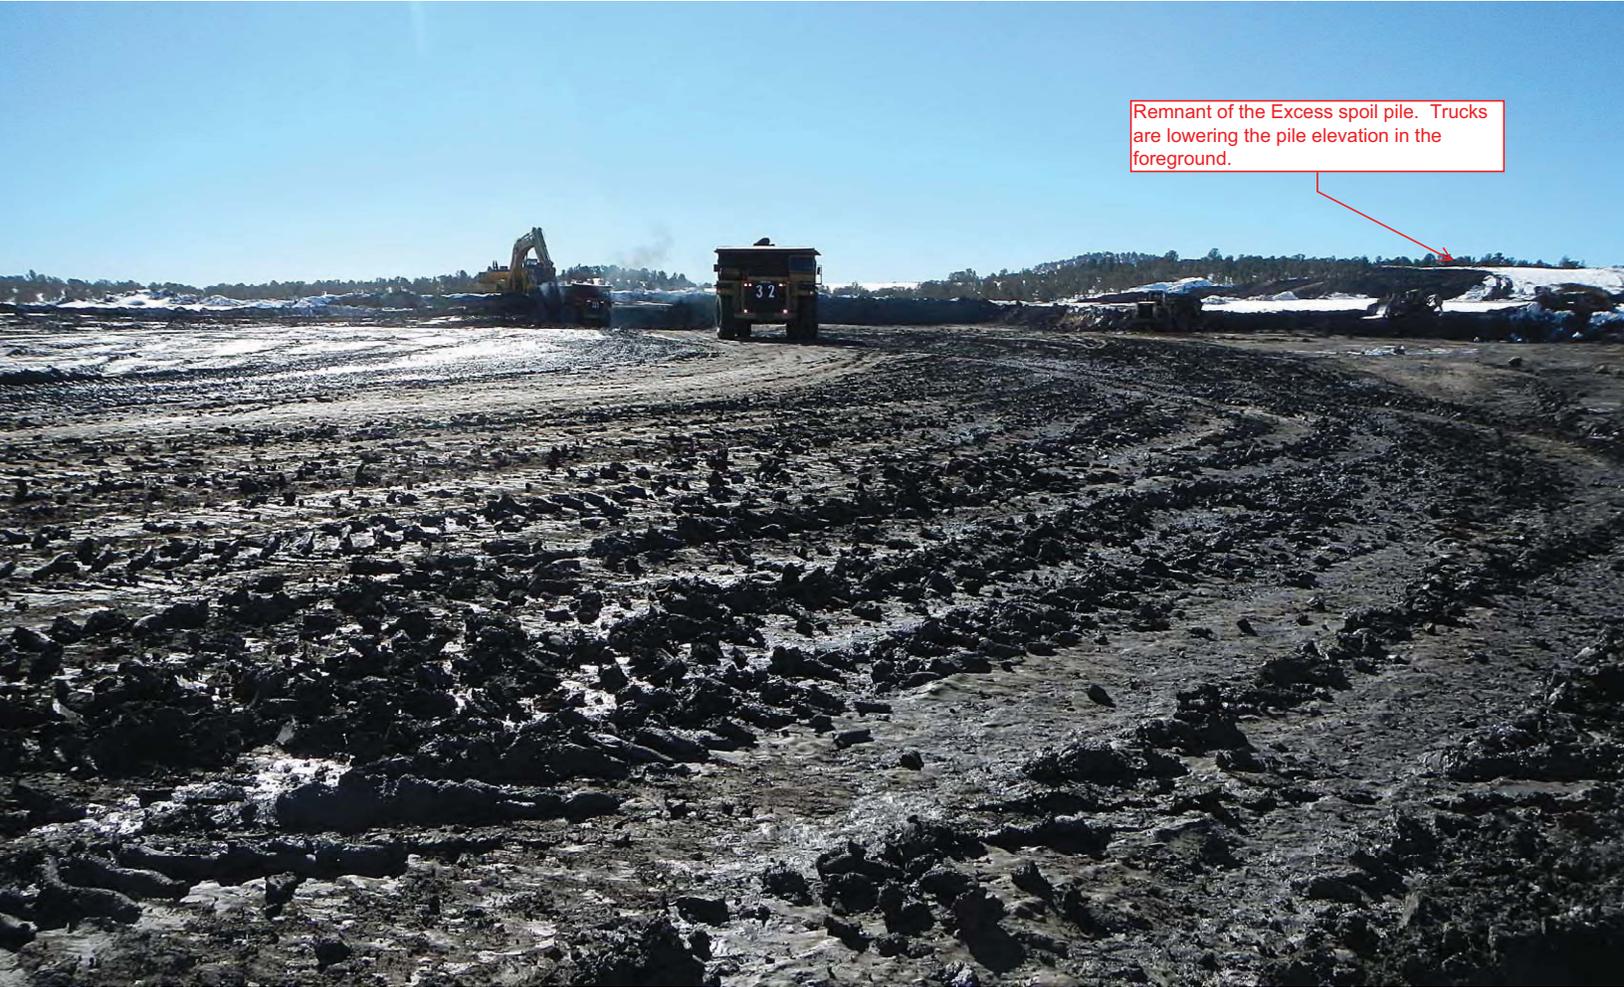
According to the certified quarterly inspection of the refuse pile, there was 1,430,000 CY remaining in the excess spoil pile on December 9, 2015. This is far less than the 2,545,000 LCY of backfill required to fill the final Pit 10 to the final post mining topography shown on Dwg 5-37 (Table 5-76 and Section 553 of the MRP).

Remnant of the Excess spoil pile. Trucks are lowering the pile elevation in the foreground.

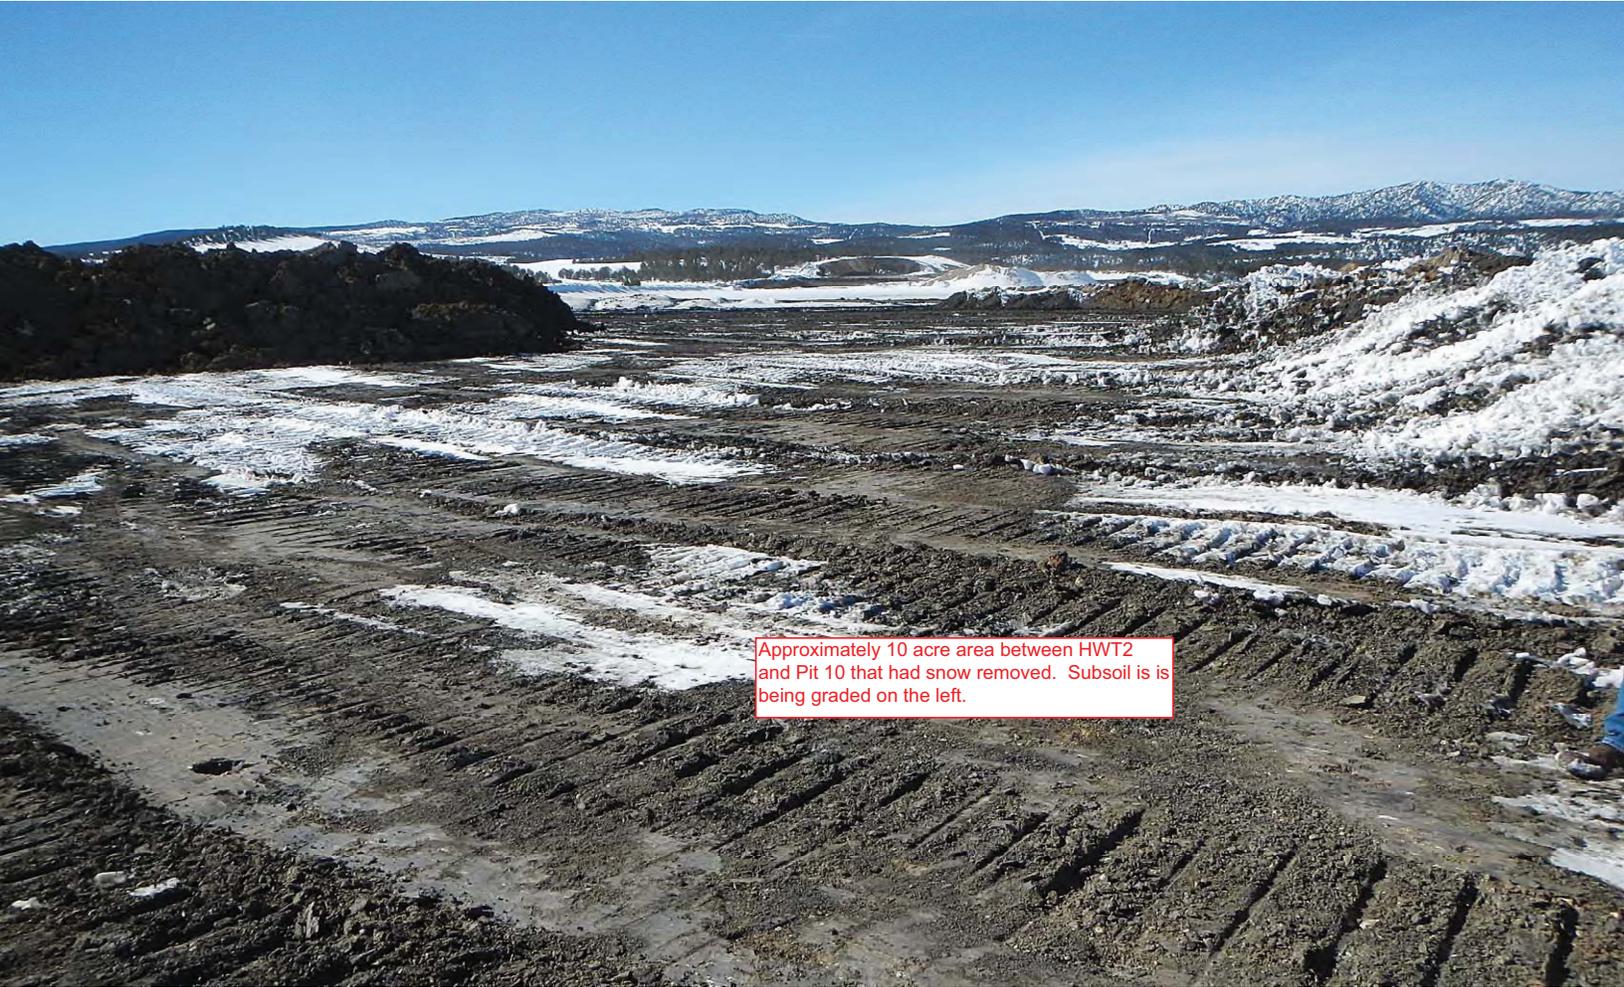
Two dozers were spreading subsoil over a 10 acre area where snow had recently been removed (between HWT2 and Pit 10). The snow was pushed into a berm along the Pit 10 highwall. This snow will eventually report to the sump in Pit 10. This is a potential violation of R645-301-742.122.

Approximately 10 acre area between HWT2 and Pit 10 that had snow removed. Subsoil is being graded on the left.
