Division of Oil, Gas and Mining

Inspection Report

Permit Number:	C0250005
Inspection Type:	PARTIAL
Inspection Date:	Wednesday, March 16, 2016
Start Date/Time:	3/16/2016 4:00:00 PM
End Date/Time:	3/17/2016 1:00:00 PM
Last Inspection:	Tuesday, March 29, 2016

Permittee: **ALTON COAL DEVELOPMENT LLC**
 Operator: **ALTON COAL DEVELOPMENT LLC**
 Site: **COAL HOLLOW**
 Address: **463 North 100 West, Suite 1, CEDAR CITY UT 84720**
 County: **KANE**
 Permit Type: **PERMANENT COAL PROGRAM**
 Permit Status: **ACTIVE**

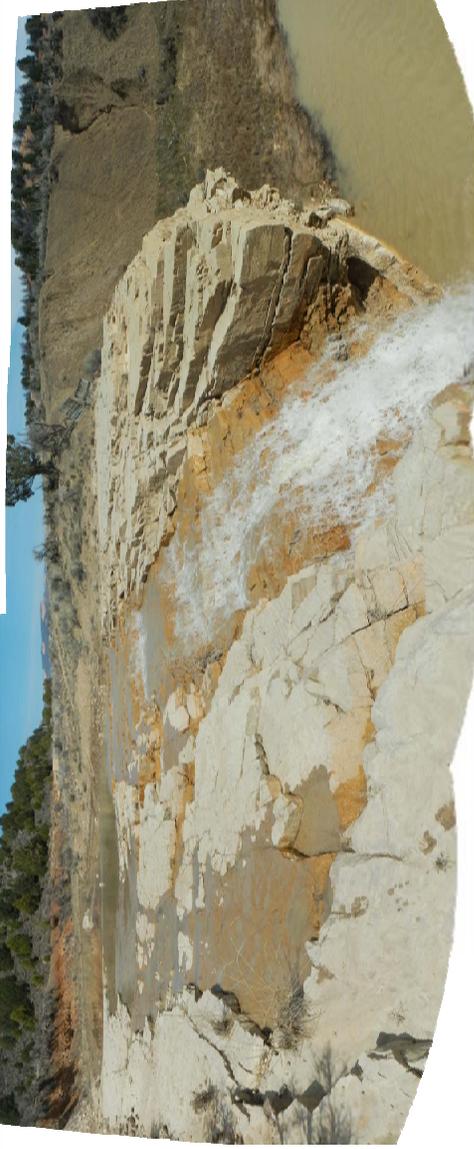
PANORAMA 1

a) There was a significant amount of water flowing over the Falls along Kanab Creek south of the mine (Panorama 1 and 2).

The Falls on Kanab Creek below the mine site.
March 16, 2016

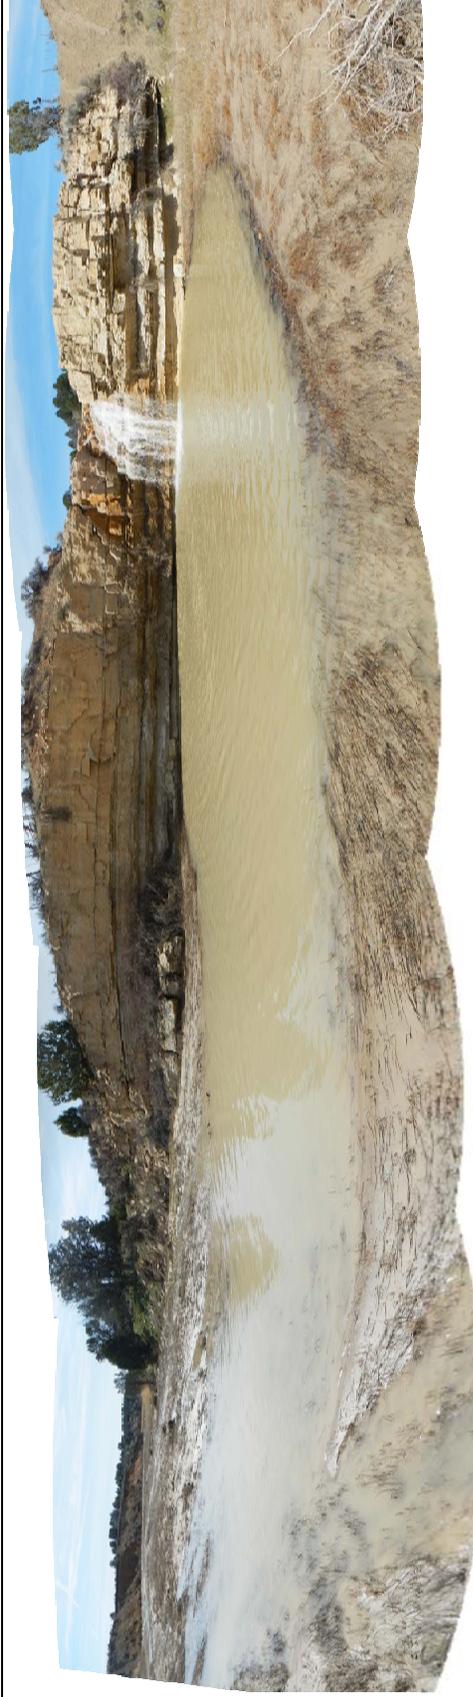
PANORAMA 2

The Falls on Kanab Creek below the mine site.
March 16, 2016

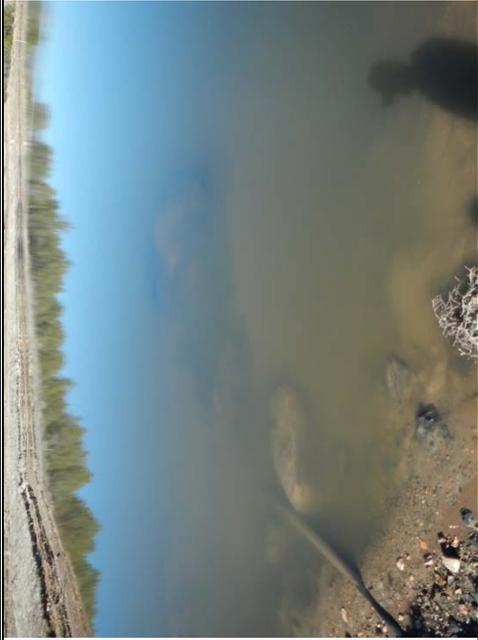
The end of the Pit 10 to Pond 3 pipe was submerged beneath the water. Thus, it was difficult to discern if the erosion control fabric and riprap had been placed properly at its outlet (Photo 1). Pond 3 water was cloudy and had an oil sheen across the surface of the water near the inlet (Photos 2, 3).

<p>PHOTO 1 End of Pit 10 to Pond 3 pipe. Difficult to discern correct placement of erosion control fabric and riprap at end of pipe. March 17, 2016</p>

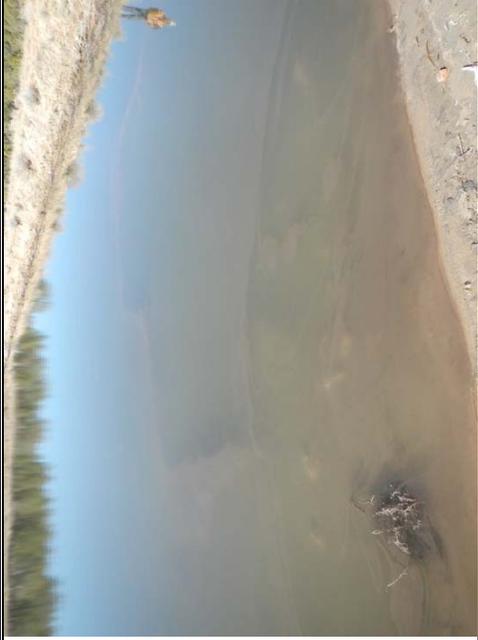
<p>PHOTO 2 Oil sheen on surface of pond near inlet. March 17, 2016</p>

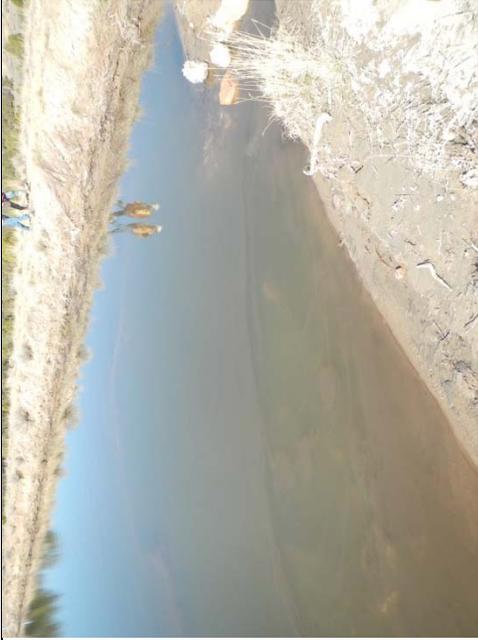
<p>PHOTO 3 Oil sheen on surface of pond near inlet. March 17, 2016</p>

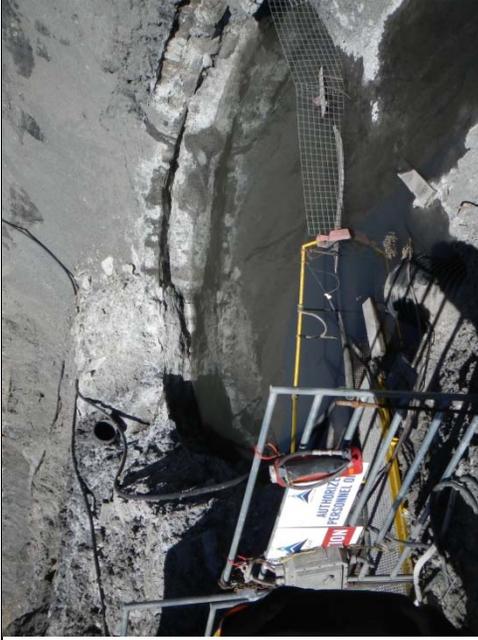
<p>PHOTO 4 Sump in Pit 10 March 17, 2016</p>

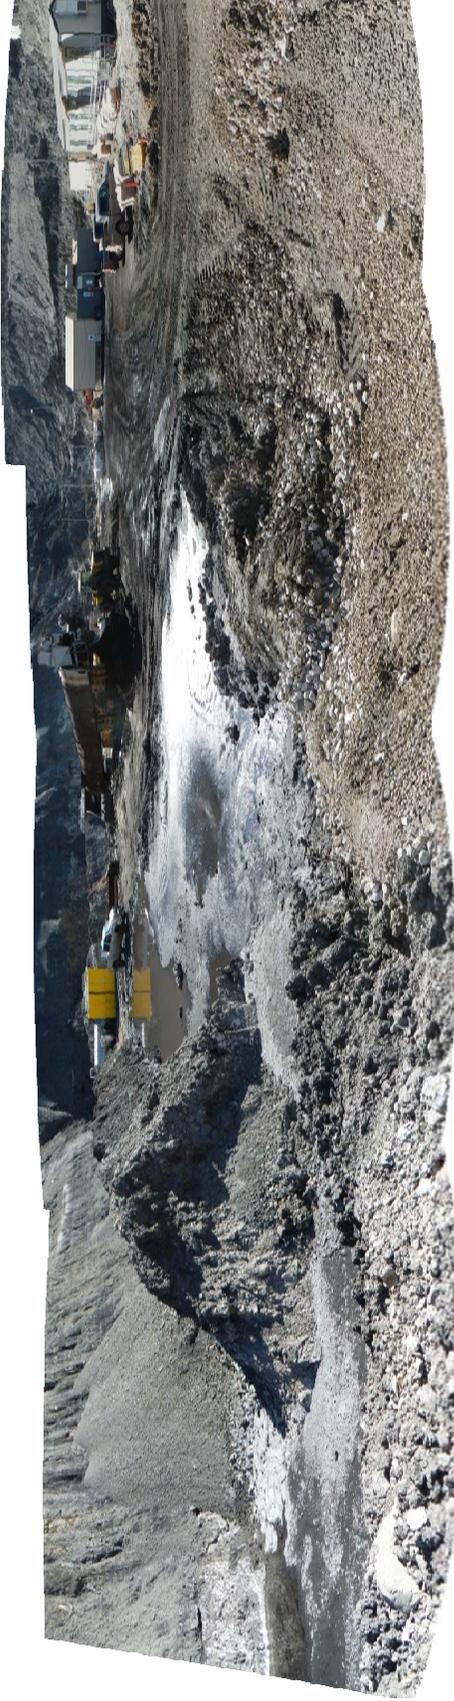
PANORAMA 3

The sump in the bottom of Pit 10 had high TSS with coal fines collecting in it. Water had recently ponded in the working area on the bottom of the pit and had flowed across workings into the sump (Panorama 3). The runoff was collecting and carrying coal fines to the sump. The Permittee discussed plans of expanding the sump into a large settling pond. The settling pond will be along the north wall of the highwall trench and separated into two cells (see notes). One cell will receive all runoff from the bottom of the pit and working areas and be the primary settling basin. Water will then pass through a filter curtain into the second cell which will act as a secondary settling basin. When the second cell is filled to capacity with water it will be pumped to Pond 3.

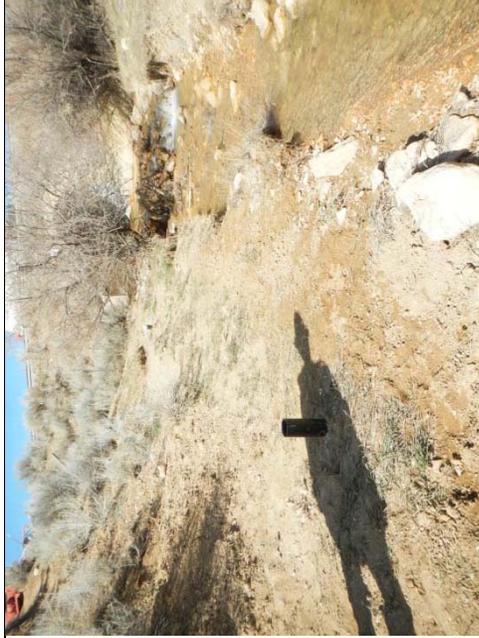
PHOTO 5

One well in the well matrix down gradient of site.
March 16, 2016

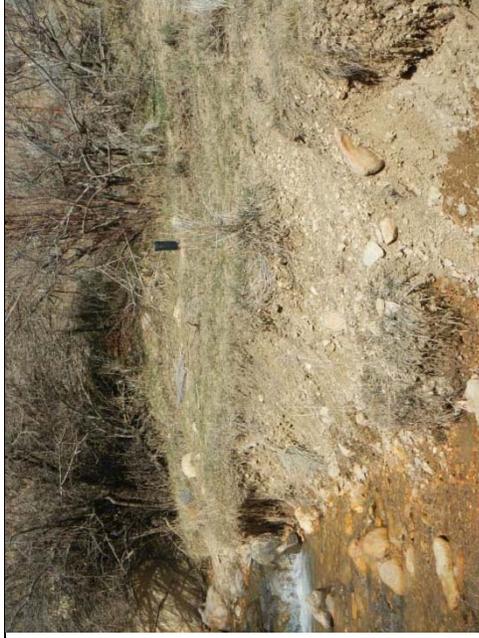
PHOTO 6

One well in the well matrix down gradient of site.
March 16, 2016

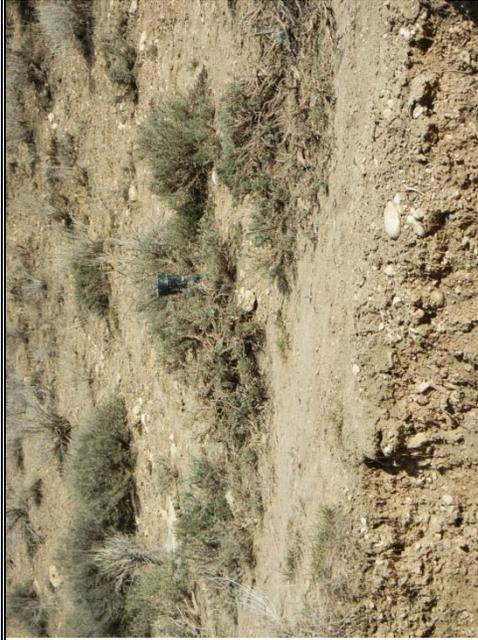
PHOTO 7
One well in the well matrix down gradient of site.
March 16, 2016

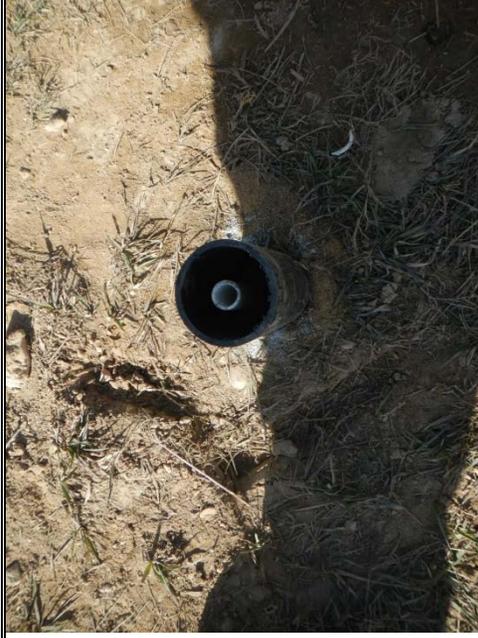
PHOTO 8
One well in the well matrix down gradient of site.
March 16, 2016

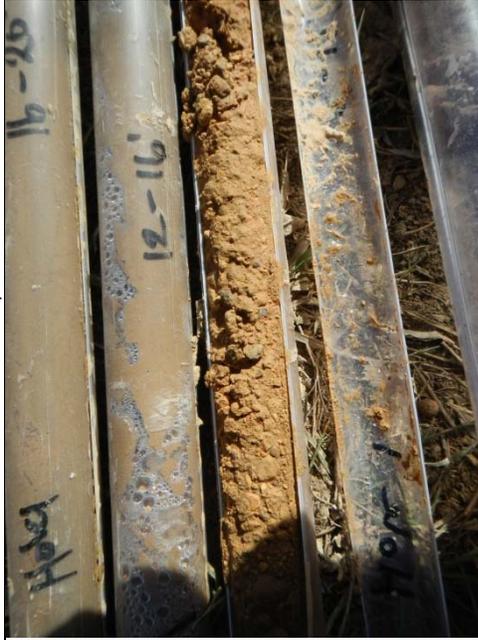
PHOTO 9
Push probe core samples at well matrix.
March 16, 2016

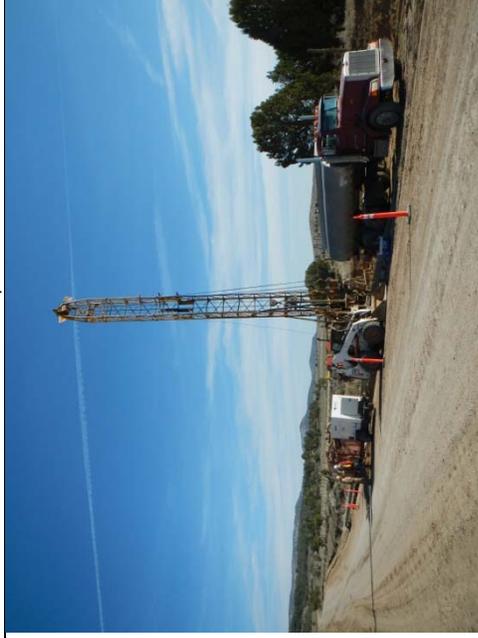
PHOTO 10
Drilling well west of Kanab Creek and south of county road creek crossing.
March 16, 2016

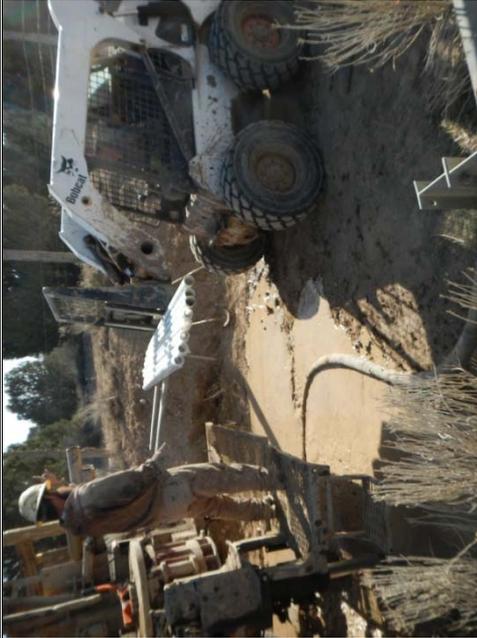
<p>PHOTO 11 Drill rig, March 16, 2016</p>

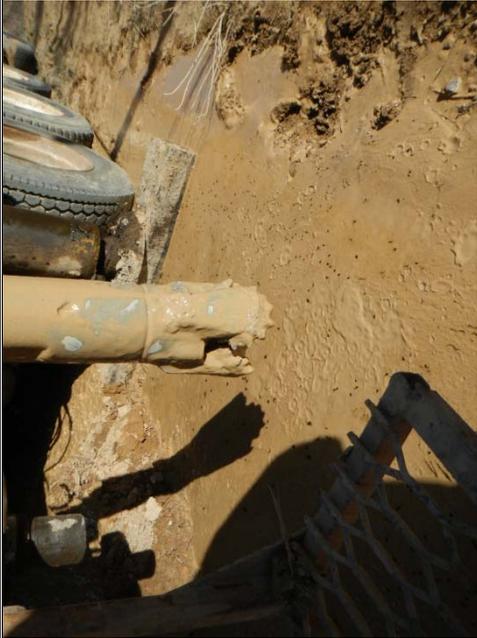
<p>PHOTO 12 Drill bit used for well hole. March 16, 2016</p>

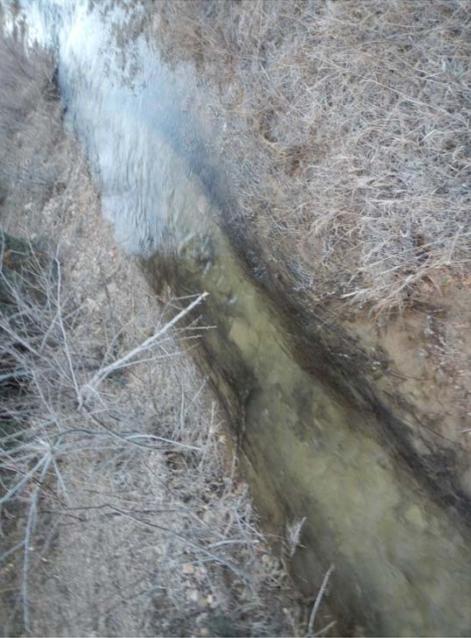
b) I measured the width, depth, and velocity of Kanab Creek 200 yards upstream from the where the county road crosses the creek (Photo 13). Refer to the attached field notes for a cross-section. The stream had a width = 3 ft (91 cm), a depth = 34 cm (1.12 ft), and two measured velocities of V1 = 1.68 m/s and V2 = 1.96 m/s.

<p>PHOTO 13 Section of Kanab creek that flow was measured. March 17, 2016</p>

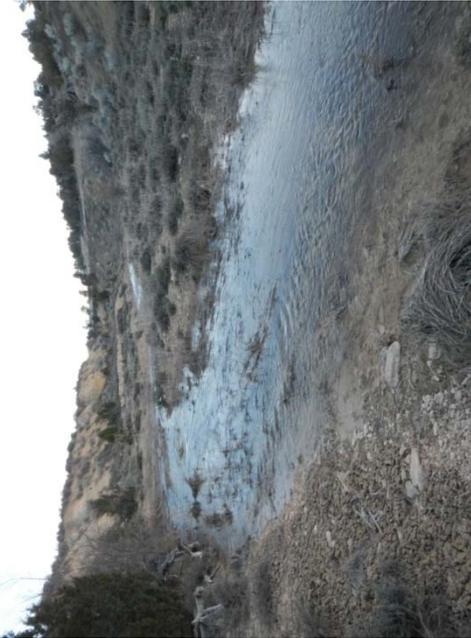
There was flow spread out onto the flood plain on either side of Kanab Creek in many areas (Photos 14 through 16).

<p>PHOTO 14 Kanab Creek in NPL up from County road crossing. March 17, 2016</p>

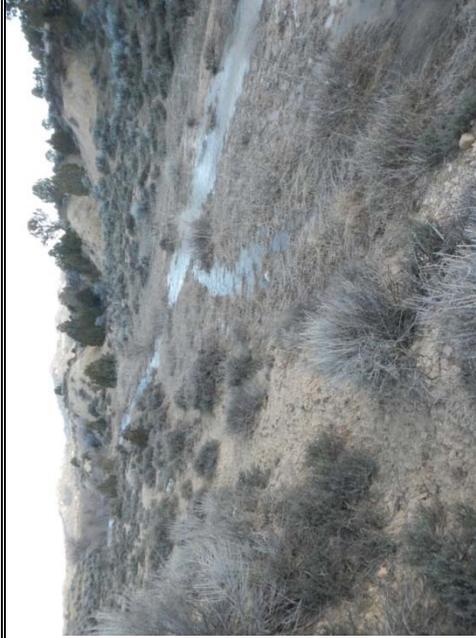
PHOTO 15
 Kanab Creek just up from County road crossing.
 March 17, 2016

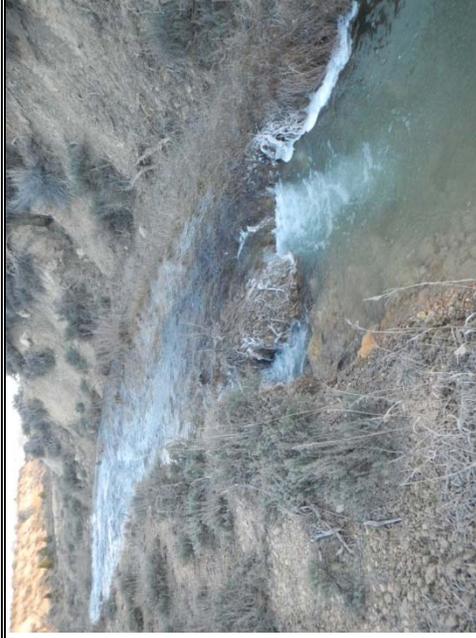
PHOTO 16
 Kanab Creek directly above County road crossing.
 March 17, 2016

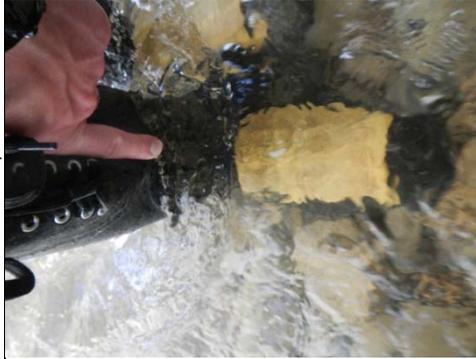
The water in the culvert passing under the county road was 10 inches deep (Photo 17 and 18).

PHOTO 17
 Flow is 10 inches deep in a 12 foot culvert.
 March 17, 2016

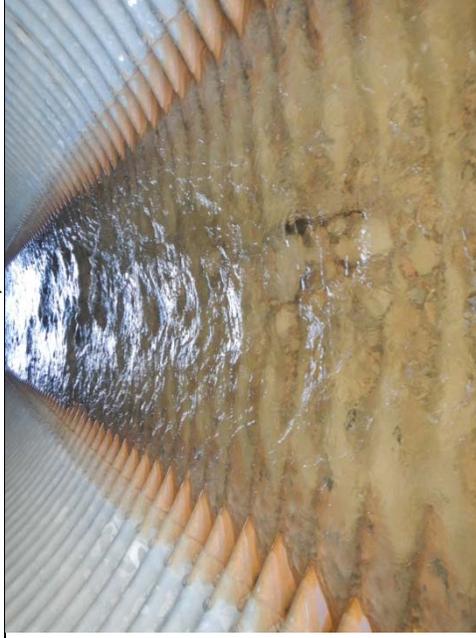
PHOTO 18
 Flow in culvert under County road.
 March 17, 2016

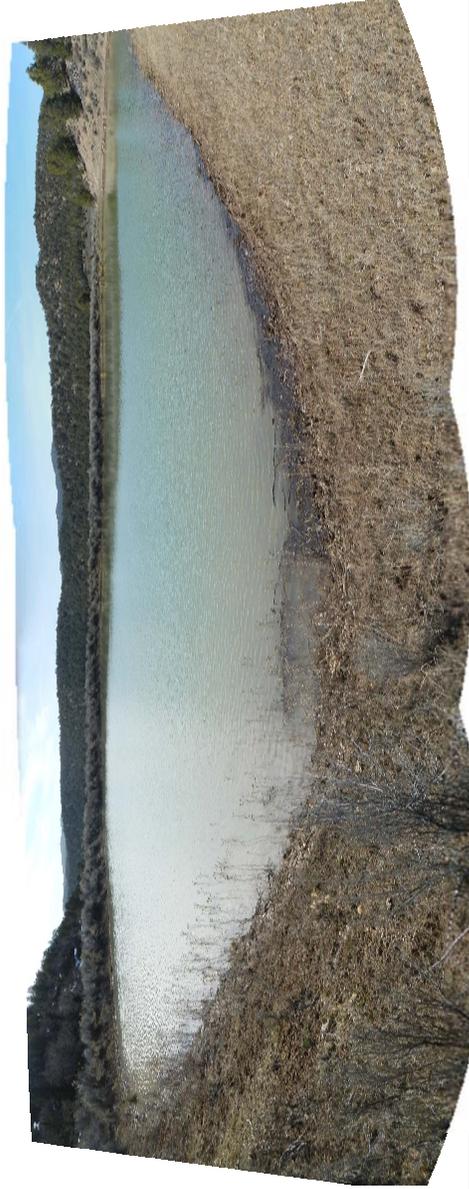
PANORAMA 4

Lamb's irrigation pond had recently been filled to capacity (Panorama 4, Photos 19 and 20).

Lamb's irrigation pond full to capacity.
March 16, 2016

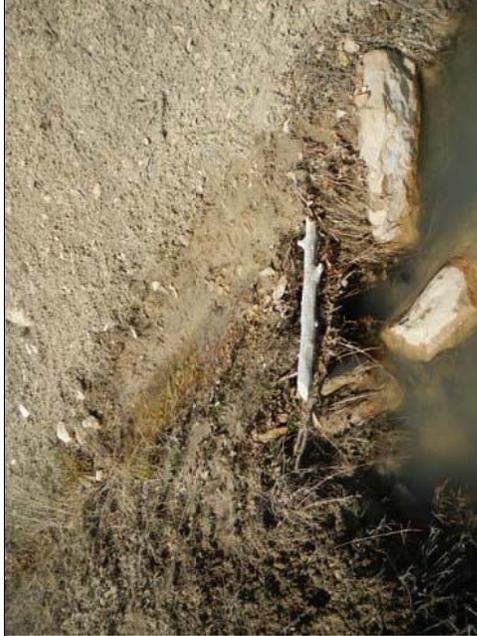
PHOTO 19

Lamb's irrigation ditch flowing into the pond. High water mark shows the ditch recently carried flow.
March 16, 2016

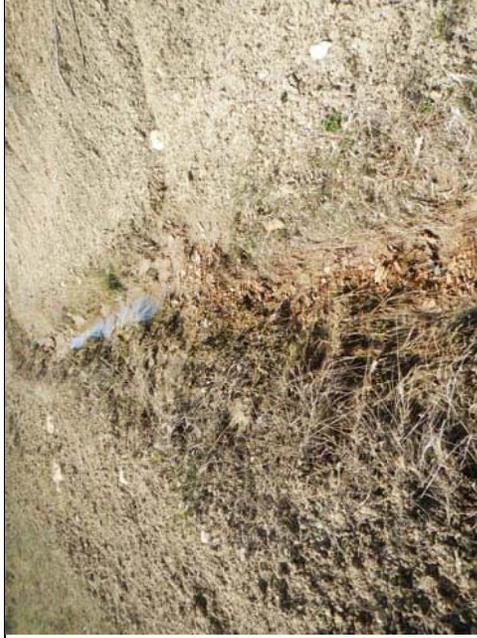
PHOTO 20

Lamb's irrigation ditch flowing into the pond. High water mark shows the ditch recently carried flow.
March 16, 2016
