# State of Utah

Division of Oil, Gas and Mining

## Inspection Report

Site: **COAL HOLLOW**

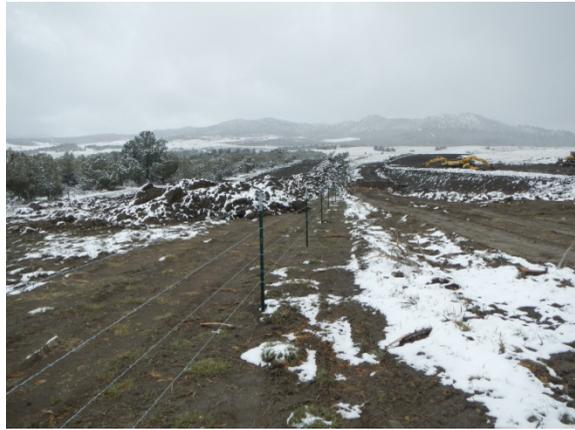
**PHOTO 1**

Eastern most point of DD-08, Missing section of Ditch to be installed, photo March 29, 2016, NOV 21174 issued April 6, 2016

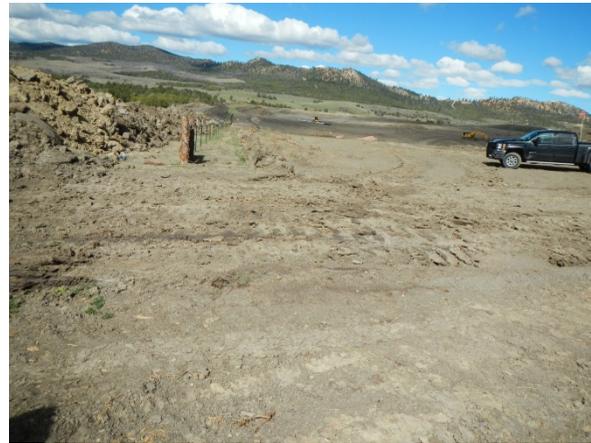
**PHOTO 2**

Eastern most point of DD-08, Fence was cut and site is being used to access County road. Missing section of Ditch to be installed on April, 12 2016

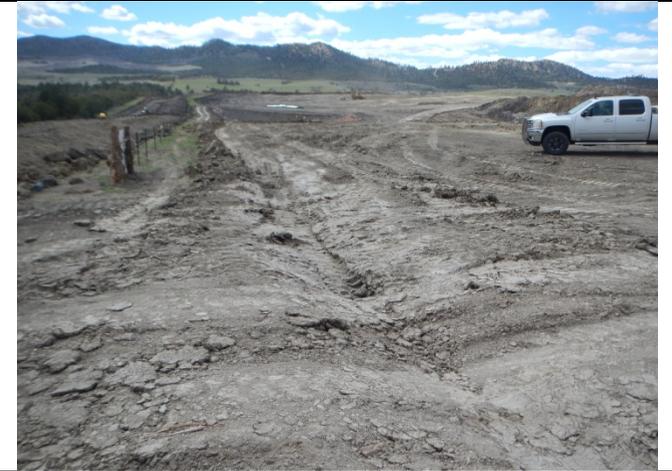
**PHOTO 3**

Eastern most point of DD-08, Ditch not well defined, but a depression is present. April 18, 2016

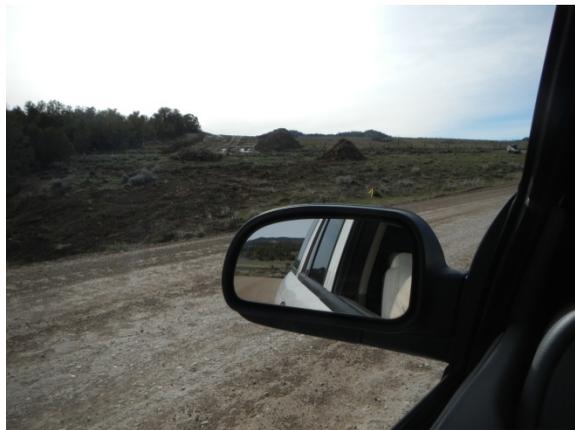
**PHOTO 4**

Looking at the proximity of the County road to left of topsoil piles and Area 1 immediately to the right. April 6, 2016

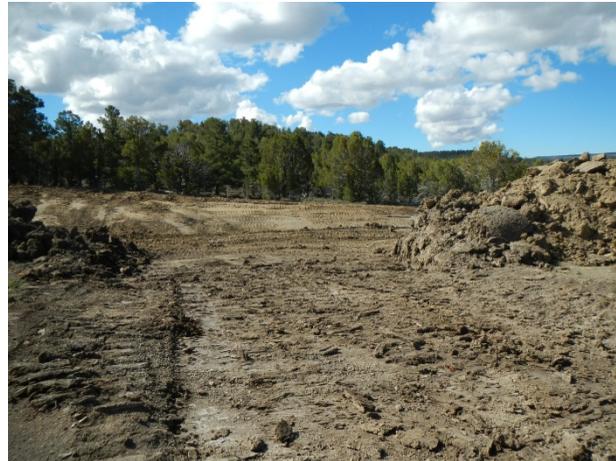
**PHOTO 5**

Permit boundary fence was removed. Missing section of DD-08, used as access to County By-Pass construction. Standing on haul road looking directly south April 12, 2016

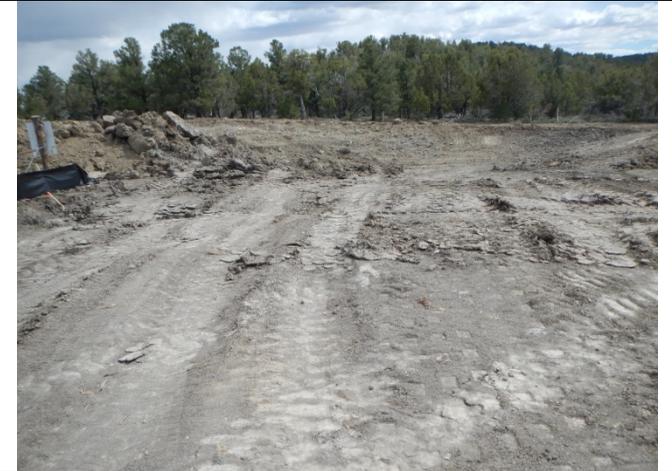
**PHOTO 6**

DD-08, used for access to County By-Pass construction. Standing on haul road looking directly south April 18, 2016

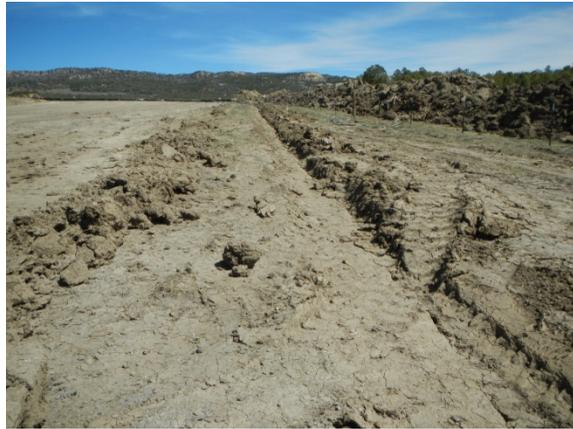
**PHOTO 7**

DD-08 looking East, up gradient, topsoil salvage required, ditch mininstallation incomplete. NOV 21174 issued, April 6, 2016

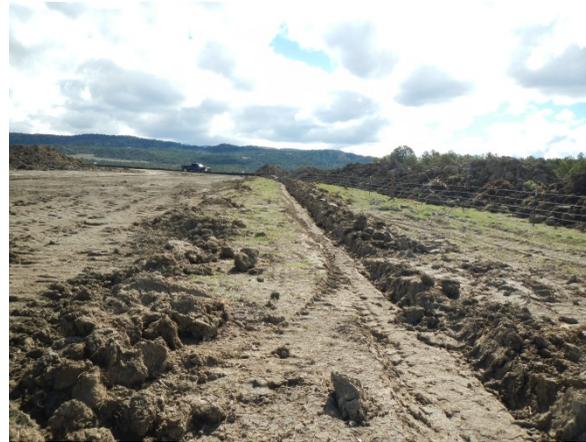
**PHOTO 8**

DD-08 looking East, up gradient, Non-salvaged soil inhibiting flow April 12, 2016

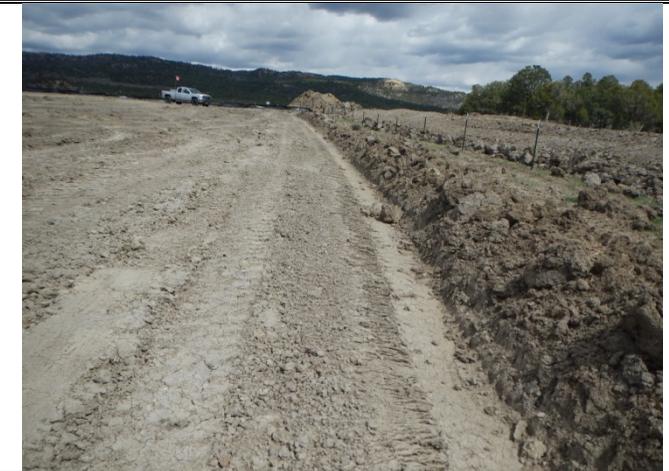
**PHOTO 9**

DD-08 looking East, installation COMPLETED April 18, 2016

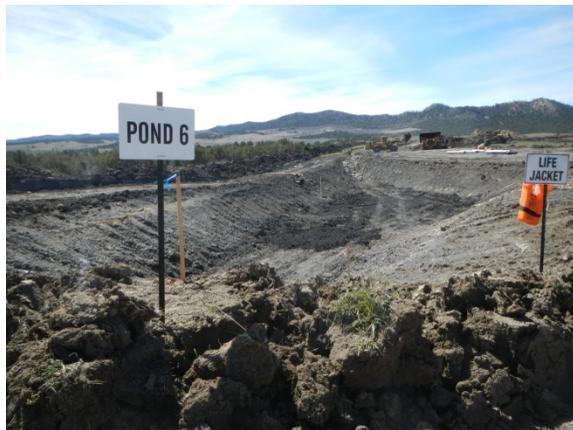
**PHOTO 10**

Looking West at Pond 6, near DD-08 outfall to Pond 6, topsoil needs to be recovered, sediment marker installed not marked. April 6, 2016

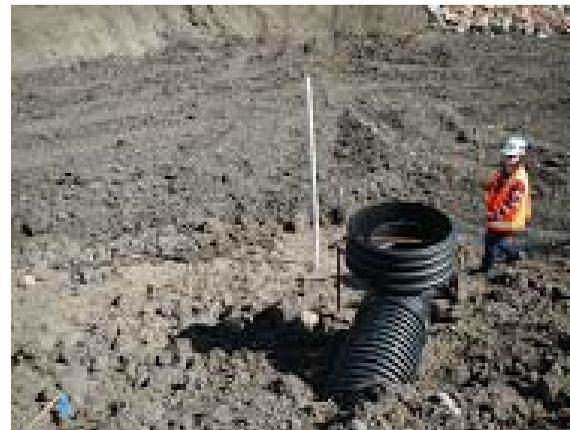
**PHOTO 11**

Pond 6 Sediment markers marked with two elevations: 6,880 ft is 60% clean out. 6,861 ft is max sediment level. April 12, 2016

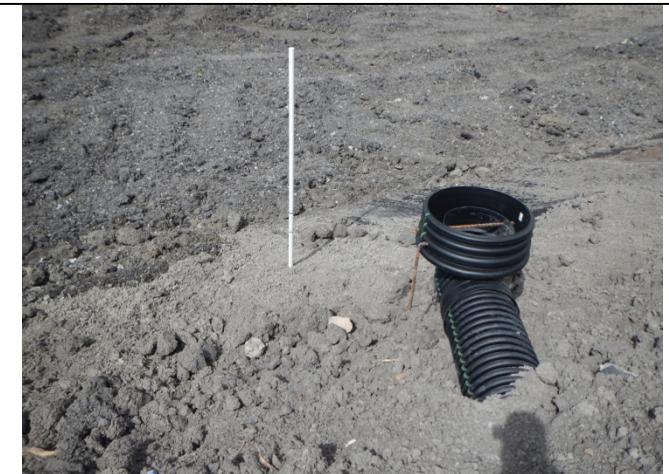
**PHOTO 12**

Pond 6 sediment marker correctly marked. April 18, 2016

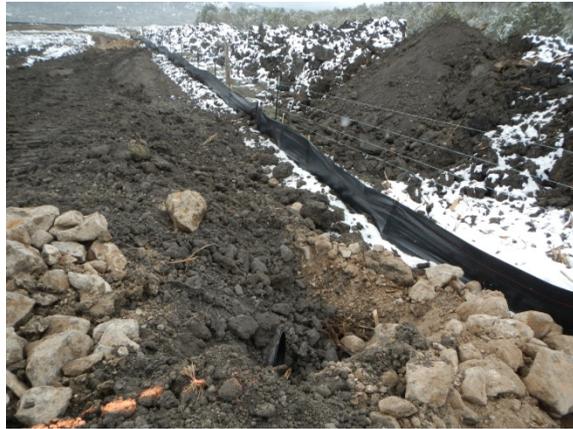
**PHOTO 13**

Looking E at Pond 6 emergency spillway and pipe outlet not completed on 3/29/2016

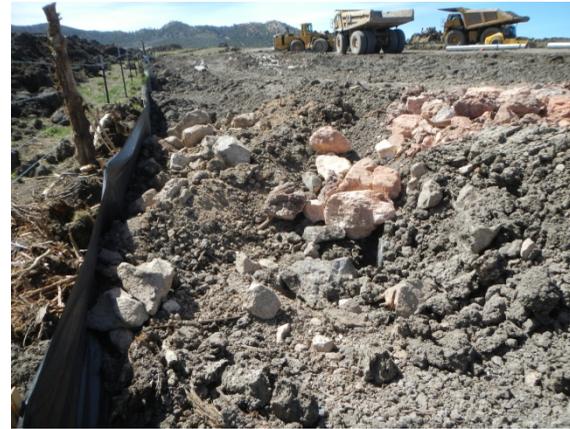
**PHOTO 14**

Looking W at Pond 6 emergency spillway and pipe outlet not completed on April 6, 2016. NOV 21174 written.

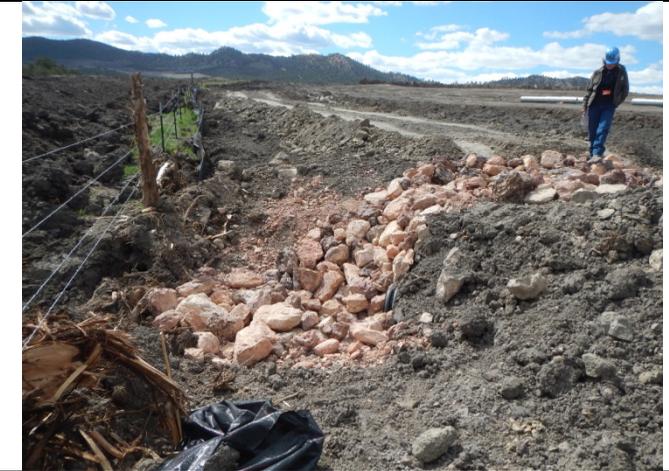
**PHOTO 15**

Emergency spillways at Ponds 5 and 6 have been completed (Photos 15 and 24). Final pond certifications are dated 4/14/2016 and were received at the Division on 4/15/2016. The 60% cleanout and the 100% clean out levels were clearly marked on the sediment markers. It was agreed during this inspection that after each storm, the water in Pond 6 will be reduced to be below the 100% sediment clean out level and Pond 5 will be reduced to be below the 60% sediment cleanout level. This will allow the ponds to capture the required for a 10 yr/24 hour storm (MRP Section ~~742.221.32~~ *App. 5-12 and Sec. 742.221.32*). As-built drawings 5-67A and 5-67B, received with abatement of NOV 21174 on April 15, 2016.

Pond 6 Emergency Spillway completed. Final certification completed. April 18, 2016

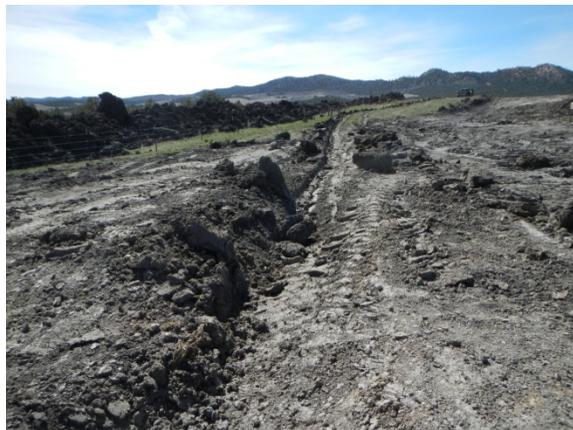
**PHOTO 16**

DD-07 looking West, up gradient, towards ongoing topsoil recovery, ditch to be fixed and soil to be removed, follow up required, NOV 21174 April 6, 2016

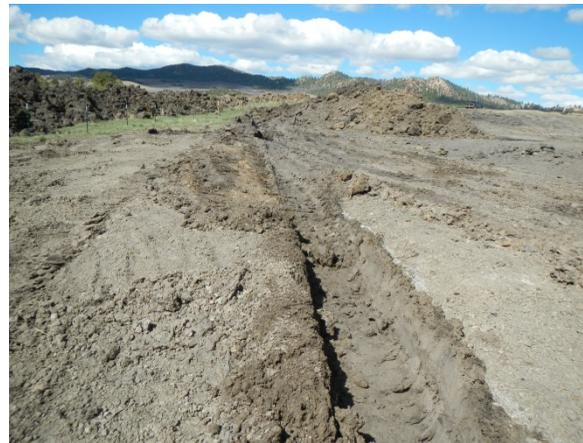
**PHOTO 17**

DD-07 looking West, up gradient, towards recently recovered Topsoil, ditch to be fixed and soil to be removed, follow up required April 12, 2016

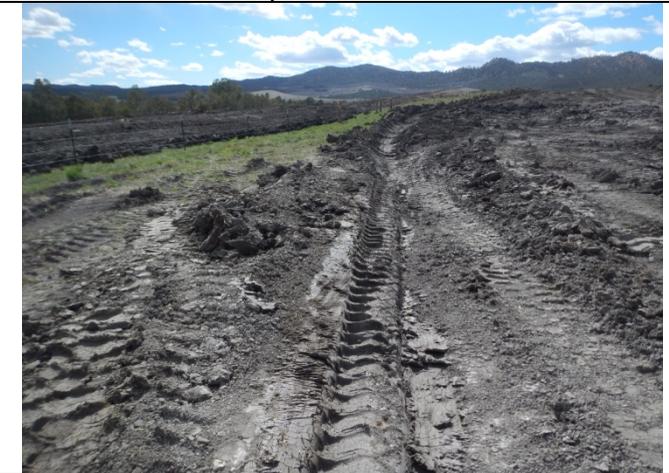
**PHOTO 18**

DD-07 sloped and graded to drain runoff as designed. Topsoil stockpiles removed. April 18, 2016

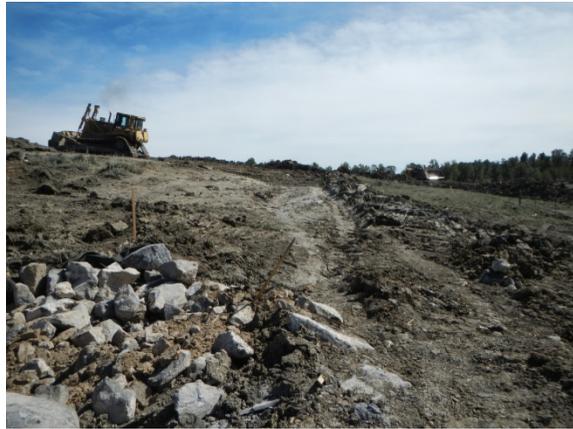
**PHOTO 19**

Standing at DD-06 inlet to Pond 5 looking S. Topsoil salvage on going. Ditch 6 needs maintenance. NOV 21164 issued.  
April 12, 2016

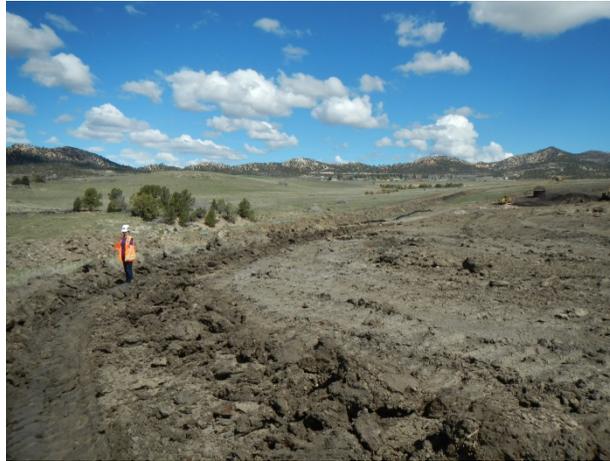
**PHOTO 20**

DD-06 looking down gradient NW towards Pond 5. Staff standing at stress point in the ditch. Ditch to be fixed, follow up required  
April 12, 2016

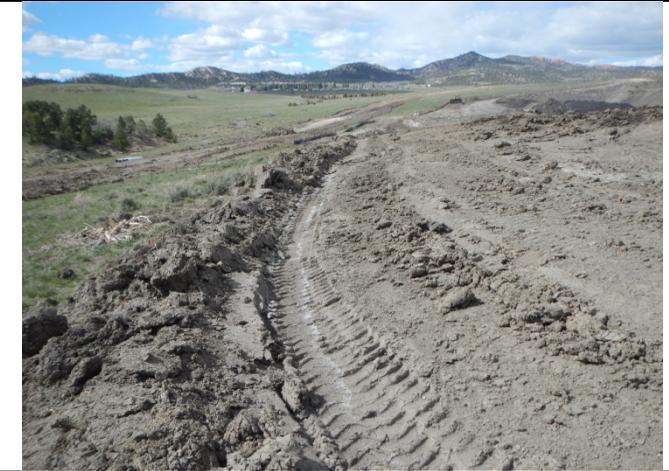
**PHOTO 21**

DD-06 looking down gradient NW towards Pond 5. Ditch correctly graded at bend.  
April 18, 2016

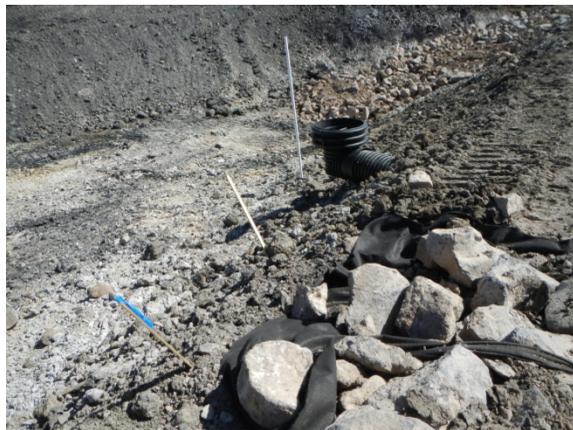
**PHOTO 22**

Pond 5 sediment markers in place, but no elevations marked. Pipe outlet at embankment elevation. Geotextile installation needs repair.  
NOV 21174 issued,  
April 6, 2016

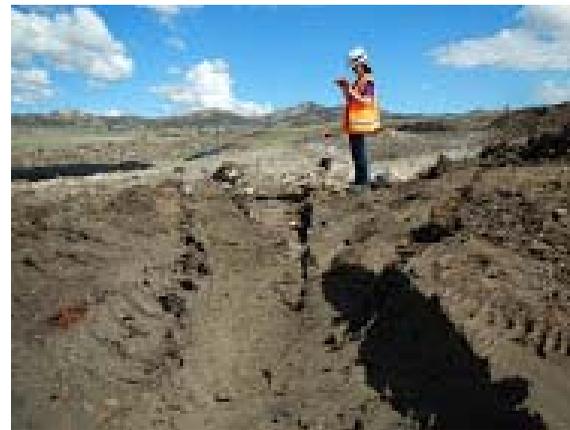
**PHOTO 23**

Ditch 6 at pond 5 inlet need repair, draining off site. Pond 5 embankment survey stakes indicate Pond 5 work not yet completed. Embankment needs to be raised 1 ft – 1.5 ft.  
April 12,2016

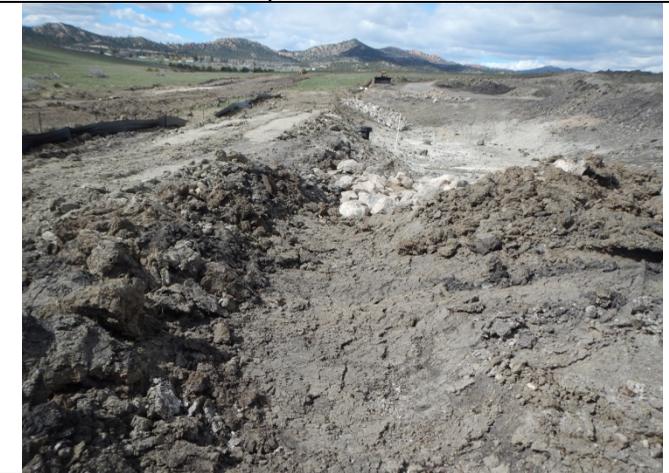
**PHOTO 24**

Ditch 6 inlet to Pond 5 repaired. Embankment raised 1 ft – 1.5 ft, to 6850 ft. Pond 5 emergency spillway is finished.  
April 18,2016

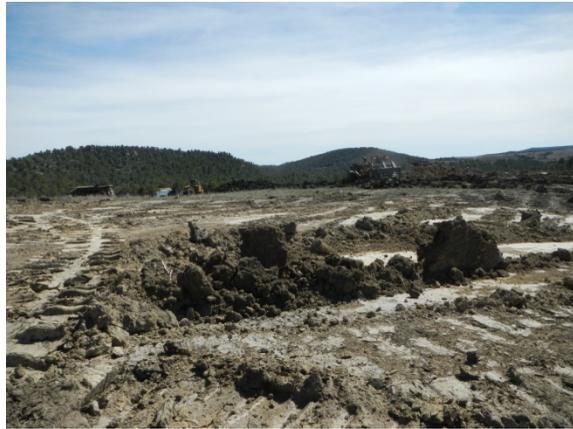
**PHOTO 25**

Looking N at haul truck emerging from Pit 1 and topsoil recovery above Pit 2. NOV issued 21174  
April 6, 2016

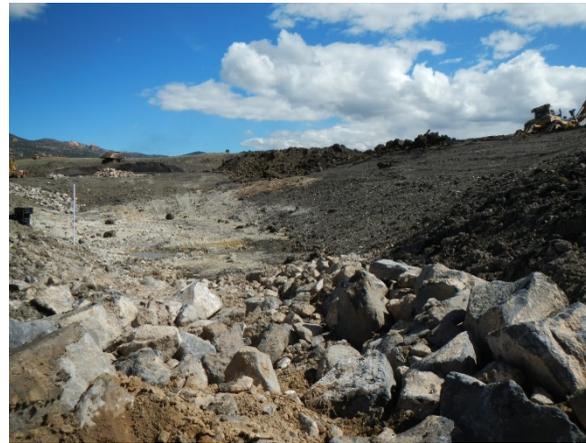
**PHOTO 26**

Standing at DD-06 inlet to Pond 5 looking at topsoil stockpiled on ridge and mining out of Pit 1.  
April 12, 2016

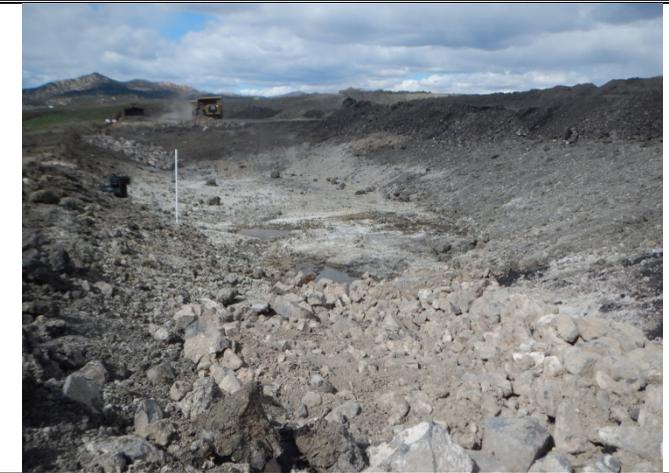
**PHOTO 27**

Topsoil and subsoil completely recovered from Area 1 Pit 1 and 2. Pond 5 maximum water/sediment level is 60% cleanout mark.  
April 18, 2016

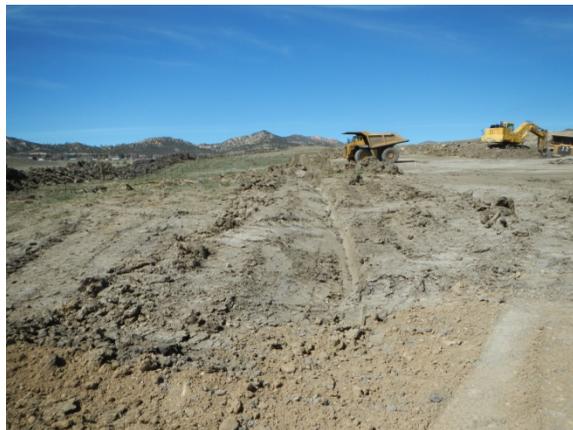
**PHOTO 28**

Looking N from Pond 5 up gradient, at DD-05 which is not cut to required one foot deep with 2h:1v side slopes. Mining in Pit 1 is ongoing in background. NOV 21164 issued,  
April 6, 2016

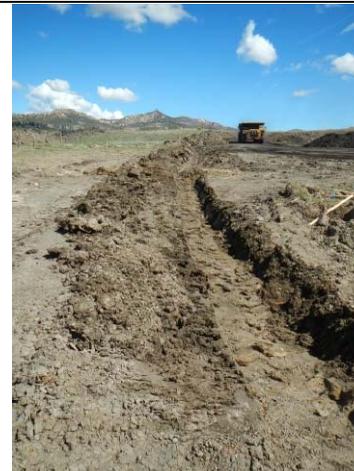
**PHOTO 29**

Looking N from Pond 5 up gradient, at DD-05, ditch cut deeper, topsoil needs to be recovered.  
April, 12, 2016

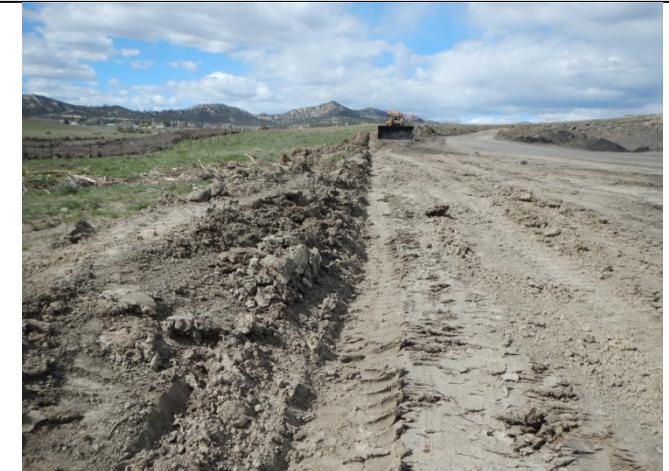
**PHOTO 30**

Looking N from Pond 5 up gradient, at DD-05 installed correctly.  
April, 18, 2016

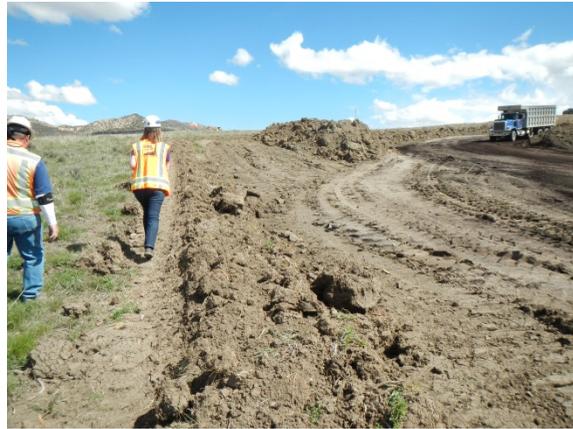
**PHOTO 31**  
Looking No at D5 and topsoil pile.  
April 12, 2016

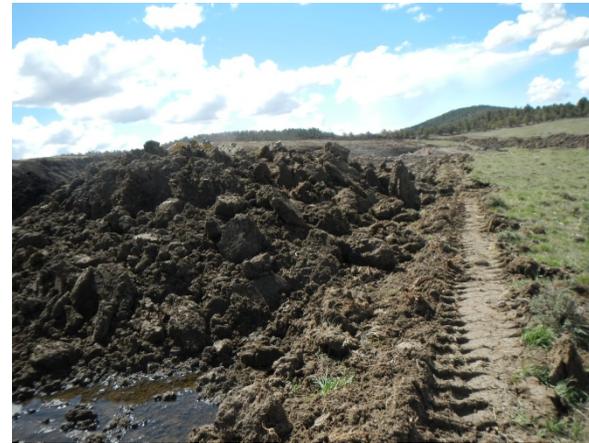
**PHOTO 32**  
Looking S at topsoil pile along haul road blocking DD-05.  
April 12, 2016

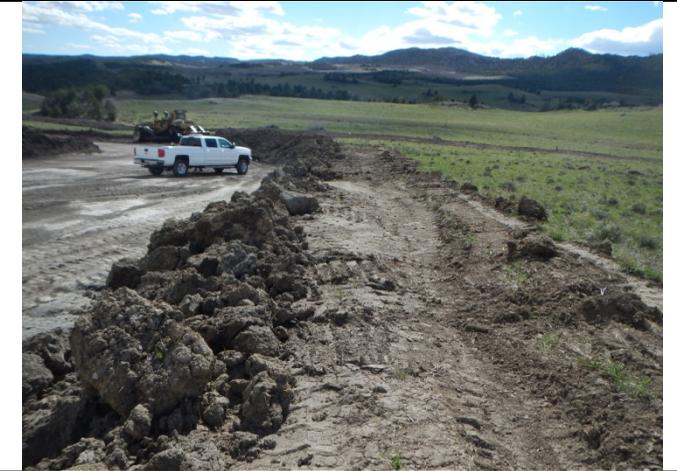
DD5 was not well defined from the bend in the temporary haul road east to the subsoil pile (Photo 33). A grader was brought out to blade the ditch, but then it was noticed that topsoil had not been removed from the ditch and adjacent disturbed area. The topsoil was removed and placed in the topsoil pile during the inspection. A field change was approved to allow DD 5 to begin at the bend in the haul road. Flow from the subsoil pile goes overland down the temporary haul road. Ditch DD5 picks up some of the overland flow at the bend in the haul road. The field change in DD5 will be monitored. Ditch DD 5 may need to be cut along its full length in the future.

**PHOTO 33**  
DD-5 was nearly non-existent at beginning of inspection. DD-5 was repaired by the end of the inspection.  
April 18, 2016

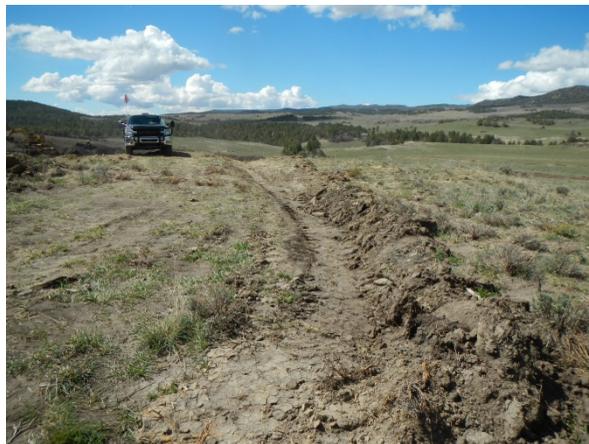
**PHOTO 34**  
DD-05 starting point, topsoil to be salvaged and ditch repaired.  
April 12, 2016

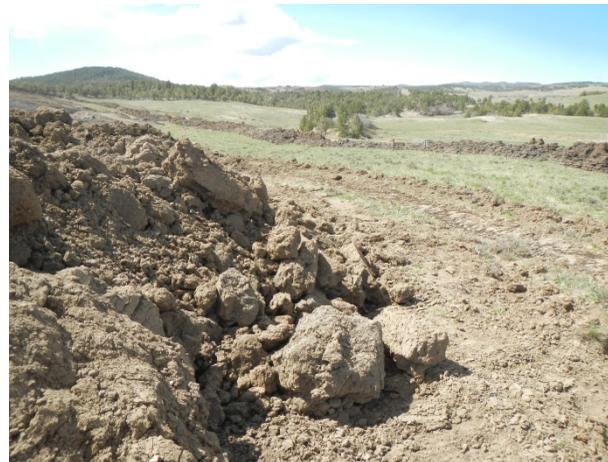
**PHOTO 35**  
Walking DD-05 North, second topsoil pile in DD5.  
April 12, 2016

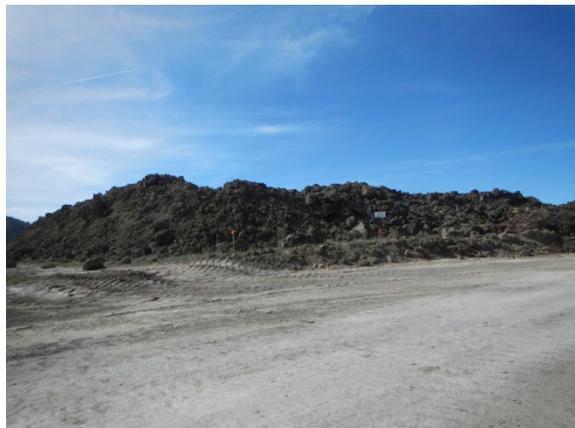
**PHOTO 37**

Looking N at subsoil pile from temporary haul road. Subsoil salvage incomplete. NOV 21174 issued. April 6, 2016

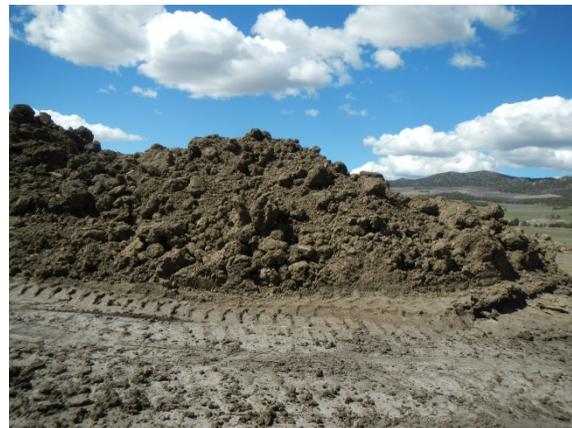
**PHOTO 38**

NW point of subsoil pile, began driving around subsoil. To be bermed when lift is placed by dozer, follow up required April 12, 2016

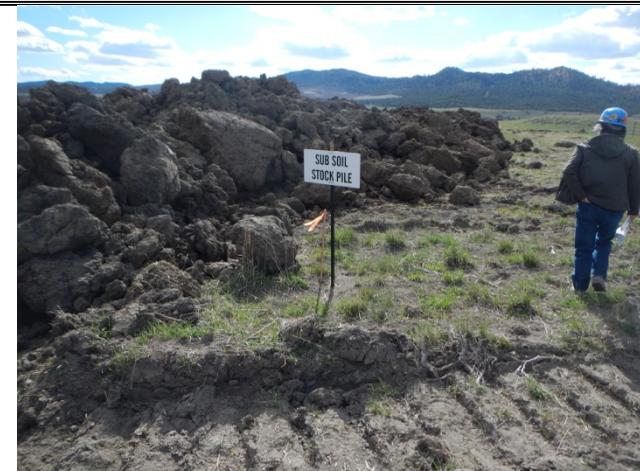
**PHOTO 39**

NW point of Subsoil pile not lifted. No berm at beginning of inspection. April 18, 2016

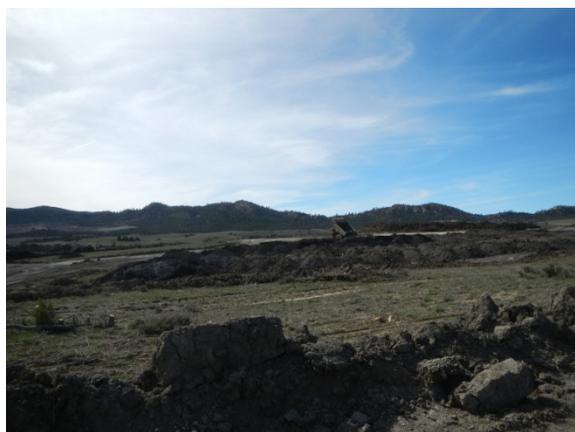
**PHOTO 40**

Looking W across spoil pile pile with first lift on west side, but topsoil remaining on East half. NOV 21174 written April 6, 2016

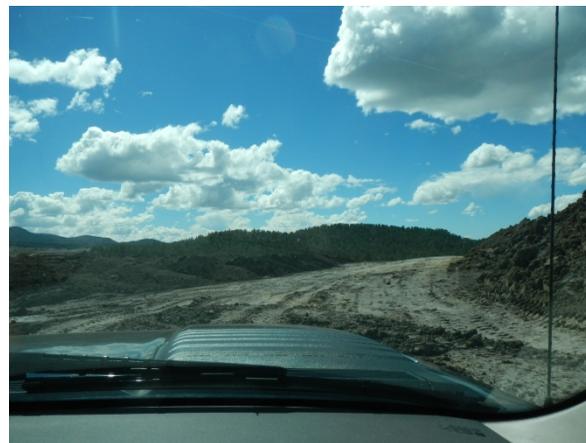
**PHOTO 41**

Looking S on temporary haul road. Subsoil pile on right (East) and spoil on left (West). No MSHA berms. April 12, 2016

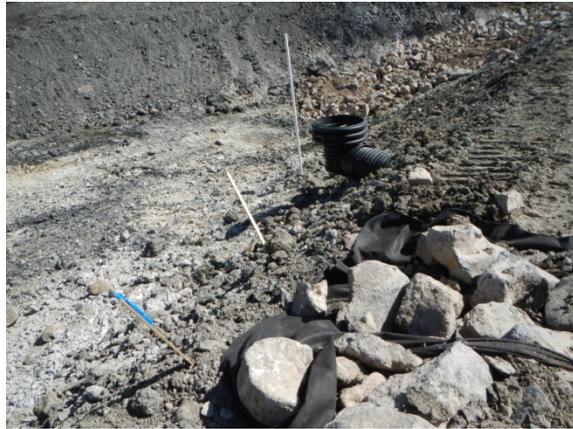
**PHOTO 55**

Pond 5 geotextile installation at Pond 5 emergency spillway.  
April 6, 2016

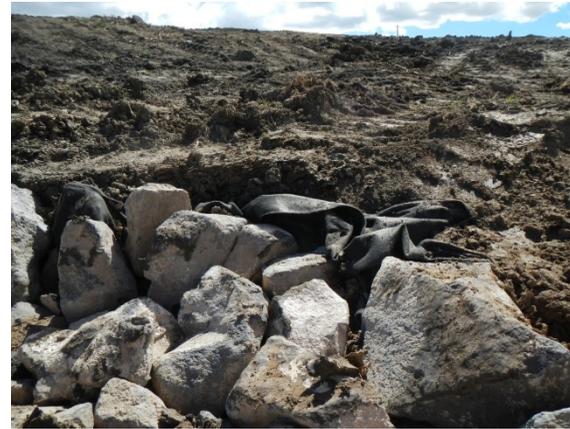
**PHOTO 56**

Topsoil removal not complete at DD6 inlet to Pond 5 and geotextile needs repair.  
April 12, 2016

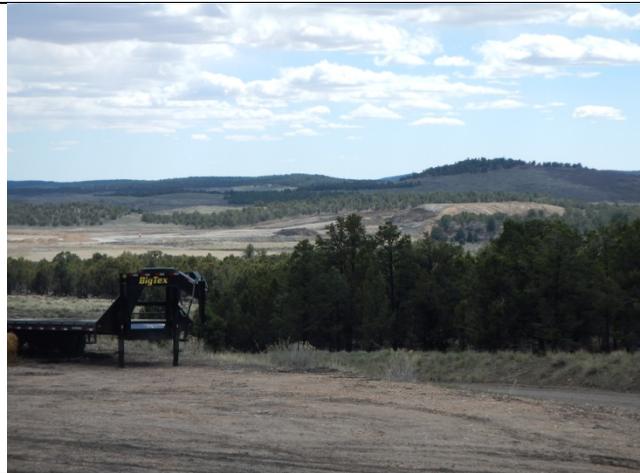
**PHOTO 58**

There was no reclamation work being done at HWT 2 or the spoil pile during this inspection (Photos 58 - 61). Two haul trucks were idle at the Area 1 location. Two haul trucks were moving spoil and coal. One haul truck was idle at the facilities maintenance yard. The location of the fill in HWT 2 was walked and surveyed with a GPS unit. The edge of HWT 2 appeared to be within 20 feet of the BRP1-7 pit boundary that was walked during the bond release inspection on March 30, 2016. Since no reclamation had been noticed at HWT 2 during several previous inspections, we advised Mr Nicholes that meeting the June 9, 2016 date was of paramount importance to avoid a cessation order.

Refuse pile in south lease area. No equipment is present on the Refuse pile during the inspection.  
April 6, 2016

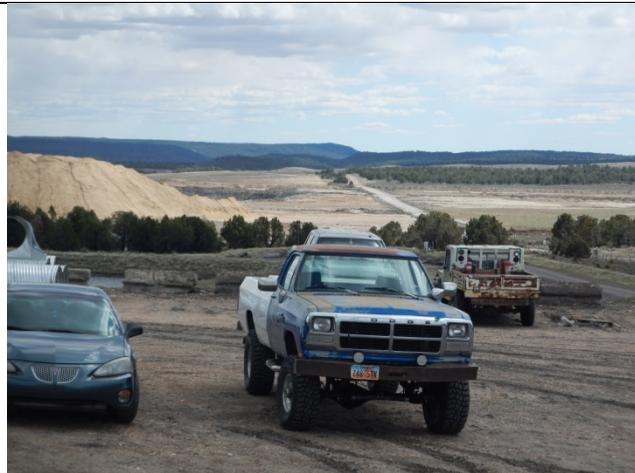
**PHOTO 59**

Background of photo shows haul road between the Refuse pile and HWT 2. No equipment is working to backfill HWT 2.  
April 12, 2016

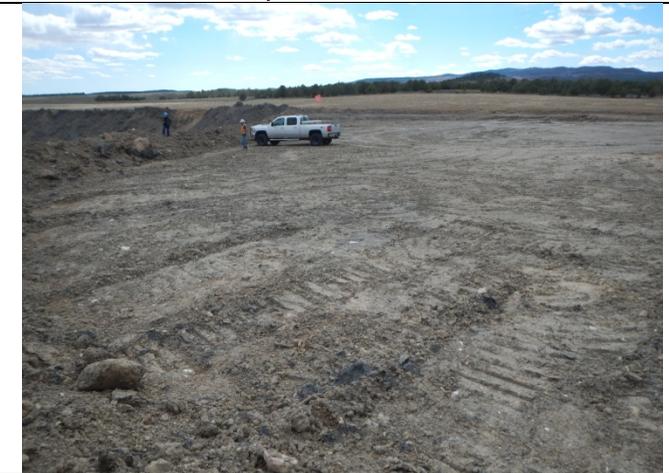
**PHOTO 60**

HWT 2 backfill dump zone. No equipment is working to backfill HWT 2 during the inspection.  
April 18, 2016.

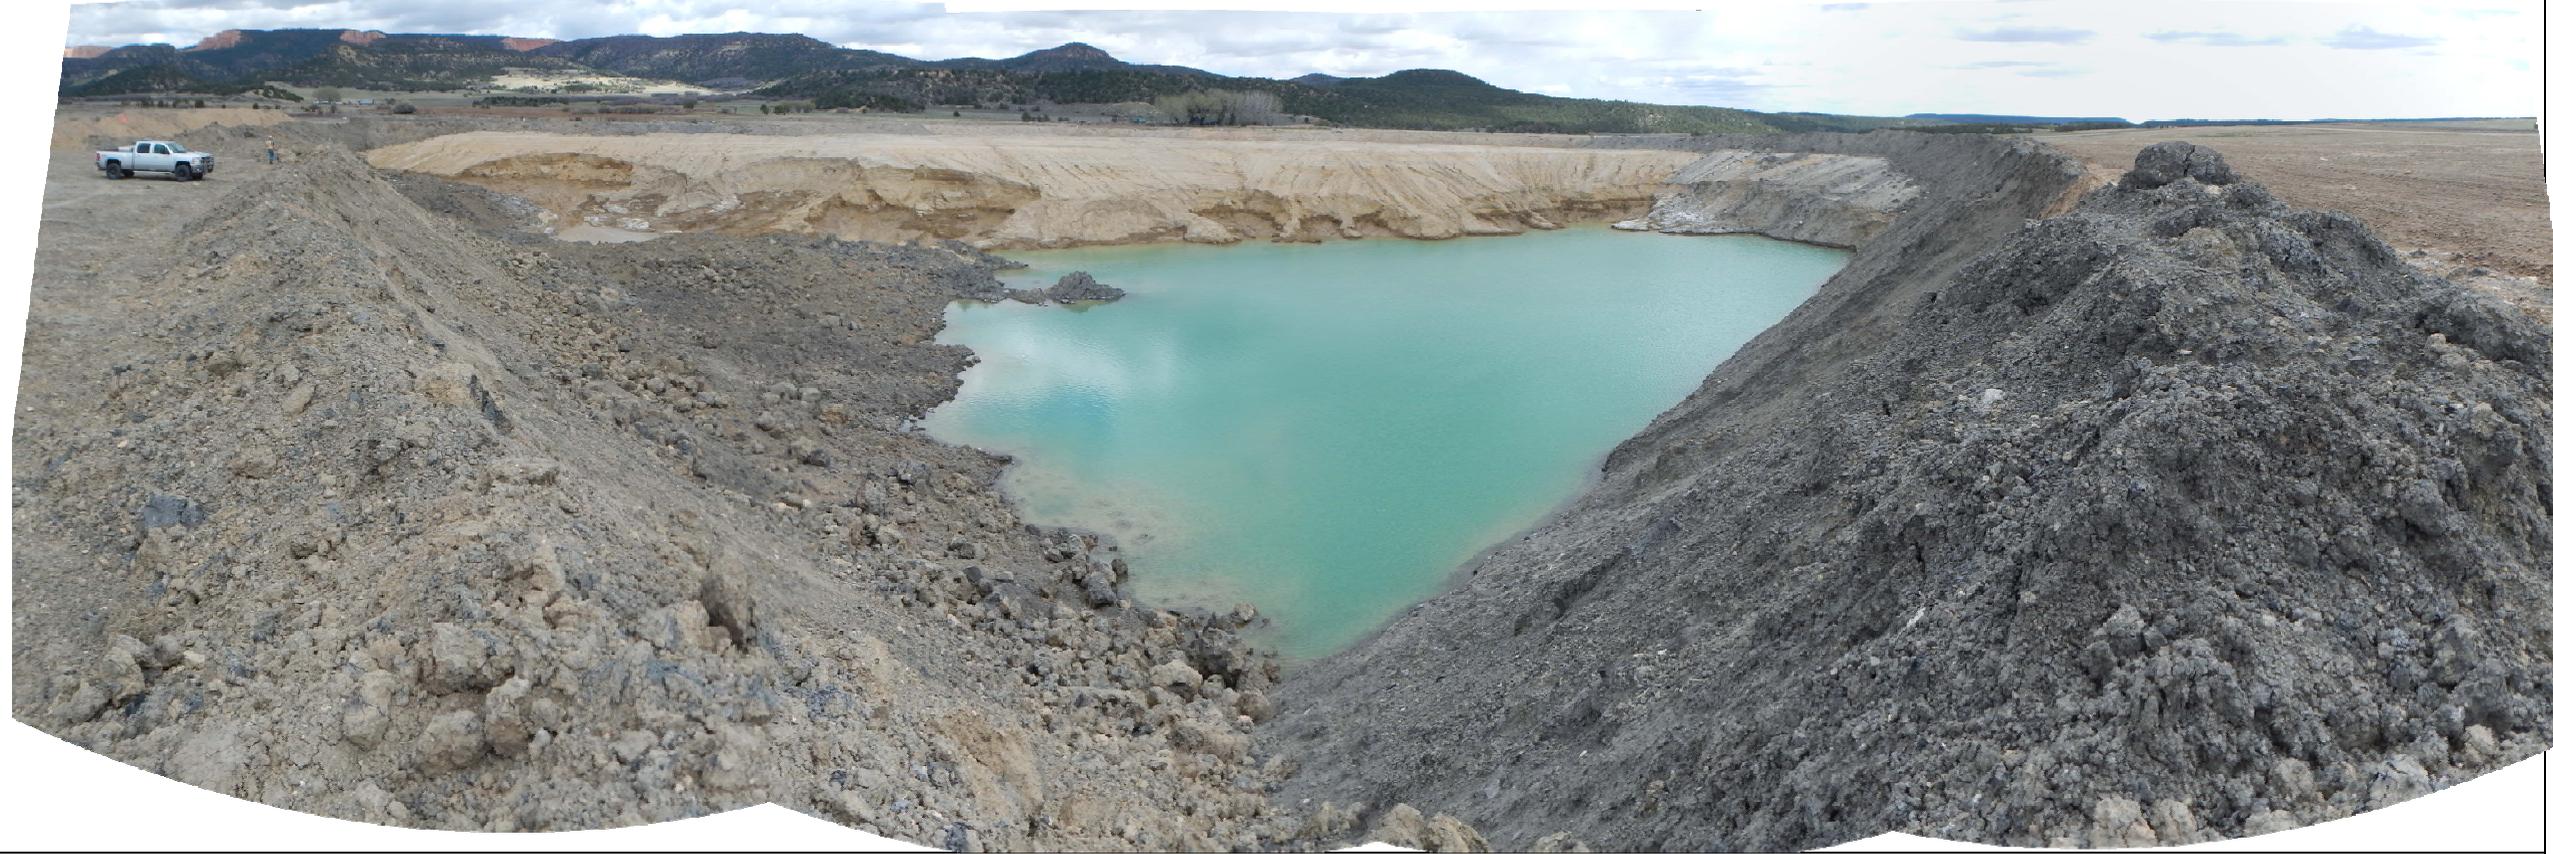
**PHOTO 61**

Panorama from Northeast corner of HWT 2 looking southeast.  
April 18, 2016
