## Inspection Report

Permit Number:	C0250005
Inspection Type:	COMPLETE
Inspection Date:	Tuesday, May 24, 2016
Start Date/Time:	5/24/2016 9:30:00 AM
End Date/Time:	5/25/2016 3:00:00 PM
Last Inspection:	Tuesday, May 17, 2016

Permittee: **ALTON COAL DEVELOPMENT LLC**  
 Operator: **ALTON COAL DEVELOPMENT LLC**  
 Site: **COAL HOLLOW**  
 Address: **463 North 100 West, Suite 1, CEDAR CITY UT 84720**  
 County: **KANE**  
 Permit Type: **PERMANENT COAL PROGRAM**  
 Permit Status: **ACTIVE**

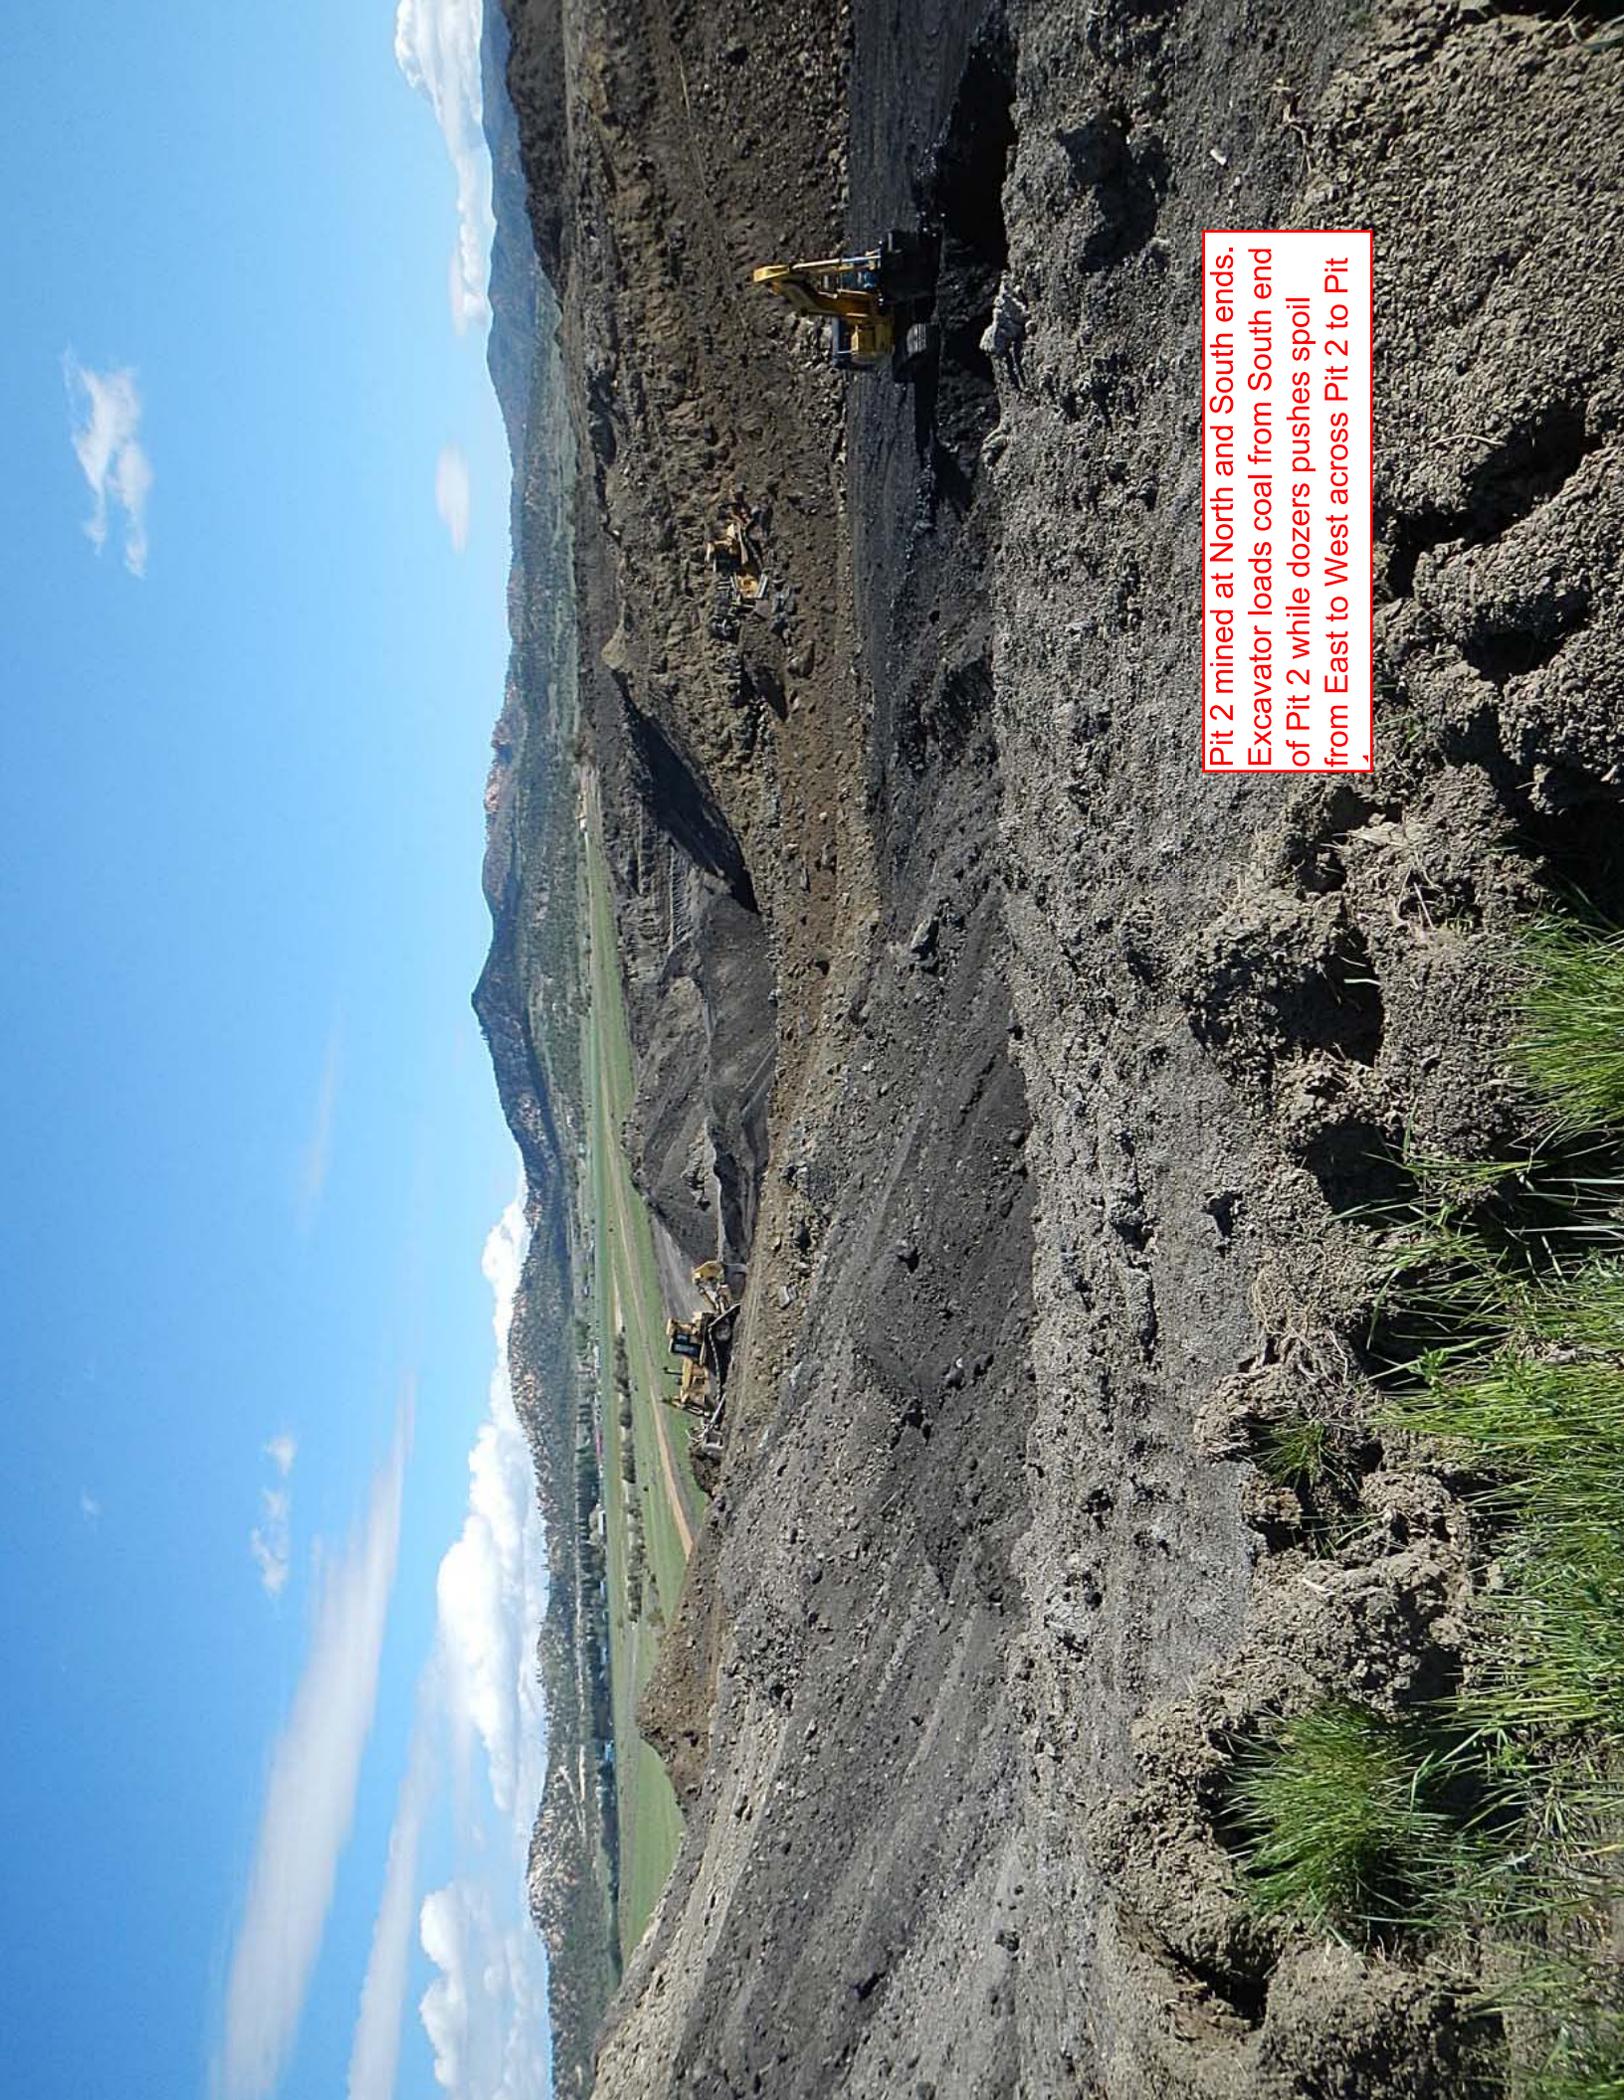
Pit 2 mined at North and South ends. Excavator loads coal from South end of Pit 2 while dozers push spoil from East to West across Pit 2 to Pit

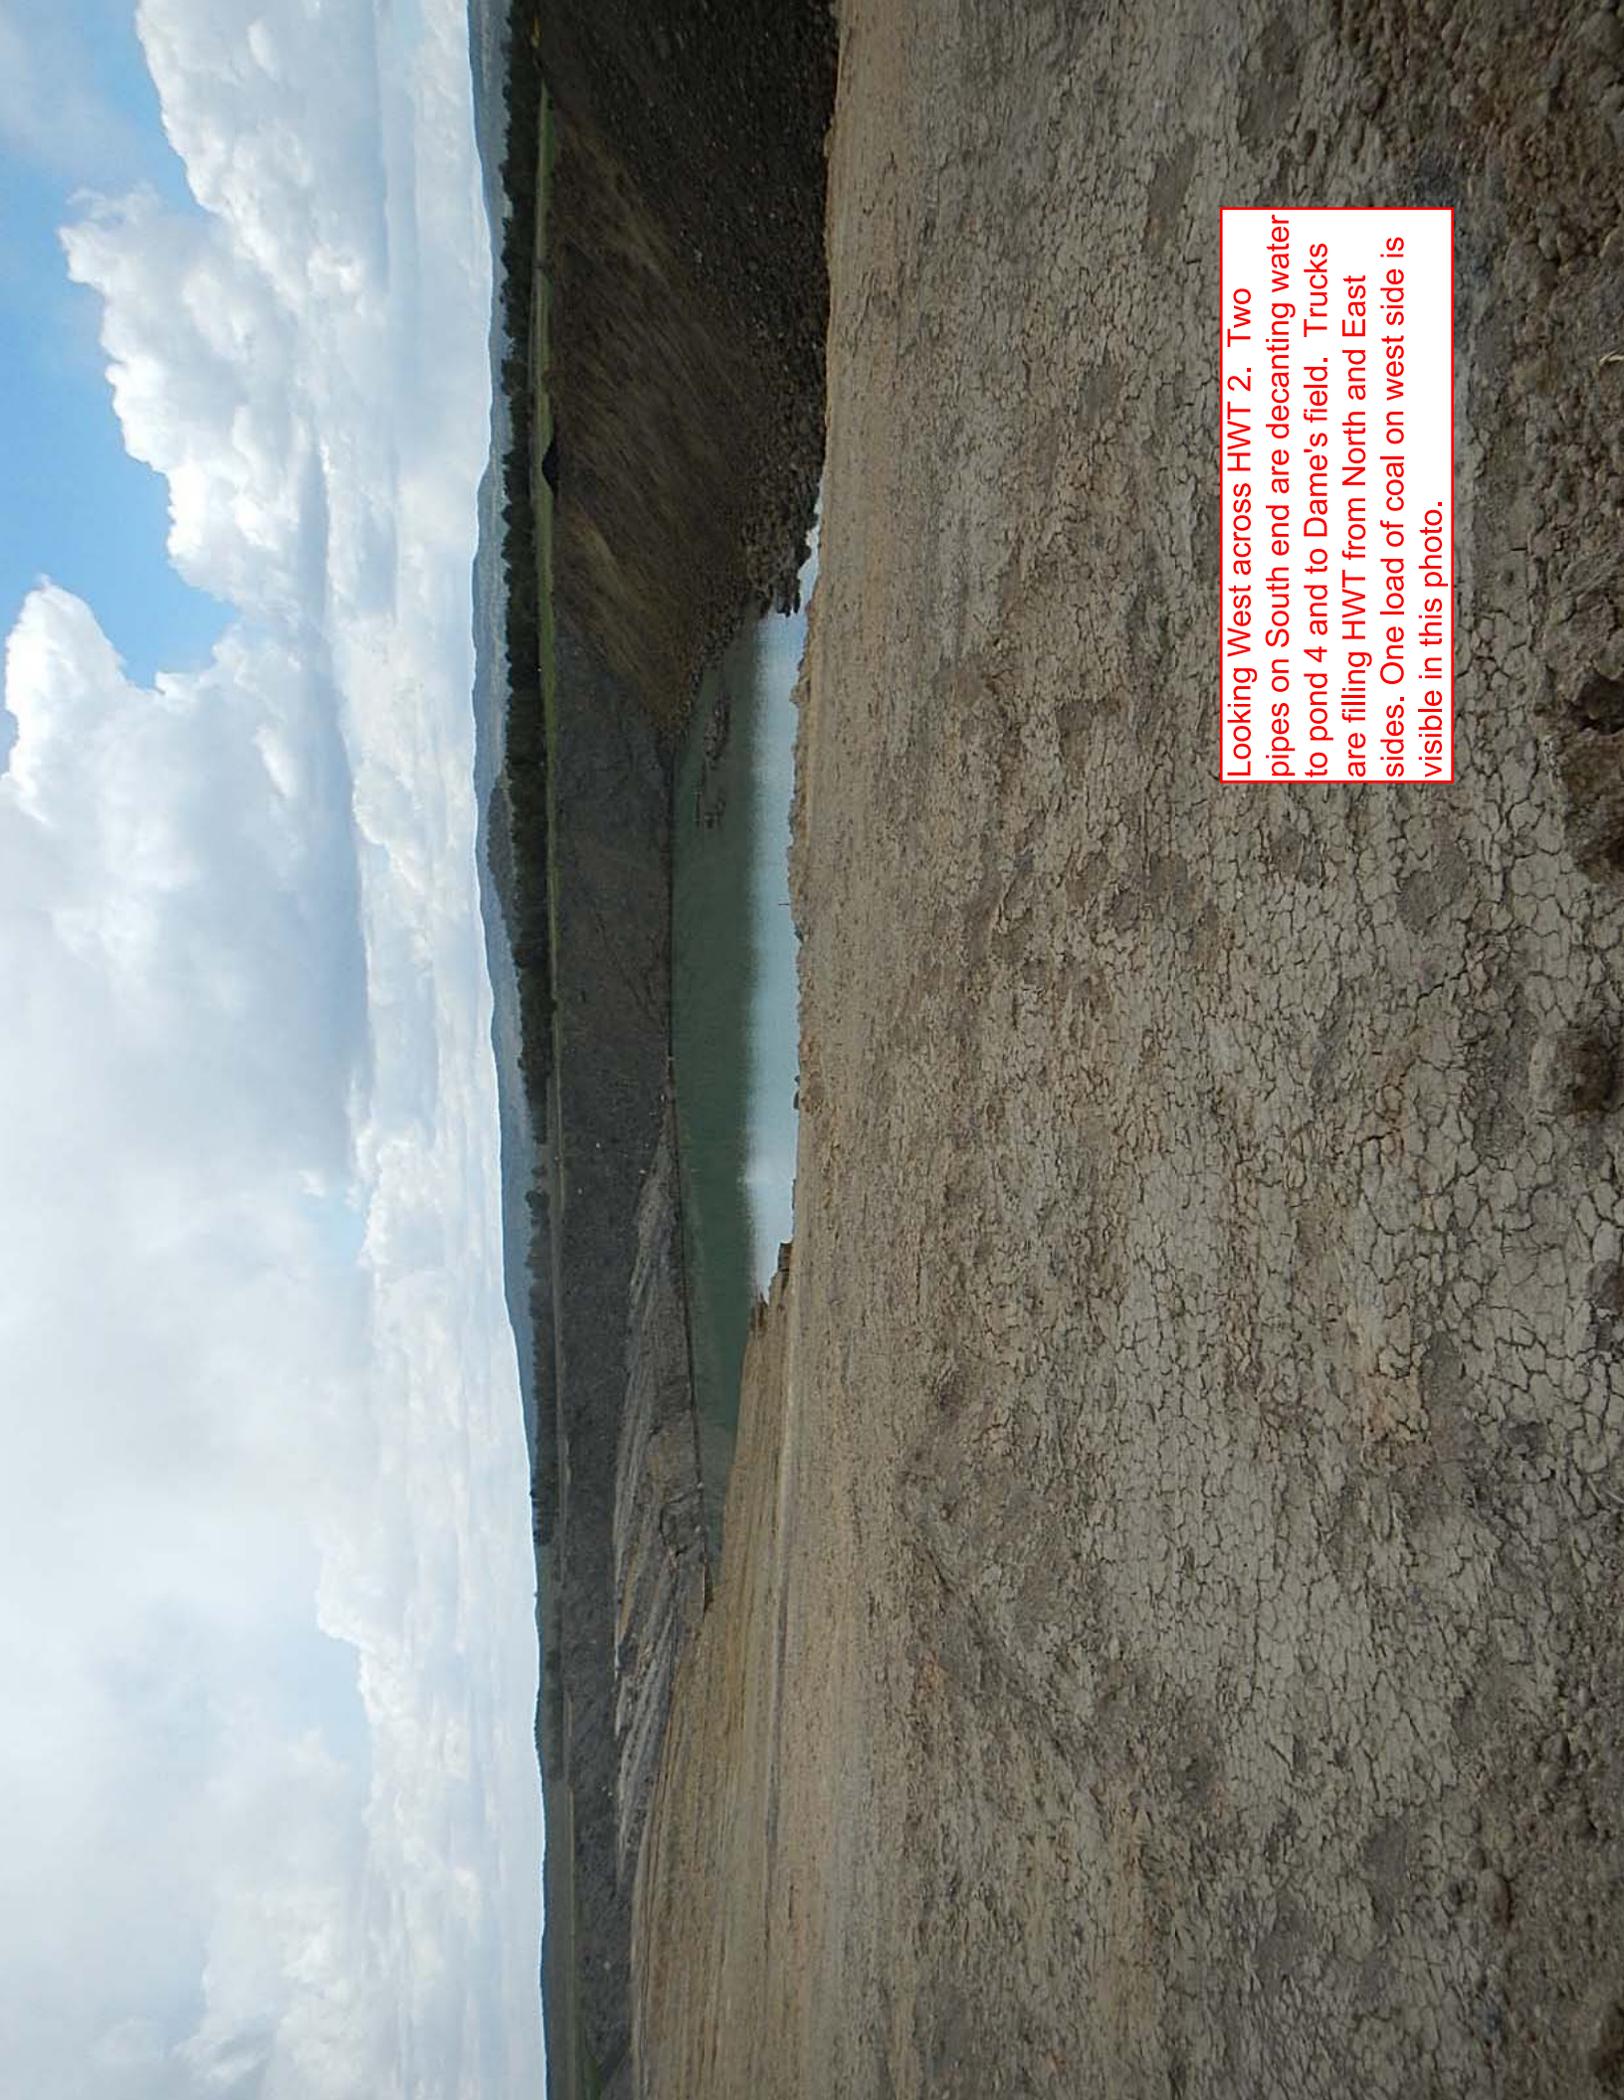
Backfilling of HWT 2 was ongoing during the inspection. (Mr. Anderson and Mr. Nicholes agree that HWT 2 will be completely backfilled by next week.) The PC 2000 track hoe was loading spoil. Three 150 Ton (CAT 785) haul trucks were hauling spoil to the north and east edge of HWT 2. A loader was loading subsoil from subsoil pile #2. One 150 Ton truck was hauling subsoil to the HWT 2 area.

Looking West across HWT 2. Two pipes on South end are decanting water to pond 4 and to Dame's field. Trucks are filling HWT from North and East sides. One load of coal on west side is visible in this photo.

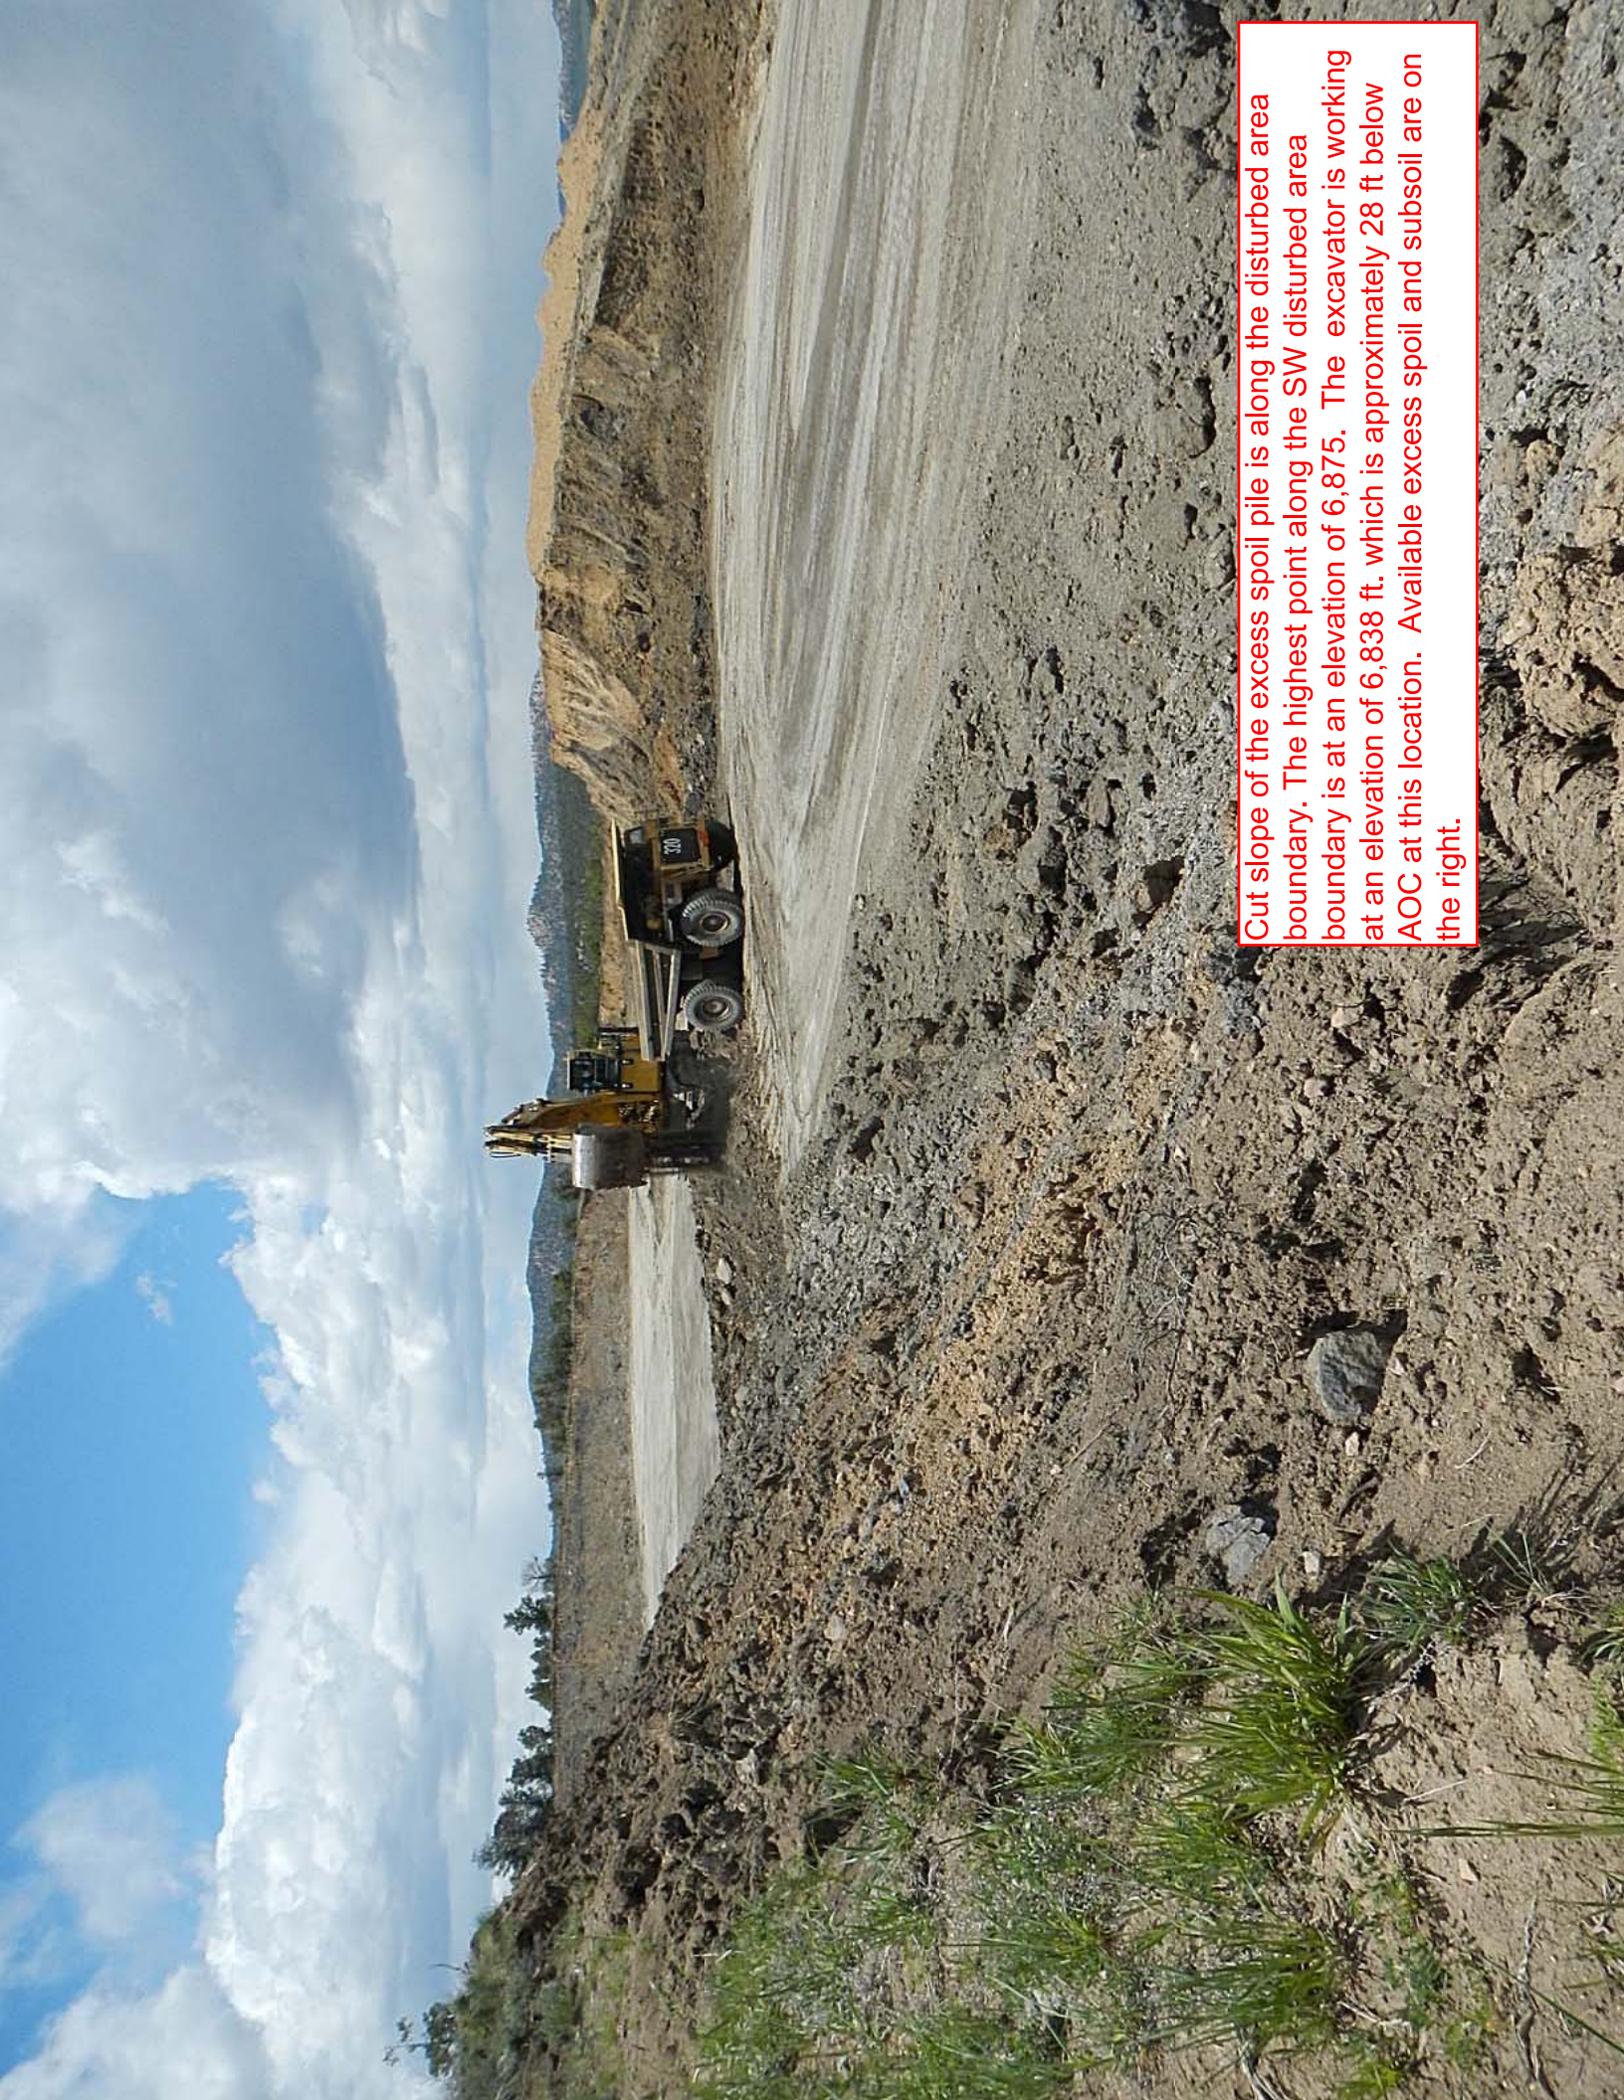
Excess spoil has been removed from almost the entire excess spoil pile. The spoil was over-excavated along the south and west boundary. The slope along the south side was steep (estimated at 1.5h:1v). The pre-existing topography is shown on Dwg 5-1. Pre-existing slopes were about 10% (10h:1v). The last certified inspection of the excess spoil pile is dated 3/15/2016. In March, the working surface was at 6,918 ft. On Dwg 5-1, the location of the pre-mining surface in the working area was about 6830 ft. My gps unit showed the existing elevation of the working area to be 6805 feet. The boundaries of overburden removal as shown on Dwg 5-15 were discussed. The failure to follow the plan for removing spoil down to AOC was discussed. The potential for an NOV was discussed. However, accurate elevations were needed. Therefore, I asked for surveyed elevations of the working area of the excess spoil pile and for the contours of the cut face. Those elevations were provided the next day. Drew Christensen presented the survey information to Division staff on May 31, 2016 in a meeting at the Salt Lake office. The working surface elevation is 6,838 ft.. Along the south disturbed area boundary, an area of 5 acres was over-excavated 28 feet below the pre-mining surface. 72,000 CY of overburden was removed from this area and used as backfill in HWT 2. This cut is in the location of the proposed borrow for Pit 10 reclamation. However, disturbance of the borrow area had not been approved and was not anticipated until final reclamation. The MRP states in Sections 528.310, Section 542.100 and Section 553 that "Any shortage of material for final backfill of the Highwall Trench will be made up by rehandle of spoil from the long term excess spoil pile...to bring both the spoil pile structure and the highwall trench areas to AOC." Therefore, NOV 21183 was issued for failure to follow the approved plan, R645-300-142.

Cut slope of the excess spoil pile is along the disturbed area boundary. The highest point along the SW disturbed area boundary is at an elevation of 6,875. The excavator is working at an elevation of 6,838 ft. which is approximately 28 ft below AOC at this location. Available excess spoil and subsoil are on the right.

**Nature of condition, practice, or violation:**  
 The excess spoil pile was over-excavated below the premining surface at the south disturbed area boundary of the excess spoil pile. The pre-mining surface grade was 10% (10h:1v). Surveyed elevations presented on May 31 confirmed that five acres of the land was cut 28 feet below premining topography, removing 72,000 CY of overburden and leaving a steep cut face (1.5h:1v).

**Provisions of Act, regulations, or permit violated:**  
 R645-300-141 and R645-300-142. *The following statement is repeated numerous times in the MRP: "Any shortage of material for final back fill of the Highwall Trench will be made up by re-handle of spoil from the long term excess spoil pile." to bring both the spoil pile structure and the highwall trench areas to AOC.* (MRP Sec. 528.310, sec 542.100, sec 553)

**Action(s) required:**  Yes  No  
 Update the MRP narrative with plans for interim reclamation and stabilization of the cut slope affected. State the size of the area affected. Include volumes of spoil to be placed as fill. Describe plans to place fill in a controlled manner, blend contours, provide compaction, control drainage and erosion and to establish vegetation. Plans will be designed and certified by a P.E. Provide a timeline for the interim work. Provide existing and proposed interim reclamation contours on a map, with a commitment to provide an as-built survey of the reclamation construction. State in the MRP the volume of excess spoil remaining for other reclamation uses. Adjust the bond line items for all work accordingly. Provide these complete and adequate plans by August 2, 2016.
