Inspection Report

Permit Number:	C0250005
Inspection Type:	IND PART OVERSITE
Inspection Date:	Monday, June 13, 2016
Start Date/Time:	6/13/2016 9:00:00 AM
End Date/Time:	6/13/2016 5:00:00 PM
Last Inspection:	Tuesday, May 24, 2016

Site: **COAL HOLLOW**

ATTACHMENT A – Photos June 13, 2016, Inspection Report #5548

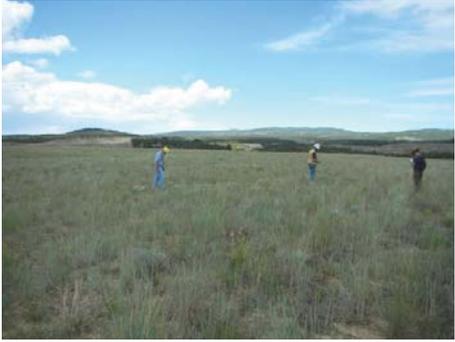
PHOTO 1

Reclaimed areas had been seeded one to two years prior. The seeded vegetation provided good cover and was diverse, and most of the seeded species were found growing. Weed control as described in Section 341.250 is necessary for noxious weeds, such as musk thistle. Cheat grass control is recommended to ensure meeting the diversity success standard.

Reclaimed Pits 3 & 5 Sagebrush Grass seed mix

6.Control of musk thistle will be conducted this year on reclaimed areas (per Section 341.250).

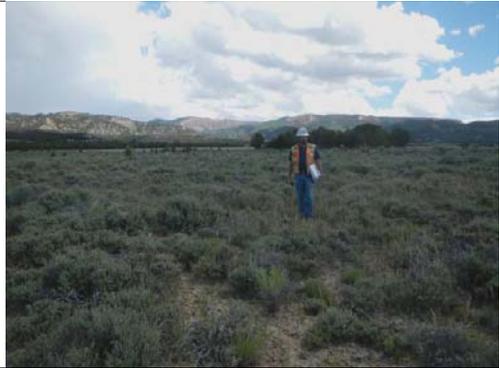
PHOTO 2

Woody plant density in both the P/J reference area and Sagebrush/Grass reference areas was notably higher than that in the sagebrush/grass reclaimed area. We discussed the woody plant requirement and options for re-seeding or planting. The plan describes planting containerized stock in minimal stocking and planting in consultation with the Division (MRP Section 356.231. And the plan states that 400 containers will be planted per acre in MRP Section 341.220 (p. 3-65). We discussed the requirement to accomplish any augmented seeding or woody plantings by year four to meet the criteria described in MRP Section 356.232.

Kirk standing in middle of Sagebrush grass reference area

- 1.As discussed the GPS location(s) will be added to the MRP along with sufficient

description to allow a person to know the boundary of the reference area in relation to the GPS location(s).

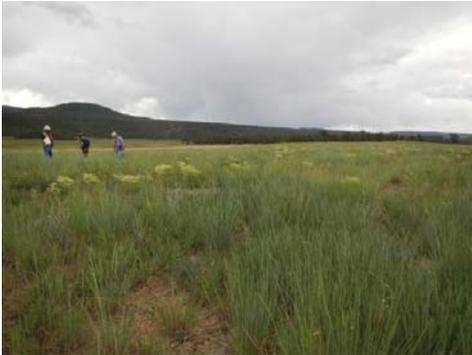
PHOTO 3

Reclaimed sagebrush grass over Pit 26 West of County road formerly Pinyon Juniper vegetation.

2.ACD will obtain a written recommendation from the DWR for woody plant density that is appropriate for the post mining land use of wildlife habitat (sagegrouse emphasis) to meet the requirements of MRP Sections 341.220, 356.231 and 356.232. This recommendation will be forwarded to the Division and will be described in the MRP success standard for sagebrush/grass seeded areas.

3.ACD and the Division will consult with experienced staff at the DWR, NRCS, BLM, and their consultant and reclamation contractors to develop the treatment methods for improving woody plant density on existing seeded areas, with minimal effect on established vegetation, to meet MRP Section 356.231 requirements. The MRP will be amended to include said treatment measures to improve woody plant density in the reclaimed sagebrush/grass seeded areas.

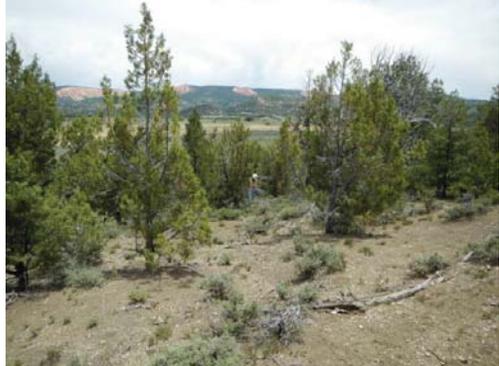
PHOTO 4

The approximate locations of reference areas are shown on Dwg 3-1, but the GPS location is not in the MRP. We navigated to the Sagebrush/Grass reference area and the Pinyon/Juniper reference area and the Riparian reference areas using GPS locations. The sites were on BLM land. Other than Russian Olive and cheat grass (neither is on the noxious weed list), these reference sites were free of weeds. Both sites were open to grazing animals. The P/J site was adjacent to a fence. The P/J site included an old campfire ring and vehicle tracks along the fence line.

Kirk in the middle of the Pinyon Juniper reference area

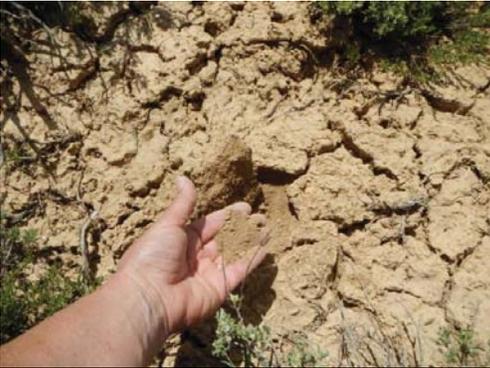
PHOTO 5

Soil in the Sagebrush Grass reference area.

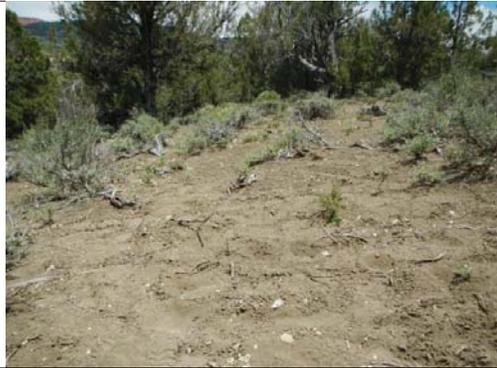
PHOTO 6

Soil in the Pinyon Juniper Reference Area.

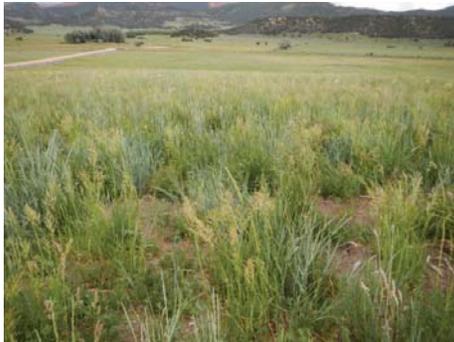
PHOTO 7

The MRP does not identify a reference area for pastureland, but states that a success standard will be developed for pasturelands (p. 3-8).

Reclaimed pasture East of County road.

4.The success standards for the pasture land reclaimed areas must be developed and added to the MRP as required (Chap 3, p. 3-8).

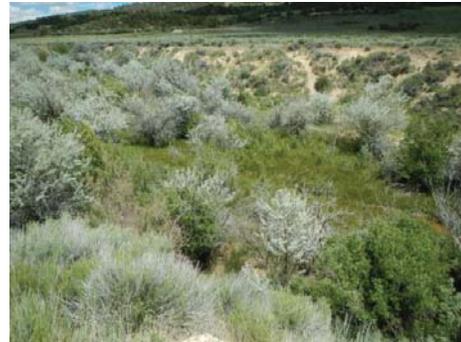
PHOTO 8

Looking down on riparian reference area in the North Lease.
