# State of Utah

Division of Oil, Gas and Mining

## Inspection Report

Permittee: **ALTON COAL DEVELOPMENT LLC**  
 Operator: **ALTON COAL DEVELOPMENT LLC**  
 Site: **COAL HOLLOW**  
 Address: **463 North 100 West, Suite 1, CEDAR CITY UT 84720**  
 County: **KANE**  
 Permit Type: **PERMANENT COAL PROGRAM**  
 Permit Status: **ACTIVE**

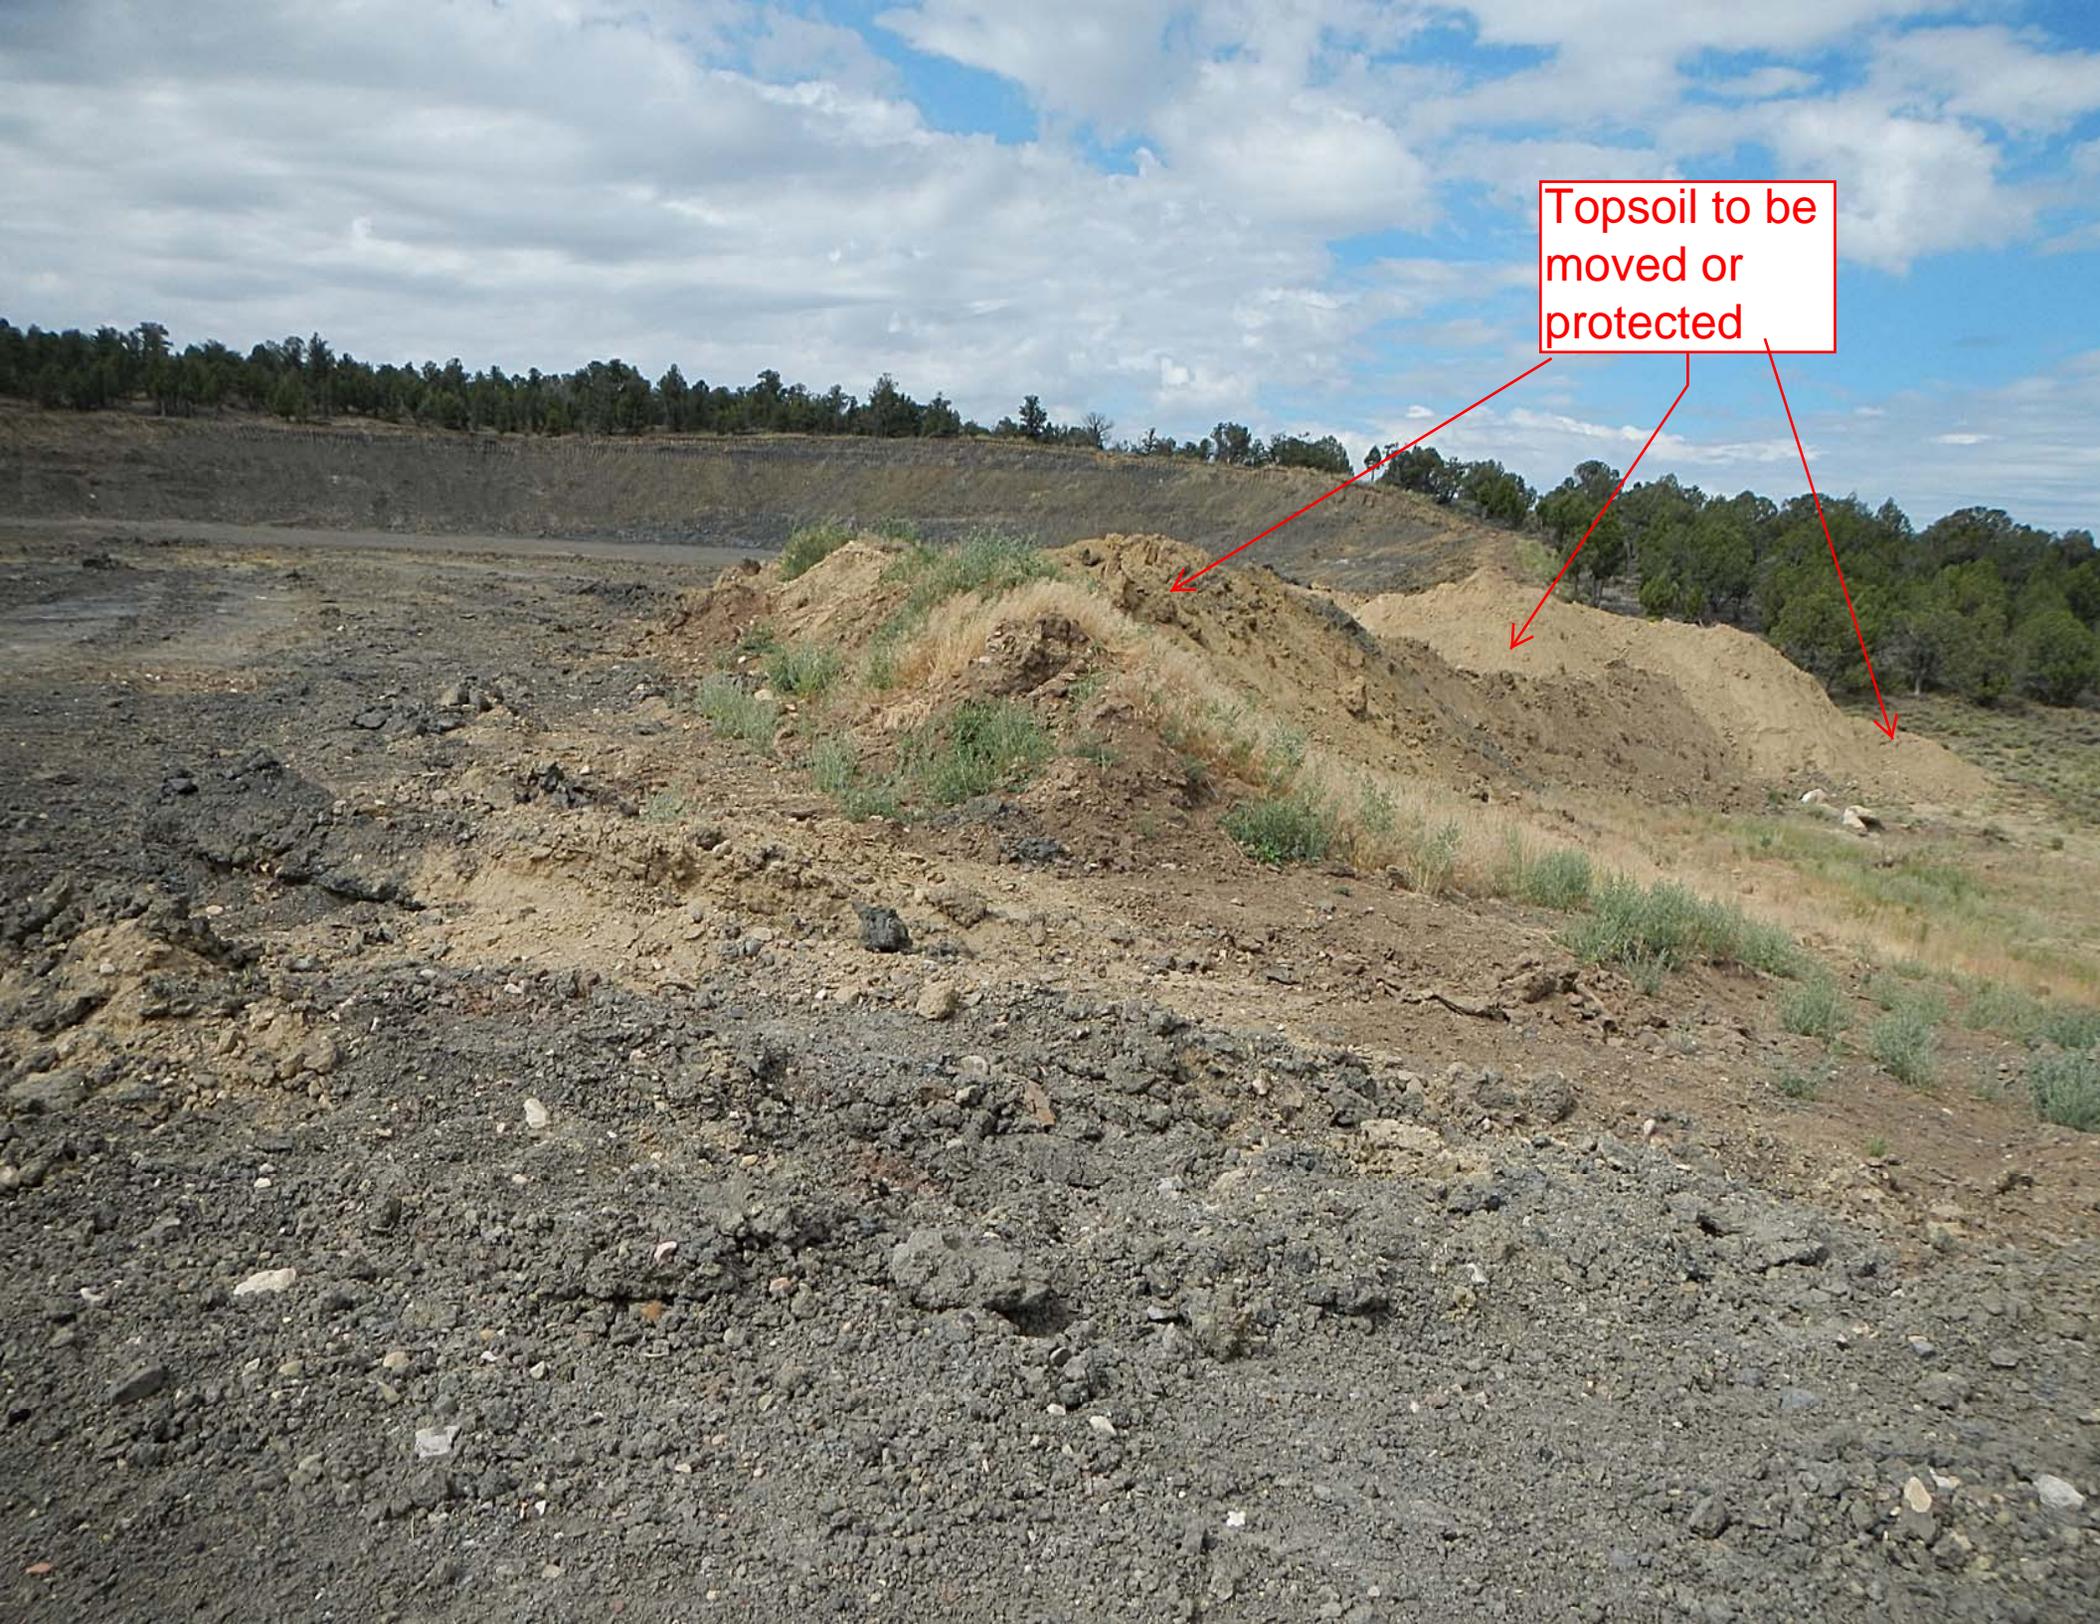
At the South lease, Topsoil pile 4 has been fully utilized. There is a small pile of topsoil, perhaps 1,000 CY, remaining at the Excess Spoil pile. Mr. Anderson assured me that this topsoil will either be signed and bermed or used this week on Phase I bond release areas.

Topsoil to be moved or protected

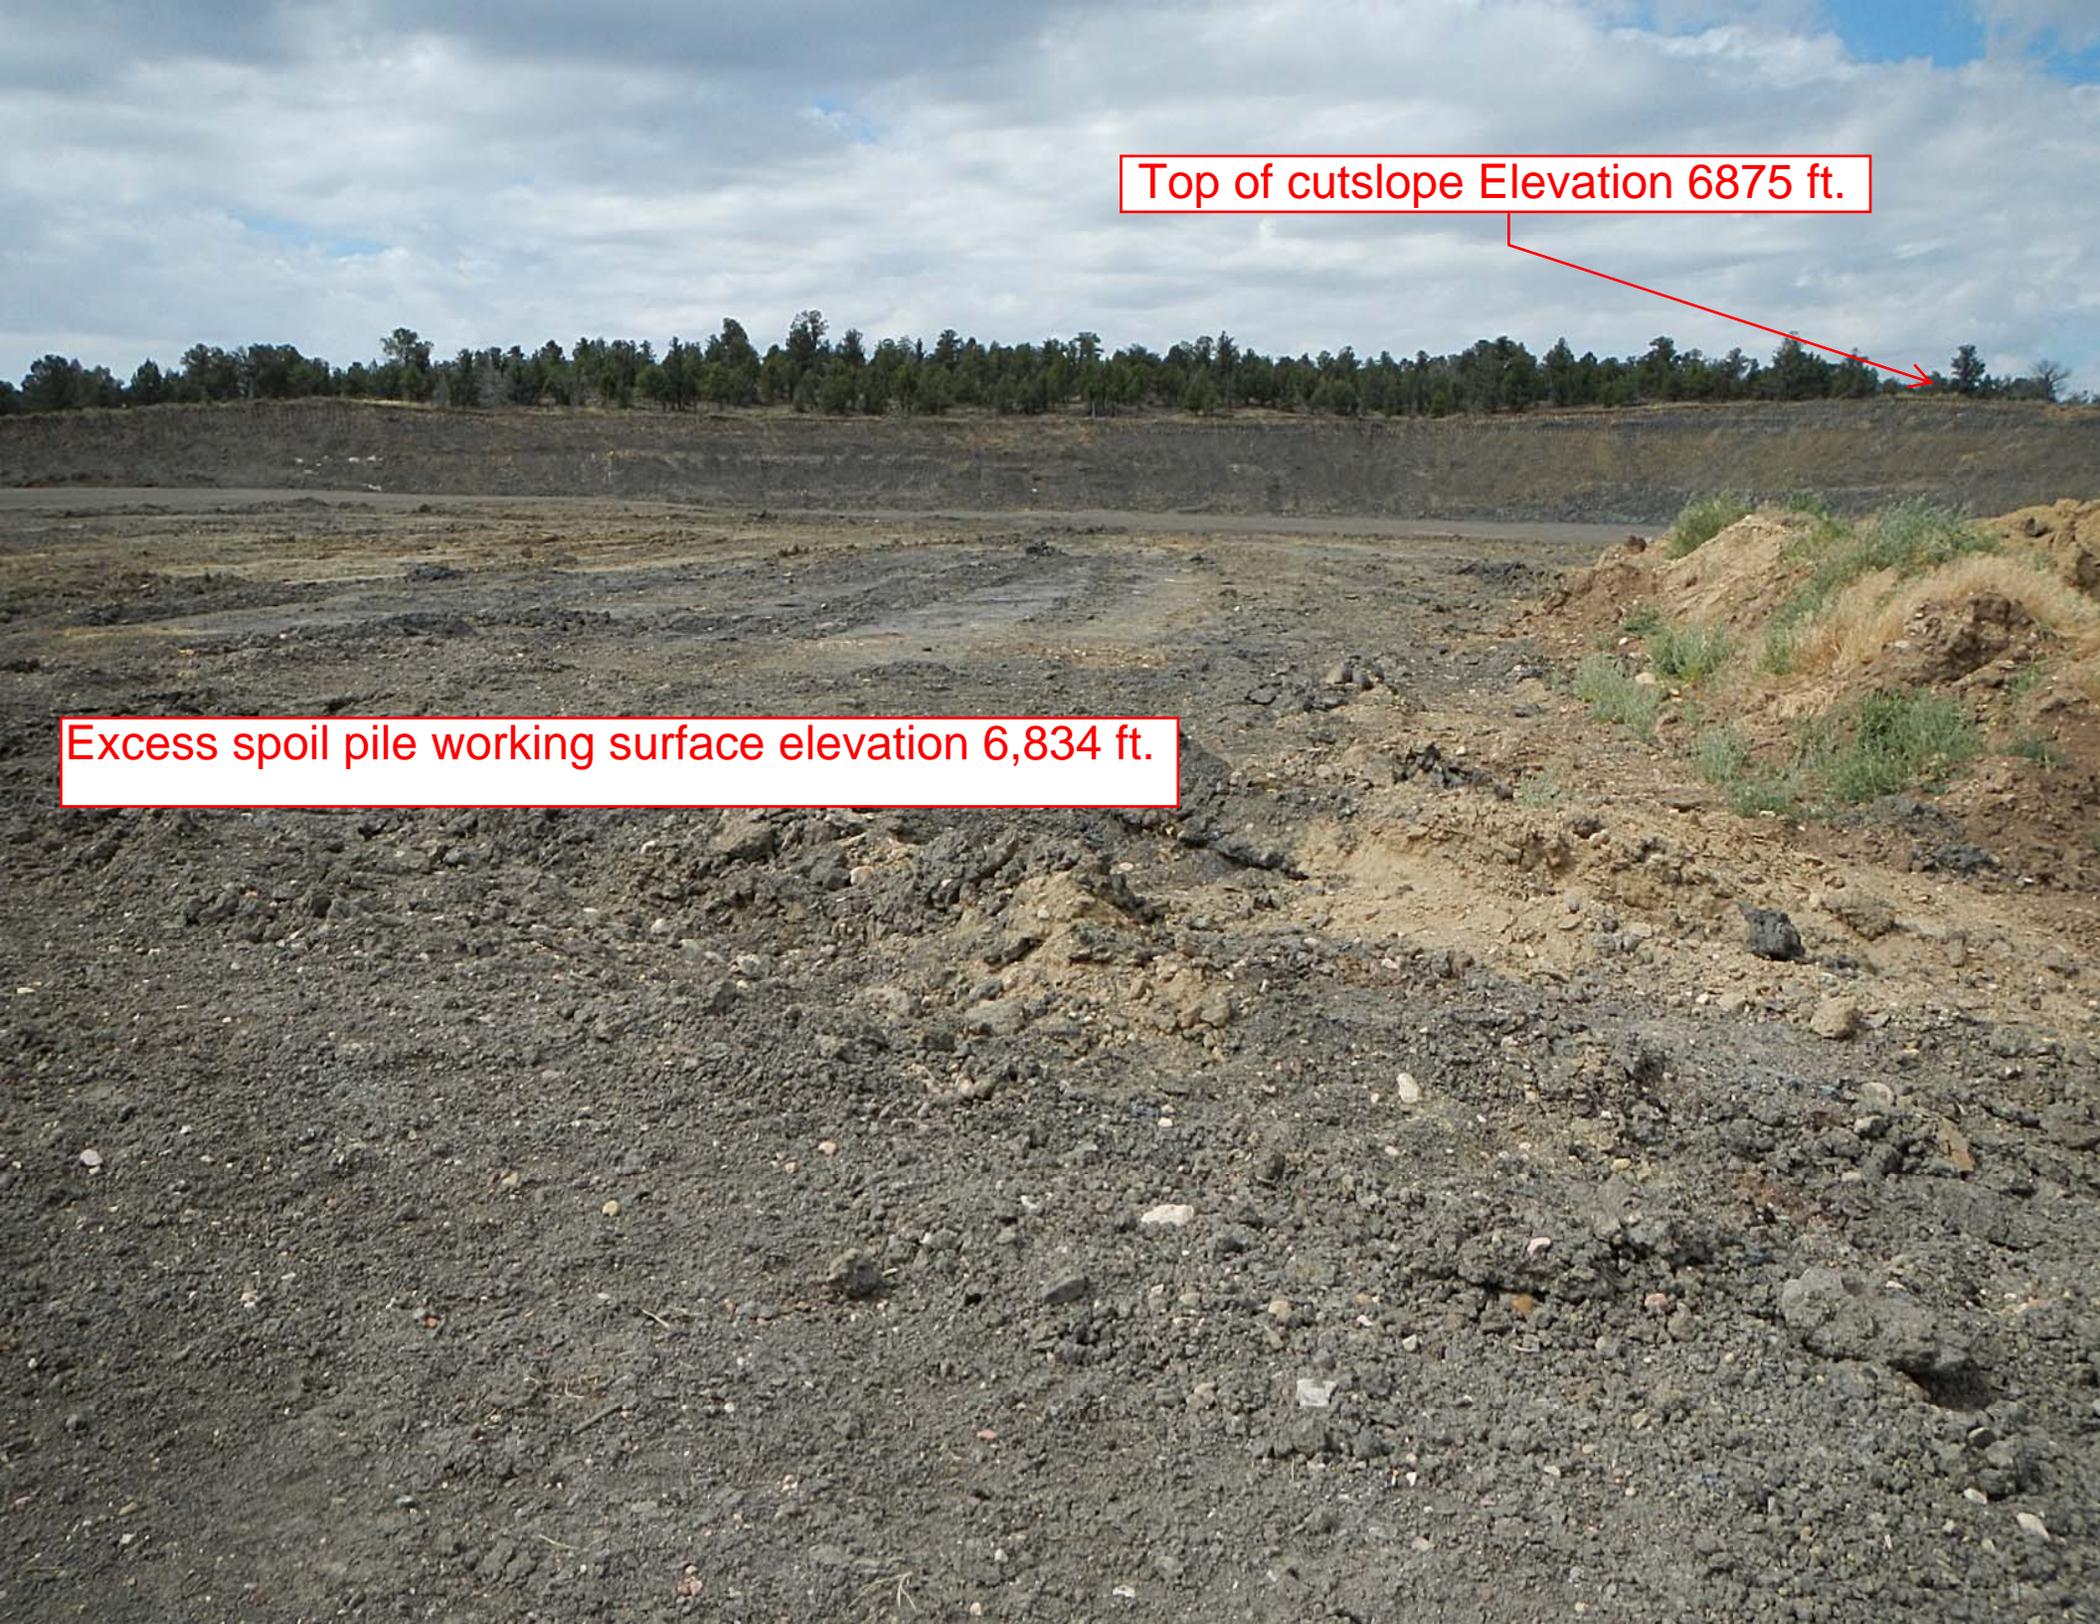
The excess spoil pile has been leveled and was surveyed at an elevation of 6,834 ft. on June 27, 2016. The pile is approximately 15 feet above DD4 at the north end. The entire 32 acre foot print of the pile has been smoothed out. (MRP p. 5-45, dated 1/14//2014 provides the acreage). There was no activity at the Excess Spoil pile.

Top of cutslope Elevation 6875 ft.

Excess spoil pile working surface elevation 6,834 ft.

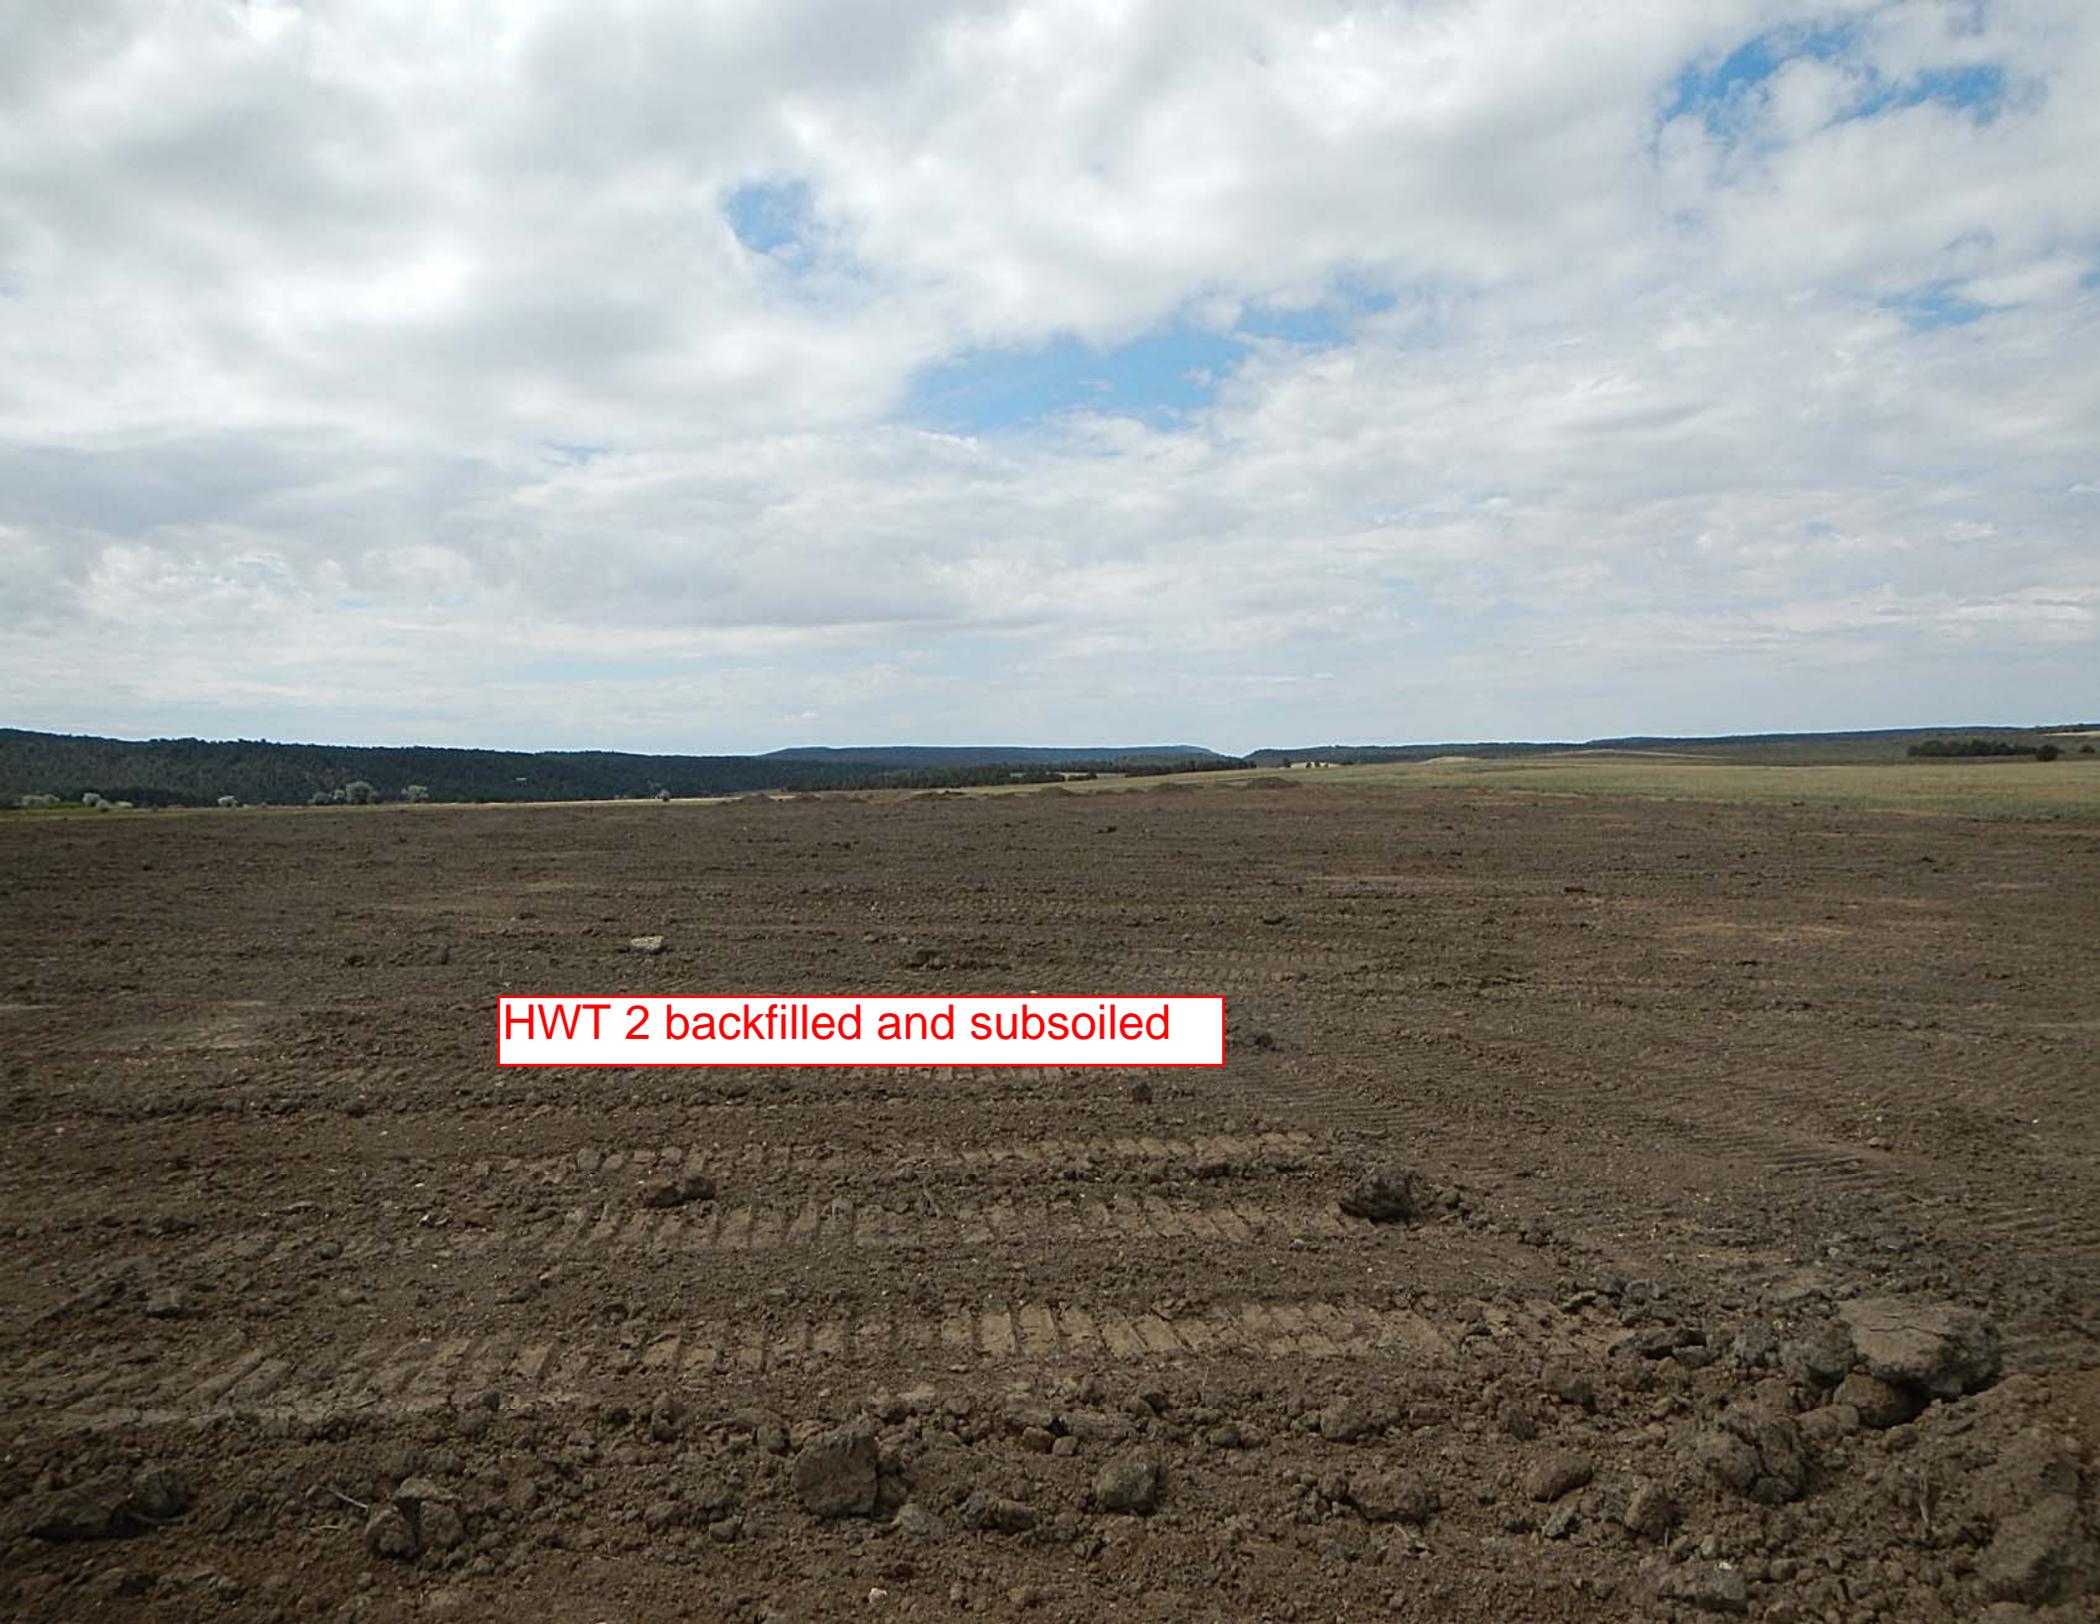
Subsoil and topsoil redistribution over HWT 2 area is in process, but was temporarily halted due to wet substrate. There is 87,397 CY remaining in Subsoil Pile #2. (It was surveyed very recently.)

HWT 2 backfilled and subsoiled

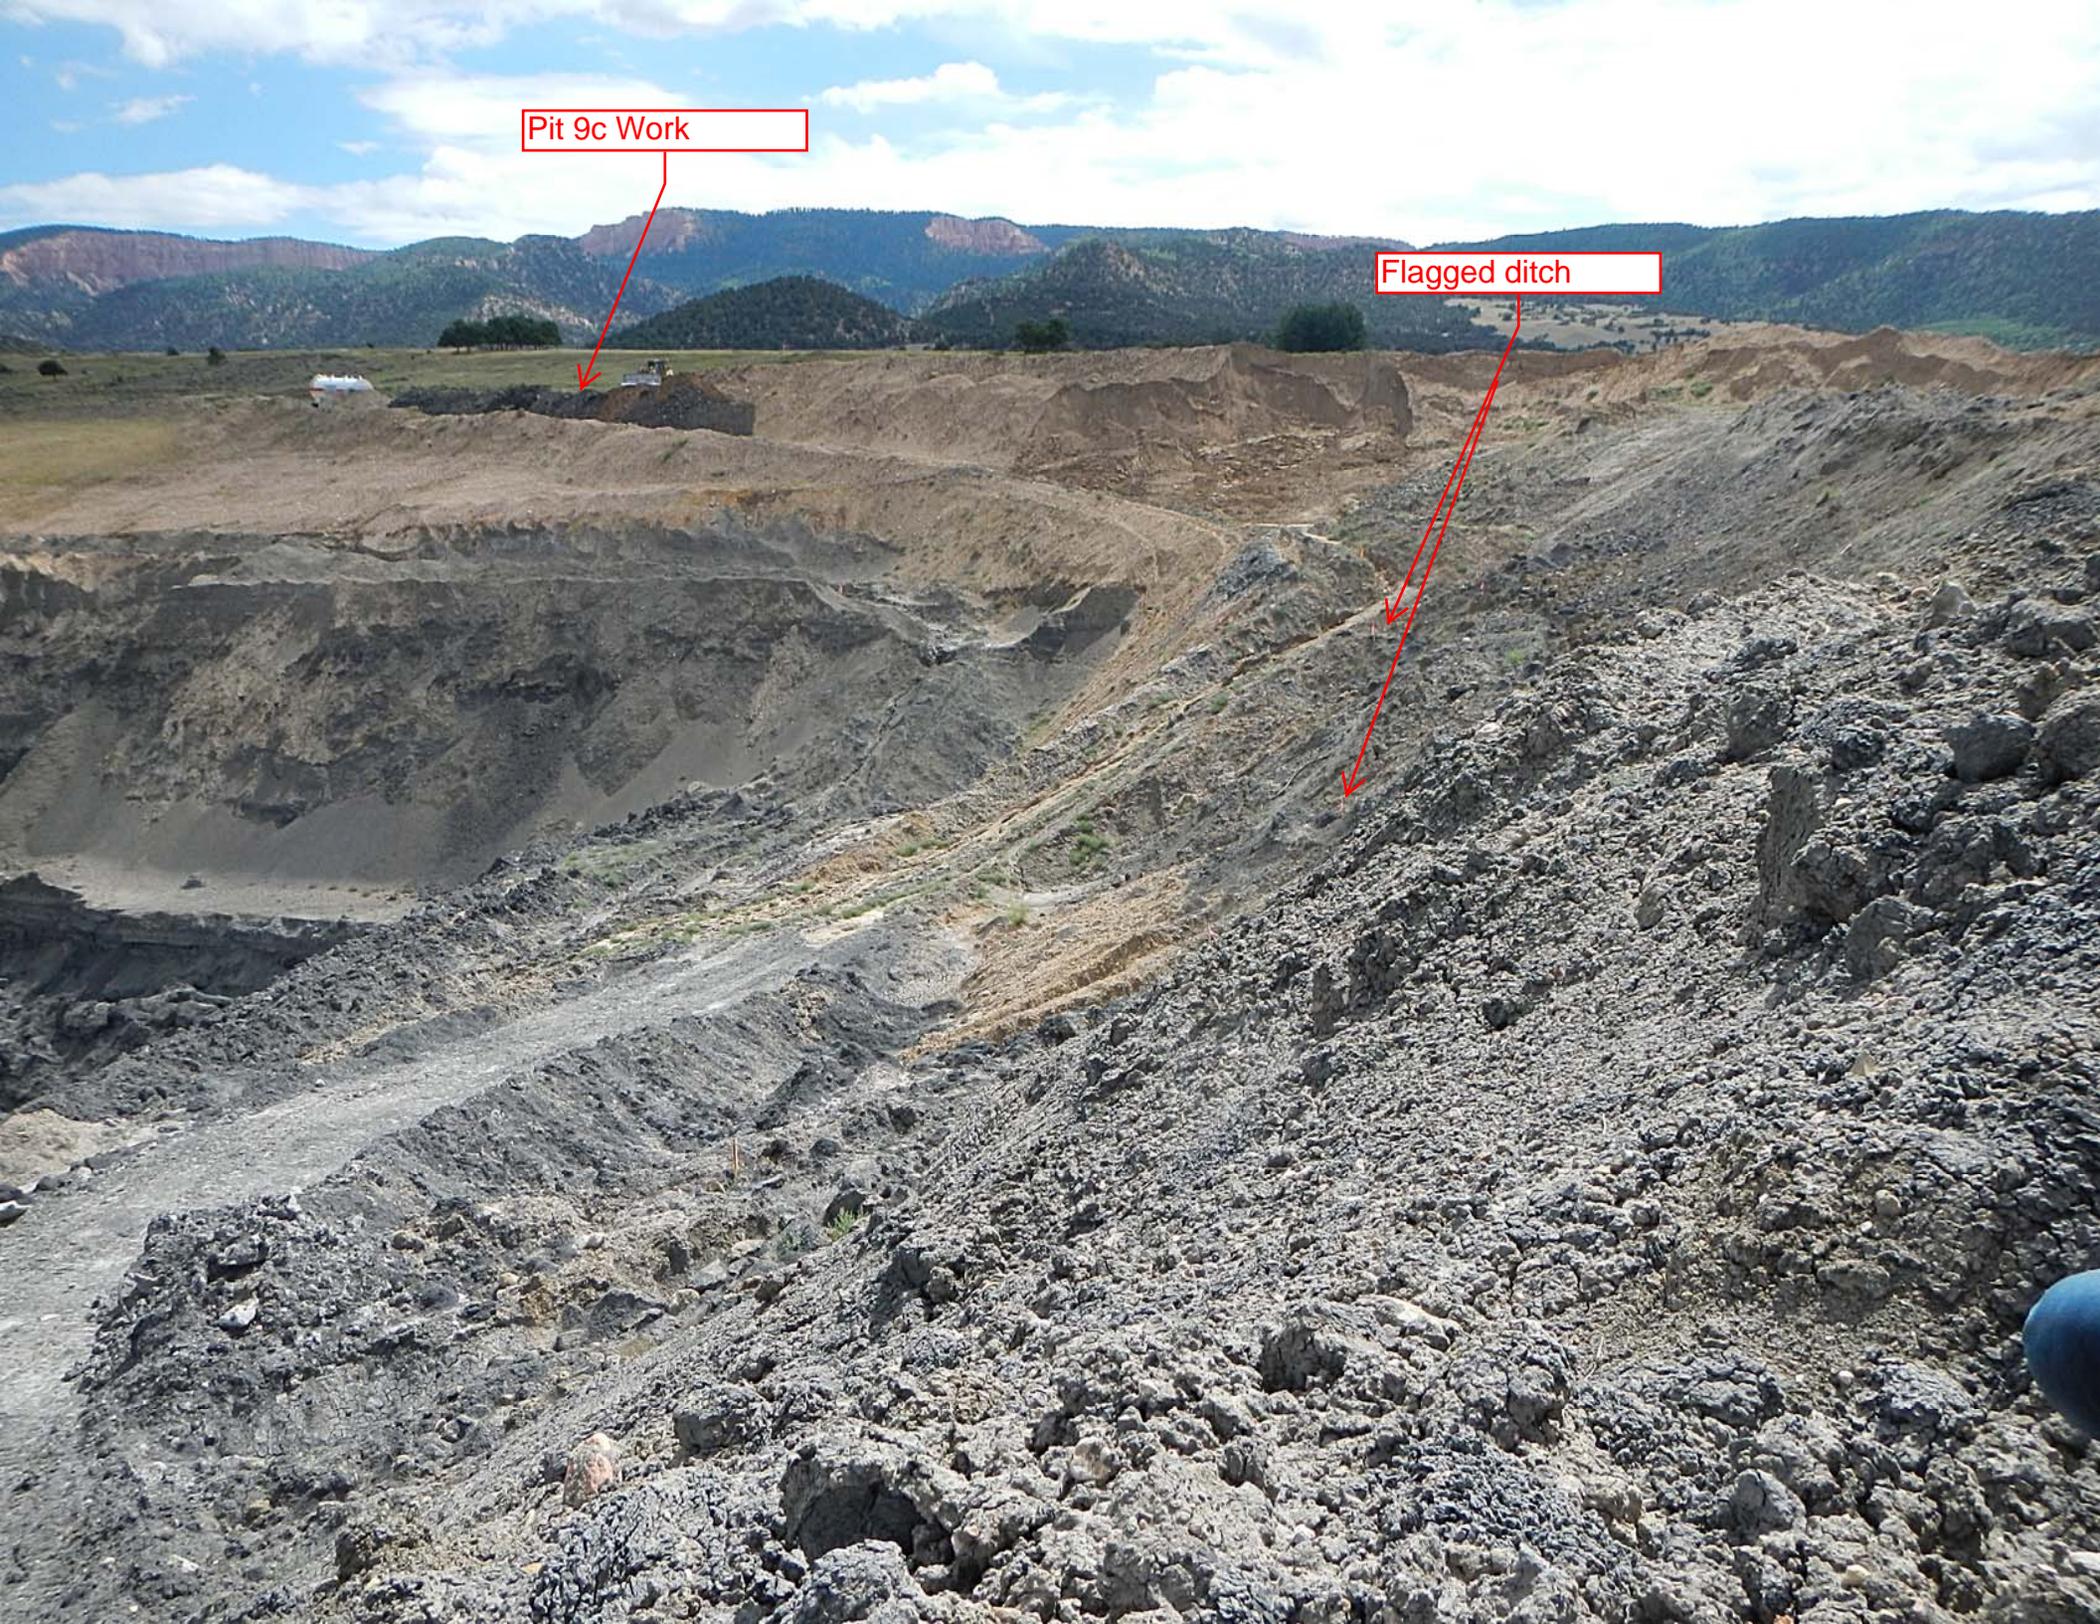
Pit 9c alluvium is sloughing. Pit 10 MSHA 1st bench has sloughed in the SE corner of the Pit..

Pit 9c Work

Flagged ditch

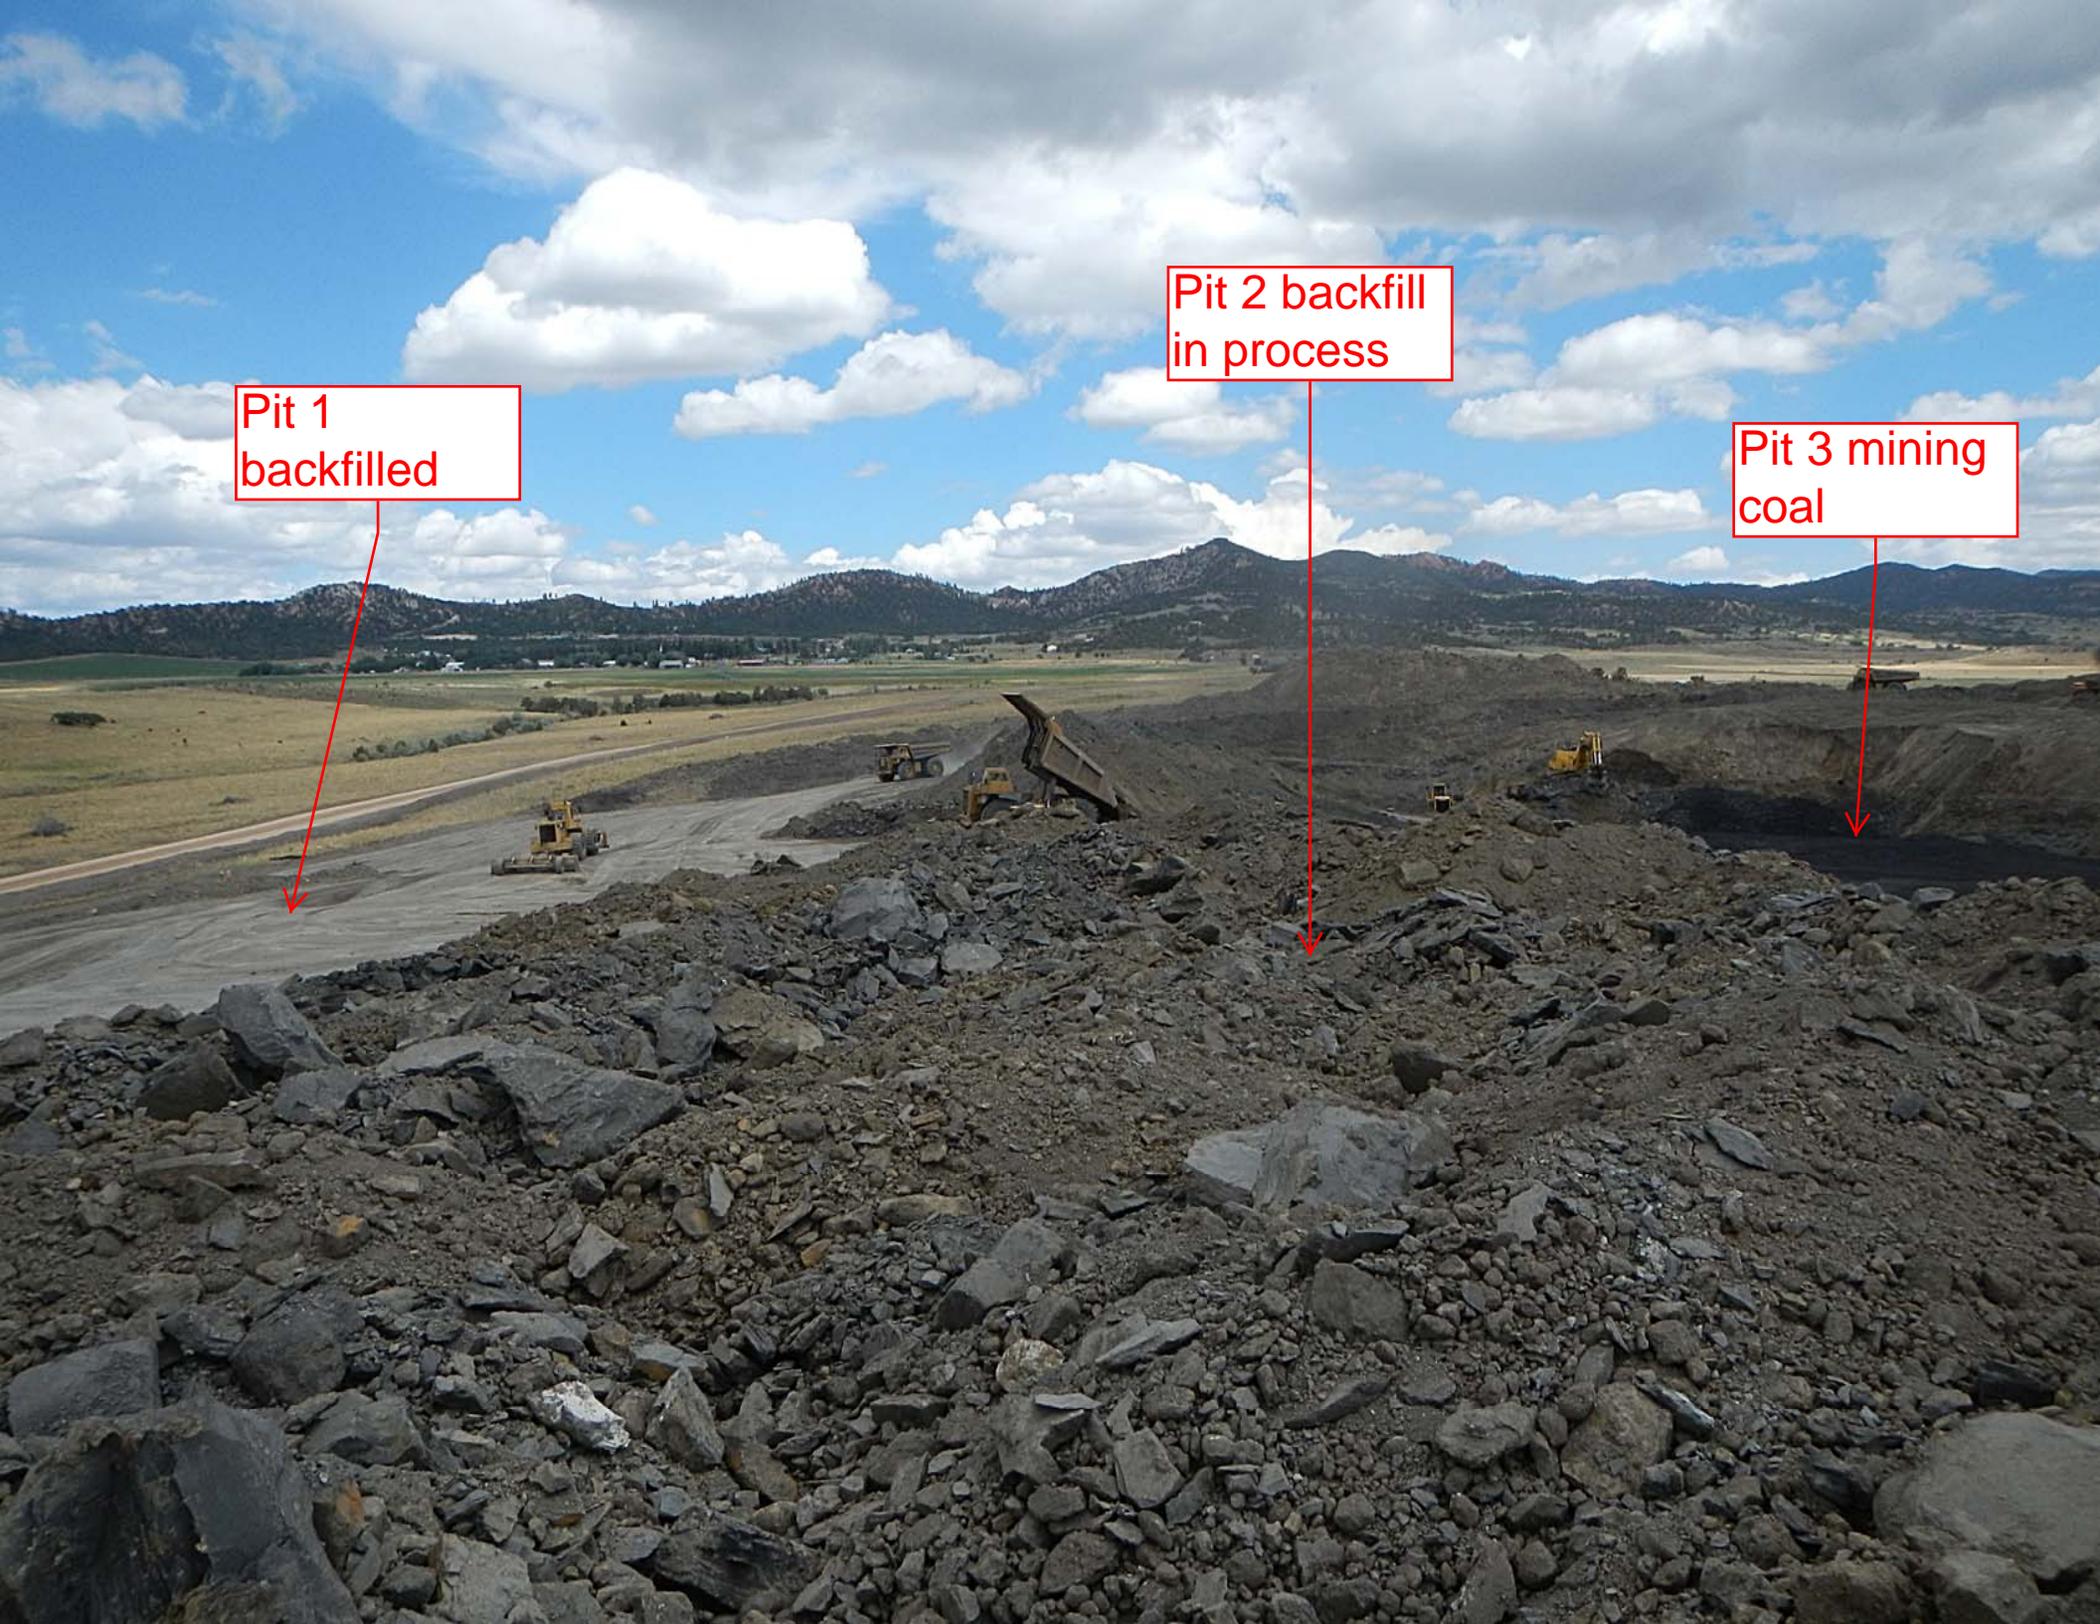
Area 1: Pit 1 is at AOC and has subsoil placed.

Pit 1  
backfilled

Pit 2 backfill  
in process

Pit 3 mining  
coal

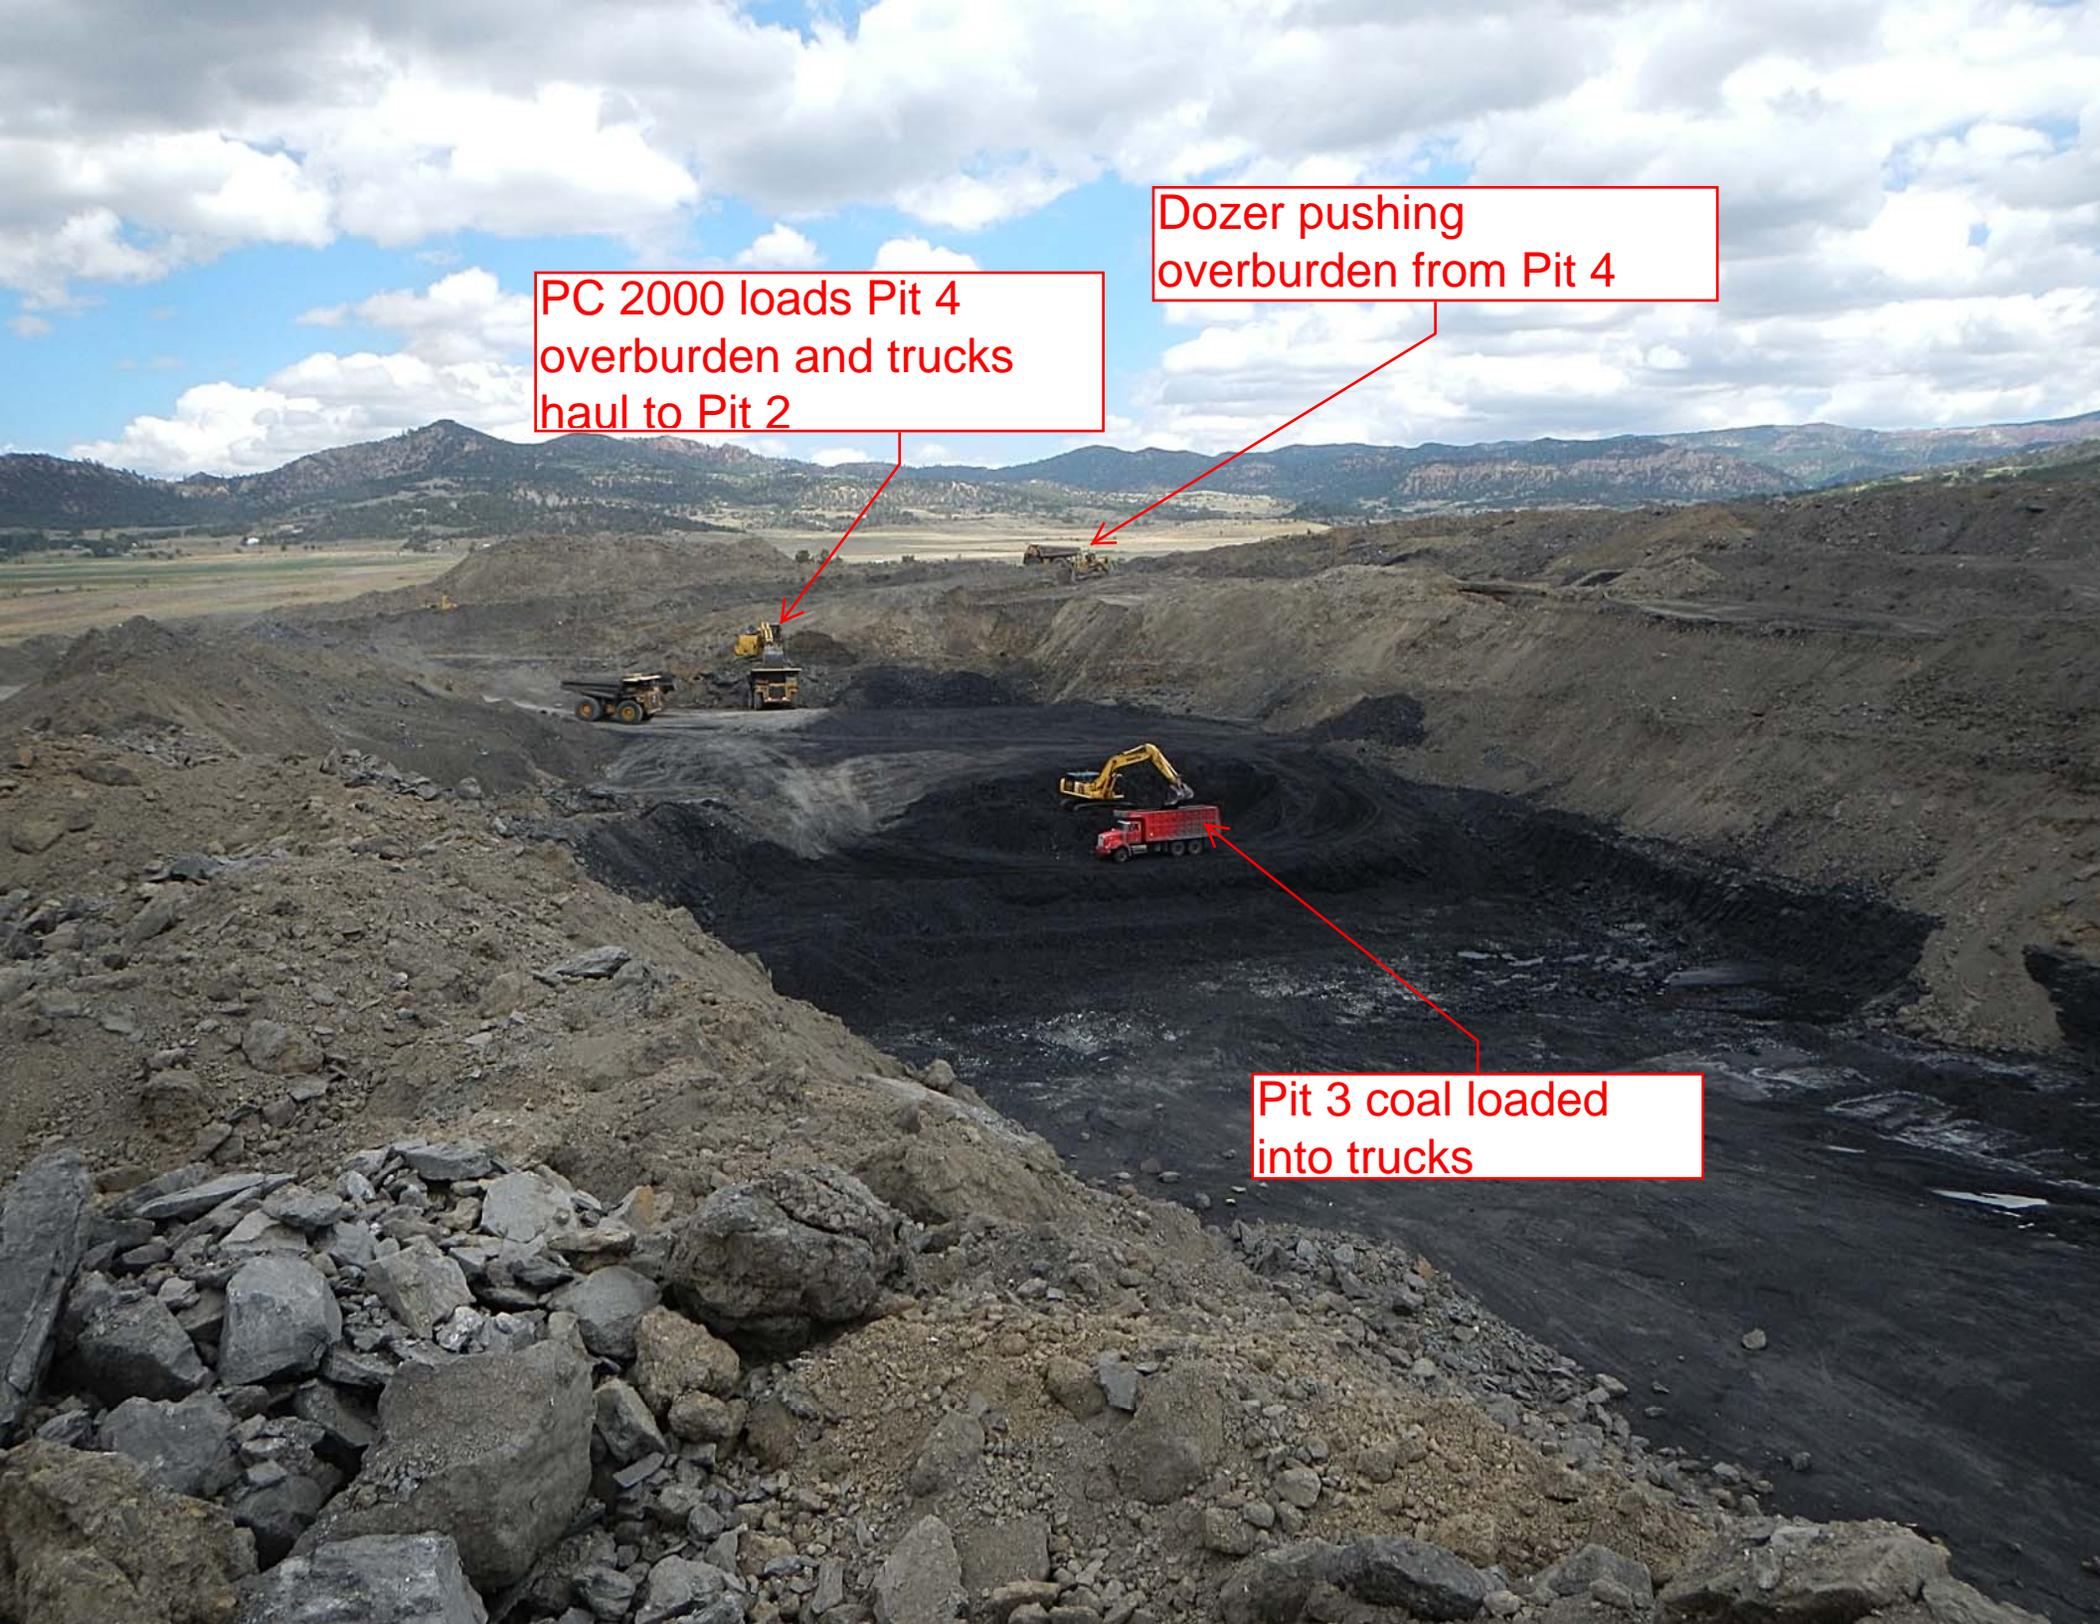
Area 1 Pit 2 is being backfilled with overburden from Pit 4. The PC 2000, the D11 dozer and two haul trucks were working to fill Pit 2.

PC 2000 loads Pit 4 overburden and trucks haul to Pit 2

Dozer pushing overburden from Pit 4

Pit 3 coal loaded into trucks
