# State of Utah

Division of Oil, Gas and Mining

## Inspection Report

Permittee: **ALTON COAL DEVELOPMENT LLC**  
 Operator: **ALTON COAL DEVELOPMENT LLC**  
 Site: **COAL HOLLOW**  
 Address: **463 North 100 West, Suite 1, CEDAR CITY UT 84720**  
 County: **KANE**  
 Permit Type: **PERMANENT COAL PROGRAM**  
 Permit Status: **ACTIVE**

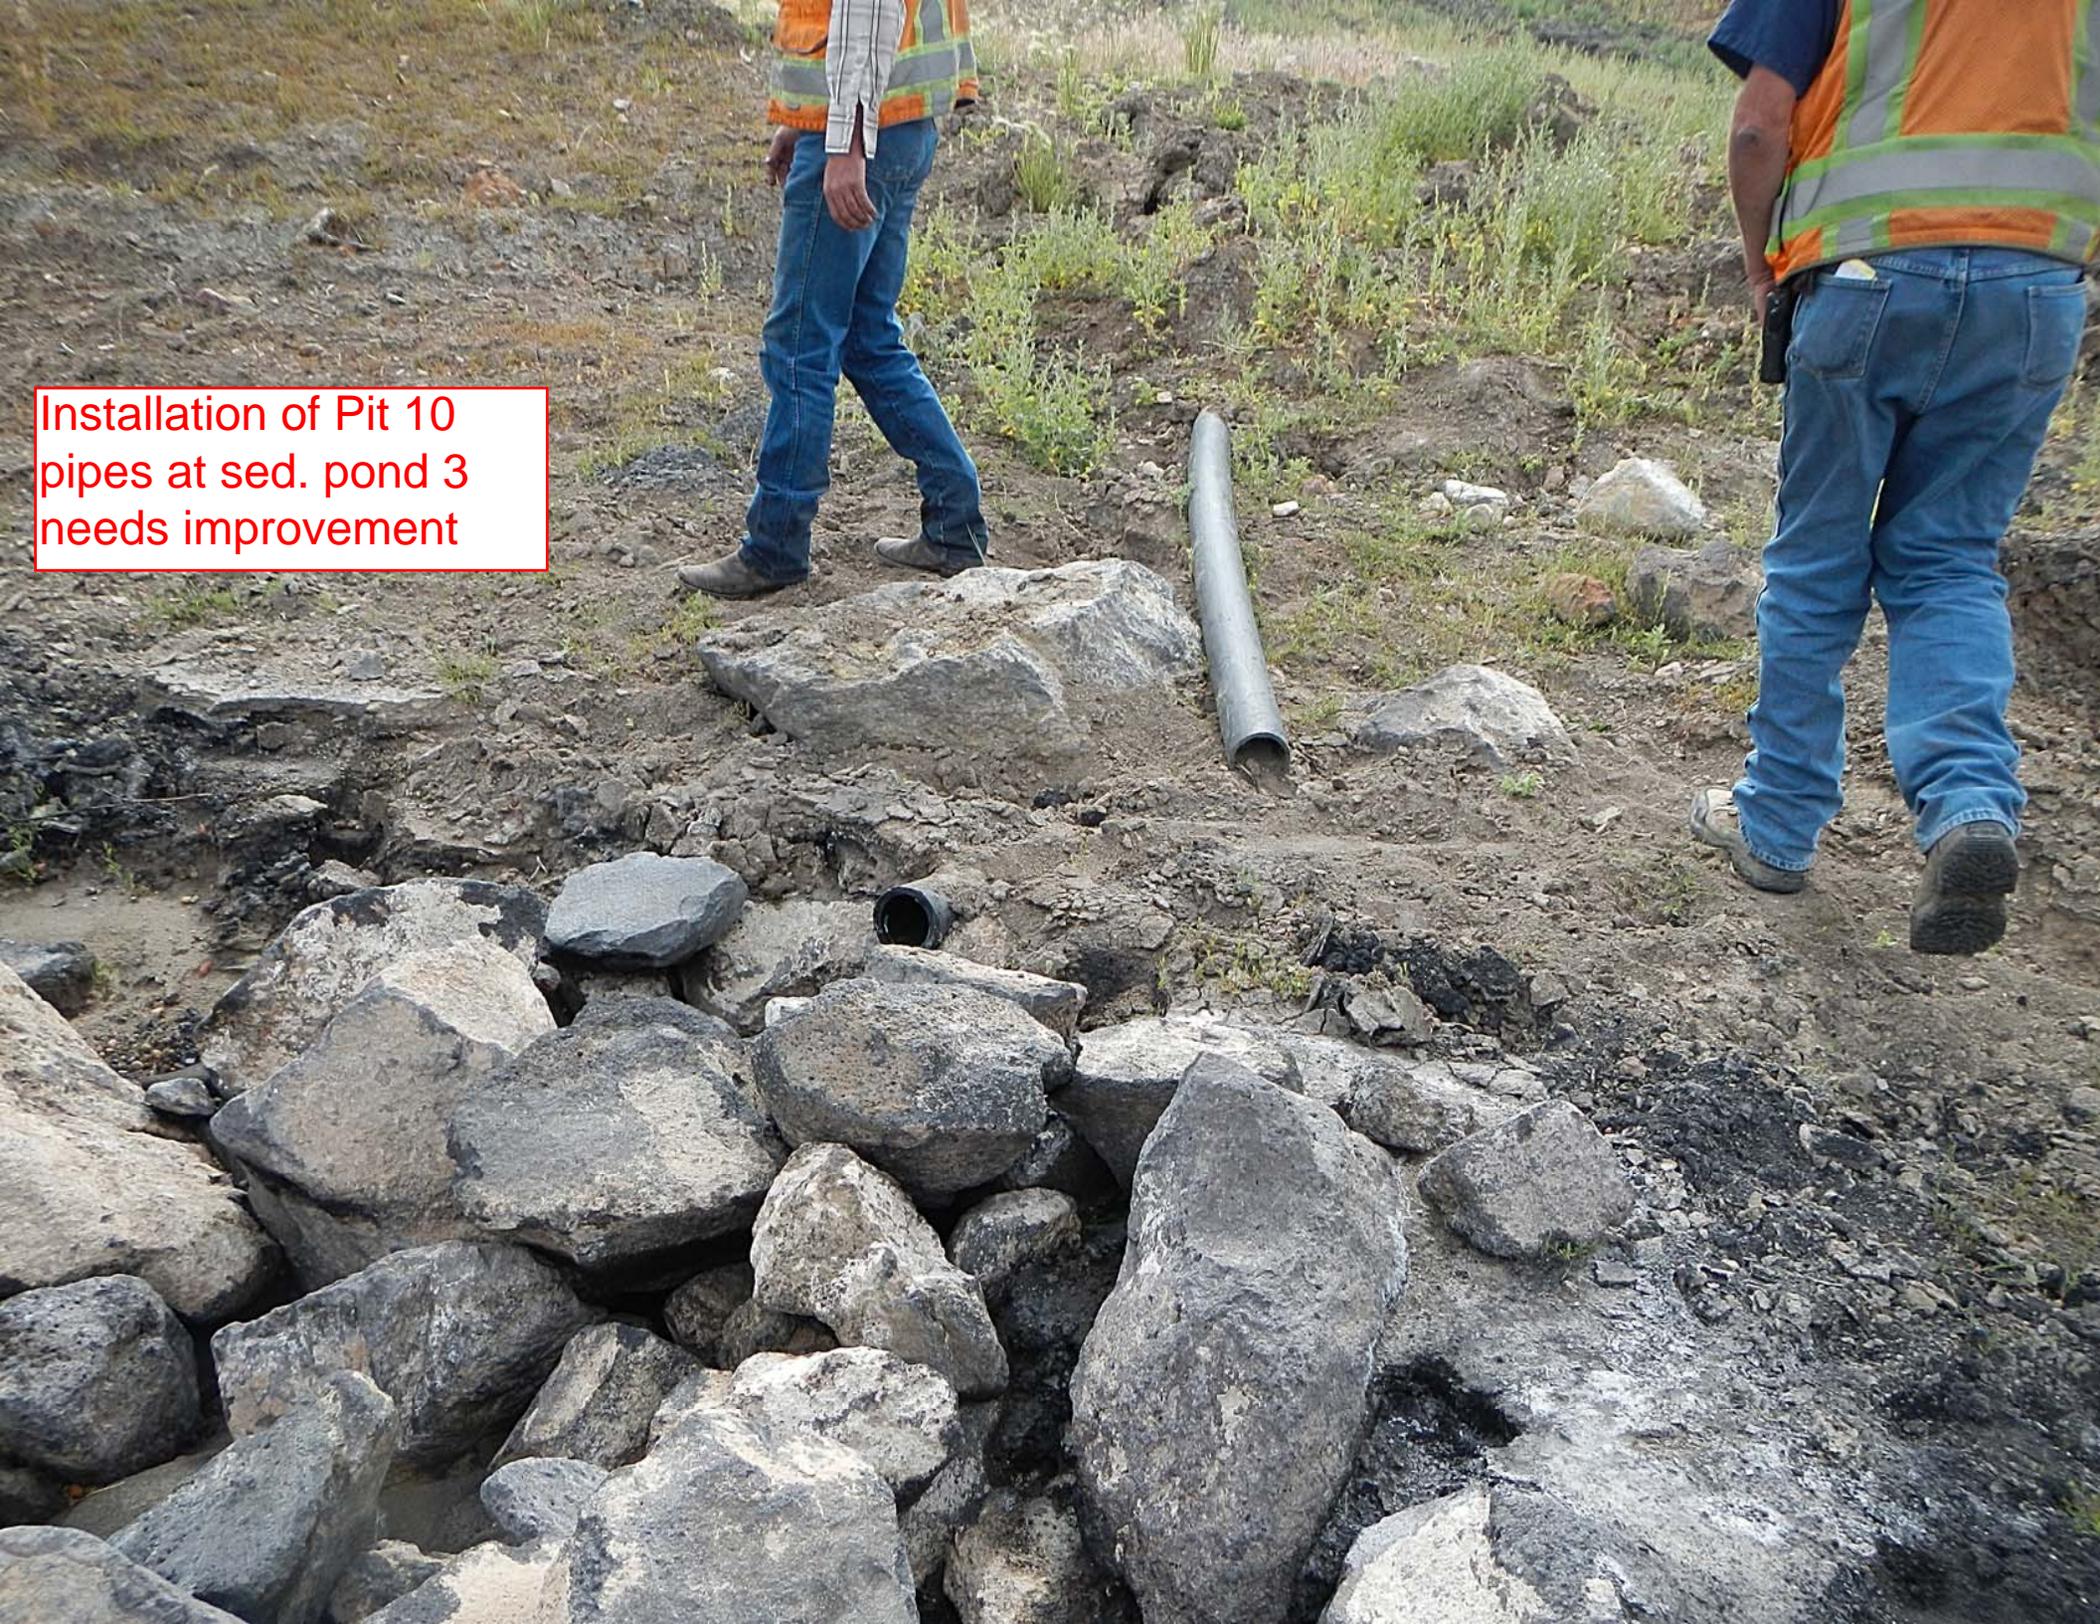
Pond 3 is bone dry, even the decant pipe inlet is exposed. The Permittee will take this opportunity to clean out sediment and repair the DD4 inlet. At my request, Mr. Anderson will also take this opportunity to ensure that the Pit 10 pipes are installed according to design. One pipe currently does not extend into the geotextile/riprap zone.

Installation of Pit 10  
pipes at sed. pond 3  
needs improvement
