Inspection Report

Permit Number:	C0250005
Inspection Type:	COMPLETE
Inspection Date:	Tuesday, September 27, 2016
Start Date/Time:	9/27/2016 9:00:00 AM
End Date/Time:	9/28/2016 12:00:00 PM
Last Inspection:	Wednesday, August 31, 2016

Permittee: **ALTON COAL DEVELOPMENT LLC**
 Operator: **ALTON COAL DEVELOPMENT LLC**
 Site: **COAL HOLLOW**
 Address: **463 North 100 West, Suite 1, CEDAR CITY UT 84720**
 County: **KANE**
 Permit Type: **PERMANENT COAL PROGRAM**
 Permit Status: **ACTIVE**

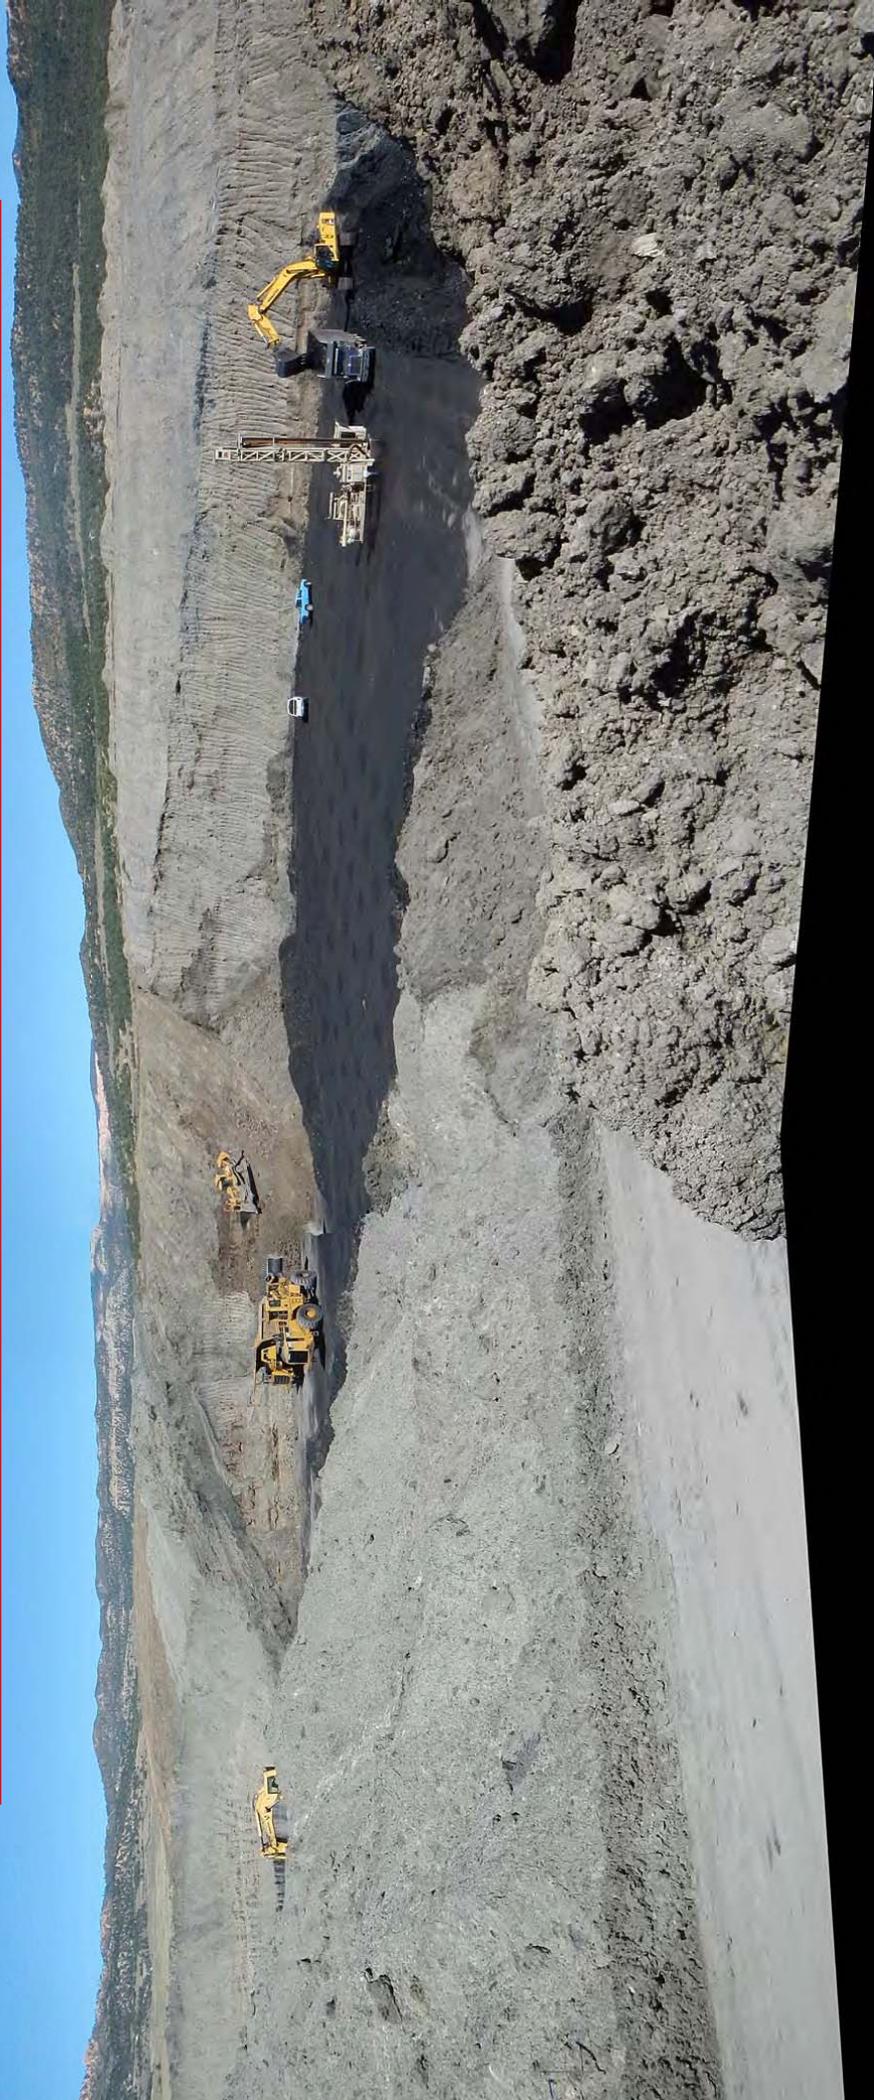
right side: Pit 5 loading coal and drilling holes for blast
left side: dozer pushes spoil down, loader fills trucks for haul to Pit
4 or subsoil pile. PC 2000 just out of frame is loading overburden
into haul trucks.

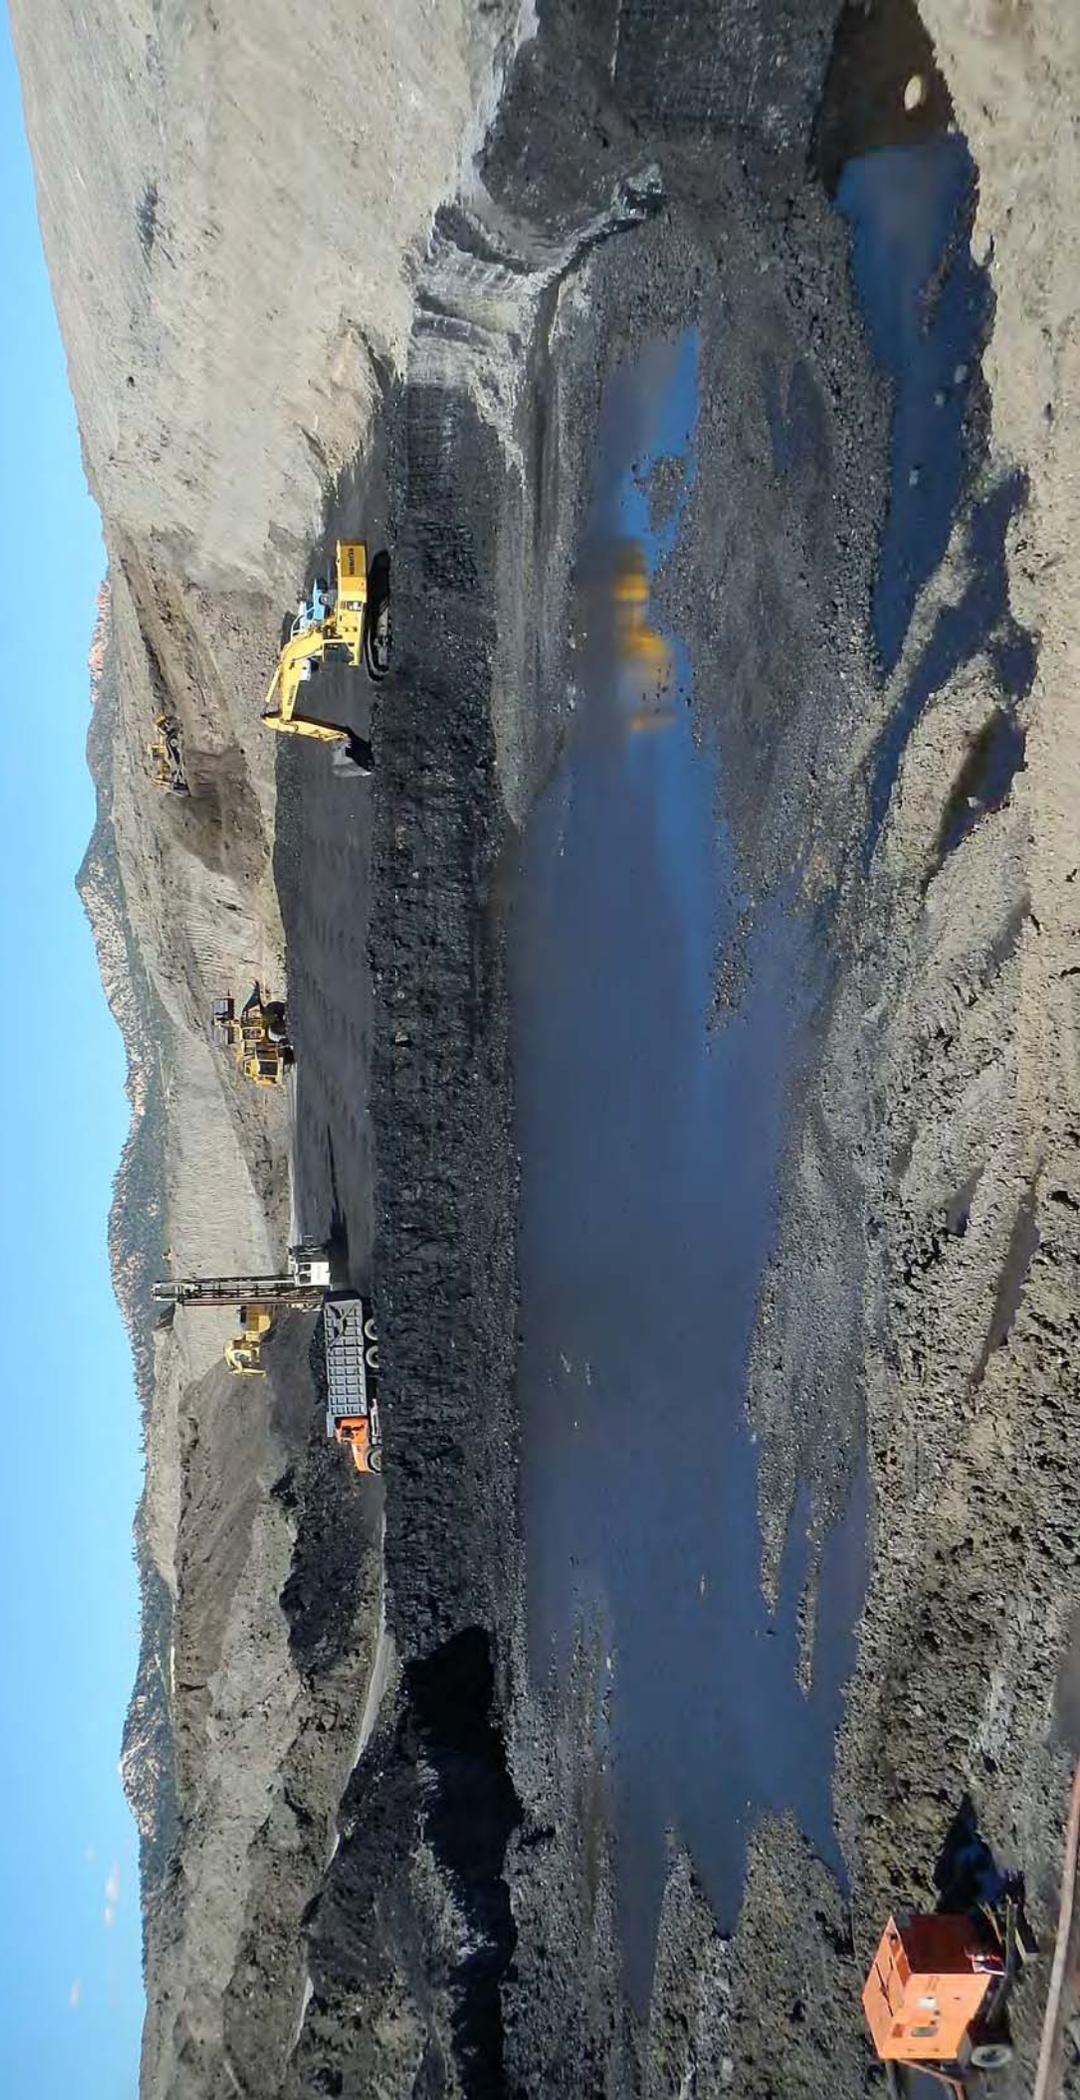
Looking North at Pit 5 activity:
drilling and loading coal

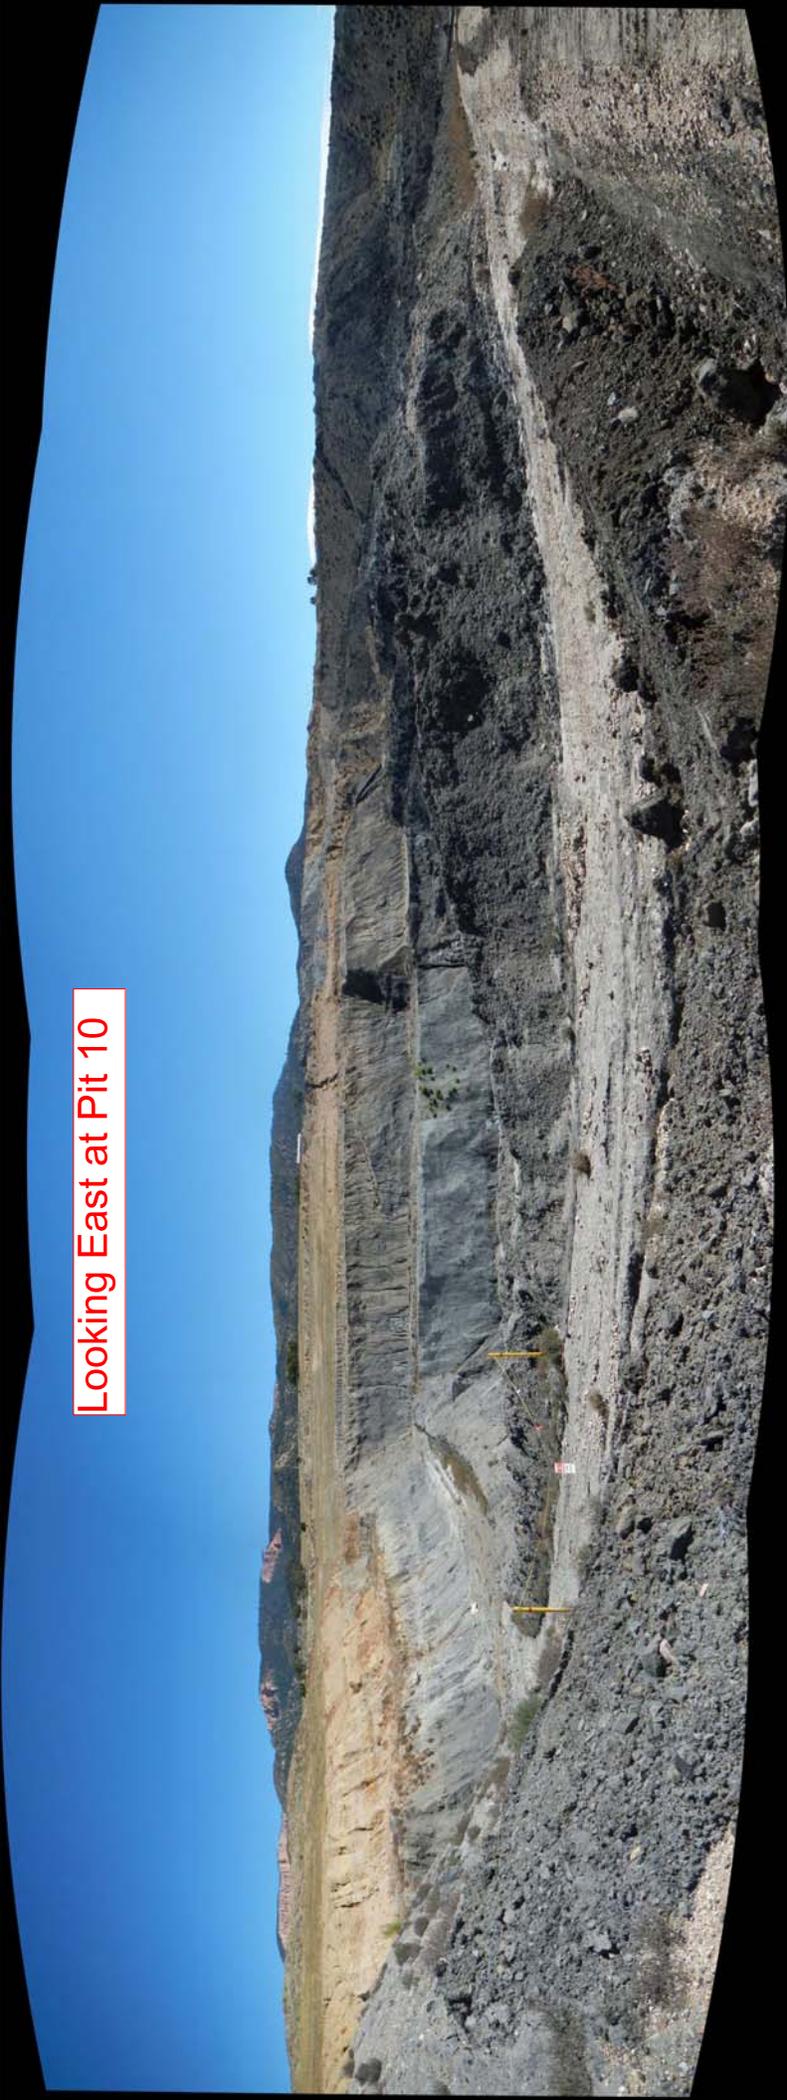
Looking East at Pit 10

Most of the Pit 10 drainage control measures outlined on Dwg 5-3C (dated 8/5/2016) have been completed. The only remaining work is to complete Ditch P10-S01 at its upper end. The underground yard was dry after the recent storm, although the run-off plugged culverts P10-03, -04, -05, and -06. The run-off eroded the slope above the inlet to P10-10 and P10-08. The storm washed riprap protection from the length of P10-R04 and the outlets of P10-08, P10-09, and P10-10. Ditches will be maintained and erosion rock will be replaced. A d50 of 6 inches is required (Appendix 5-2).

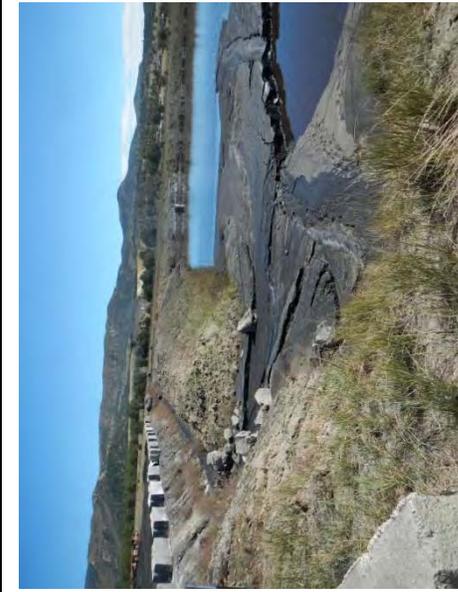
PHOTO 1
Pond 1

Photos of all ponds are attached. Ponds 1 and 1B discharged during the last week. All ponds were holding water from the storm last week. Pond 3 was 1/2 cleaned out before the storm. The water elevation was approximately 1 foot below the spillway. Water was being pumped to pond three from the excess spoil pile during the inspection.

Pond 1 is scheduled for sediment cleanout in the near future.
Maintenance of excelsior logs around the Pond 6 emergency overflow is necessary.

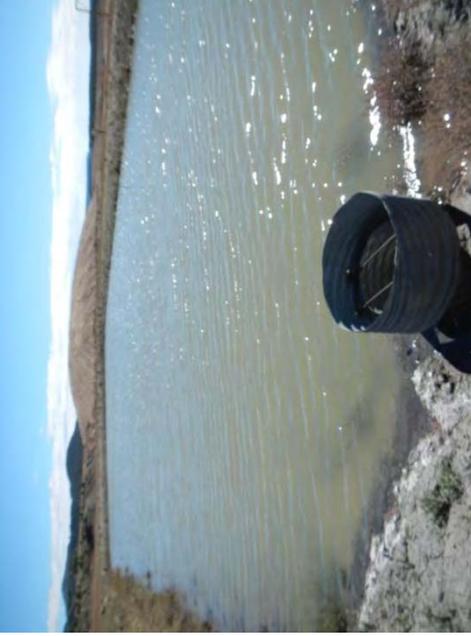
Subsoil stockpile #2 in the South Lease has been graded to lower its profile. The subsoil stockpile slopes were groomed to be very smooth in preparation for drill seeding this fall.

PHOTO 4
Pond 2 and graded subsoil pile

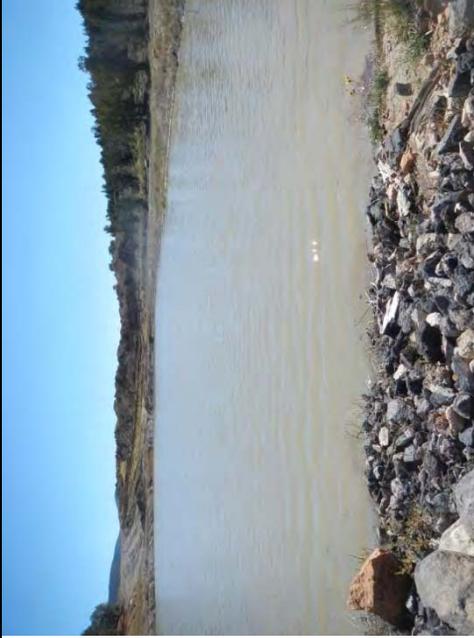
PHOTO 5

Looking E across spillway at Pond 3

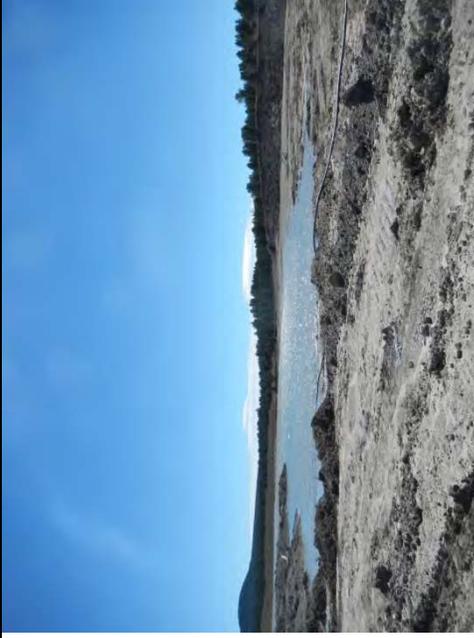
PHOTO 6

Looking SE at excess spoil pond and pipe to pond 3

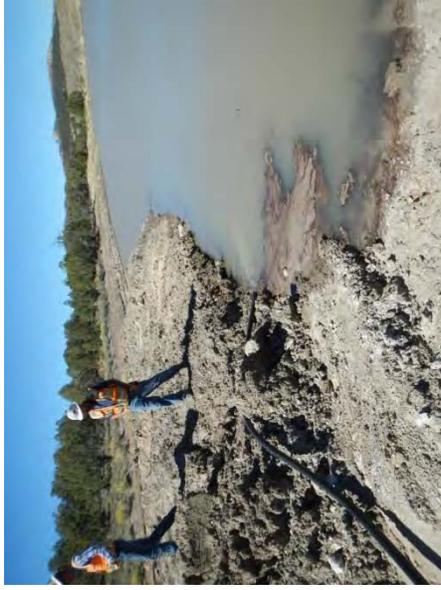
PHOTO 7

Looking SW at Pond 3 receiving water from excess spoil pond

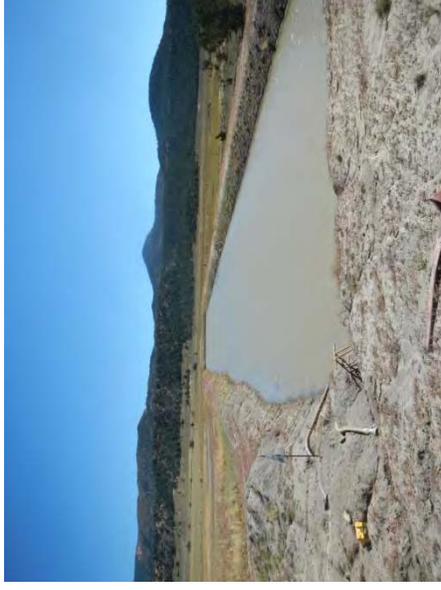
PHOTO 8

Looking E at Pond 4

Topsoil stockpiled around the water filling station at Pond 4 will be collected into a single pile/berm and seeded.

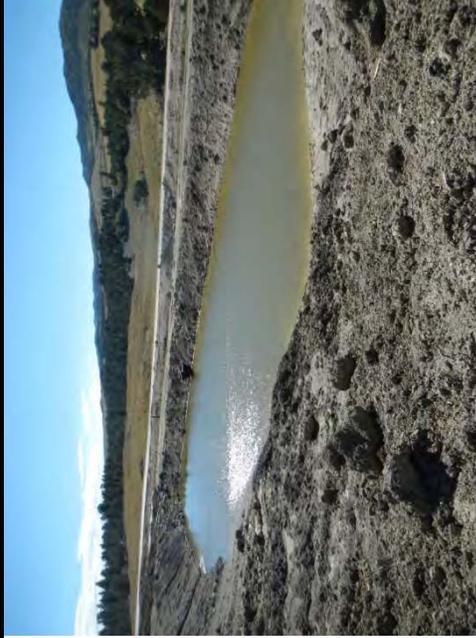
PHOTO 9
Looking SW at Pond 5

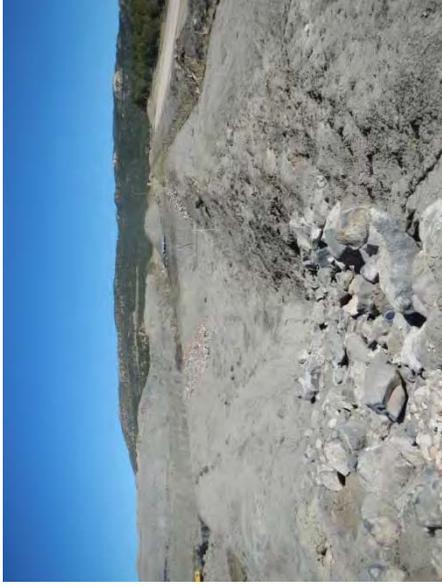
PHOTO 10
Looking E at Pond 6 (dry)

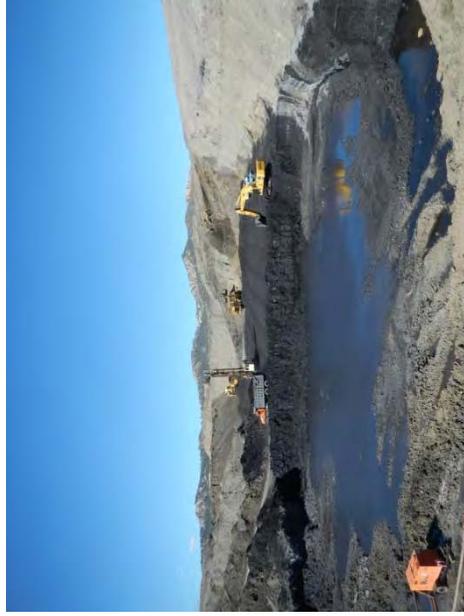
PHOTO 11
Looking N of Pond 6 at Pit 5

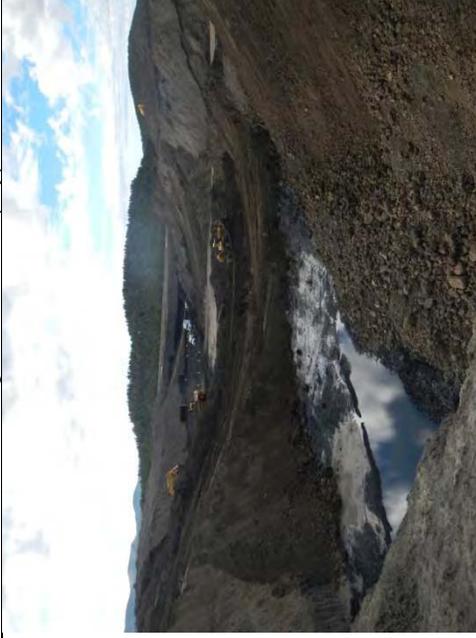
Pit 5 in the North Lease is being mined. Spoil is being replaced into Pit 4 North End. Pit 4 South slopes are being reduced to grade. Three haul trucks, the PC 2000, a loader and a dozer were dedicated to reclamation activity. The 490 trackhoe and road haul trucks were moving coal.

PHOTO 12
Looking S at backfilling of Pit 4 (foreground) with spoil pile. South end of Pit 5 is in the distance.

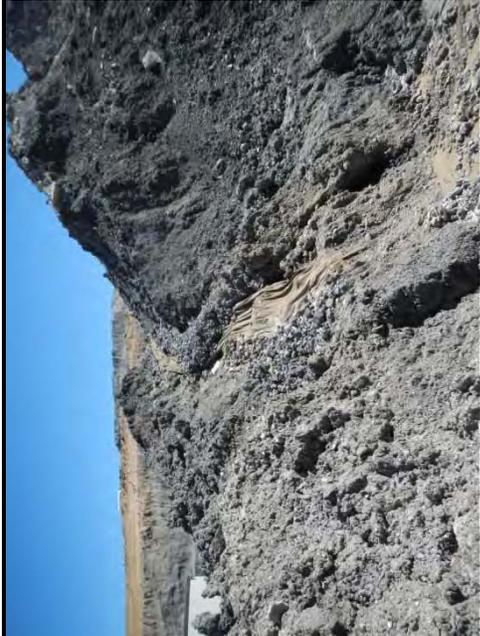
<p>PHOTO 13 Outlet of ditch P10-S03 geotextile remains riprap washed away</p>	<p>PHOTO 14 Pit 10 catch basin and inlet to P10-08</p>

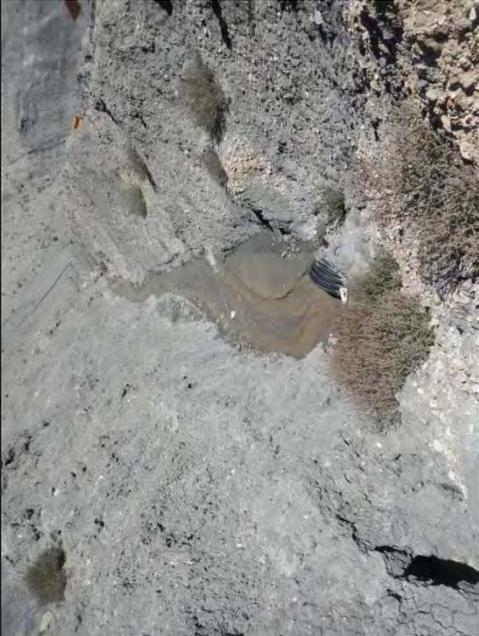
<p>PHOTO 15 Outlet P10-08 riprap washed away</p>	<p>PHOTO 16 Culvert P10-09 lower left and P10-10 upper right</p>

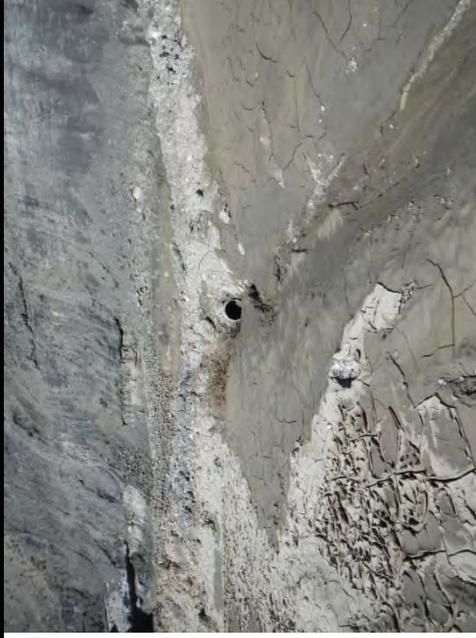
PHOTO 18
Ditch P10-F03 and unnamed culvert to sump

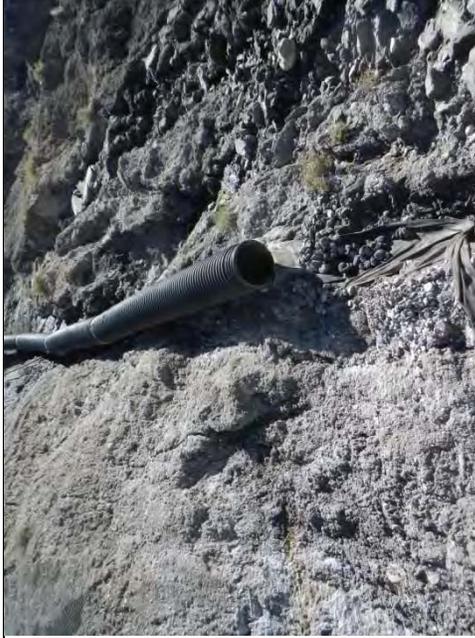
PHOTO 19
Outlet P10-09 requires new rip rap

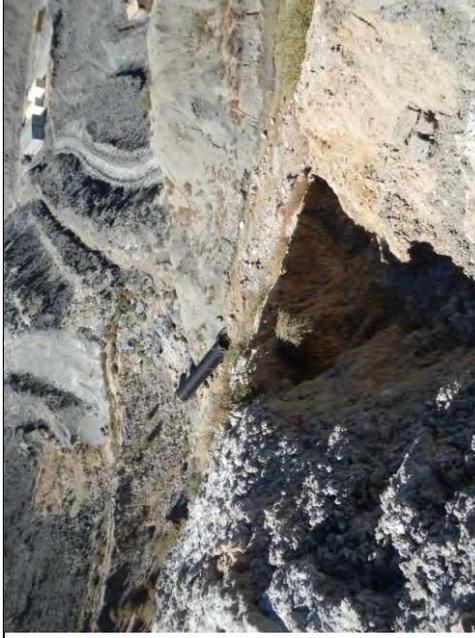
PHOTO 20
Inlet to P10-10 need repair

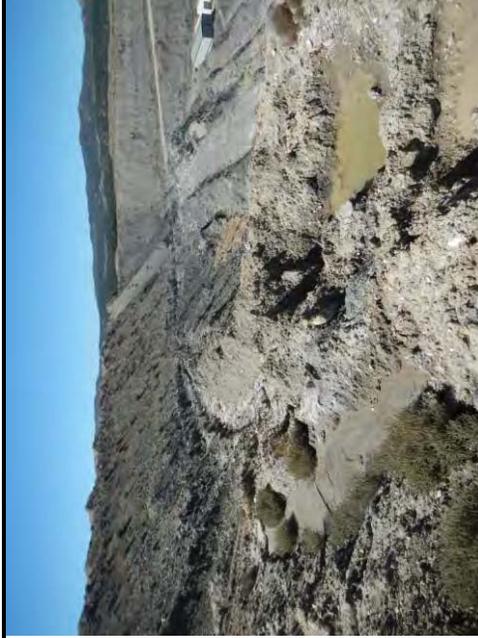
PHOTO 21

Blocked flow at outlet P10-10 and inlet ditch P10-S03

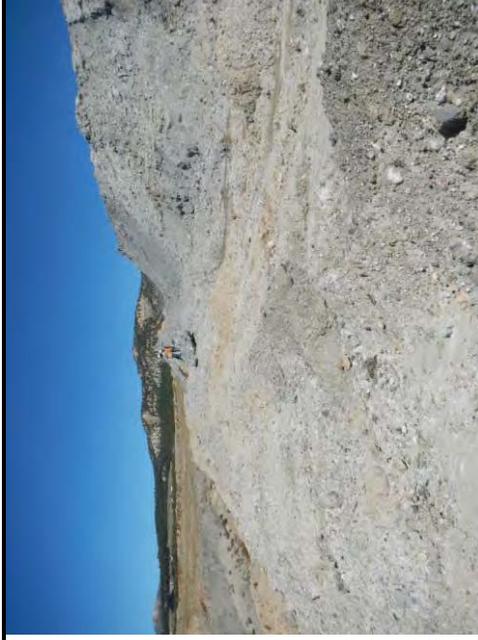
PHOTO 22

Looking NE at incomplete construction of ditch P10-S01

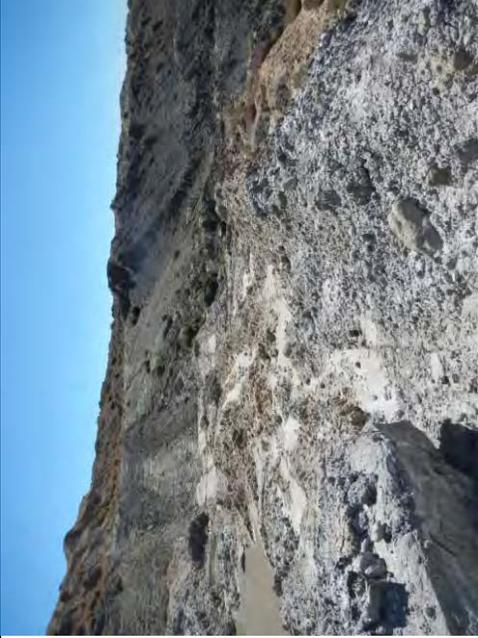
PHOTO 23

Looking SW at incomplete construction of ditch P10-S01

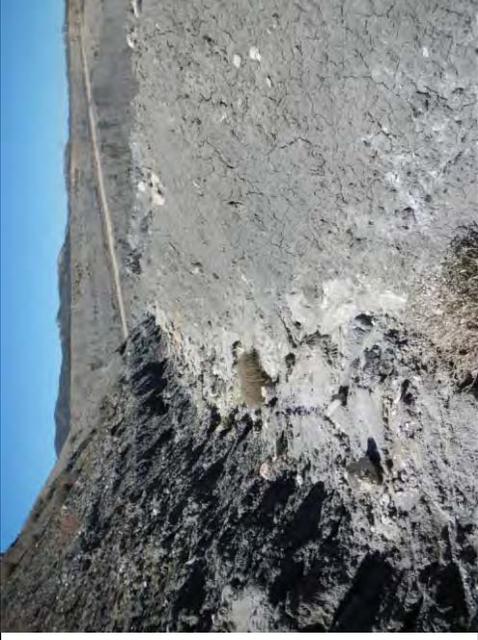
PHOTO 24

Ditch P10-S02

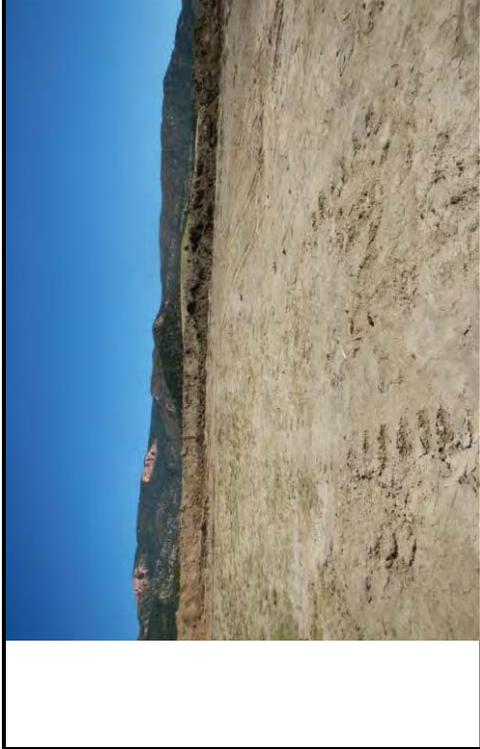
Approximately 5,000 CY (1/2 acre x 7 ft deep) of topsoil stockpile #2 was recently utilized in reclamation of Phase 1 bond release areas in the South Lease (the county road, the spoil road and HWT 2). The volume of material remaining will be surveyed. The open end of the topsoil stockpile will be reseeded and bermed this fall.

<p>PHOTO 26 Soil removed from E end Topsoil Pile #2</p>

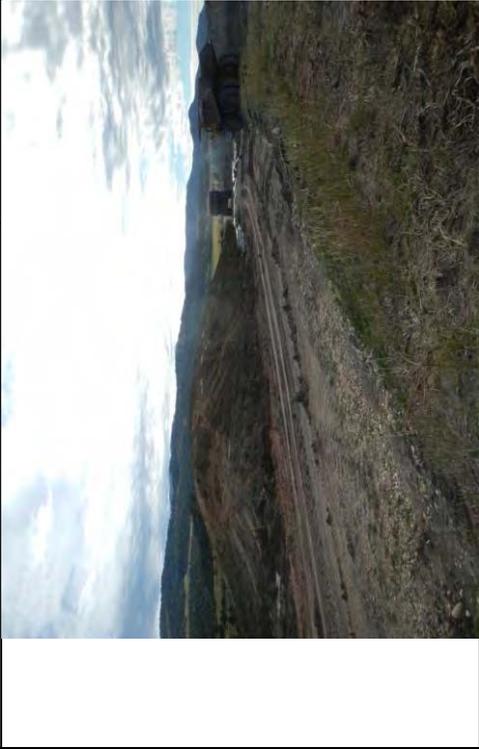
<p>PHOTO 27 Amanda Daniels and Cheryl Parker set up seismograph near Area 1 subsoil pile</p>

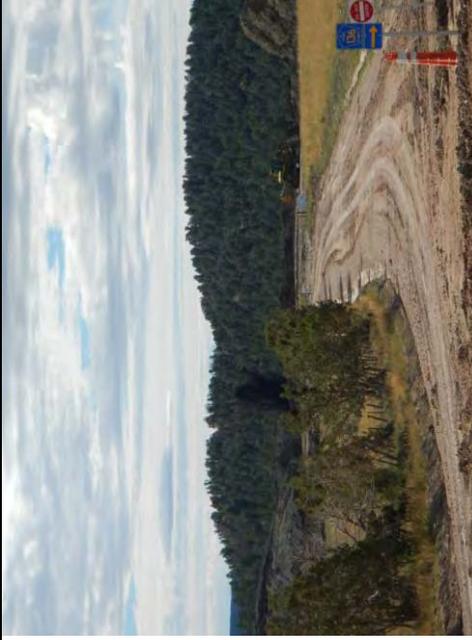
PHOTO 29

Six blasts occurred at the North Lease in the third quarter. Blasting records for blasts on July 7, July 25, August 9, August 19, and September 16 were reviewed. The sixth blast, Blast #10, took place on Wednesday, 9/28/2016, and was observed during the inspection. Division engineers: Amanda Daniels and Cheryl Parker were present along with Drew Christensen and Bob Nead. The charges were set in the center of Pit 5 by SouthWest Energy LLC, Matt Raddon Certified Blaster. A SW breeze carried the plume towards the observers and Alton.

View of blast from closed County road location

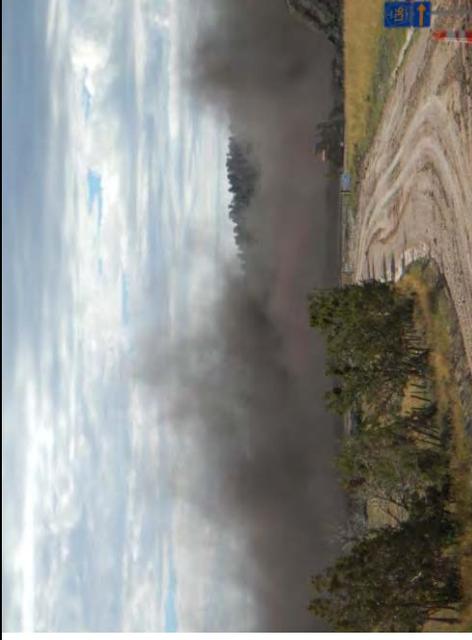
PHOTO 30

Dust cloud moves NW after blast

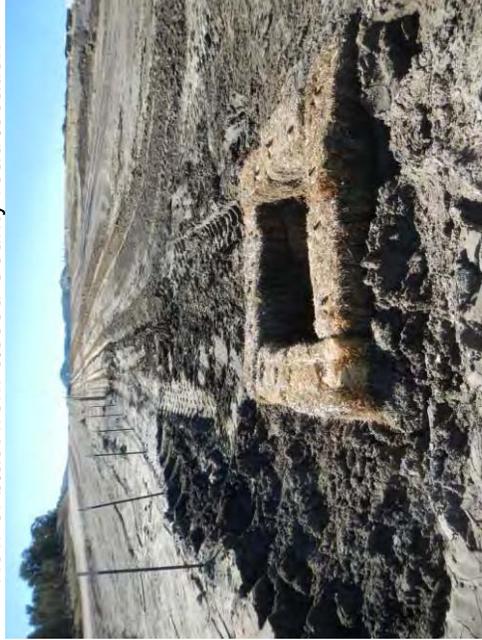
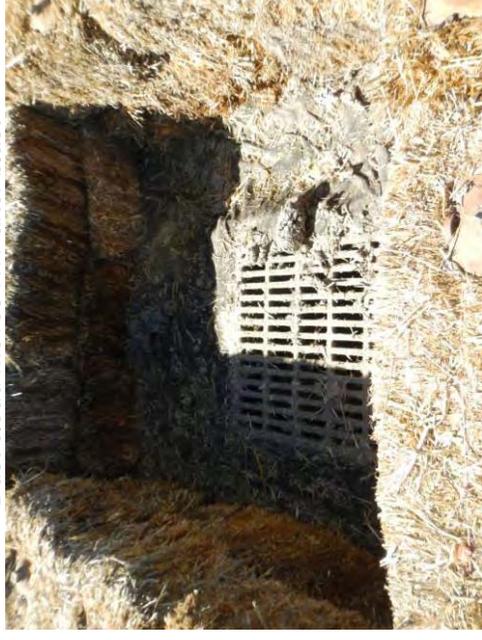
ASCA #1 Area 1

NOV 21185 was issued 9/7/2016 regarding ASCA-1 sediment control maintenance as designed in App. 5-14 of the MRP. The abatement date was 9/21/2016. Progress towards abatement was photographed for the issuing inspector.

ASCA-1 at the North Lease was being maintained to abate NOV 21185. ASCA's at the North Lease entrance to the facilities yard were recently cleaned out.
