Inspection Report

Permit Number:	C0250005
Inspection Type:	PARTIAL
Inspection Date:	Wednesday, October 26, 2016
Start Date/Time:	10/26/2016 3:00:00 PM
End Date/Time:	10/27/2016 12:00:00 PM
Last Inspection:	Tuesday, September 27, 2016

Permittee: **ALTON COAL DEVELOPMENT LLC**
 Operator: **ALTON COAL DEVELOPMENT LLC**
 Site: **COAL HOLLOW**
 Address: **463 North 100 West, Suite 1, CEDAR CITY UT 84720**
 County: **KANE**
 Permit Type: **PERMANENT COAL PROGRAM**
 Permit Status: **ACTIVE**

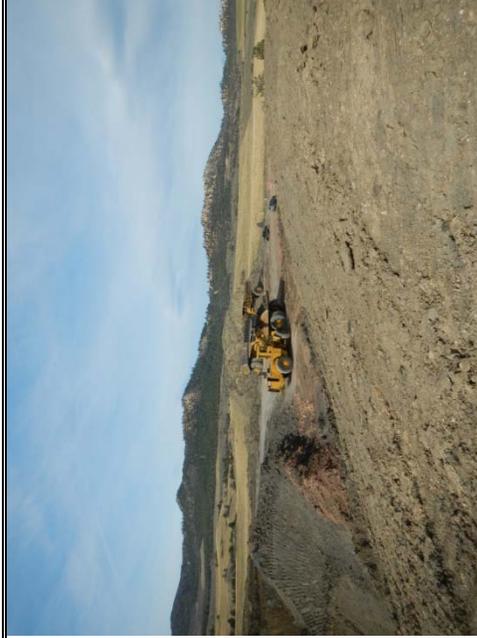
North Lease topsoil: Two haul trucks were removing topsoil from the NW end of the topsoil stockpile and dumping the topsoil on graded Pits 1 & 2. Topsoil had recently been removed from the South end of the topsoil pile. Loose topsoil at the south end of the topsoil pile will be pushed back into the pile and the pile will be rebermed. The haul road above Pit 3 will be ripped prior to topsoil placement.

PHOTO 1 Loading topsoil from NW end of the topsoil stockpile

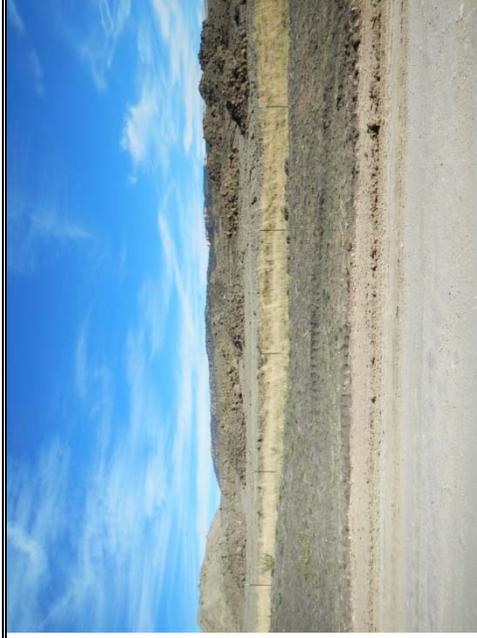
PHOTO 2 Topsoil placed on backfilled/graded Pit 1

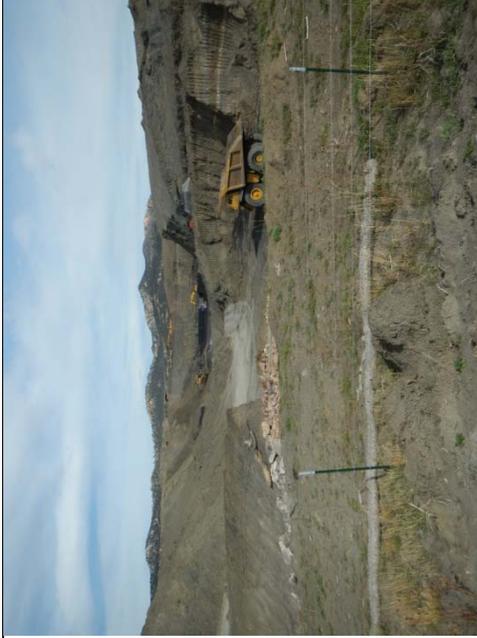
North Lease: Pit 6 excavation has eliminated DD 8.

PHOTO 3 North Lease looking North at Pit 5. Haul truck gets loaded with Pit 6 spoil will travel across Pit 3&4 to dump at the North end of Pit 5. Sediment pond 6 inlet visible. DD8 was eliminated by Pit 6 highwall.

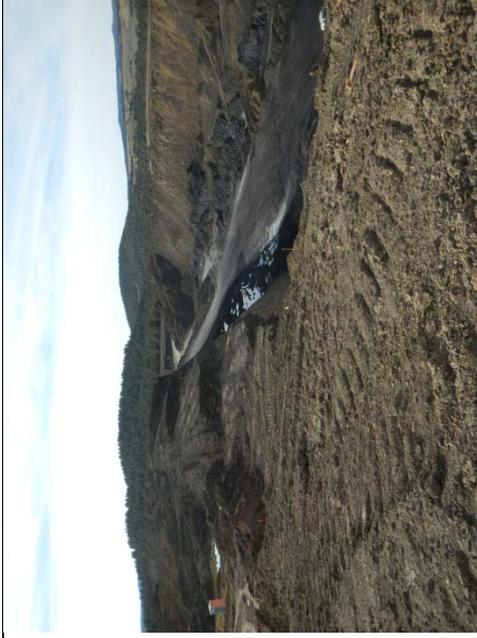
PHOTO 4 North Lease, Looking south at spoil pile and Pit 5. Topsoil in the foreground

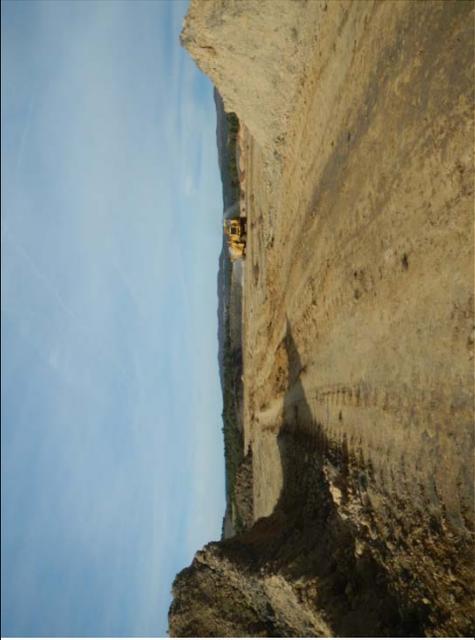
South lease topsoil: Topsoil pile #2 will be partially used to cover 2015 Ph 1 bond release areas 1-1 (between the south and north temporary spoil haul roads). These areas are compacted from water truck travel and will be ripped prior to topsoil placement. Vegetated slopes along both sides of the Temporary Robinson Creek Diversion have been recovered for use as substitute topsoil. This soil is currently windrowed above the Temporary Diversion.

<p>PHOTO 5 South Lease. Ph 1 bond release area 1-1 being watered with water truck will require ripping prior to topsoil.</p>	<p>PHOTO 6 Excess spoil topsoil pile will be utilized on Ph 1 area 1-1. Pond 3 and Pit B1 area to the west.</p>

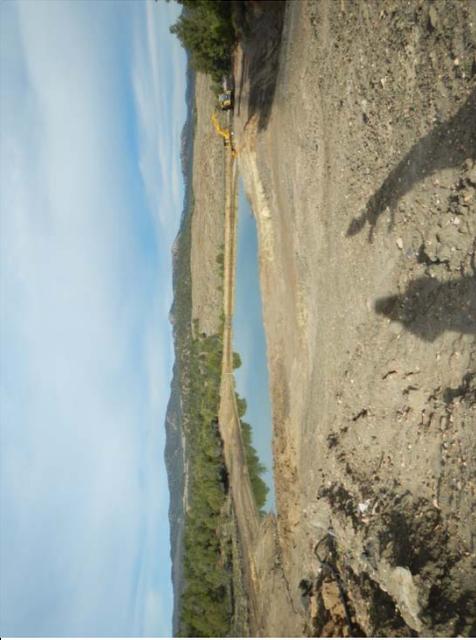
Pond 3 discharged through the decant for the past three weeks. One water sample was taken of the decanted water each week. Pond 1 and 1B were recently cleaned out.

<p>PHOTO 7 Pond 3</p>	<p>PHOTO 8 Mulching and seeding of backfilled/graded HWT 2</p>

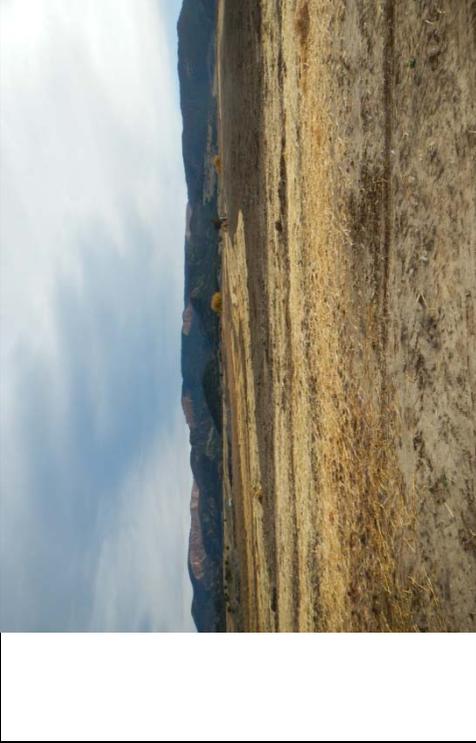
South of Pit 10 the graded/topsoiled HWT 2 area is being mulched (hay and nutrimulch) and seeded (pasture mix). Mulch and seed is also scheduled to be applied to Subsoil pile #2 and 2015 Ph 1 bond release area 1-1 (between the north and south excess spoil haul roads) in the South Lease. Seed and mulch will also take place on 10 acres in the North lease this fall.

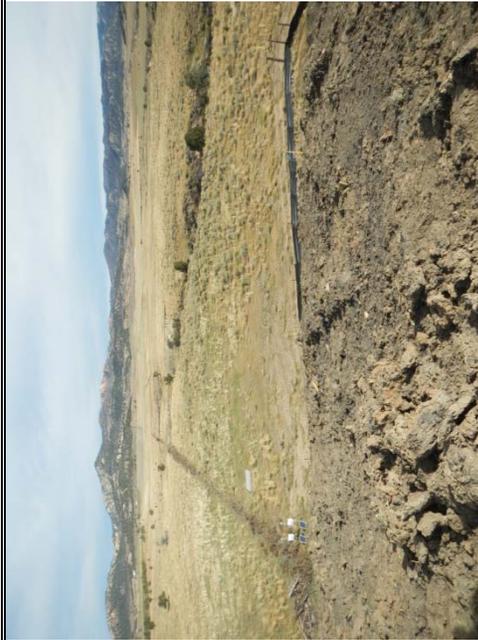
The Division engineer, Cheryl Parker, and Division hydrologist, Keenan Storrar, explained that allow Pit 6 is bonded to the full extent, the Area 1 boundary is the limit of allowable surface disturbance. This is because of the hydrologic boundary which is delineated by a silt fence on the East side of the topsoil pile (MRP Vol 7, page 7-81 and Dwg 5-48). Approval of the Area 1 Expanded area will allow construction of Pond T1 to capture disturbed area drainage. This task is currently under review as Task 5291. Approval of Task 5291 will allow full extraction of Pit 6.

<p>PHOTO 9 Area 1 permit area silt fence along North end of North Lease topsoil pile. Area 2 in the distance.</p>	<p>PHOTO 10 Area 1 permit area silt fence along East side of North Lease topsoil pile. Area 2 & 3 in the distance.</p>

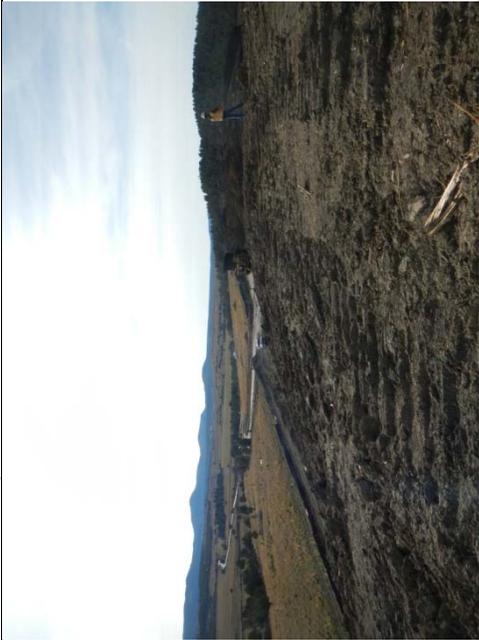
<p>PHOTO 11 Area 1 permit area silt fence along East side of North Lease topsoil pile. Mine haul road and County Road in distance.</p>	<p>PHOTO 12 Trucks hauling spoil across Pit 3 & 4 to West side Pit 5. Mining in North end of Pit 5. Topsoil pile foreground.</p>
