## Coal Hollow April 12 Inspection

# Inspection Report

Permit Number:	C0250005
Inspection Type:	PARTIAL
Inspection Date:	Tuesday, April 12, 2016
Start Date/Time:	4/12/2016 10:00:00 AM
End Date/Time:	4/12/2016 2:00:00 PM
Last Inspection:	Wednesday, April 06, 2016

TITLE  
NORTH PRIVATE LEASE  
INSPECTION 5497

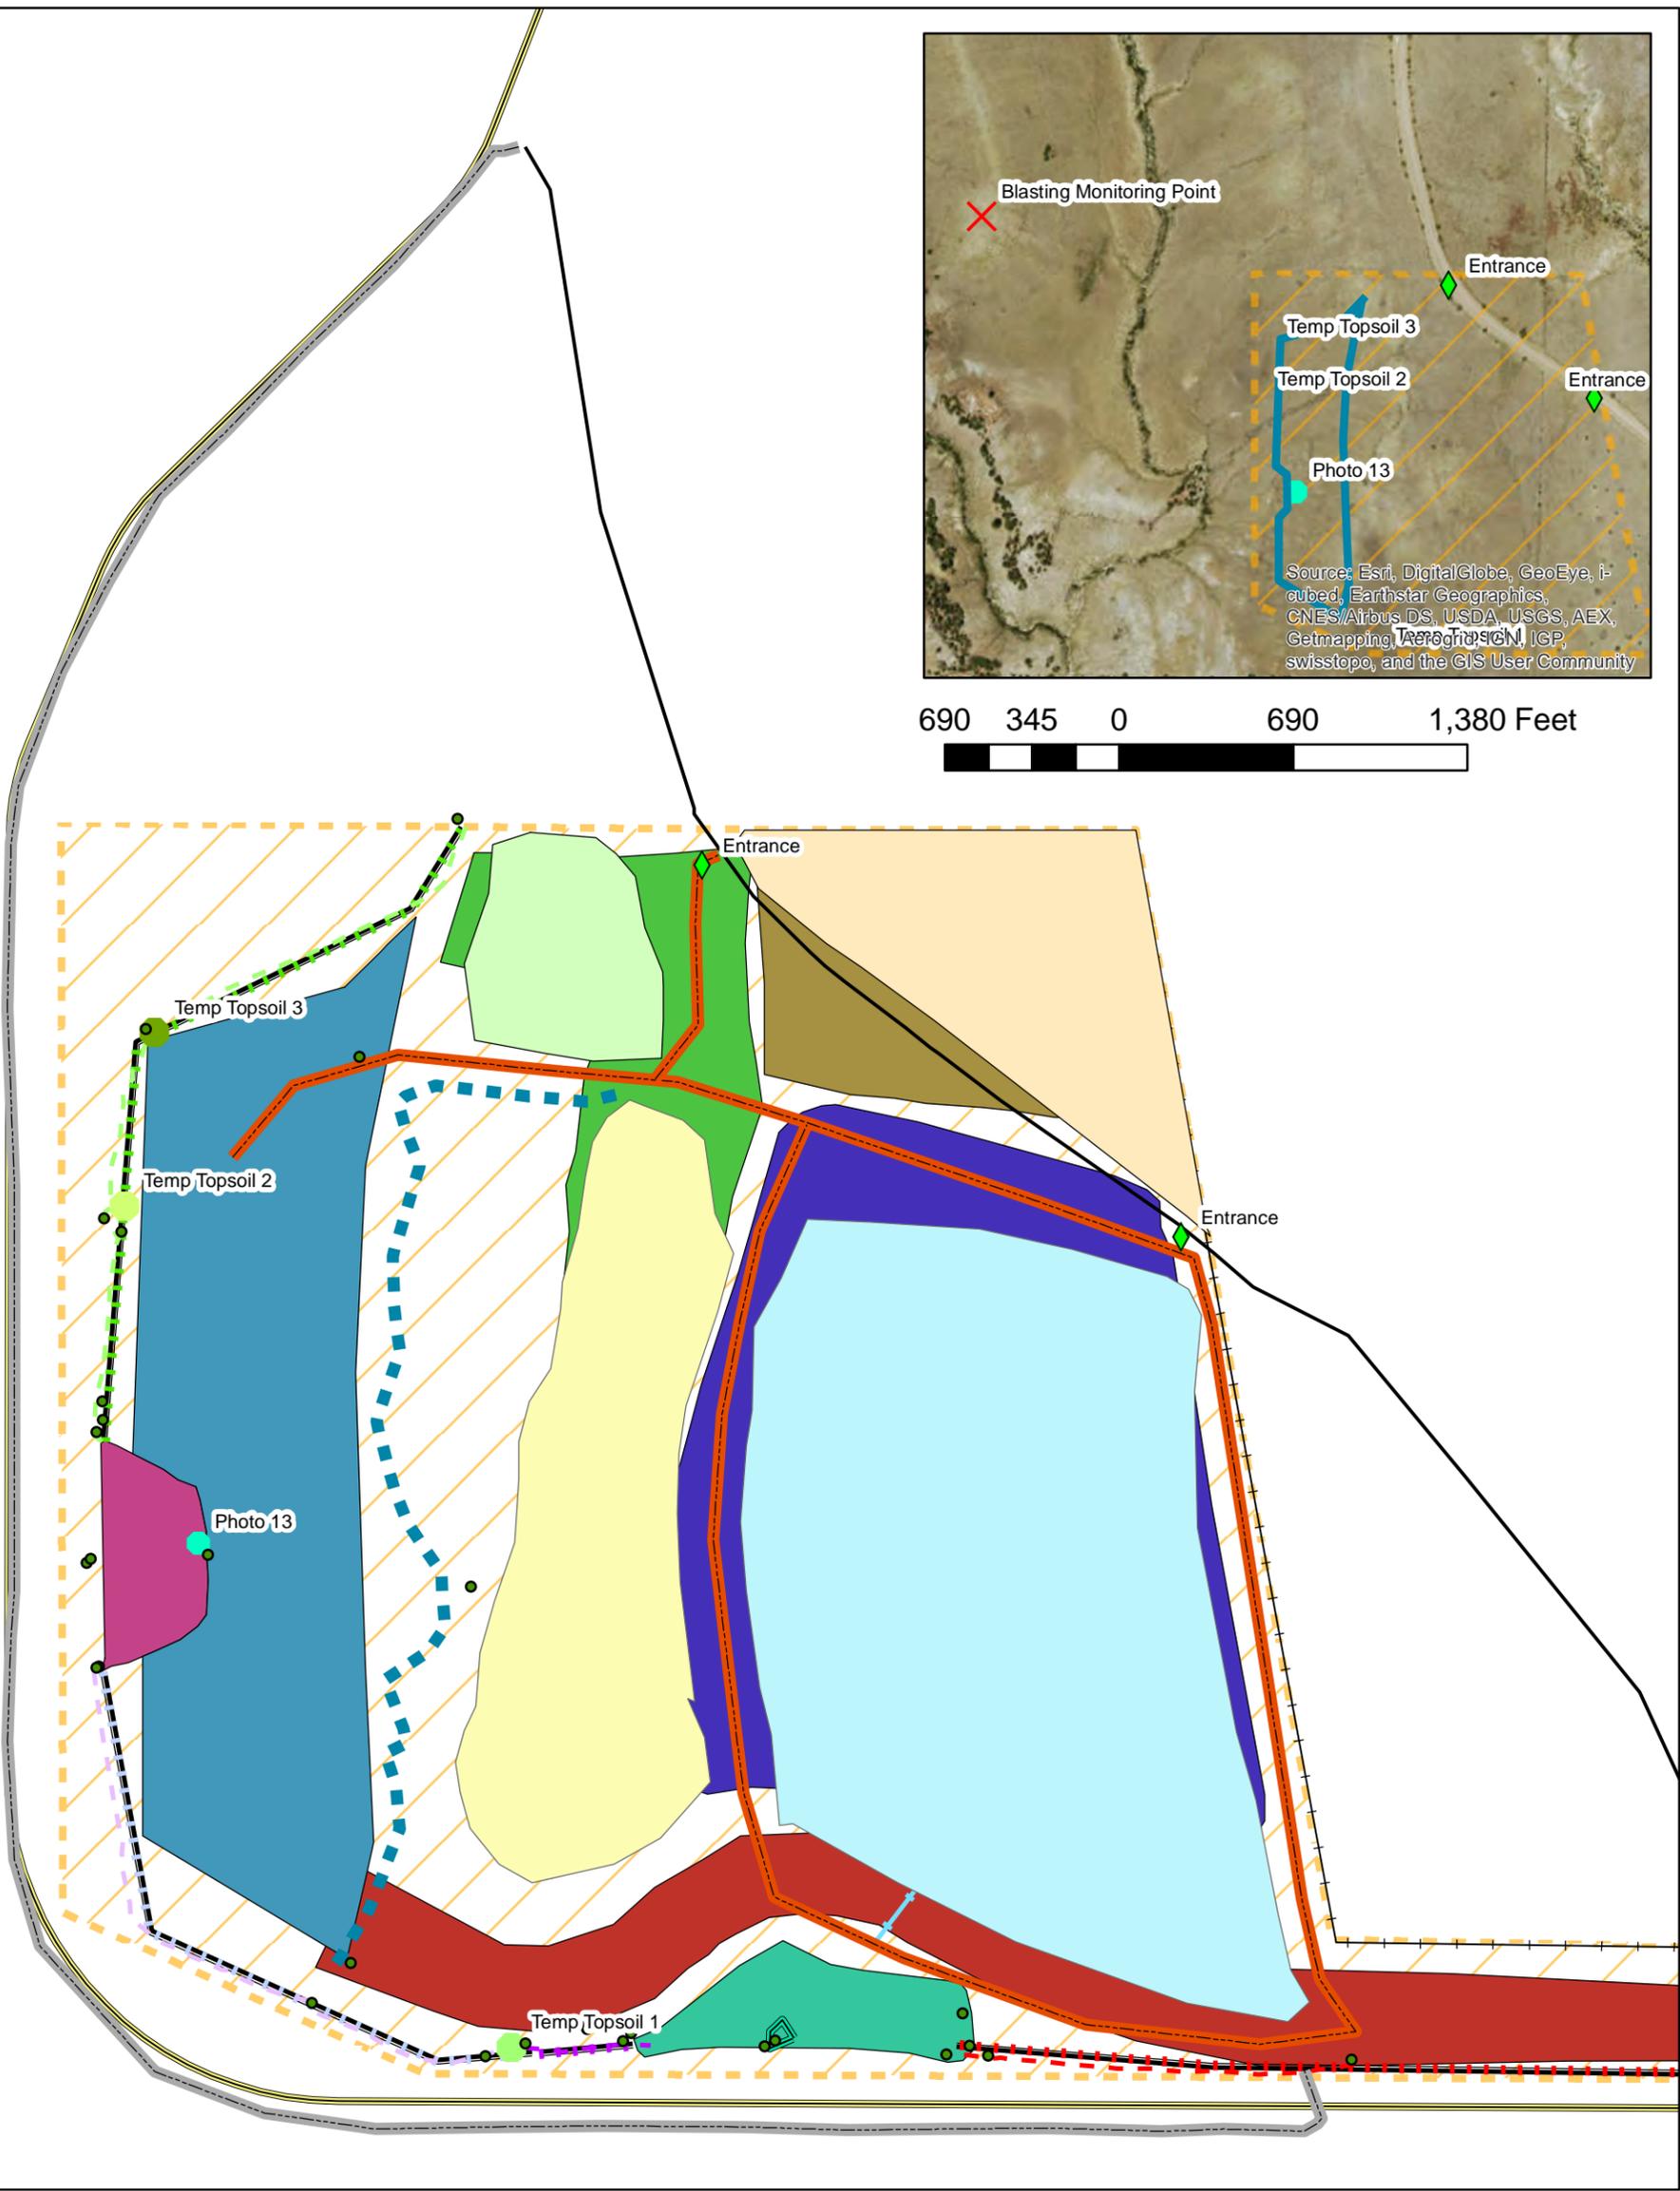
PROJECT	MINE	Ref.	FIGURE
Coal Hollow	Alton Coal Development	C/025/005	Drawing 1

The inspection included walking all the existing diversion within the North Private Lease Area 1. Drawing 1 show the GPS track of Division staff. There are no diversion features constructed east of K3900( DD-09, DD-10, DD-11). Diversion ditches DD-05 through DD-08 are constructed in Area 1 west of the existing K3900 road, as shown on Drawing 1. None of the culverts (C-1 or C-2) were installed at the time of the inspection, see photo 29).

Drawing 1 attached shows the only approved haul road for the North private lease along the southern boundary. Drawing 1 shows the Division's field gps tracking location of the existing haul roads for spoil and coal at the time of inspection. These items are covered by NOV 21174 failure to follow approved plan. The abatement of the NOV is 4/15/16. The Permittee was alerted for the need to address the location of haul road within the abatement.

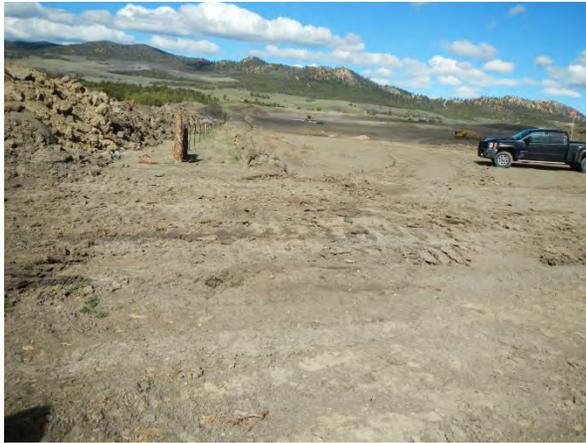
**PHOTO 1**

The initial segment of DD-08 was graded out as a point of access for equipment to build the K3900 by pass was in place, see Photo 1 and 2. The Permittee was alerted for the potential of off-site impacts due to a lack of drainage control and was told to place a hardened crossing asap. The Permittee will follow up with the Division when this task is completed and include pictures as documentation. Photo 3 begins where DD-08 was graded at the time of the inspection. The Permittee was alerted to remove the remaining topsoil just north of DD-08 that is inhibiting sheet flow to enter DD-08, see Photo 3 and 4 of Attachment A. DD-08 will then be established to the typical design shown on MRP Drawing 5-65 and 5-72. The Division will follow up with the all ditch design and clean ups at the next inspection.

Eastern most point of DD-08, Missing section of Ditch to be installed, follow up required  
April 2016

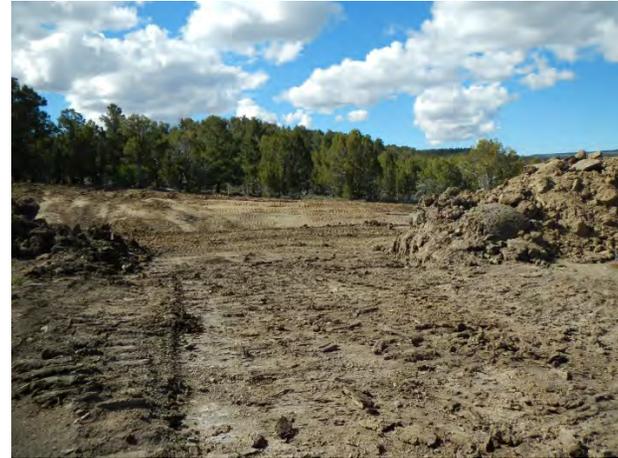
**PHOTO 2**

Missing section of DD-08, used as access to County By-Pass construction. Standing on haul road looking directly south.  
April 2016

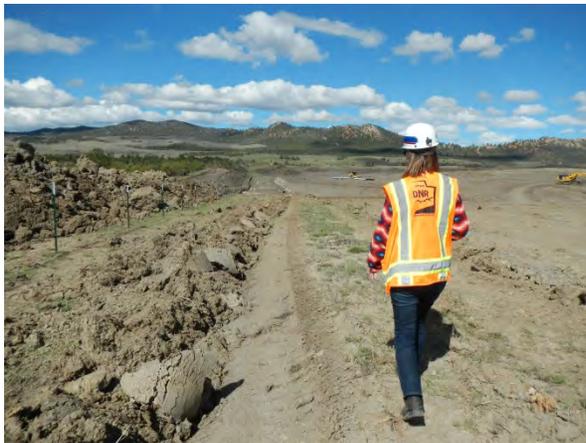
**PHOTO 3**

Walking DD-08 down gradient west towards Pond 6  
April 2016

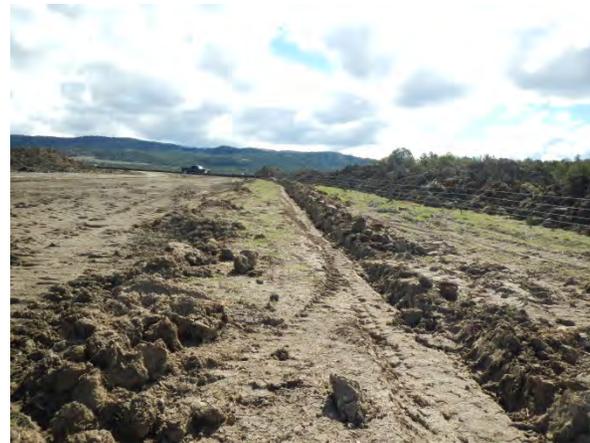
**PHOTO 4**

DD-08 looking East, up gradient, Non-salvaged soil inhibiting flow  
April 2016

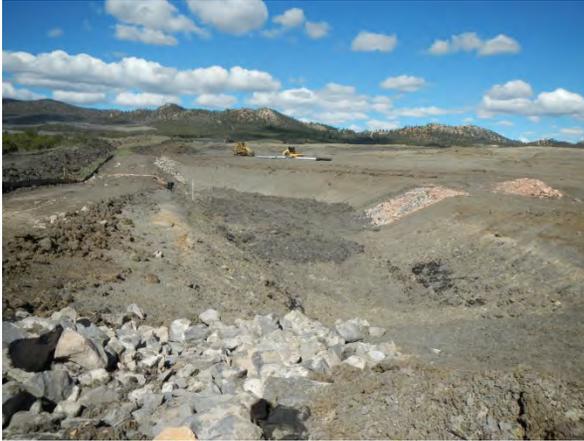
**PHOTO 5**

Photo 5 shows the outfall of DD-08 at the inlet of Pond 6. The Permittee recently repaired the south embankment of the pond as seen by the different colored dirt on the southern embankment in photo 5. The sediment clean out markers were installed since Inspection report #5490, as seen in Photo 6. The Primary spillway was installed with an oil skimmer but was not connected to the outfall culvert. The Permittee was alerted at the time of inspection that a new certified inspection by a Utah PE will be required.

Outfall of DD-08 into inlet of Pond 6, repairs to embankment previous day  
April 2016

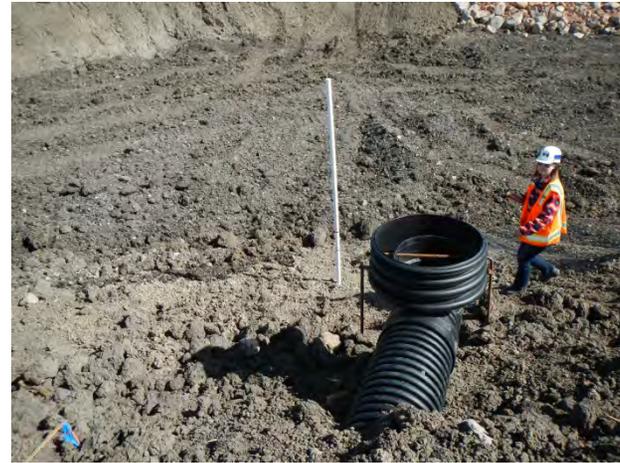
**PHOTO 6**

Pond 6, looking North, Sediment Marker and primary spillway with oil skimmer  
April 2016

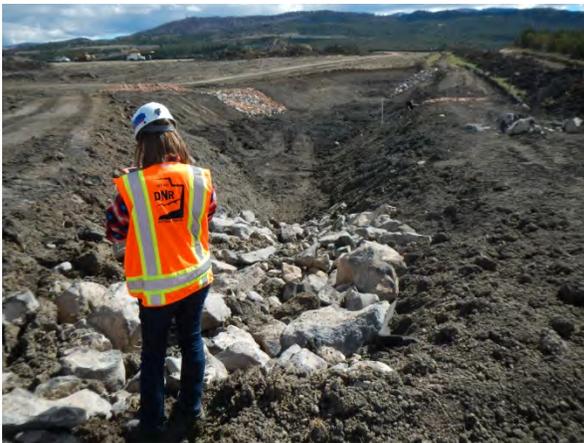
**PHOTO 7**

The second inlet to Pond 6 is the outfall of DD-07 seen in Photo 7. As stated previously, the ditch needs to be constructed to typical V Ditch approved designs instead of a tire track. The ditch must be free of loose material and flow as designed towards Pond 6. A temporary topsoil pile was present on the boundary of DD-07 that was not protected; see Temp Topsoil pile on Drawing 1 attached as well as Photos 8 and 9. The pile is associated with abatement activities with NOV 21174, so the Permit was altered to move the topsoil pile away from DD-07 and to construction a berm around the pile until it is moved to the approved topsoil pile location on the eastern side of K3900.

DD-07 outlet into Pond 6  
April 2016

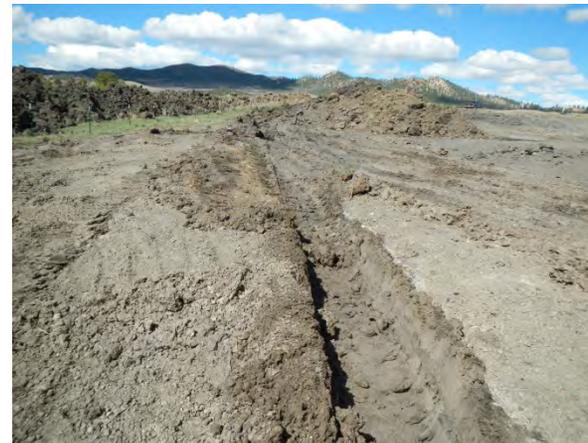
**PHOTO 8**

DD-07 looking West, up gradient, towards recently recovered Topsoil, ditch to be fixed and soil to be removed, follow up required  
April 2016

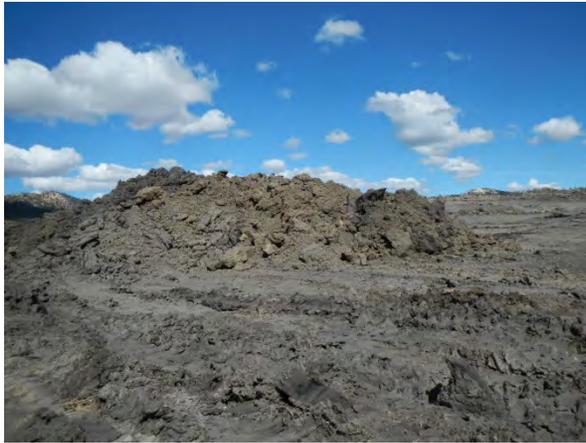
**PHOTO 9**

Salvaged Topsoil pile next to DD-07, Told Permittee to move away from ditch and protect asap, follow up required  
April 2016

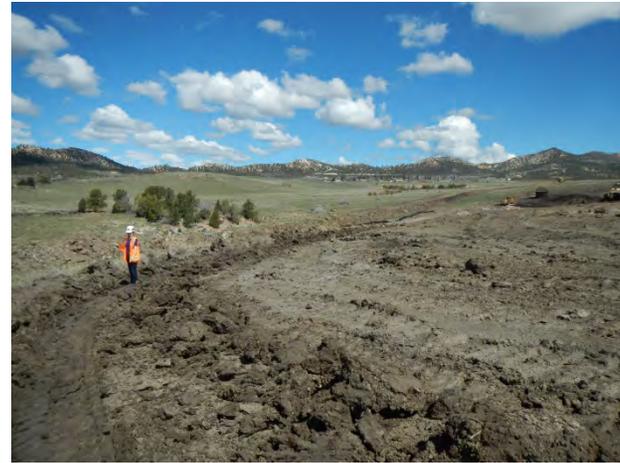
**PHOTO 10**

DD-06 begins at the top crest in elevation of DD-07, as shown on Drawing 1 attached. As stated previously, the ditch needs to be constructed to typical V Ditch approved designs instead of a tire track, see photo 10 and 11. The ditch must be free of loose material and flow as designed towards Pond 5. The Permittee and inspectors discussed reinforcing the southeast corner of DD-06, due to the potential for high erosion in the area. The higher erosion at this point is a result of the ditch slope change from an aggressively steep slope to a relevantly flatter slope, along with a focus point of sheet drainage of the pit area east of the ditch. This corner of DD-06 will be closely monitored by the Division as a likely point of ditch failure resulting in a potential off site impact. The outfall of DD-06 was not constructed properly and could result in potential off site impacts as it was graded with a tire track, see photo 12. The Permittee will address this item and re-establish DD-06 outfall into Pond 5 asap . The Permittee will follow up with the Division when this item has been addressed and include photo documentation.

DD-06 looking down gradient NW towards Pond 5. Staff standing at stress point in the ditch. Ditch to be fixed, follow up required  
April 2016

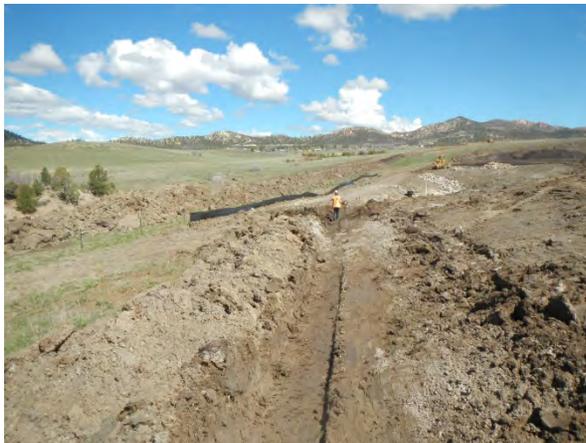
**PHOTO 11**

Walking DD-06 down gradient north towards Pond 5, to be fixed  
April 2016

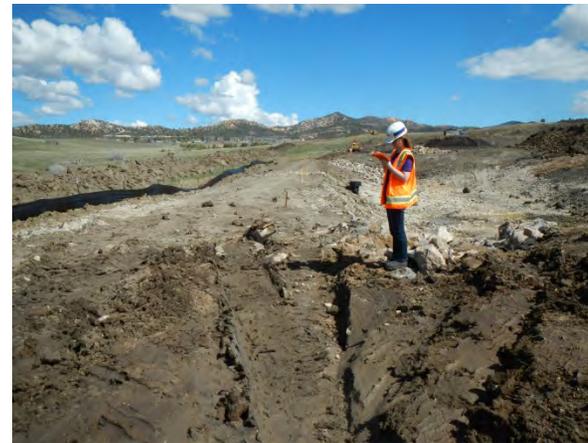
**PHOTO 12**

DD-06 has potential draining off site, looking North. Ditch Outfall to be fixed asap and follow up required.  
April 2016

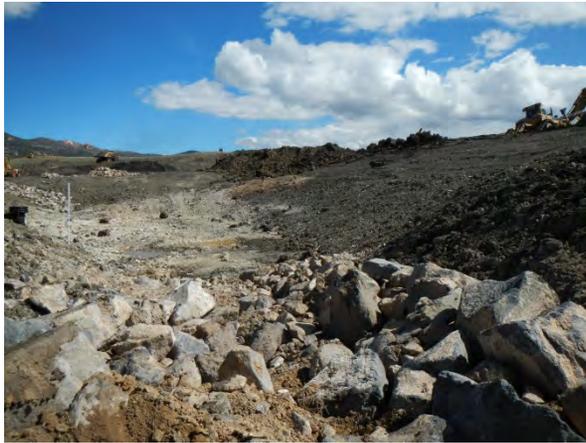
**PHOTO 13**

Photo 13 shows Pond 5 from the southern end, Outfall of DD-06, looking north. The pond has been installed with the primary spillway with an oil decanter. The sediment marker was also installed since the previous inspection. Inspection 5490 called out specific repairs required to build the pond to design. The Permittee addressed how stakes had been placed detailed the required amount of additional fill (1-1.5 feet).

Standing at DD-06 inlet to Pond 5 looking at sediment marker installed, primary spillway with oil decanter, and DD-05 outfall/inlet into Pond 5.  
April 2016

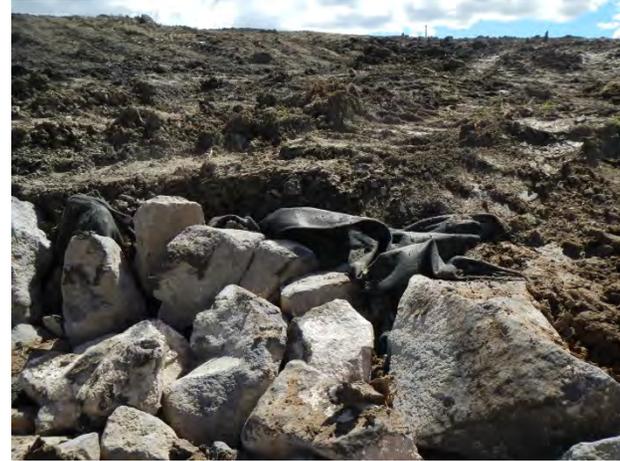
**PHOTO 14**

Pond 5 inlet from DD-06, DD-06 linear needs to be keyed in  
April 2016

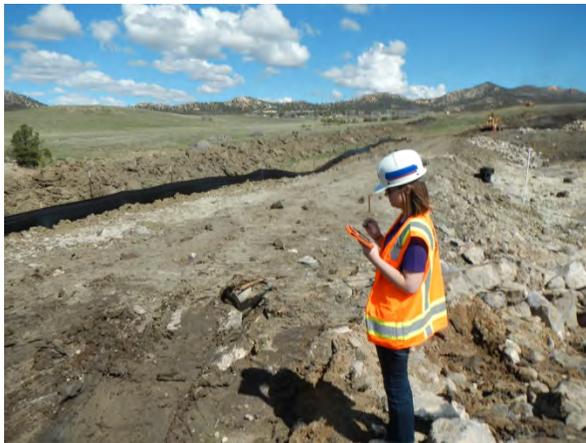
**PHOTO 15**

Photo 15 shows where the tracks over the embankment are along with the fill stakes. Photo 16 is standing on the pond embankment looking directly west. A silt fence is currently installed along the boundary as the outfall culvert has not been established yet. The Permittee was alerted at the time of inspection that a new certified inspection by a Utah PE will be required.

Pond 5 embankment needs to be repaired and raised 1 ft – 1.5 ft, follow up required  
April 2016

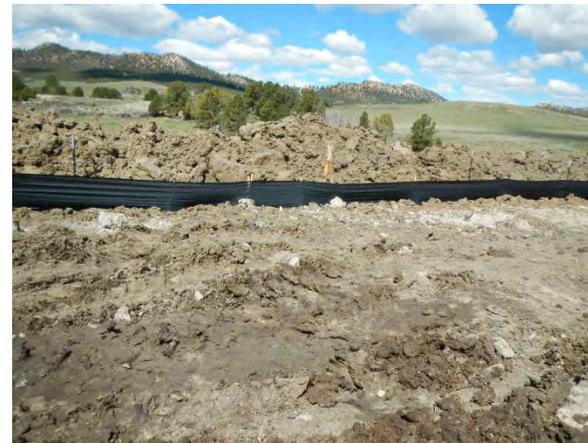
**PHOTO 16**

Looking west on Pond 5 embankment at Silt fence control measures at area to be repaired. Disturbance drainage captured by silt fence and salvaged soil piles for County By-Pass  
April 2016

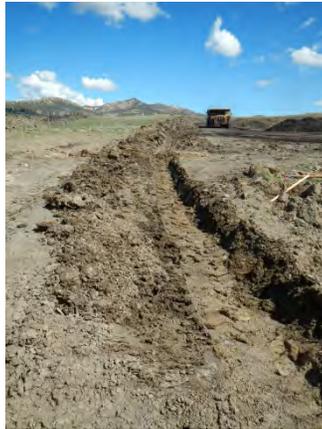
**PHOTO 17**

The outfall of DD-05 is shown in photo 17 looking up gradient of the ditch. As stated previously, the ditch needs to be constructed to typical V Ditch approved designs instead of a tire track. The ditch must be free of loose material and flow towards Pond 5. Photo 19 -23 show the previously discussed topsoil piles along the ditch that must be removed. The permittee will also salvage the additional topsoil see in photo 24. The overall lack of ditch design and flow problems are part of NOV 21174 which has an abatement date of 4/15/16.

Standing at DD-05 outlet into Pond 5 looking North , up gradient, of DD-05 to be repaired  
April 2016

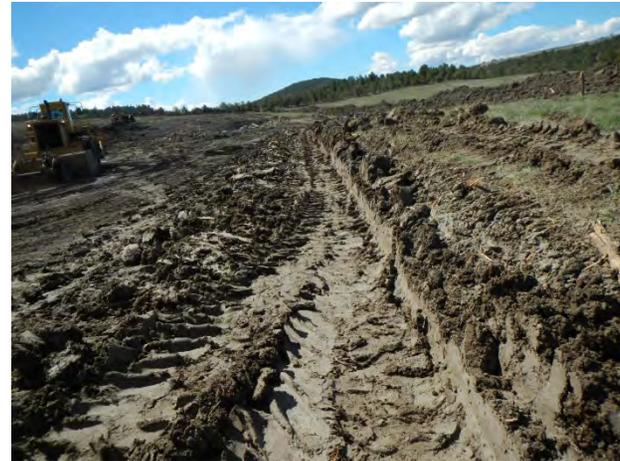
**PHOTO 18**

DD-05 looking south, down gradient, along haul road, to be repaired  
April 2016

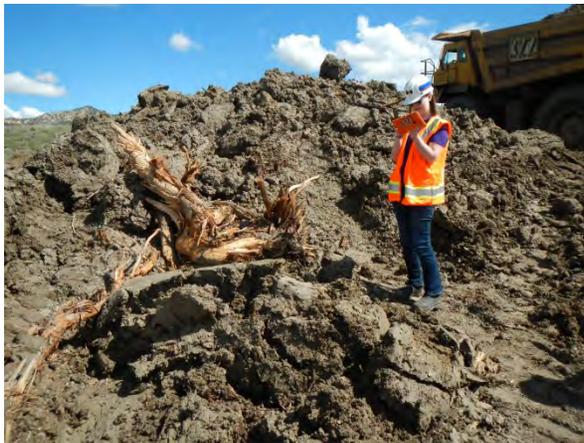
**PHOTO 19**

Salvaged Topsoil in DD-05 and a long haul road, looking north. To be moved asap to southern topsoil pile, follow up required  
April 2016

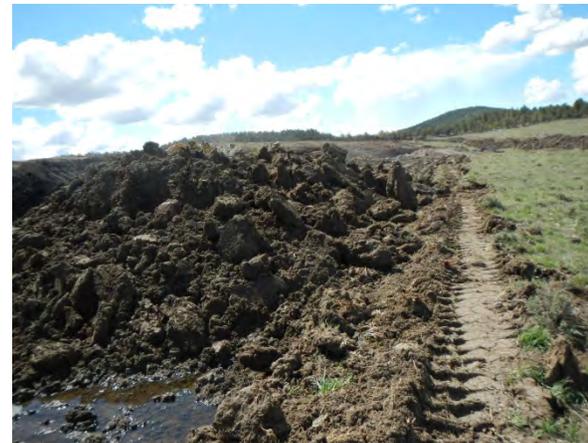
**PHOTO 20**

Looking south at Photo 19 Topsoil pile along haul road and DD-05. To be moved asap to southern topsoil pile, follow up required  
April 2016

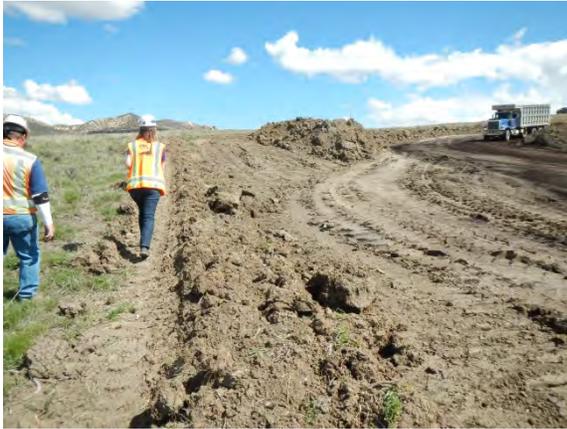
**PHOTO 21**

Photos 21, 23, 25, 26, 27, and 28 show how the existing haul roads do not currently have any drainage controls associated with the roads. Drawing 1 shows the Division's field gps tracking location of the existing haul roads for spoil and coal at the time of inspection. These items are covered by NOV 21174 failure to follow approved plan. The abatement of the NOV is 4/15/16. . The Permittee was alerted of the need to address the location of haul roads within the abatement.

Walking DD-05 North, up gradient, towards second topsoil pile. Ditch to be repaired, follow up required  
April 2016

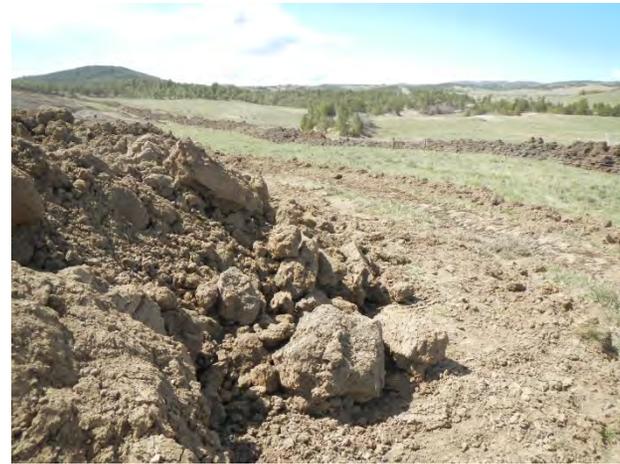
**PHOTO 22**

DD-05 looking south, down gradient, at Second topsoil pile shown in Photo 21. Topsoil to be moved and ditch to be repaired, follow up  
April 2016

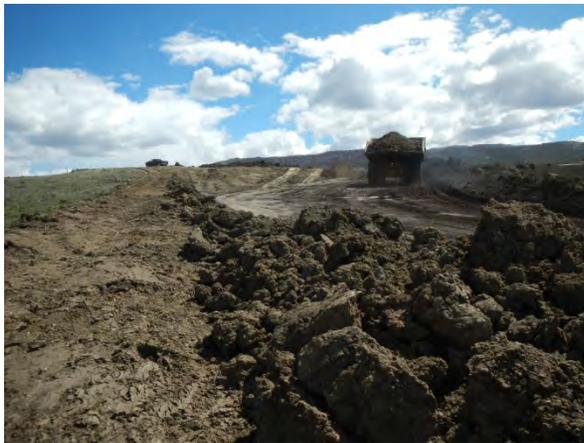
**PHOTO 23**

Walking DD-05 North, up gradient, towards just past second topsoil pile. Ditch to be repaired, follow up required, haul road no drainage  
April 2016

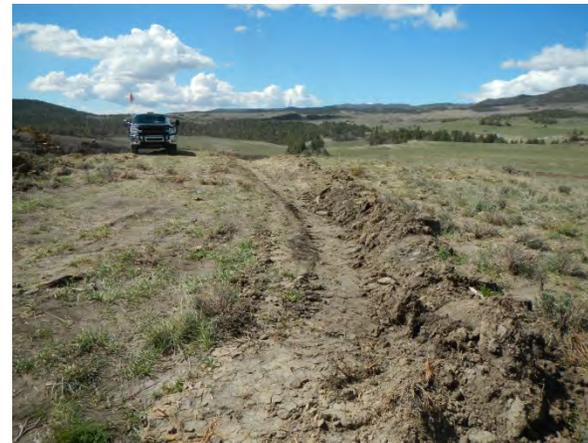
**PHOTO 24**

DD-05 starting point, soil to be salvaged and ditch repaired, follow up required  
April 2016

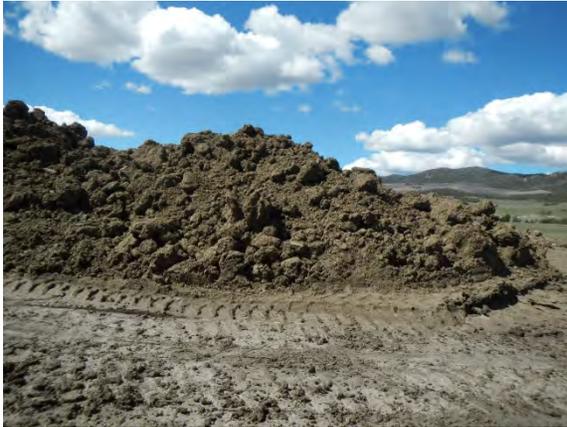
**PHOTO 25**

The subsoil pile, as shown on Drawing 1, is currently divided into two sections by the haul road out of NLPit 1. Photo 25 shows the northern most point of subsoil pile 1. The pile had not been placed by a dozer and the Permittee will establish the erosion control berm around the subsoil piles when the lifts are placed. The Division still requires the foundation inspection's per MRP and R645 regulations. This is part of NOV 21174. Photo 26 shows the haul road separating the two subsoil piles.

NW point of subsoil pile, began driving around subsoil. To be bermed when lift is placed by dozer, follow up required  
April 2016

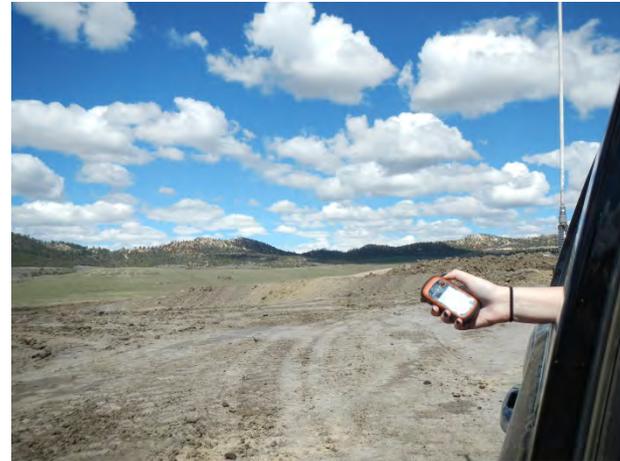
**PHOTO 26**

Haul Road dividing subsoil piles, looking towards the route into the pit.  
April 2016

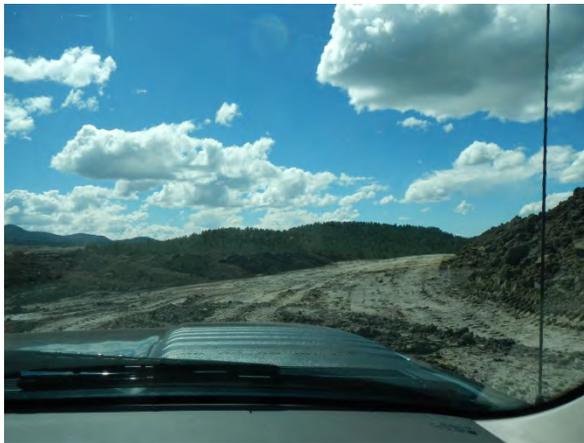
**PHOTO 27**

Photo 27 and 28 show the current state of the temporary excess spoil pile from the development of NLPit 1. The size and general location can be seen on Drawing 1 of the Division's GPS tracks. Off road haul trucks continued to haul throughout the inspection from just above pond 5, see photos 31 through 35. The Division still requires the foundation inspection's per MRP and R645 regulations. This is part of NOV 21174.

Driving South on haul road to spoil pile. Subsoil pile on right and spoil on left.  
April 2016

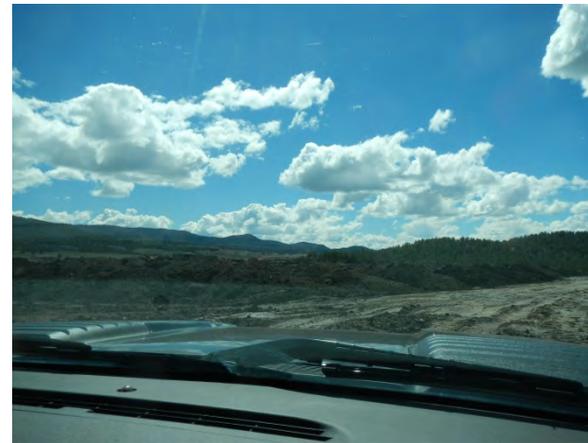
**PHOTO 28**

Spoil pile for North Private lease  
April 2016

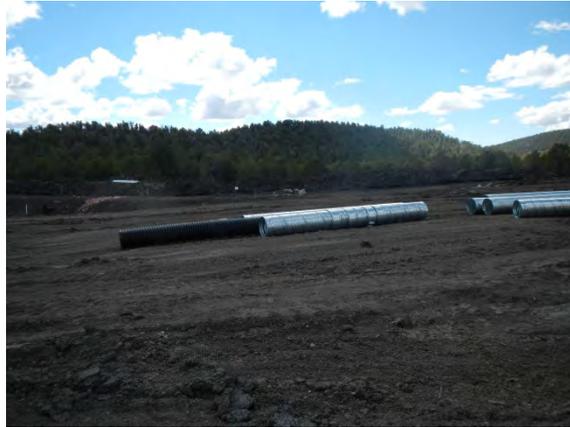
**PHOTO 29**

Culverts, C-1 to be installed under haul road, follow up required  
April 2016

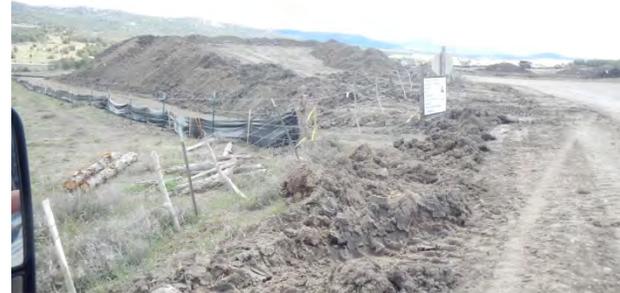
**PHOTO 30**

The company sign was present at the two access points to the North Private Lease on the west side of County Road 3900 and at the access point to Topsoil pile on the eastern side of County Road 3900, see Photo 30 in Attachment A. All information presented on the three signs displayed the correct ownership and contact information.

Topsoil pile East of County Road 3900, bermed and fenced  
April 2016

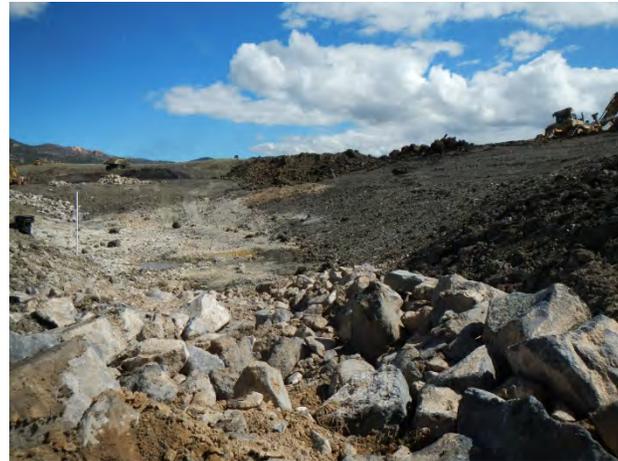
**PHOTO 34**

Overburden removal of pit development rolling into Pond 5.  
April 2016

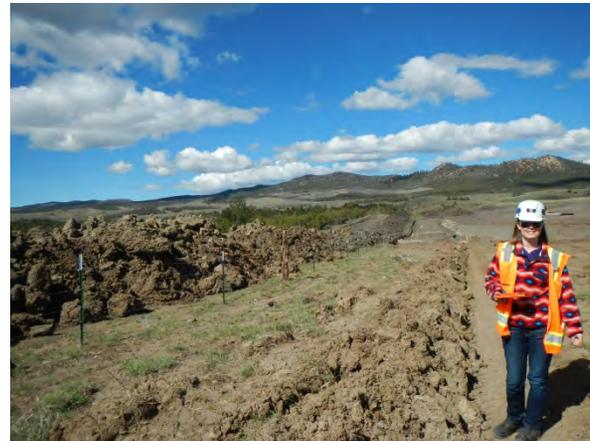
**PHOTO 40**

Salvaged soil for County By-pass road alongside permit boundary.  
To be graded and seeded at time of inspection  
April 2016
