**U.S. DEPT. OF THE INTERIOR
OFFICE OF SURFACE MINING
Mine Site Evaluation
State Program**

MINE SITE INSPECTION NARRATIVE

COMPANY: ALTON COAL DEVELOPMENT LLC

MINE: Coal Hollow

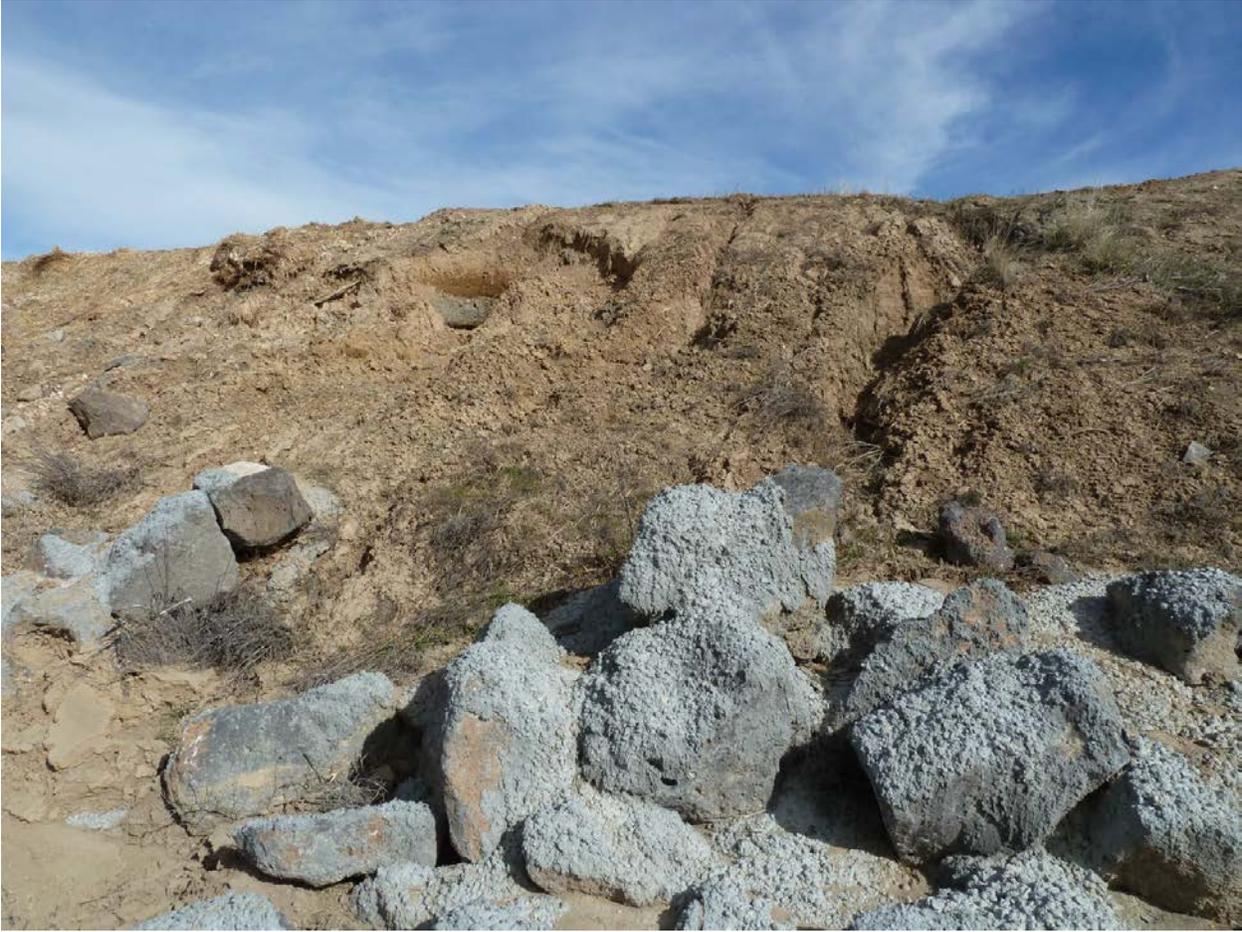
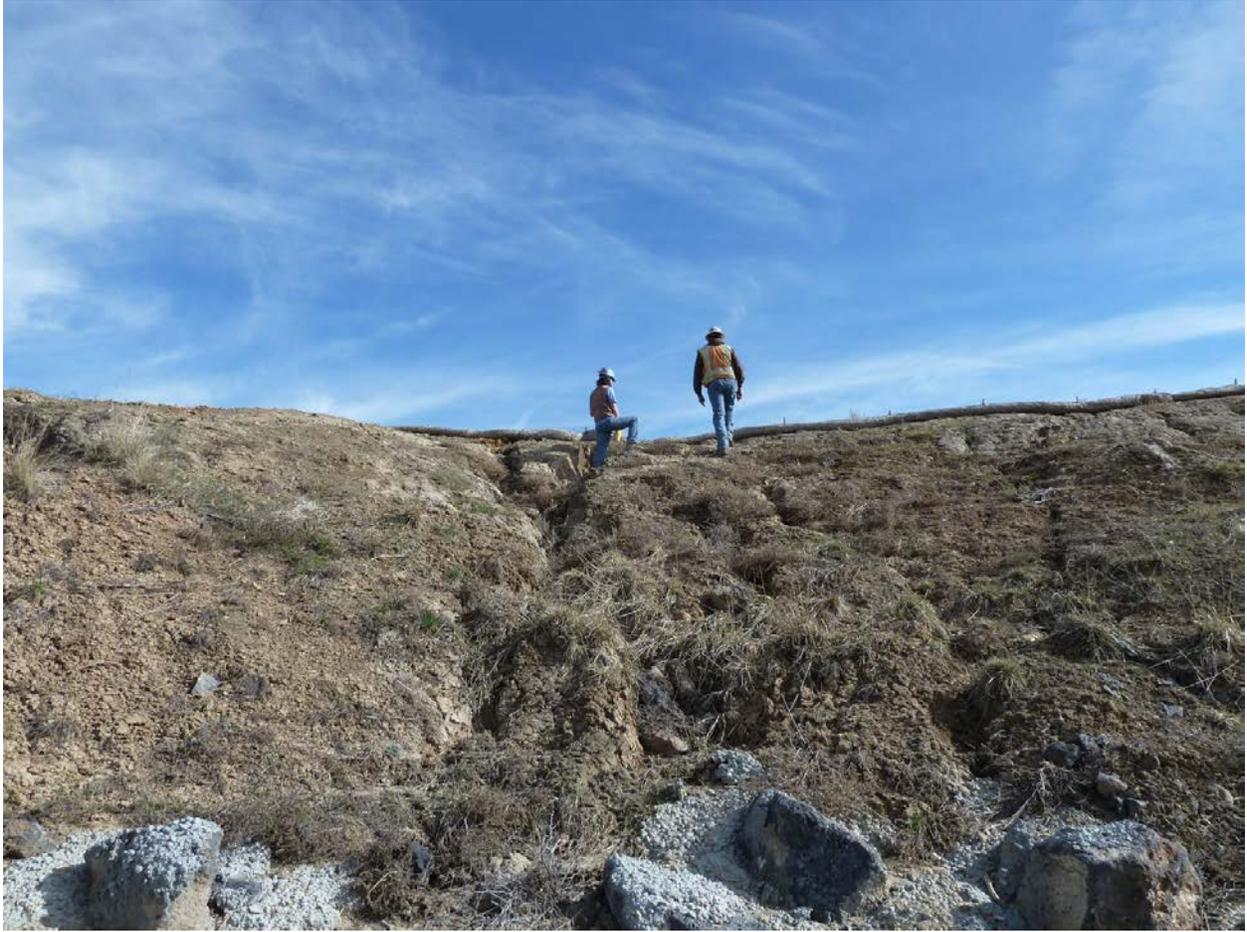
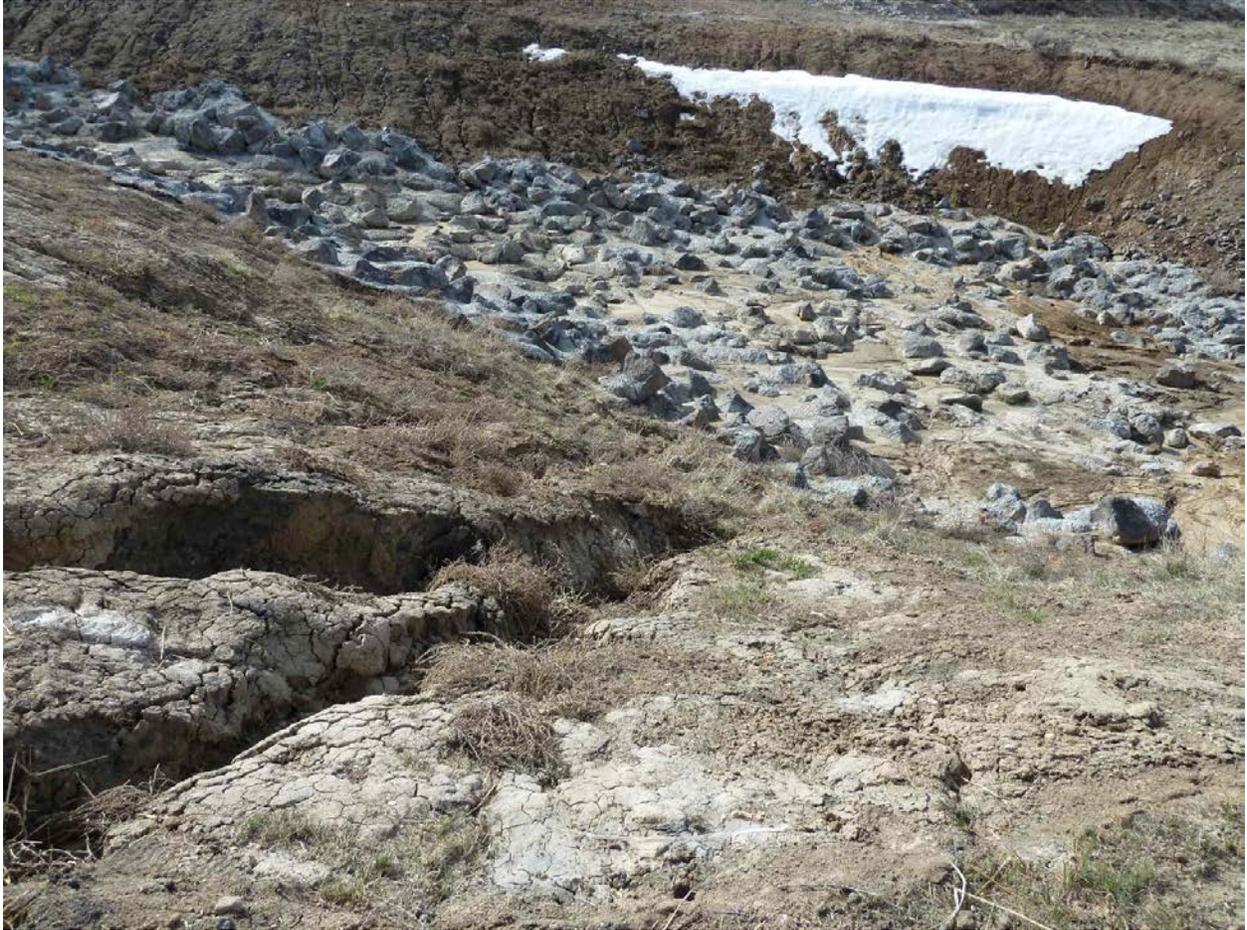
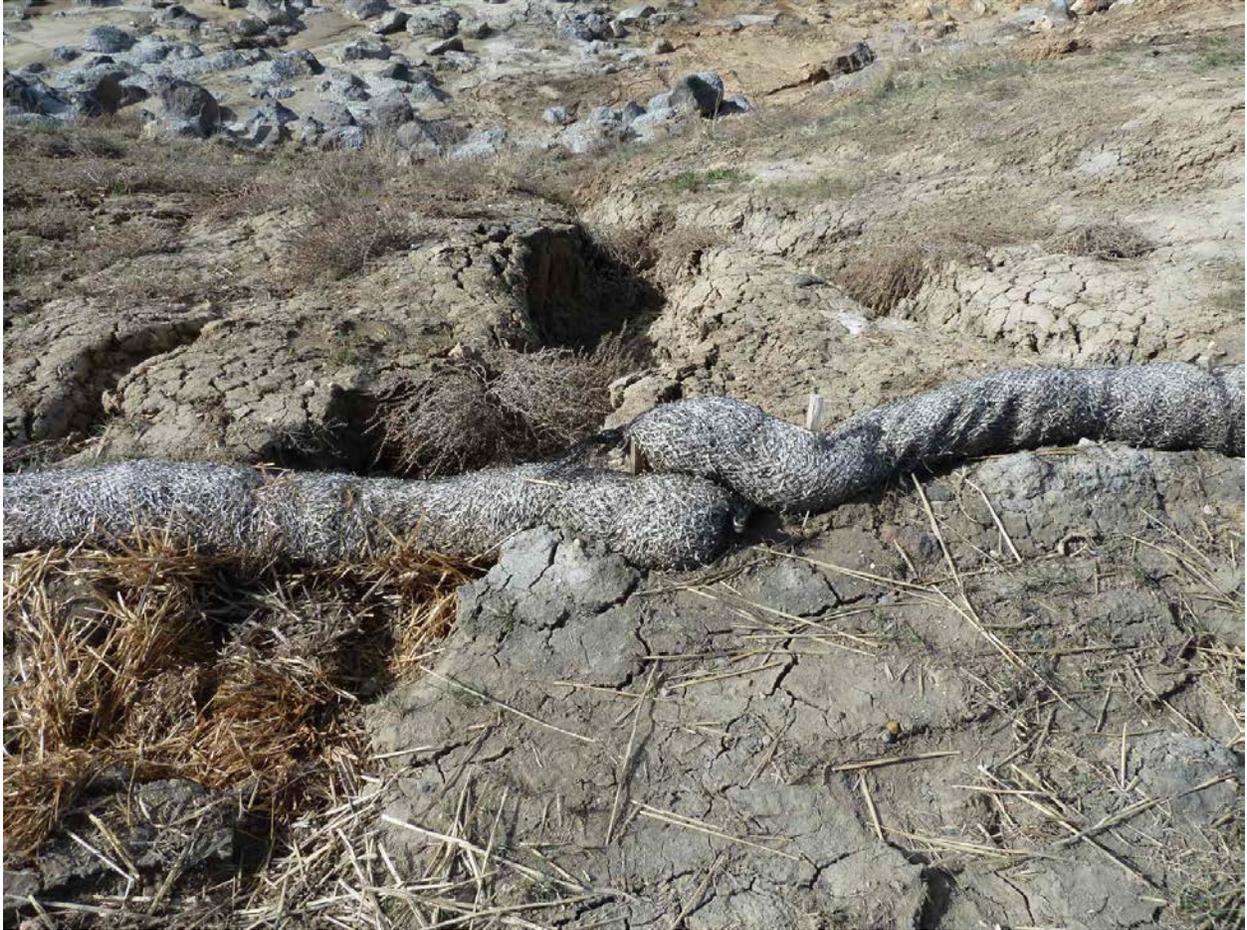
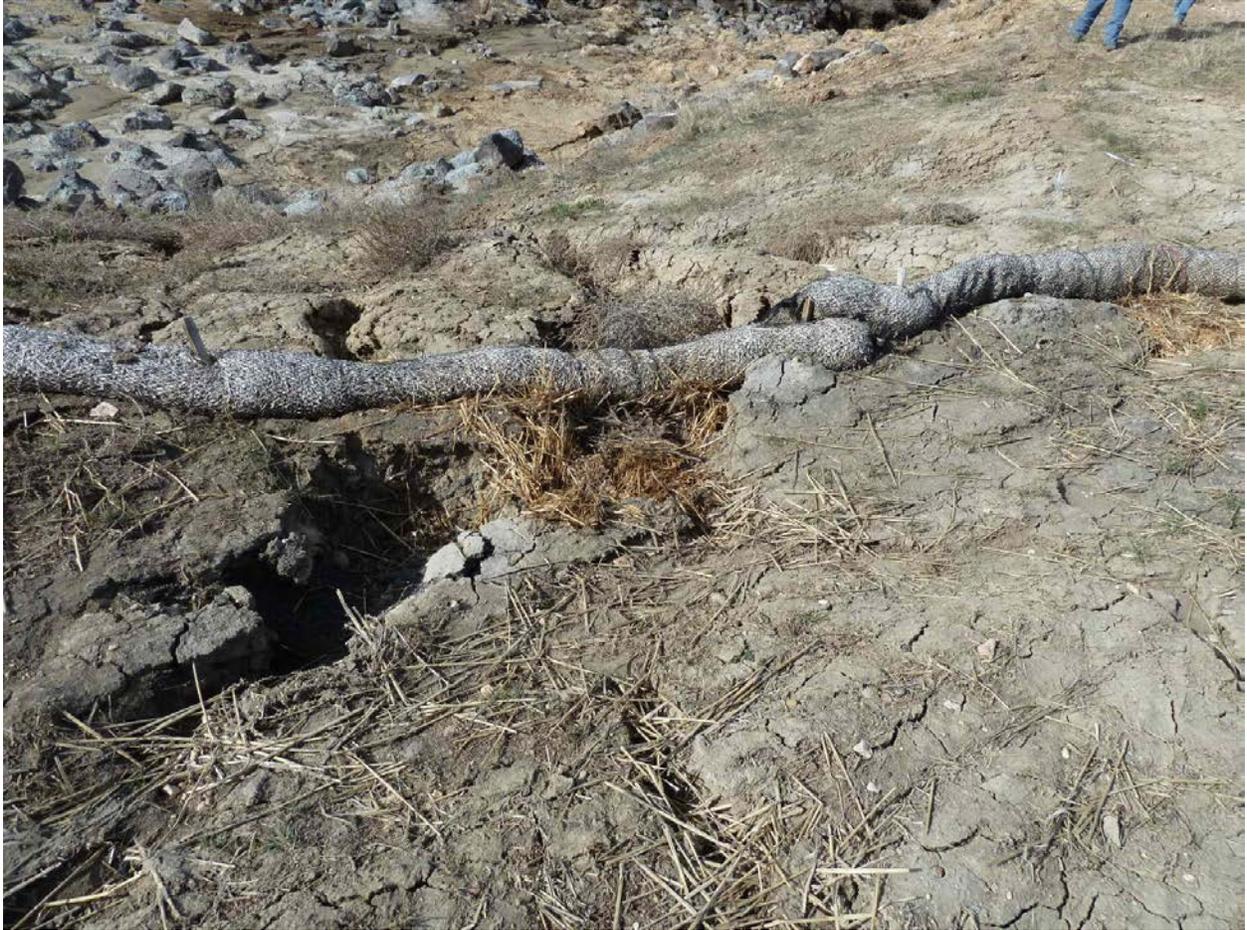
Phase I bond release area on the east side of Robinson Creek (see the Hydrologic Balance Section below for a further discussion of Robinson Creek) at the Robinson Creek shotcrete turn and downslope of this turn is in need of some maintenance work. There are portions of the former topsoil pile that still need to be spread, and due to previous heavy equipment working in this area, the site should be reworked (e.g. regarded and potentially reseeded). In addition, even with straw wattles installed on this site, significant rills and gullies have formed on this side of the bank and upslope of Robinson Creek (Figures 1-6). Pocking this area (i.e. extreme surface roughening) was discussed as a possible solution to these problems.

Figure 1 - Rills / Gullies on the banks of Robinson Creek, Picture 1.

Figure 2 - Rills / Gullies on the banks of Robinson Creek, Picture 2.

Figure 3 - Rills / Gullies on the banks of Robinson Creek, Picture 3.

Figure 4 - Rills / Gullies on the banks of Robinson Creek, Picture 4.

Figure 5 - Rills / Gullies on the banks of Robinson Creek, Picture 5.

- The bank and slope instability at the Phase I bond release area on the east side of Robinson Creek.
- The regrading of the Excess spoil pile bounded on the North by DD4 and on the South by the haul road.
- Sloping and seeding of B-1 Topsoil Pile.
- Pond 5 emergency spillway sediment control fortification.
- Repairing the emergency spillway damage to Pond 3.
- Regrading ditch B-T1-L to prevent water ponding within its channel.
- Perform maintenance to the underground facilities, including ordering more rip-rap for ditch P10-R04.
- Repair the pipe at the coal wetting water station.
- The safe removal of the unauthorized structure containing petroleum products and water.
- Finishing the reclamation of Robinson Creek, where it enters the permit for the second time.

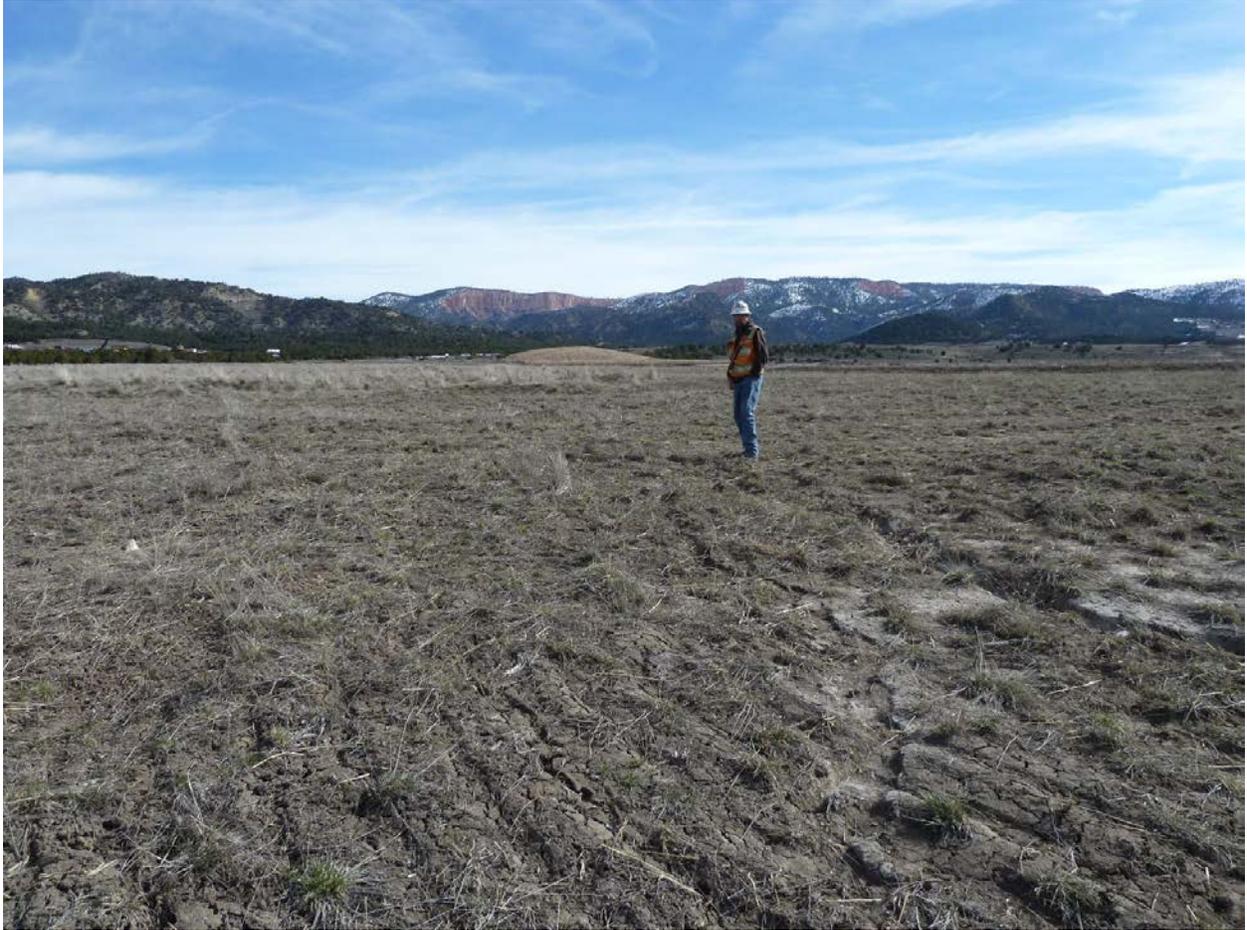
Figure 6 - Rills within the reclaimed land upslope of Robinson Creek, Picture 6.

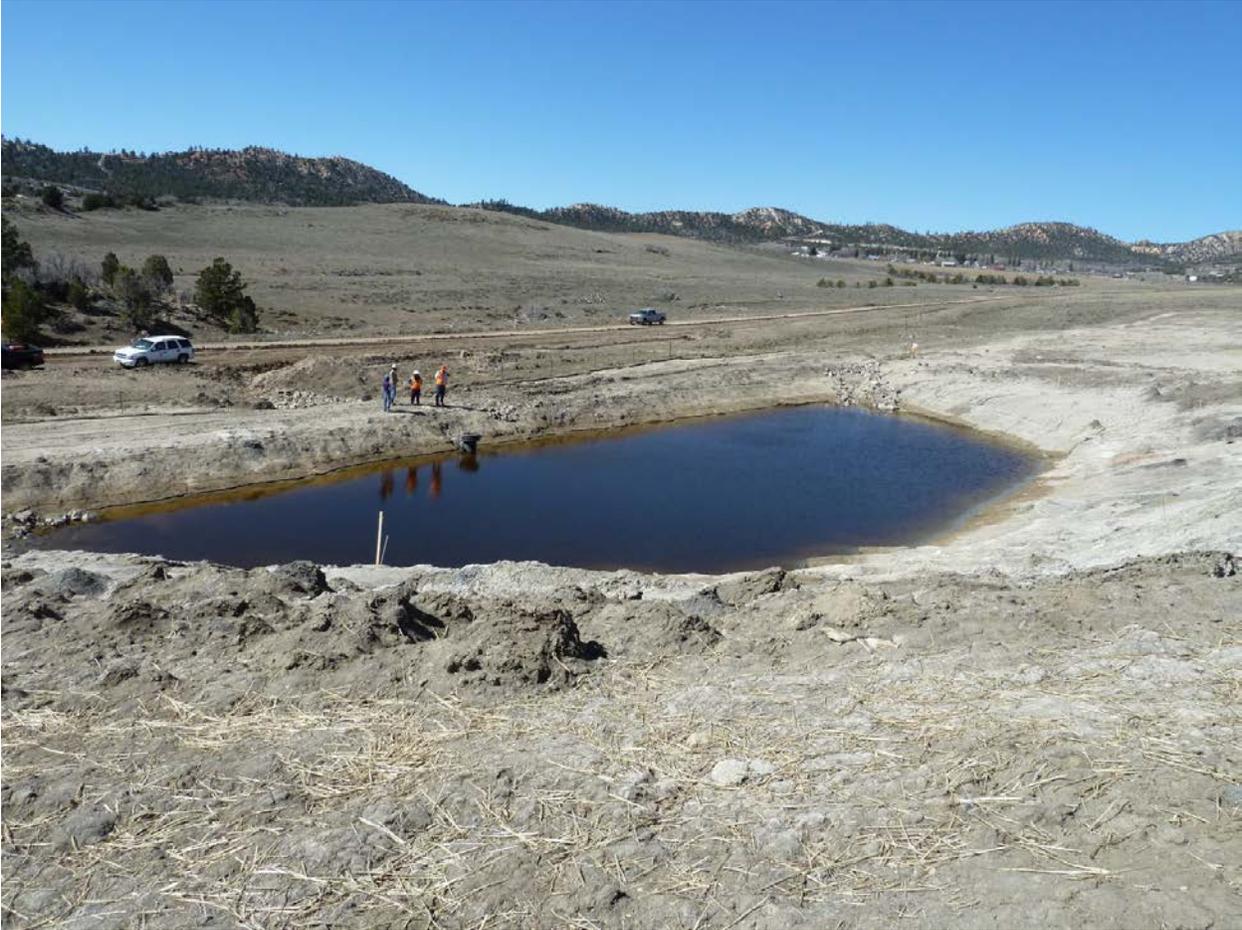
Pond 5 (Figure 7). Keenan Storrar (DOGM hydrologist) spoke to the operator about the high precipitation in the past month which resulted in the emergency spillway discharging water high in TDS. Keenan will follow up with the operator on this issue. This pond also had sediment controls that were overtaken by the high precipitation and subsequent spillway use; of particular note the straw wattles designed to control sediment were clogged with sediment and needed maintenance (Figures 8 and 9). Keenan recommended silt fences, properly installed, to replace these wattles. The operator agreed to fortify this area.

Figure 7 - Pond 5 Overview.

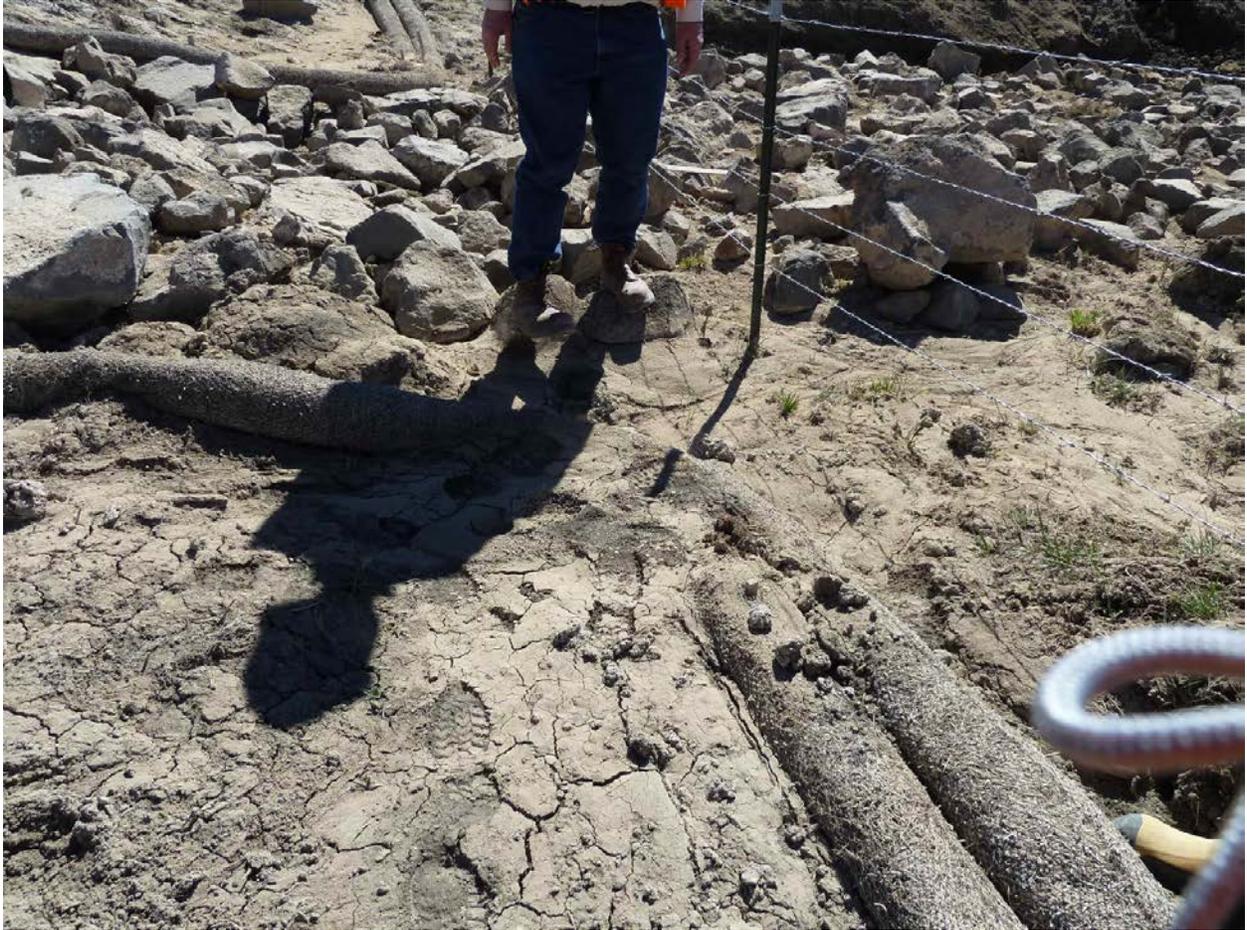
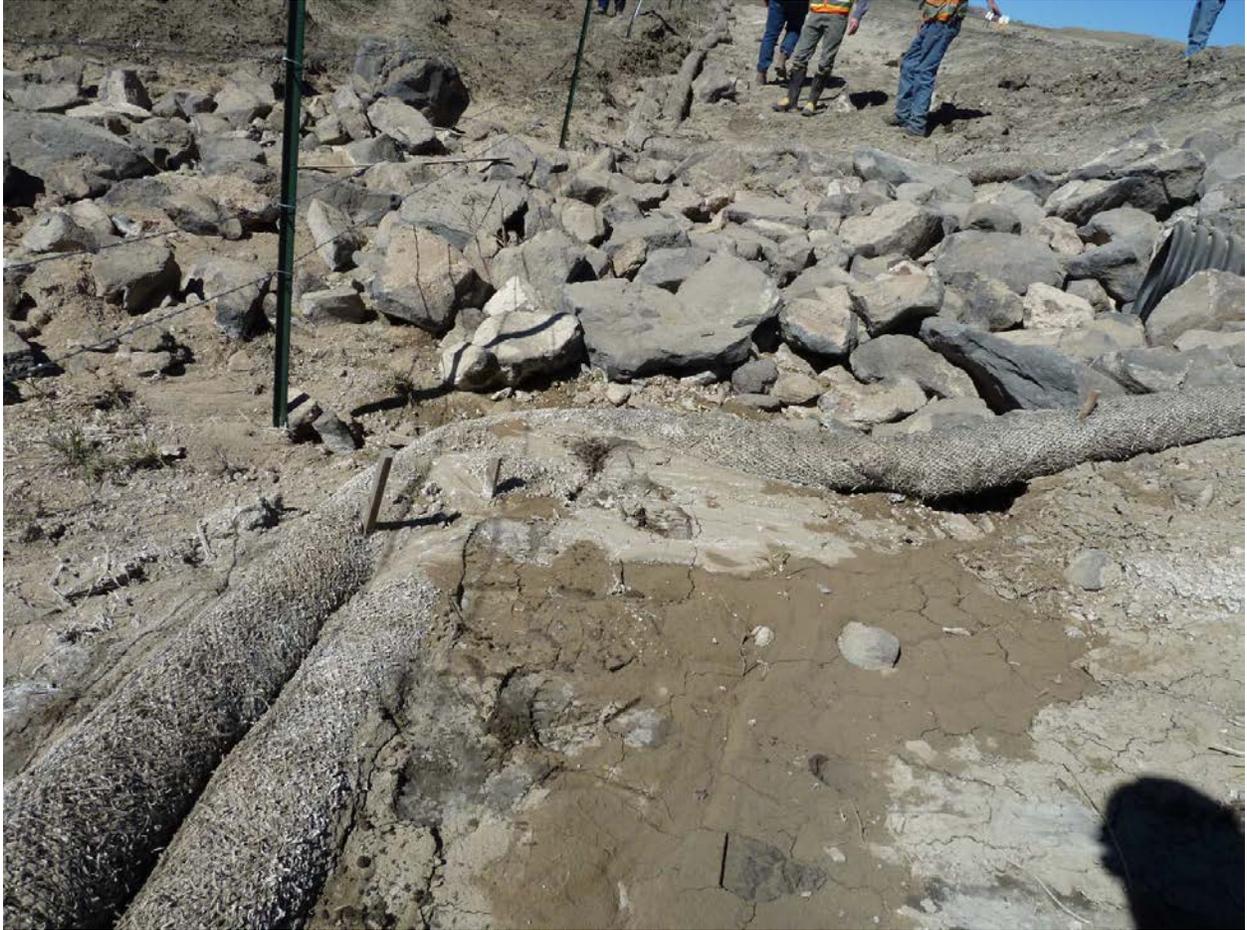
Figure 8 - Pond 5 Emergency Spillway. Straw Wattles overcome with sediment, Picture 1.

Figure 9 -Pond 5 Emergency Spillway. Straw Wattles overcome with sediment, Picture 2.

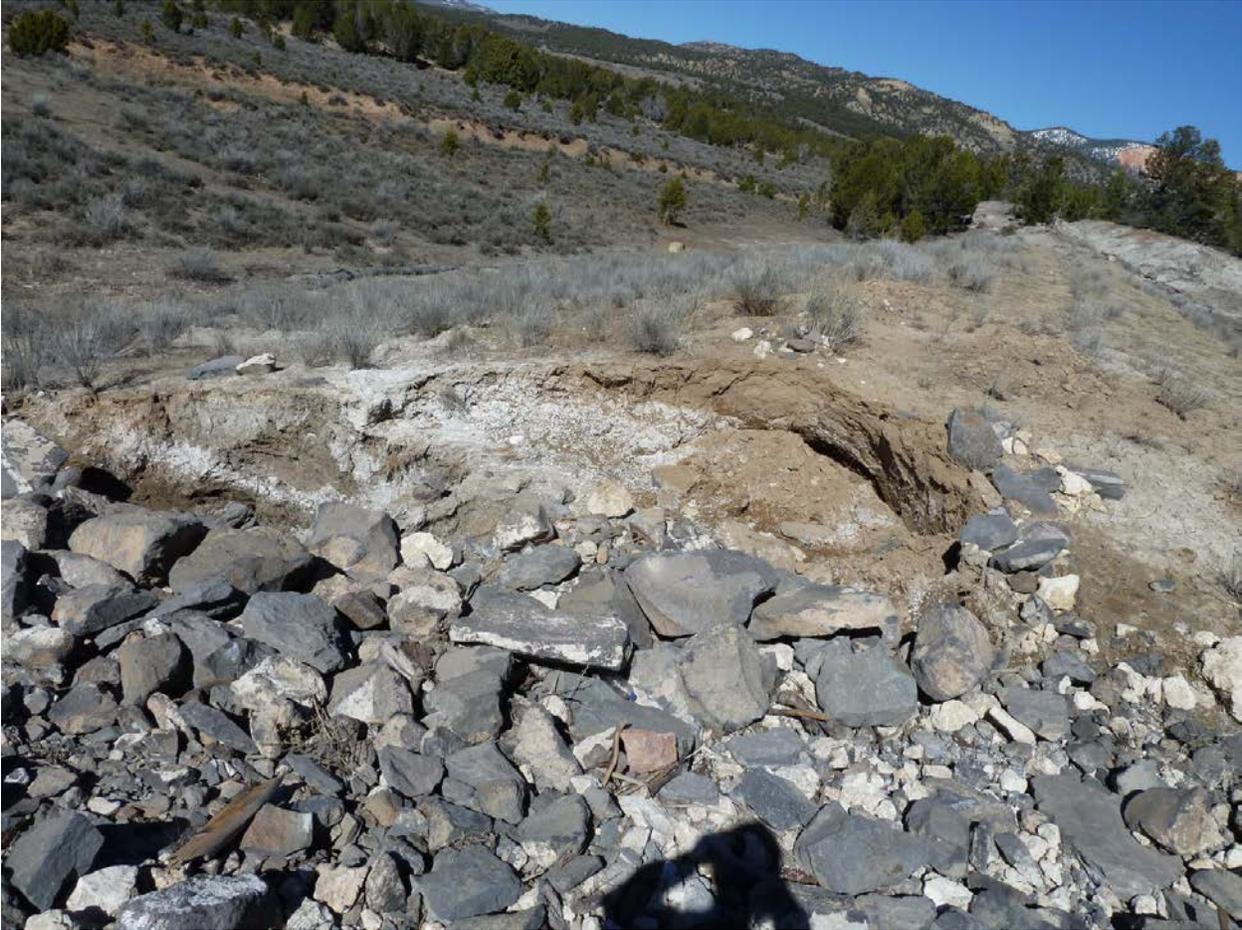
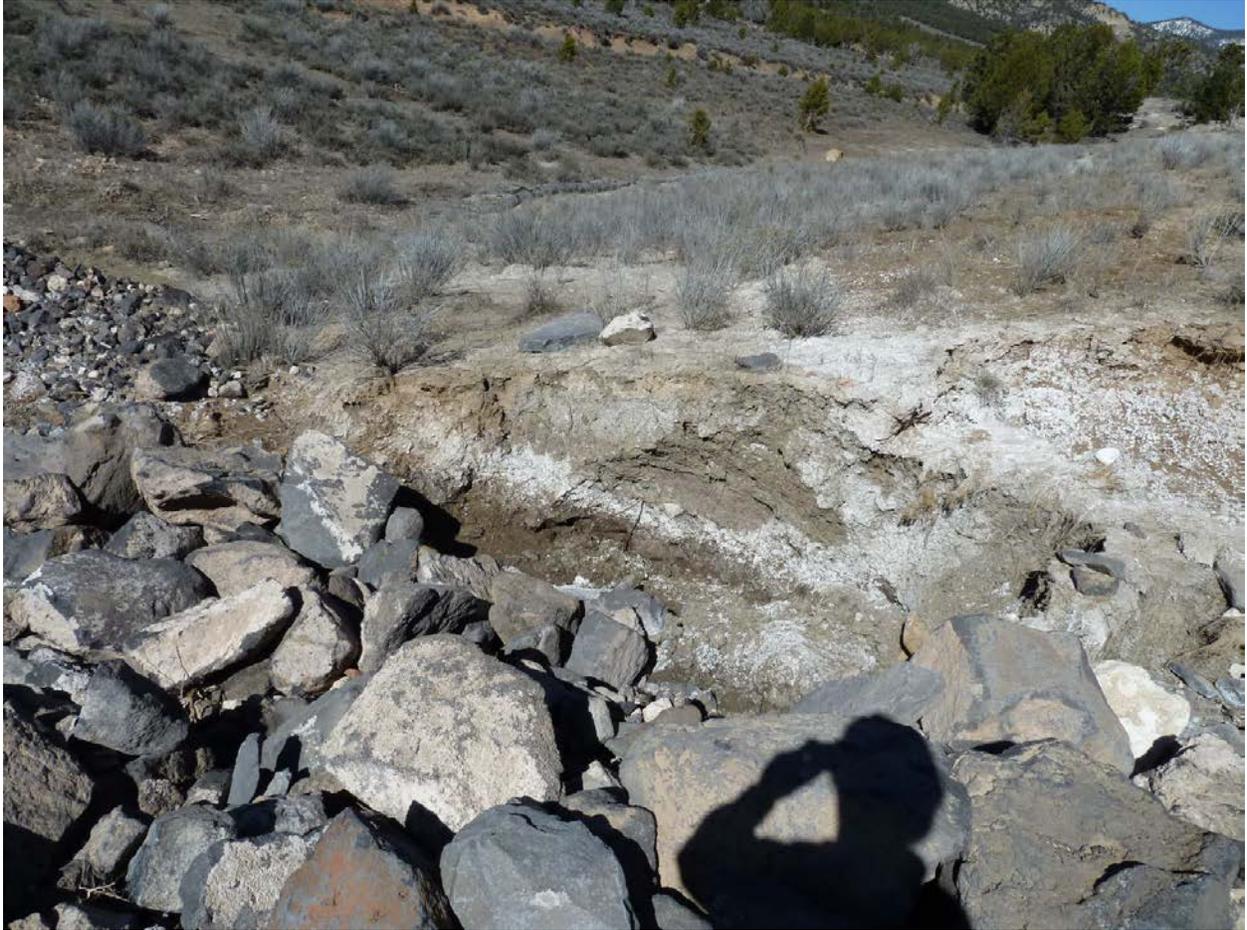
Pond 3. The emergency spillway is failing and damaged due to the high precipitation over the past month or so (Figures 10 and 11). There was significant sidecutting to the spillway. The operator has plans to repair this spillway with rip-rap at the end of March when the area has dried and is stable enough for vehicle traffic. The operator was decanting this pond at about 50 gallons/per minute (estimate produced by the operator, no actual volume measurements were made at the time of this inspection). An unofficial pond has been created (naturally, not through activities by the operator) by the precipitation events of the past few weeks, and it occurs above grade of Pond 3. There are plans for a temporary ditch to be dug so this pond can drain into Pond 3.

Figure 10 - Pond 3 Emergency Spillway Damage, Picture 1.

Figure 11 - Pond 3 Emergency Spillway Damage, Picture 2.

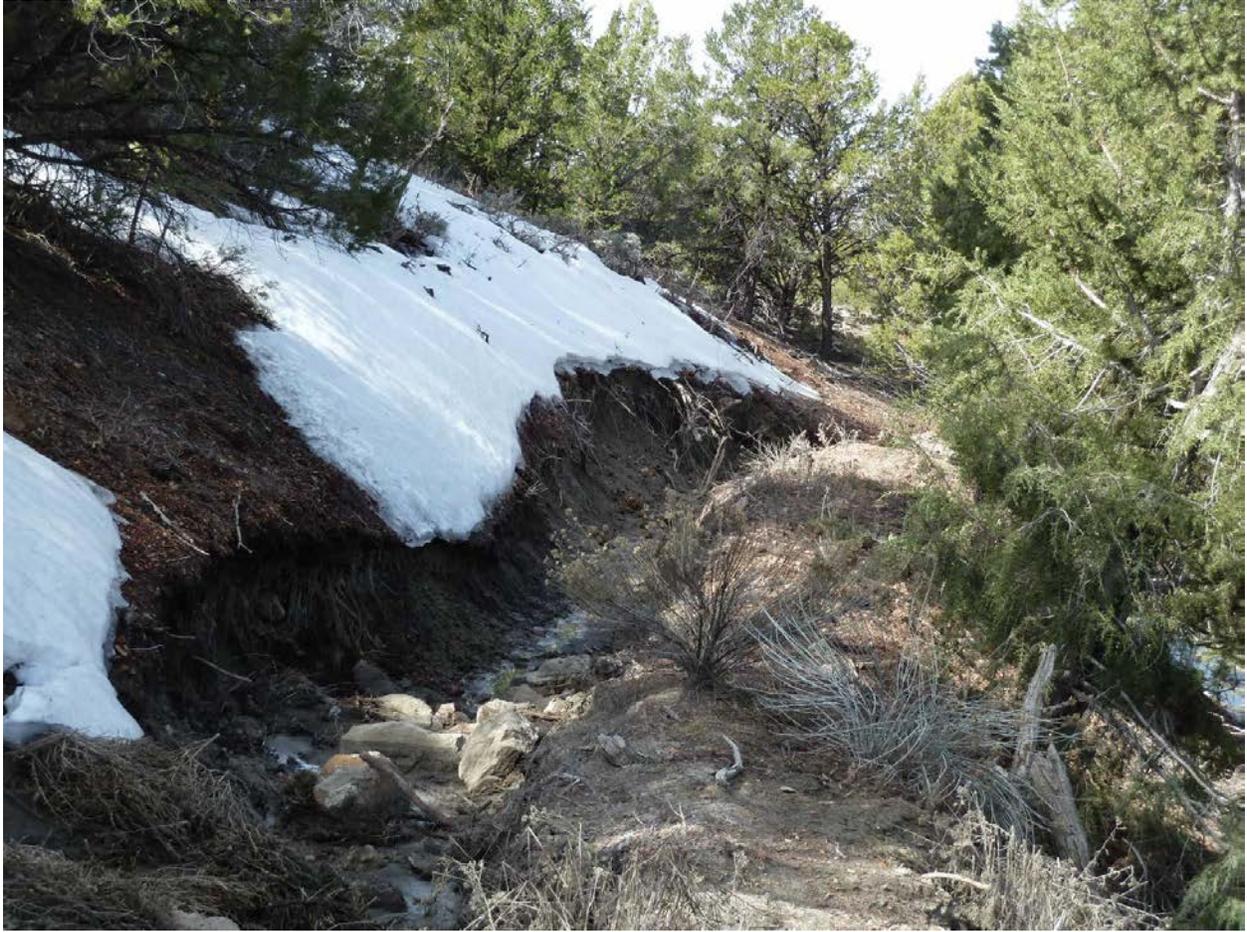
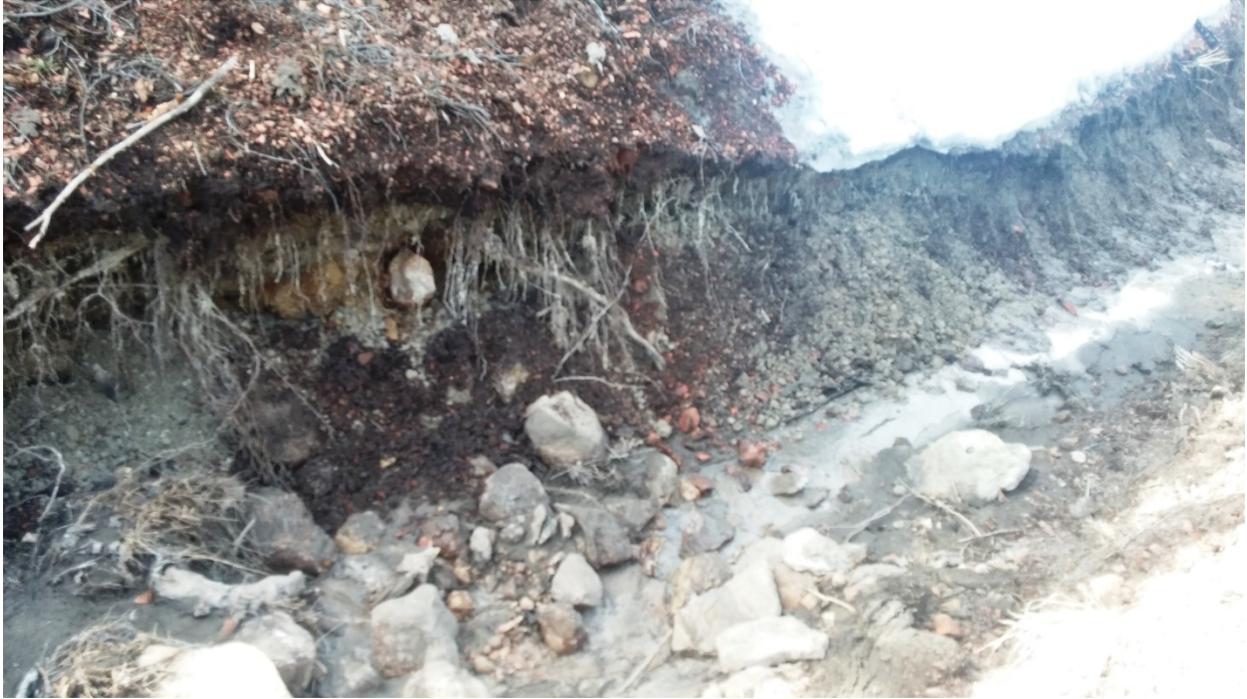
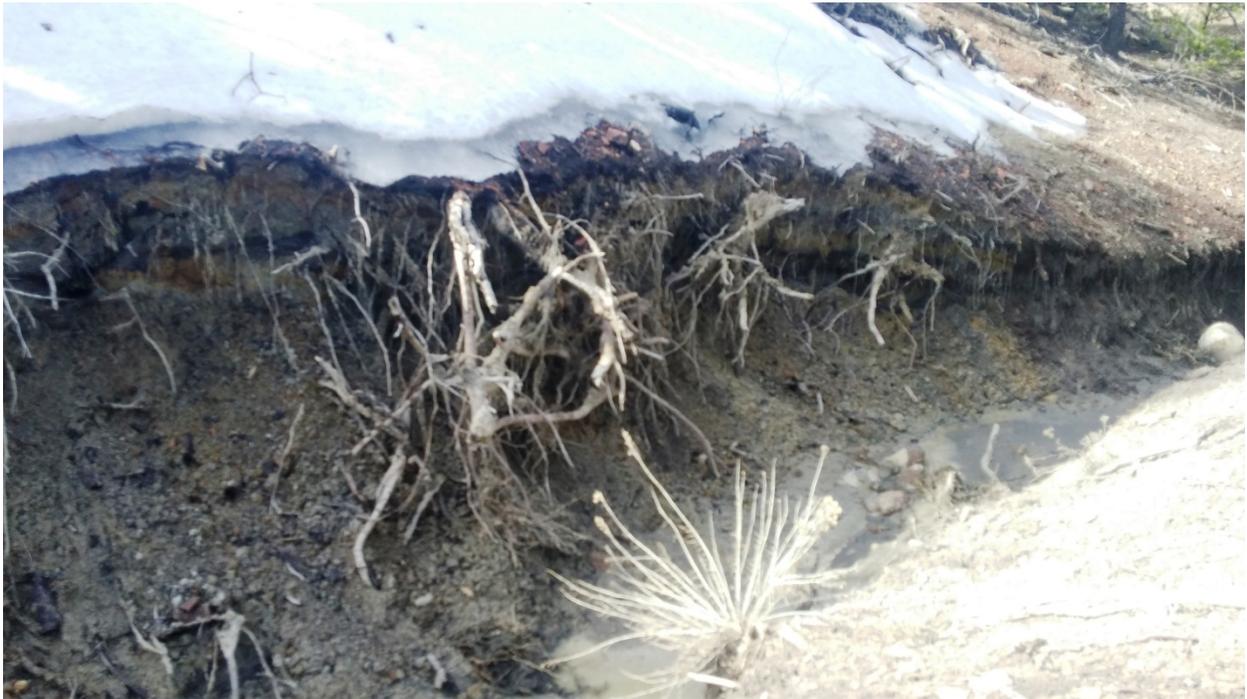
Ditch 4, which runs mostly parallel to Robinson Creek (see the discussion of Robinson Creek below in the Hydrologic Balance Section) appeared to have flow in it recently, but did not at the time of the inspection. During this inspection, no problems were noted with this ditch until it reaches the hill that will be used to fill in Pit 10. The stretch that follows this hill requires some maintenance, as some filling in and other types of erosion have occurred that could effectively block some water flow (Figures 12-14). This stretch of the ditch did not have water flow during the time of this inspection.

Figure 12 - Ditch 4 Condition, Picture 1.

Figure 13 - Ditch 4 Condition, Picture 2.

Figure 14 - Ditch 4 Condition, Picture 3.

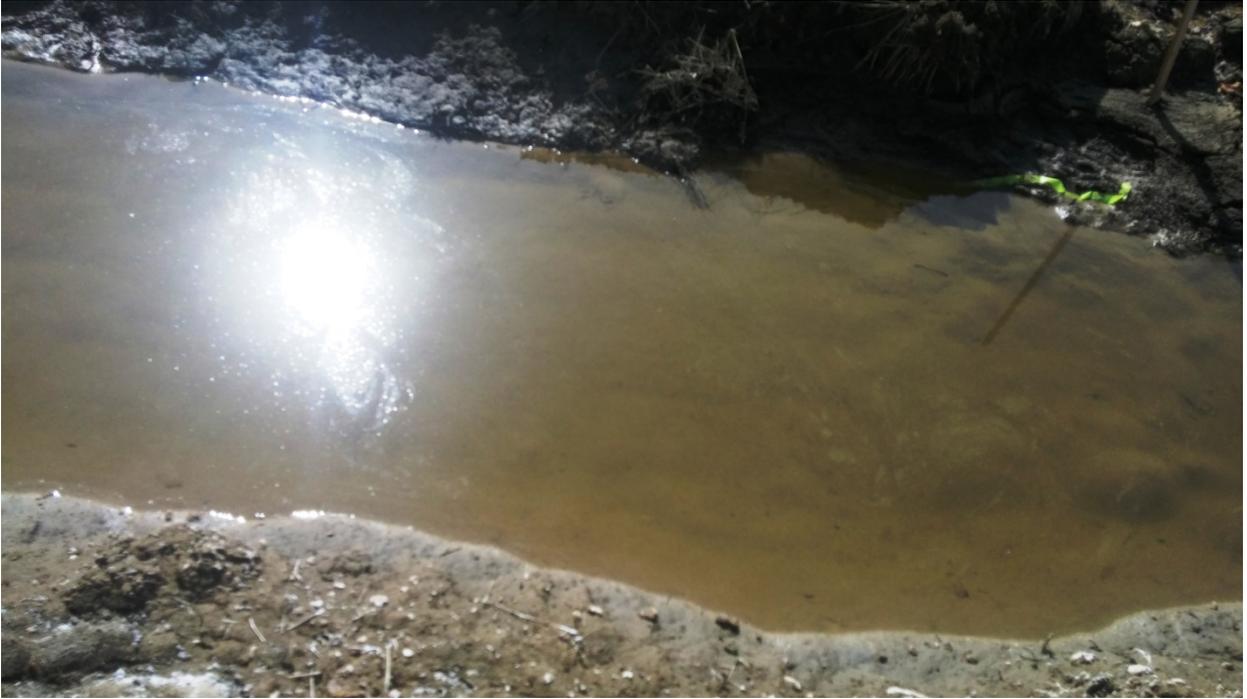
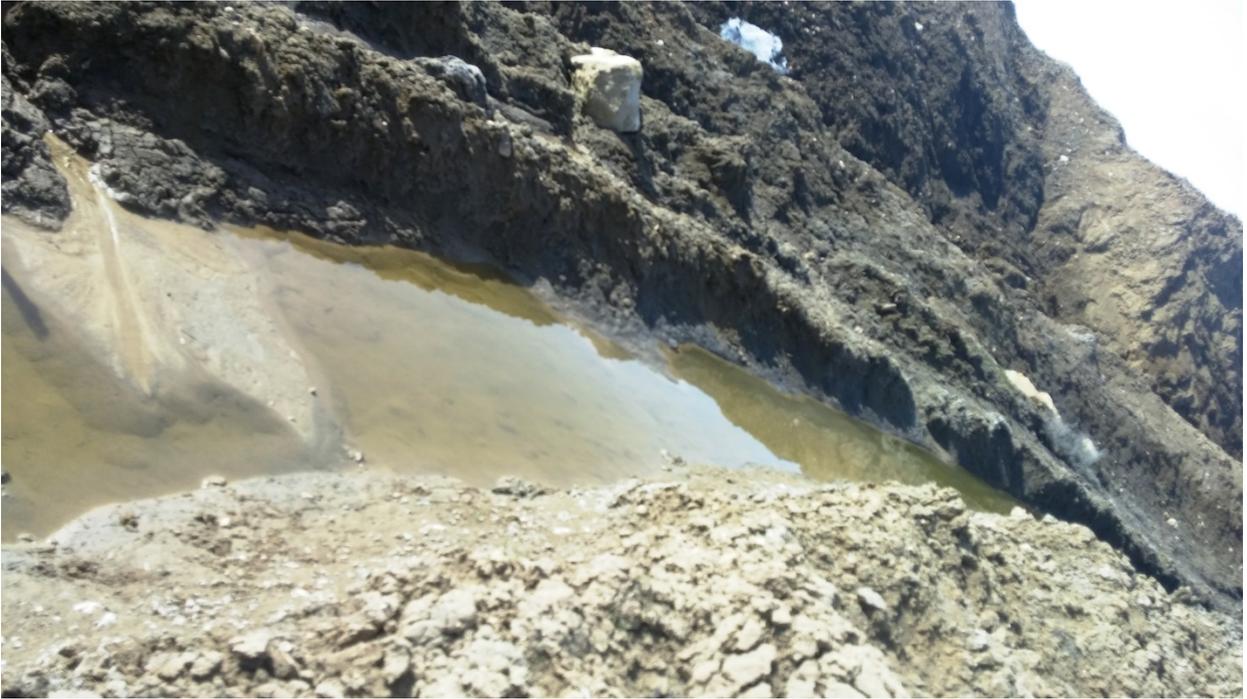
Ditch B-T1-L has some ponded water, which should not occur, so some maintenance here to reestablish grade and flow into Pond 3 is required (Figures 15 and 16). The land above grade also appears to be saturated, therefore better drainage should be established in this area. The operator agreed to this repair.

Figure 15 - Pondered water at B1-1T Ditch, Picture 1.

Figure 16 - Pondered water at B1-1T Ditch, Picture 2.

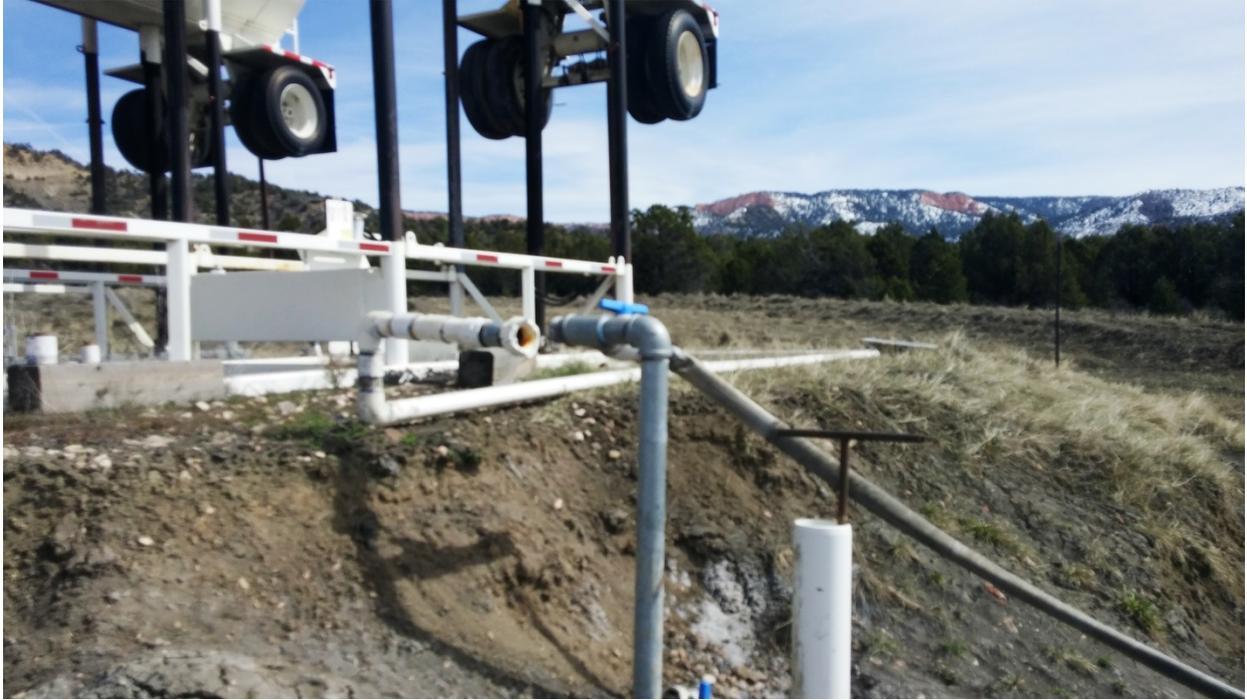
The permitted chemical storage facilities appeared to be functioning as designed. No spills were observed at the time of this inspection at this location. A pipe at the coal wetting water station was broken; this should be repaired in time to fulfill the needs of coal processing when drier times are present (Figure 18). The operator stated that the repairs are planned.

Figure 18 - Broken pipe at the coal wetting station.

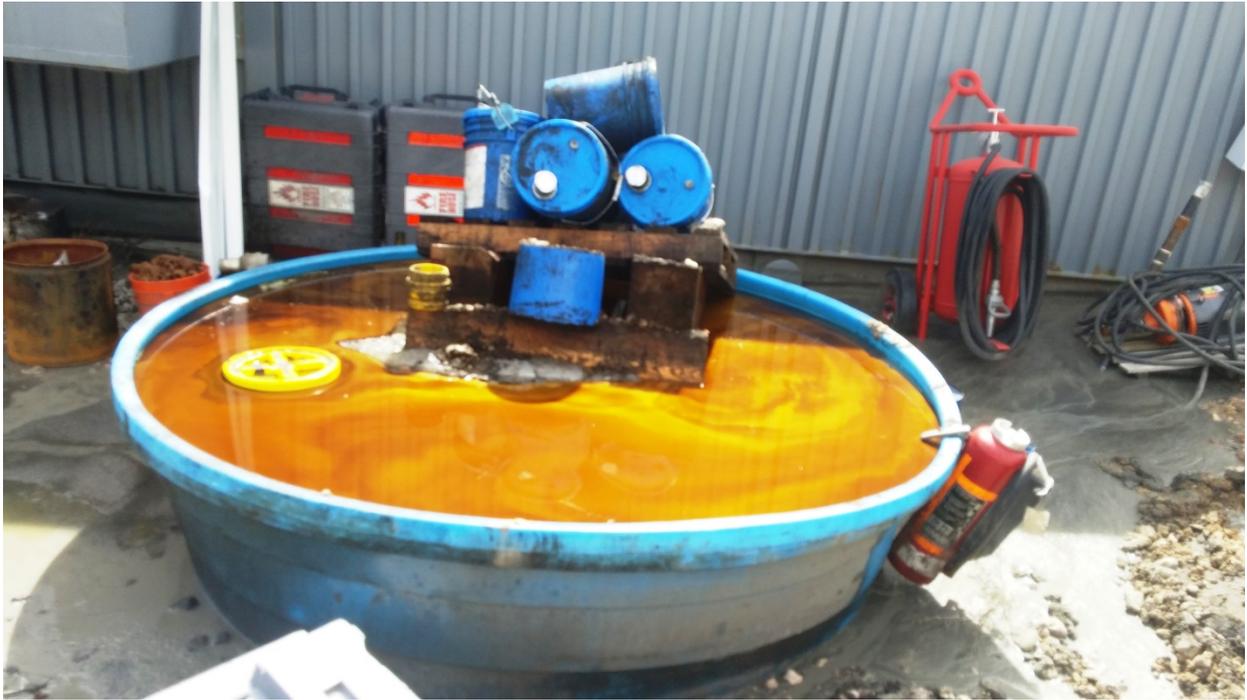
Underground Pit. What appeared to be an open-air livestock watering tank was used as a secondary containment for some petroleum product; this product had spilled into the secondary containment and the tank was nearly full, potentially leaking hazardous liquid onto the pit floor (Figure 19). According to the DOGM inspector, this is not a permitted storage/containment structure or location, and the safe removal of this tank and its contents are of primary importance to the safety of this area and the groundwater to which it contributes. In addition, the water collection tank from the underground pit area showers is in need of emptying (Figure 20).

Figure 19 - Stock tank filled with water an unknown petroleum product.

As a result of this inspection, DOGM issued 2 Notices of Violation (NOVs), one for failure to store oil and grease in a controlled manner in a designated area of the permit area, per the Spill Prevention Control and Countermeasure (SPCC) Plan, and another for failure to maintain siltation structures and diversions at the underground mine. OSMRE supports these NOVs.

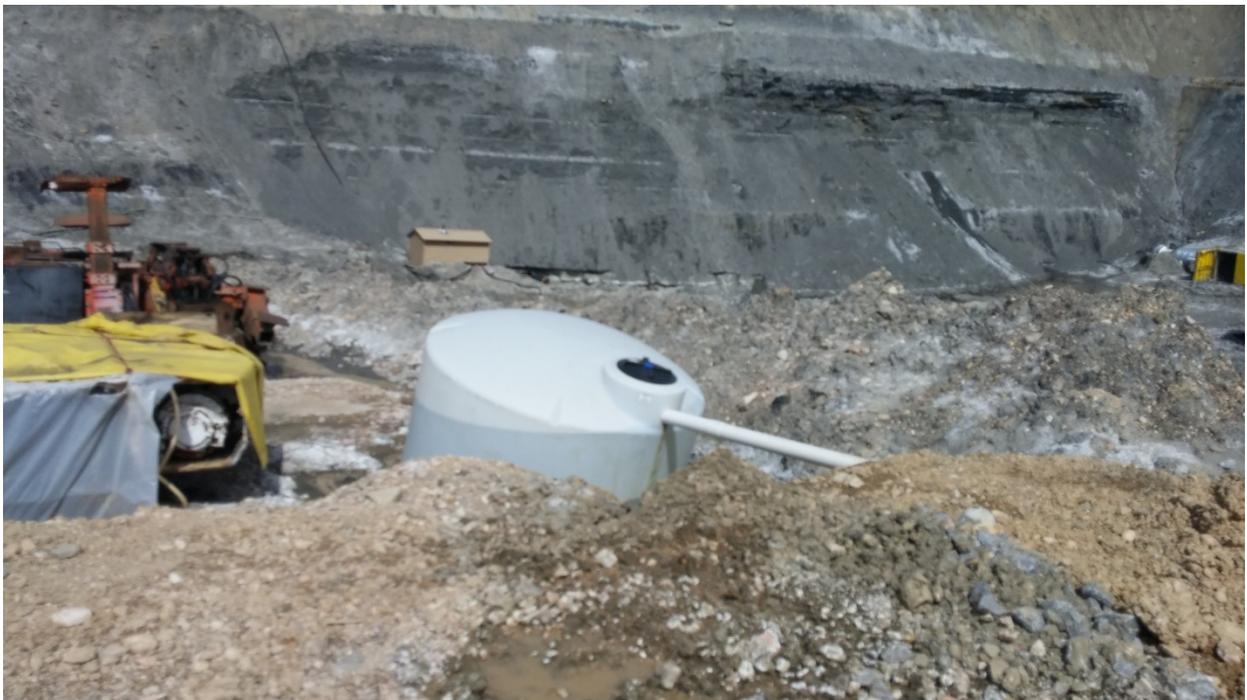
Figure 20 - Shower wastewater containment tank full.
