**U.S. DEPT. OF THE INTERIOR
OFFICE OF SURFACE MINING
Mine Site Evaluation
State Program**

MINE SITE INSPECTION NARRATIVE

COMPANY: ALTON COAL DEVELOPMENT LLC

MINE: Coal Hollow

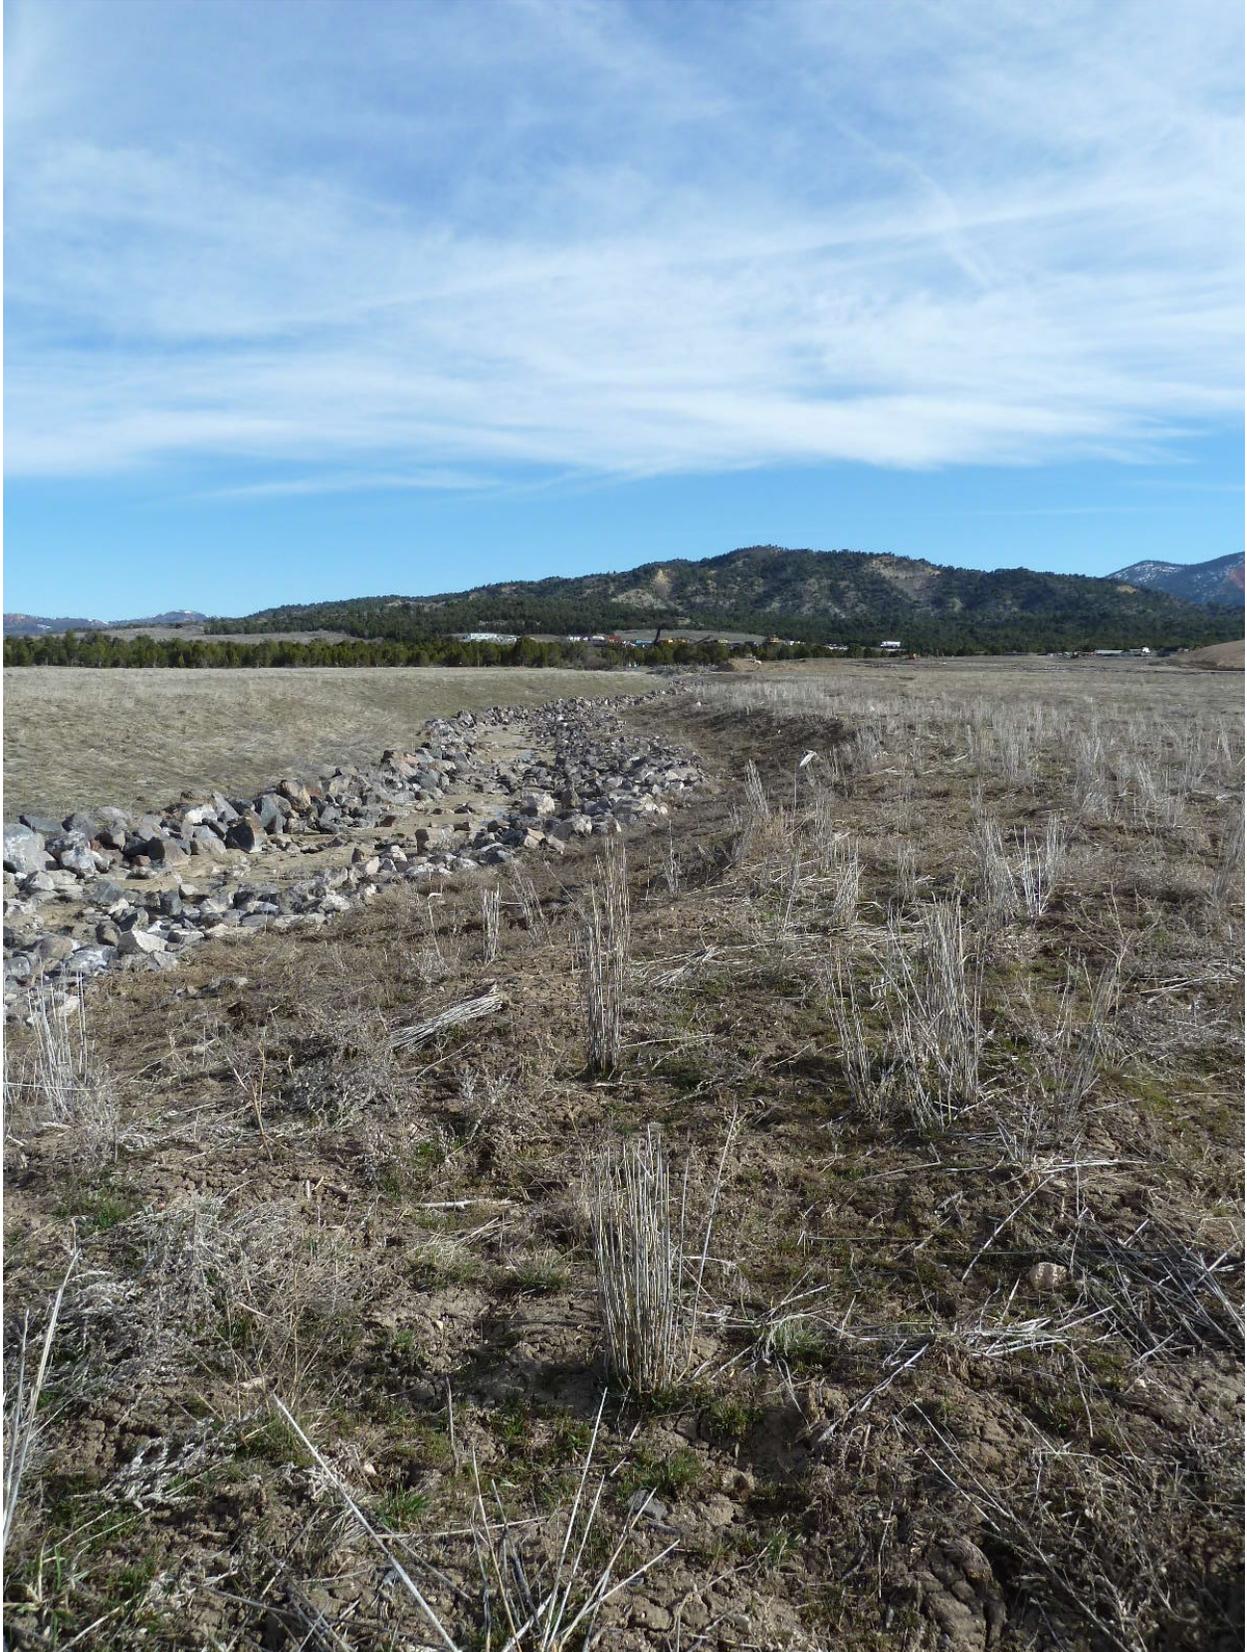
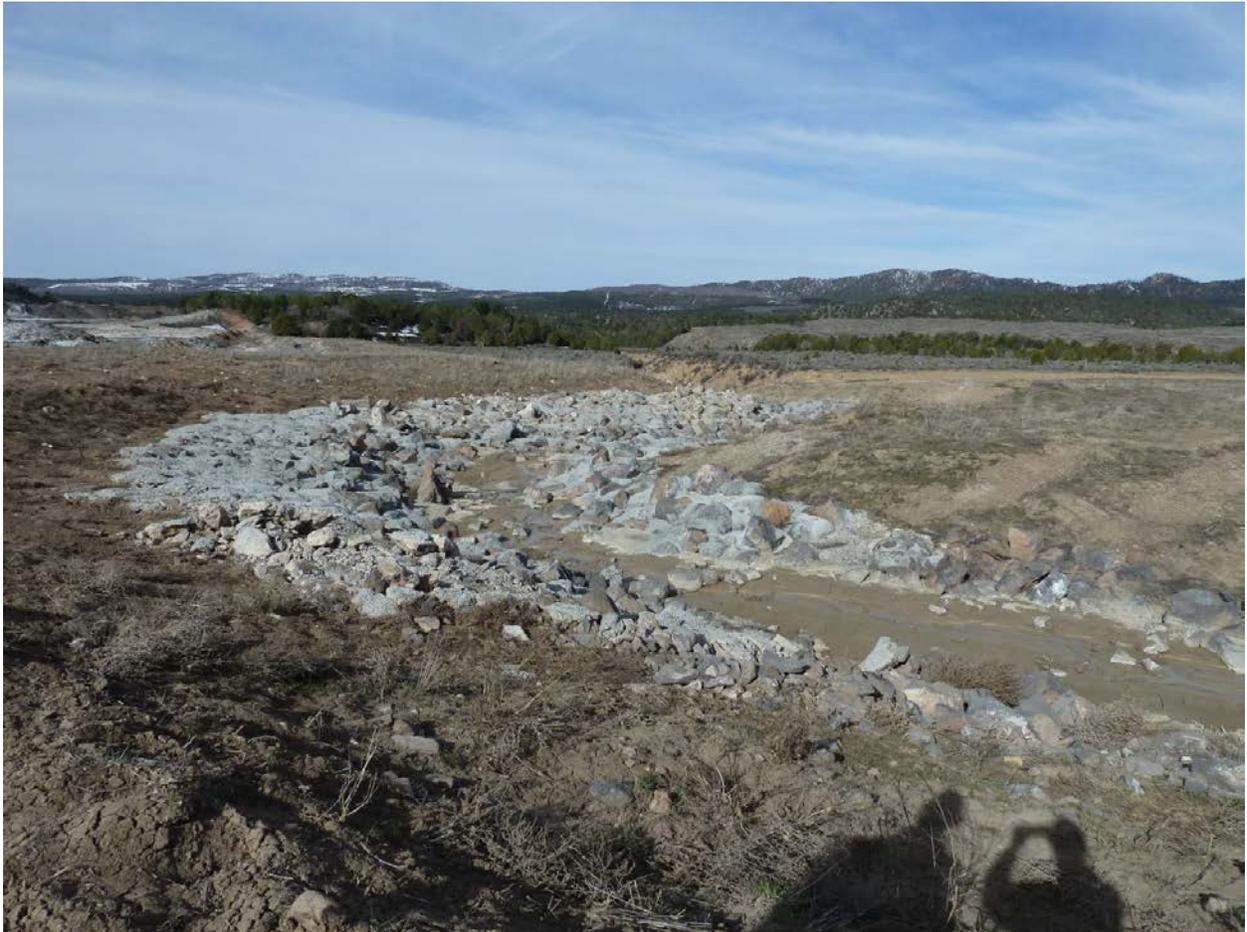
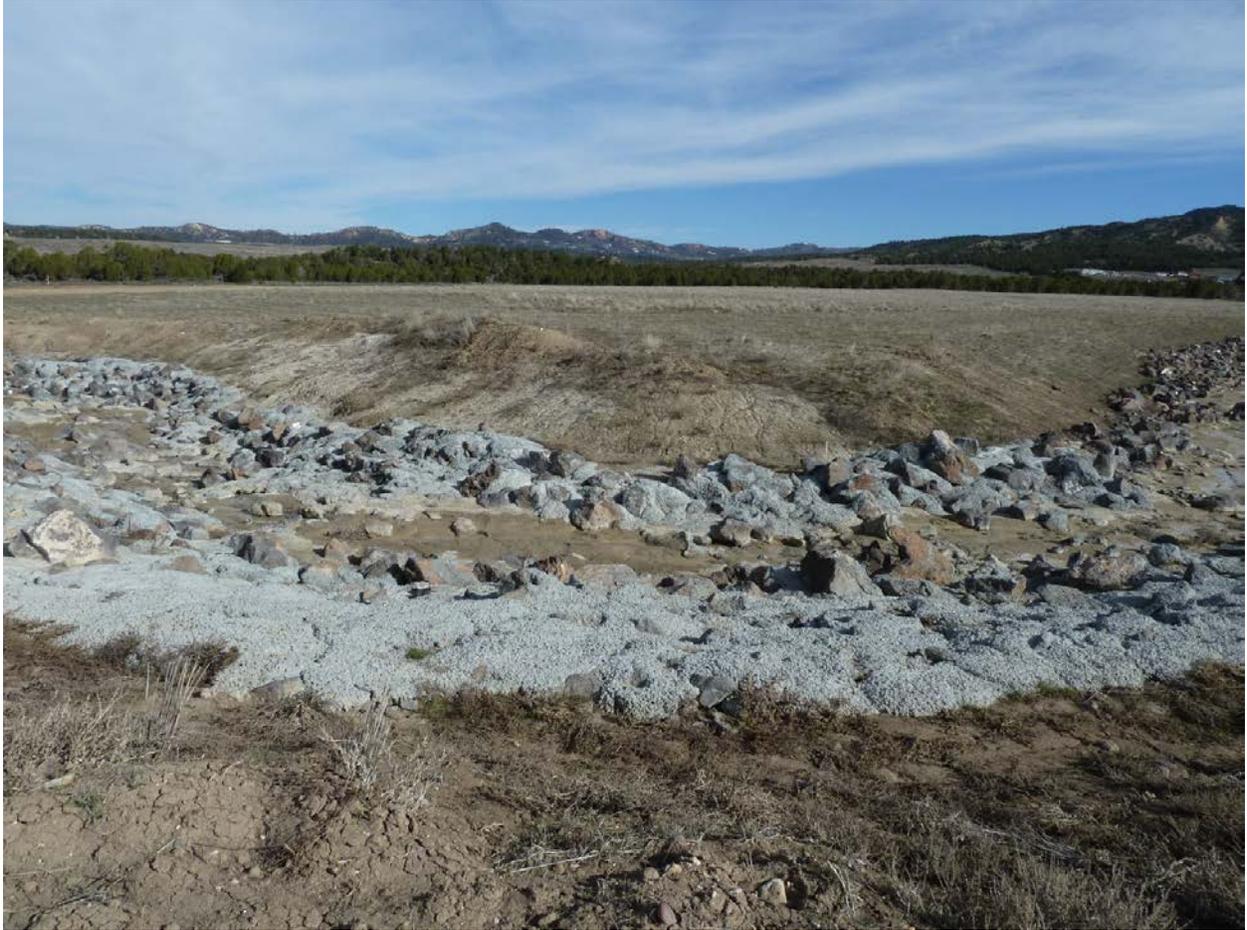
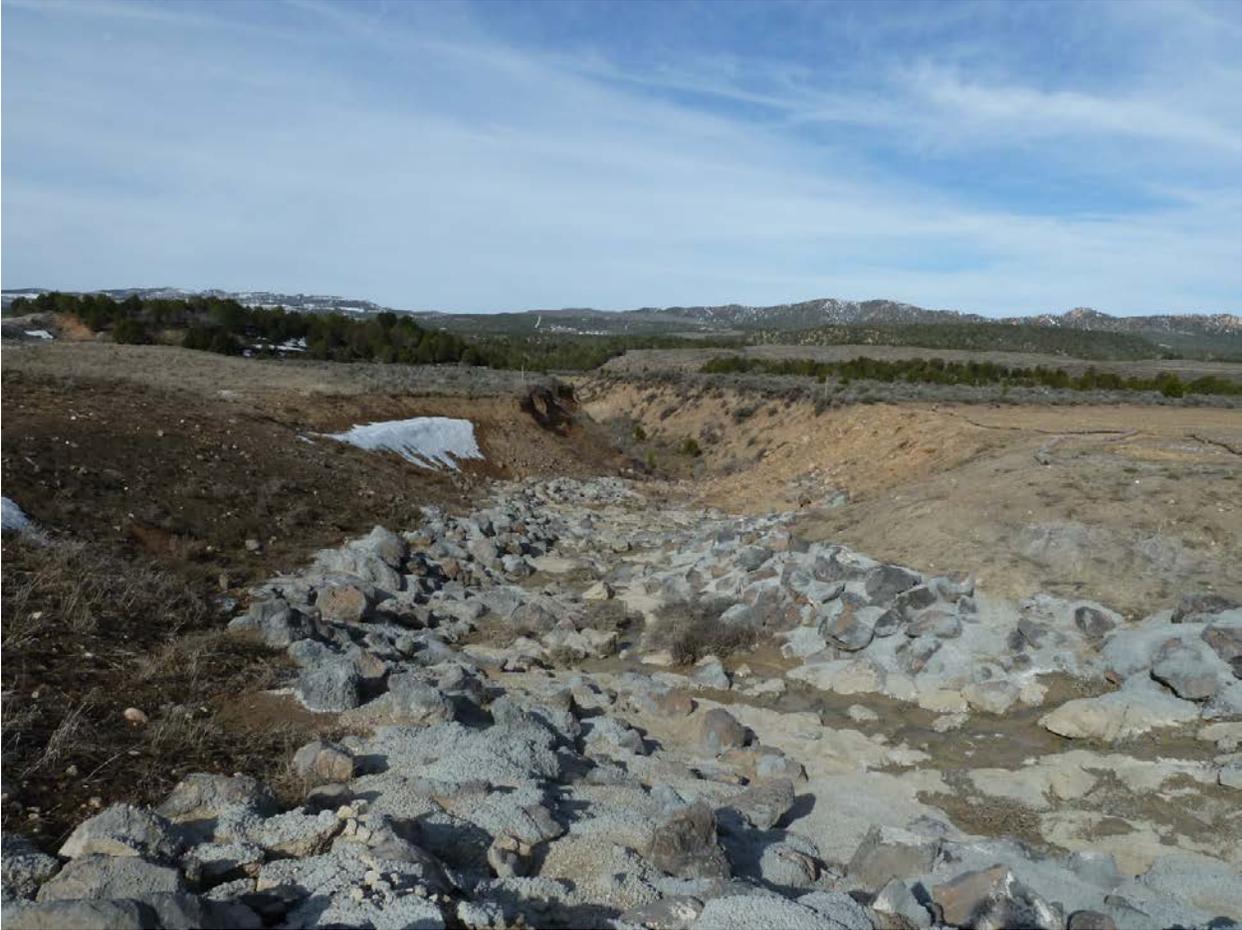
Robinson Creek. Water was flowing through the permitted area in the reconstructed portion of this creek, where the creek enters the permit for the second time. Some work still needs to be done at this site to complete the reconstruction; for example, rip-rap still needs to be installed in a section. The operator agreed that the site is dry enough for work at this location. As the creek proceeds through the permitted site, a small amount of water was flowing through it at the time of this inspection. No flow measurements were made during this inspection. Up until the section where the creek bends dramatically, and where the operator used shotcrete to stabilize the creek bank was stable, and appeared to be functioning as designed with no significant bank erosion (Figures 21-24). The section that has been shotcreted also appears to be functioning as designed.

Figure 21 - Functioning section of the redesigned Robinson Creek, Picture 1.

Figure 22 - Functioning section of the redesigned Robinson Creek, picture 2.

Figure 23 - Functioning section of the redesigned Robinson Creek, picture 3.

Figure 24 - Functioning section of the redesigned Robinson Creek, picture 4.
