WATER QUALITY MEMORANDUM

Utah Coal Regulatory Program

RE: Third Quarter 2016 Water Monitoring, Alton Coal Development LLC, Coal Hollow, C/025/0005, Task ID #5320

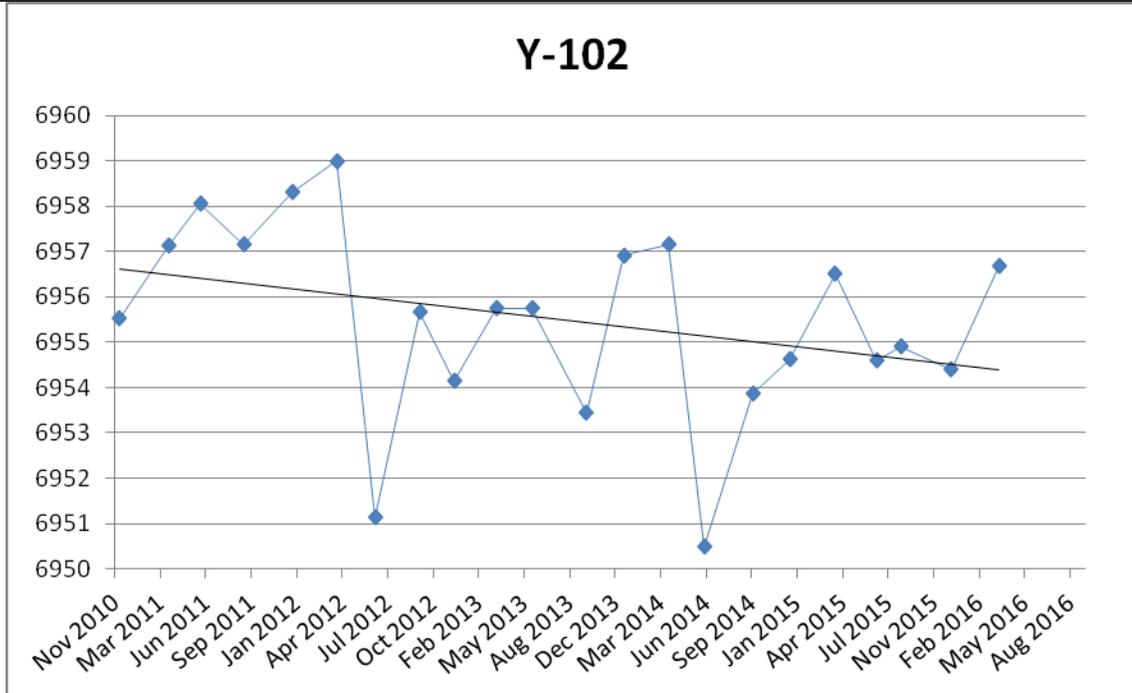
Well 102 is on a downward trend. These levels are probably dropping because the mine's production well is pumping just up-gradient (Figure 1).

Figure 1. Well Y-102: Alluvial well in upper Sink Valley to the east of pit 9 in permit area. Graph will be updated for 2016 Q4 following installation and analysis with AqQA software.

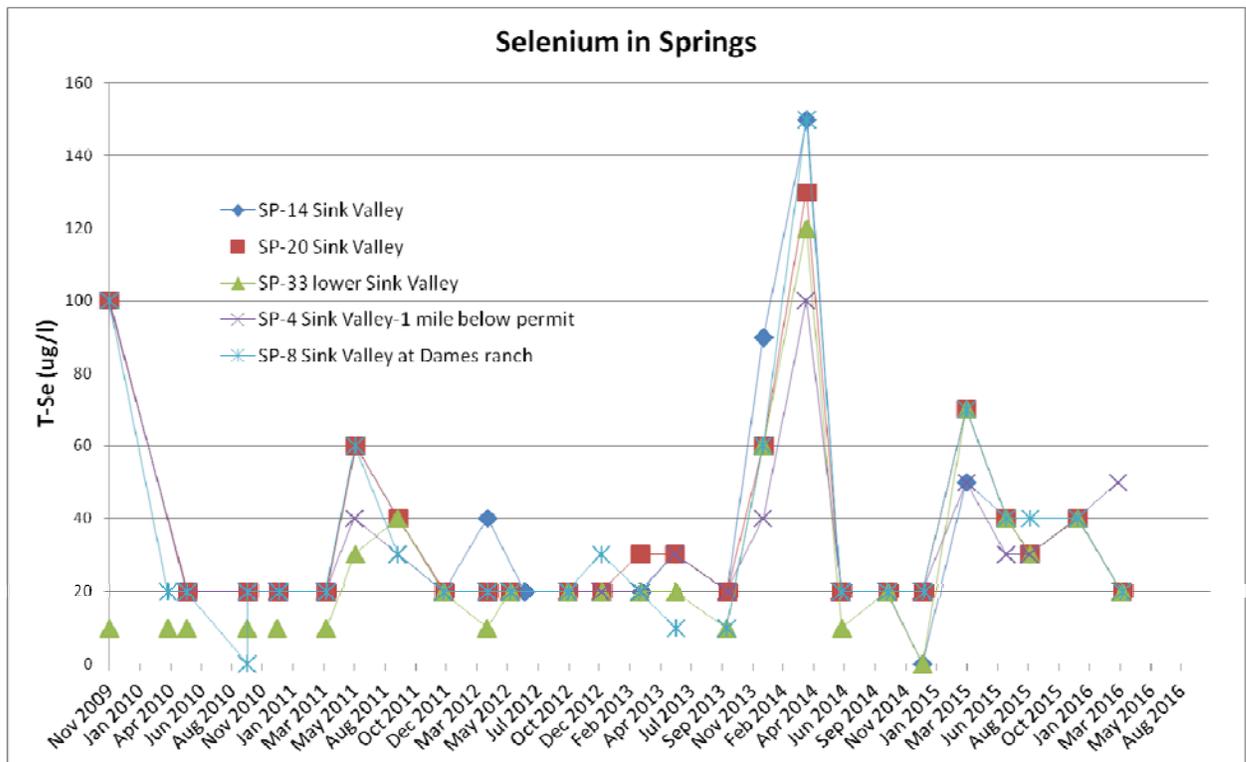
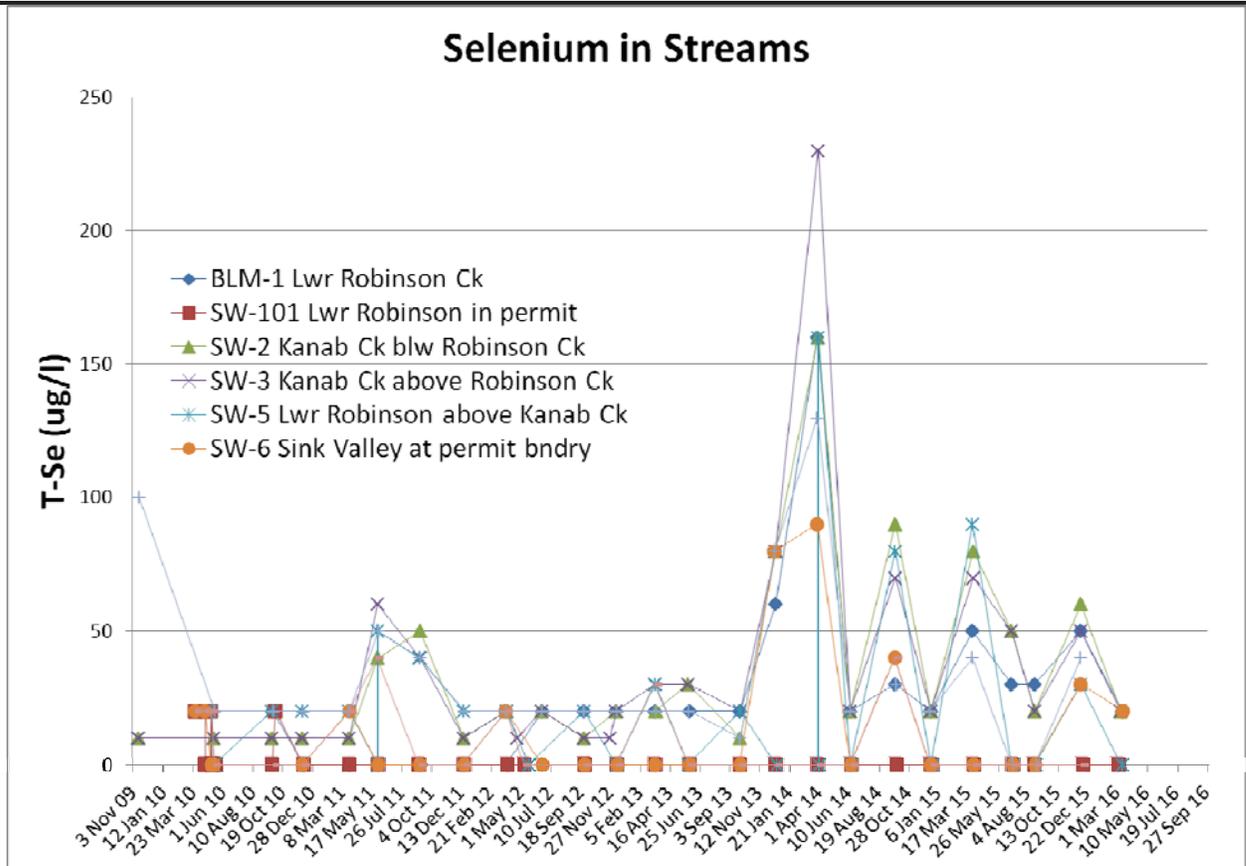
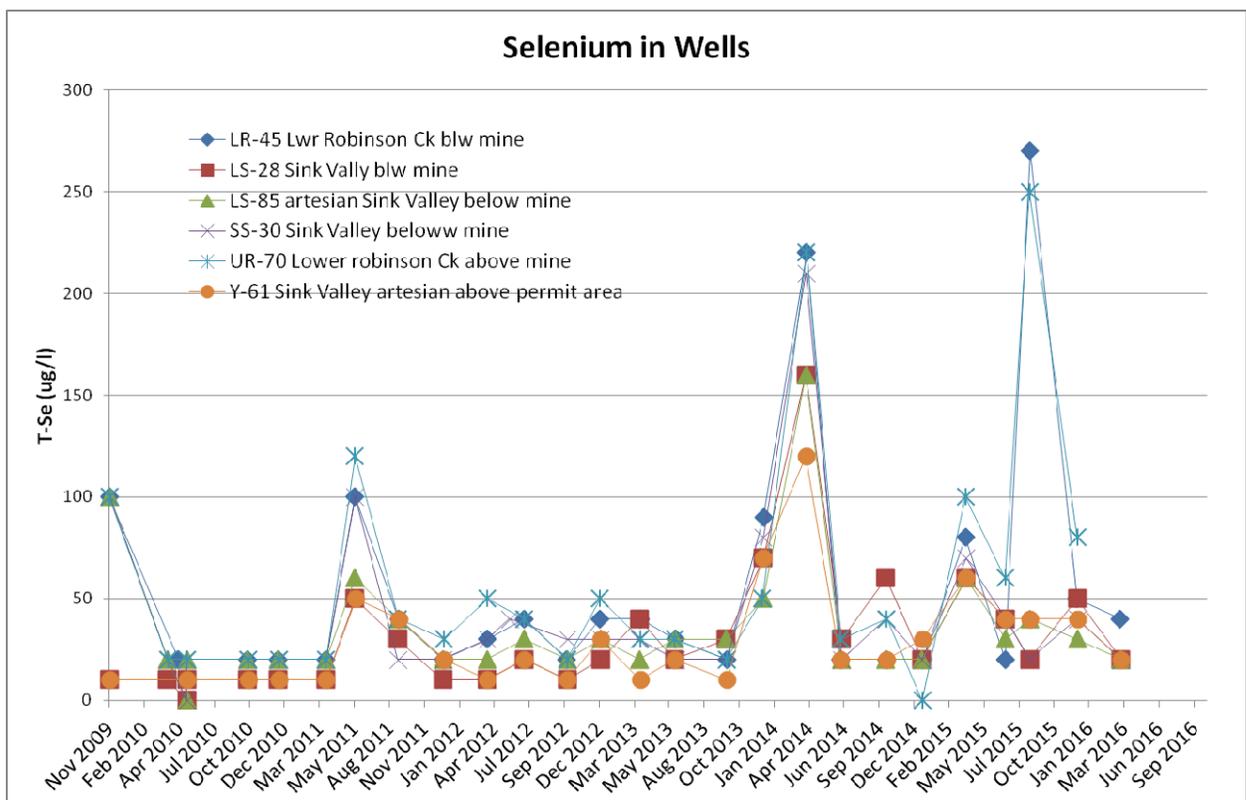
There have been significant spikes in T-Se in the past few years (see Figure 2). Chemtech-Ford has difficulty processing Selenium when samples are murky. In an effort to process murky samples they dilute samples X5 raising the detection limit to <100.

Figure 2. Elevated Selenium levels at Spring, Stream, and Well locations through Q1 2016. 20 ug/l and below on the y-axis is the ND limit for measuring Selenium. Graphs will be updated for 2016 Q4 following installation and analysis with AqQA software.

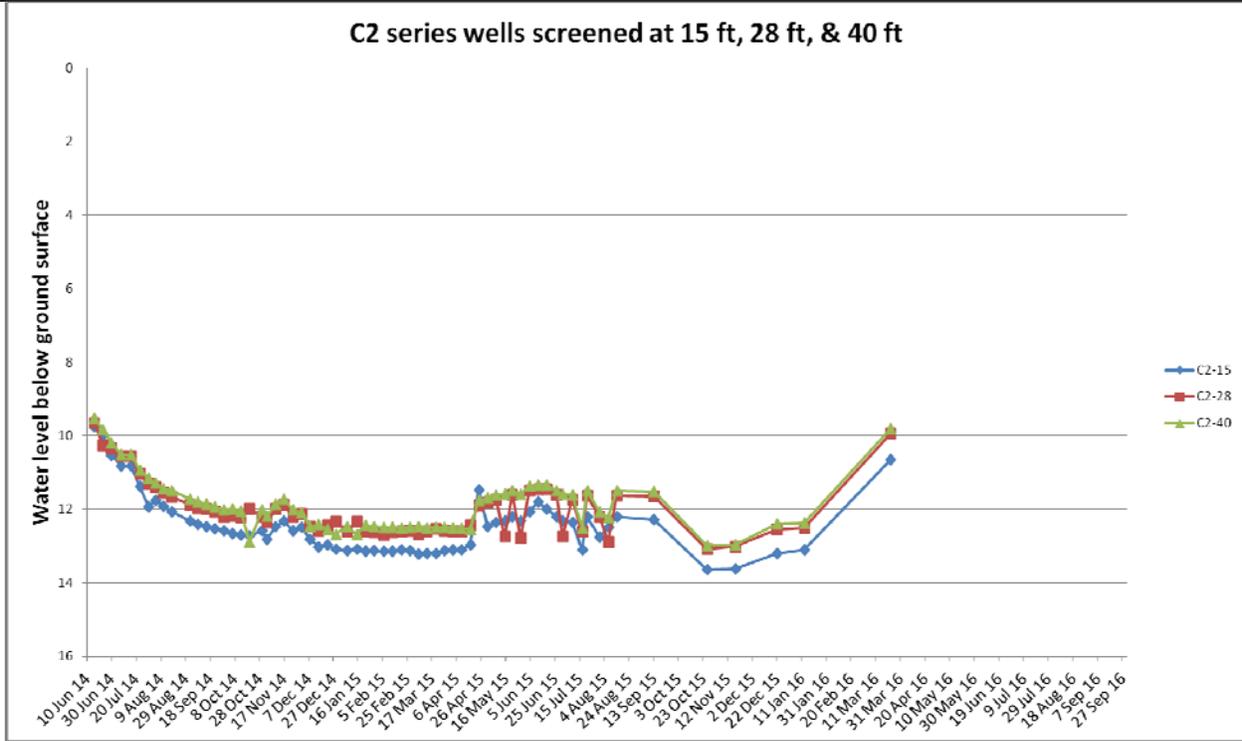
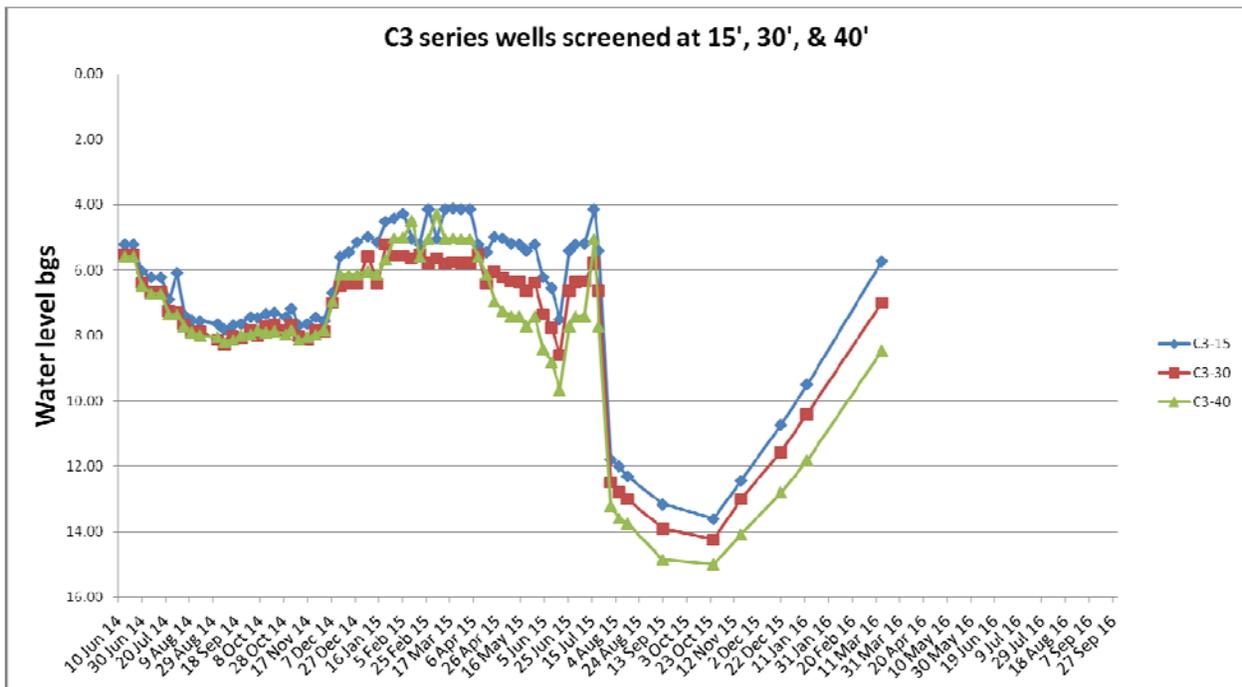
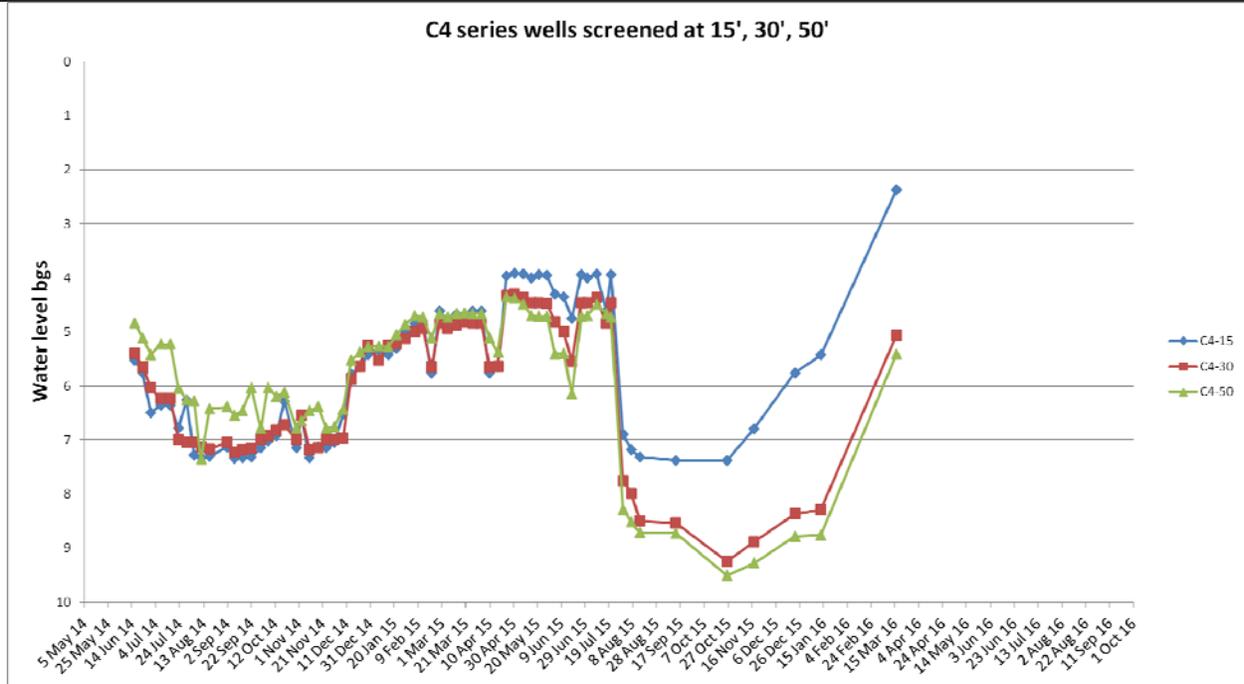
Highwall Trench 2 up-to-date status of wells C-2, C-3, C-4

The C-2, C-3, C-4 fluctuated in response to development and backfilling of HWT 2. See the graphed levels at the end of this report.

These wells saw a dramatic drop as groundwater drained uncontrollably west into HWT 2 when it was open. Now HWT 2 has been backfilled water levels appear to be stabilizing and recovering. There has been a rapid recharge as seen in the Q12016 levels. This recharge is most likely attributed to dewatering HWT 2 and using the water to irrigate the field in front of Dame's home which is upgradient of these wells.

Division Order: A division order will be written to install a well in the deepest backfill of HWT2. This well will monitor the resaturation of the backfilled area. According to the Permittee's commitment in Appendix 7-1 the PHC must be updated regarding the fall in water levels and to estimate the re-saturation time of the backfill (this will likely be on the order of decades to +100 yrs).
