**Citation for Non-Compliance
Utah Coal Regulatory Program**

Inspection Report

Permit Number:	C0250005
Inspection Type:	COMPLETE
Inspection Date:	Tuesday, March 14, 2017
Start Date/Time:	3/14/2017 12:30:00 PM
End Date/Time:	3/15/2017 5:00:00 PM
Last Inspection:	Wednesday, February 22, 2017

Photo Attachment
Inspection Report #5803
March 14-15, 2017

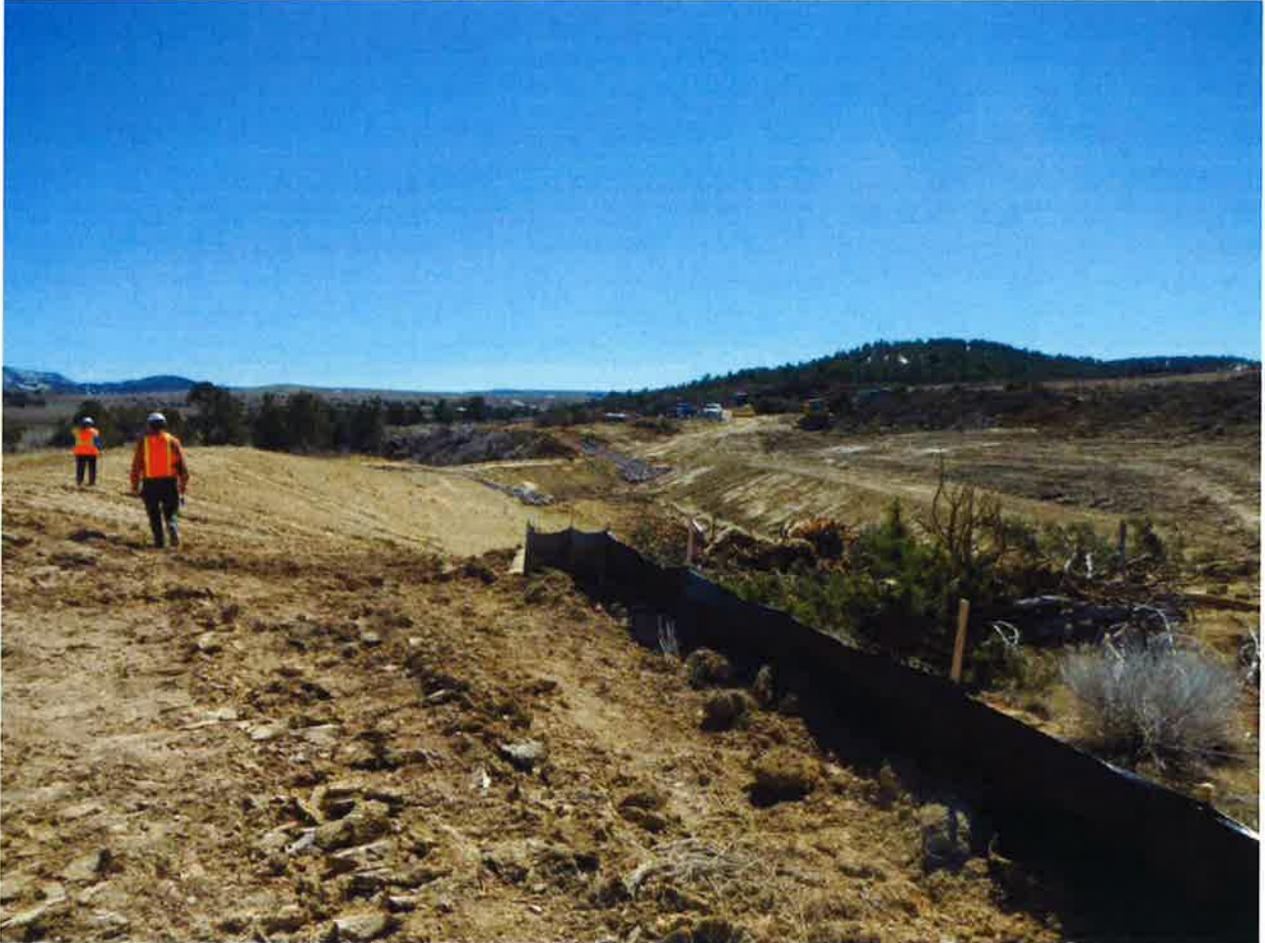
Looking South at Pond T1 and spillway (center). DD T1-01 inlet on left (East) side.
Topsoil salvage on right (West) side.

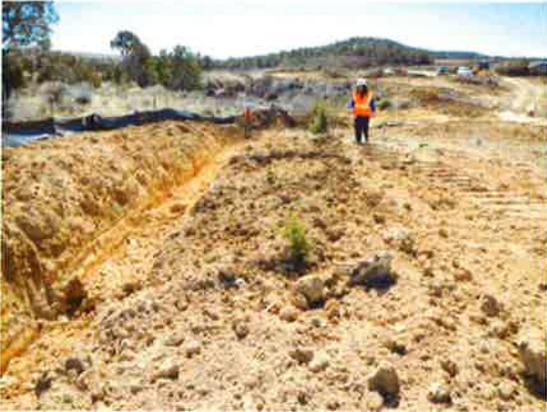
Looking S at ditch T1 cut into subsoil, place excelsior logs.

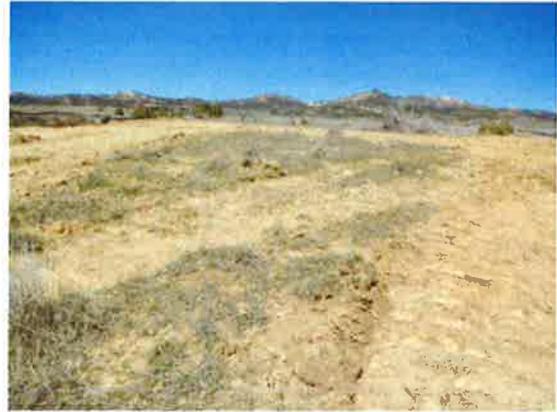
Map Unit G topsoil not removed from East side pond T1. Place excelsior log at toe.

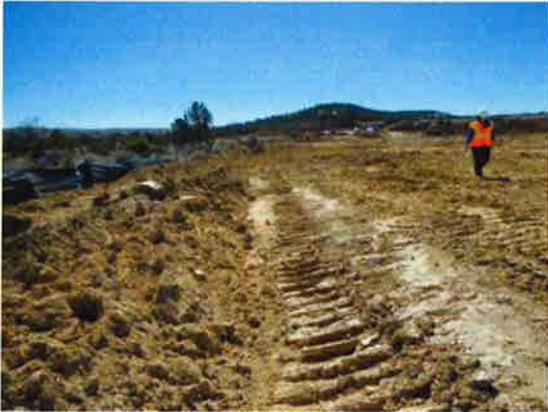
Looking S at upper ditch T1 cut into Map Unit G topsoil, place excelsior logs.

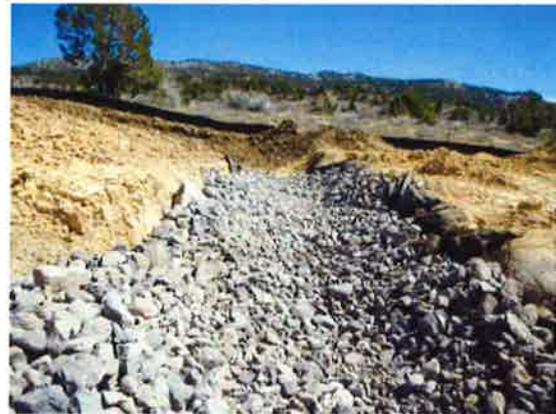
Ditch T1 inlet to pond T1. Excelsior logs to be placed on left side. Below: Boundary of topsoil salvage on slope above UC-T1-01 inlet.

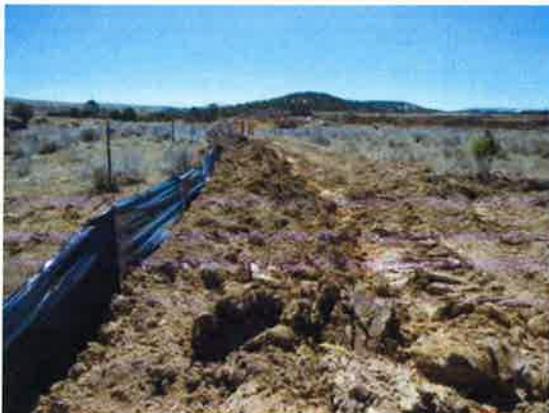
Looking south at uppermost ditch T1 scratched in, place excelsior logs.

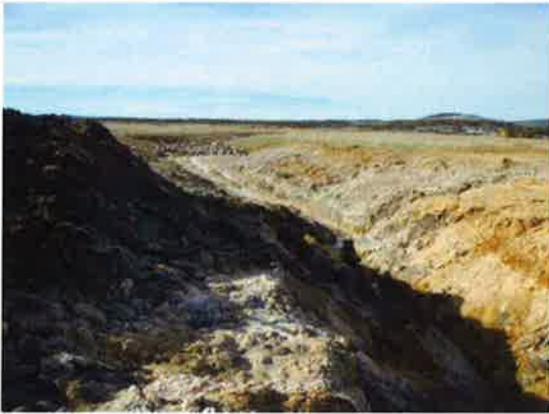
Incomplete construction Lower Robinson Creek at the disturbed area boundary

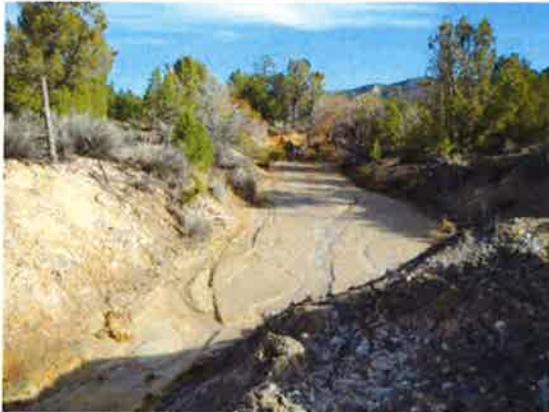
L Robinson creek entering reconstructed creek at permit boundary

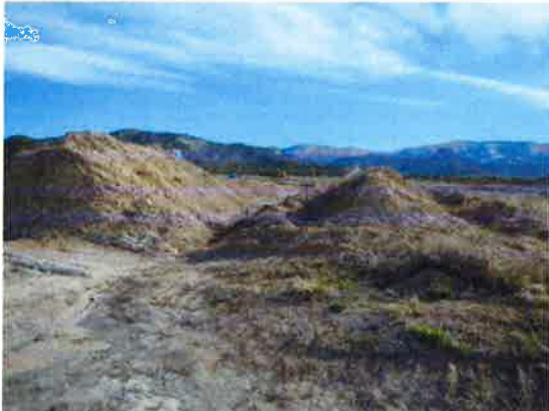
Topsoil stockpiled for replacement.

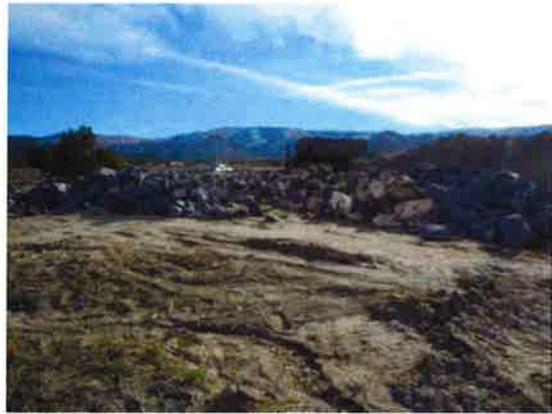
Riprap stockpiled for L. Robinson

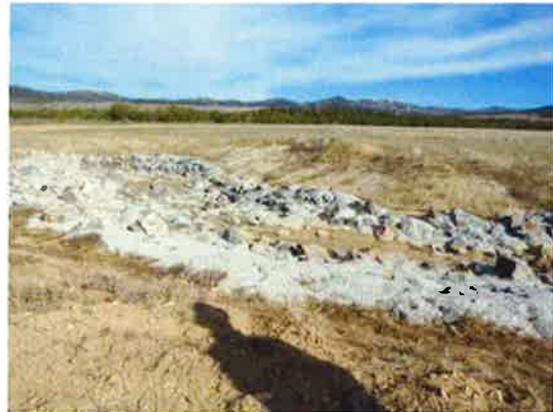
Topsoil to be spread on N bank L. Robinson.

Topsoil along the banks of Robinson Creek South facing slope must be spread.

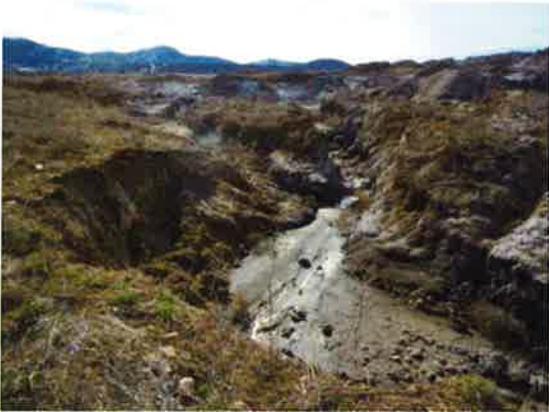
Looking S at flow off primary road to DD4

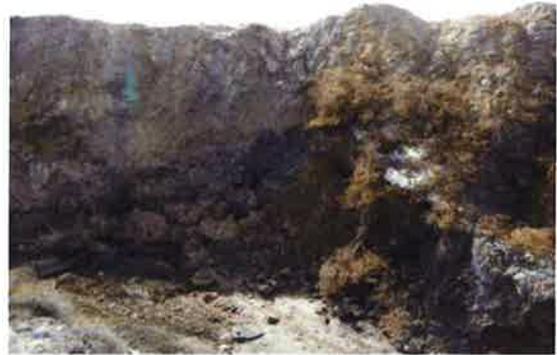
Spoil pile sloughing into DD4

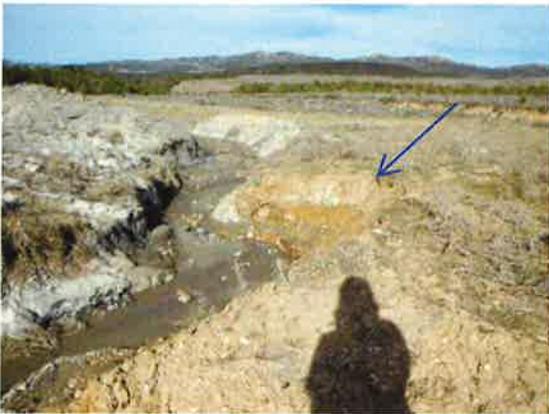
Looking W at scour of reclaimed topsoiled area from primary road flow into DD4 .

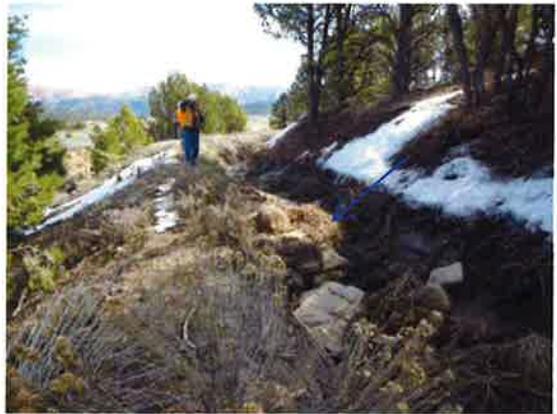
Ditch B-1T-U requires maintenance where equipment has eliminated the ditch (along the length of B-1T-U. Ditch B-1T-L requires maintenance near its outlet to allow stagnant water to flow into pond 3. Ditch DD4 requires maintenance near its outlet to remove large boulders from blocking flow. The bank of ditch DD4 has been severely eroded where flows from the haul road enter the ditch at a right angle. This location must be rippedraped. DD4 is rilled along the edge at the elbow of Robinson Creek where overland flow from the east has concentrated and entered the ditch. This location should be watched.

Rock clog in DD4

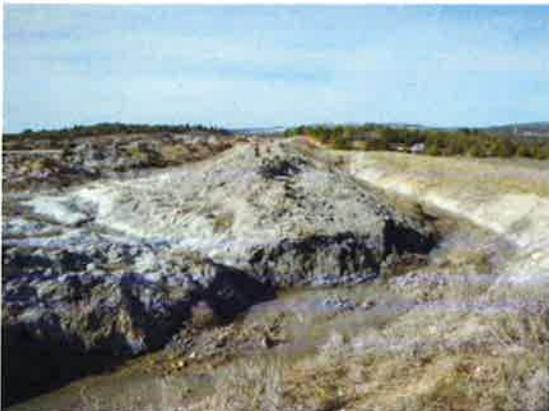
Remnants of the former Excess spoil pile remain in random mounds across an eleven acre area (500 ft x 1000 ft.), creating an impediment to overland flow. The puddled water is keeping salts at the surface, decreasing the quality of the spoil and subsoil for vegetation. This spoil will be the surface for subsoil placement in an attempt to create substitute topsoil. This spoil must be graded to drain properly this season. This spoil is bounded on the North by DD4 and on the South by the haul road. This spoil must be graded to drain water to Pond 3.

Looking W at remnant of spoil pile at DD4

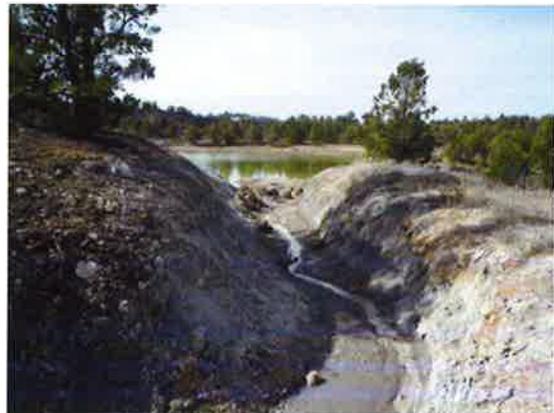
Structural damage at the Pond 3 spillway will be repaired in the next month. Pond 3 is being drawn down by decanting at approximately 50 gpm. The DD4 inlet to pond 3 also requires maintenance of riprap. There was a trickle of flow in DD4 and a trickle of flow in B-1T-L entering Pond 3 (mostly from the base of the excess spoil topsoil pile).

DD4 outlet to Pond 3.

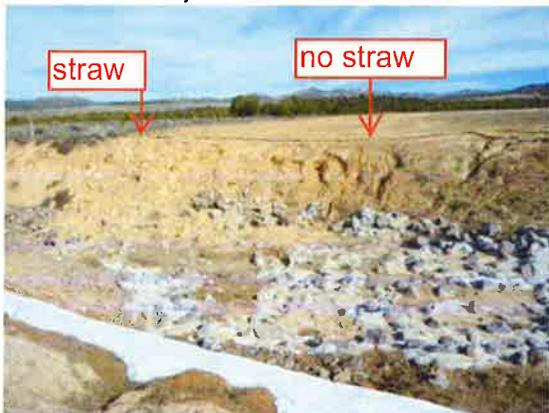
Looking N at transition zone. Straw placed on far left stabilized slope. Far right erosion.

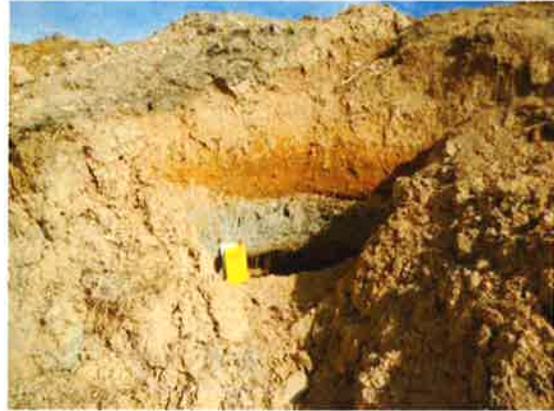
Excelsior logs placed at the transition zone were not set in to the ground and were not effective. This location has very large rills formed 3-4 ft high that have eroded the topsoil and subsoil and exposed the spoil. We discussed a solution which is to surface roughen (pock) the surface above and on the South facing slope of the transition zone.

Erosion on L. Robinson reclaimed slope at transition zone

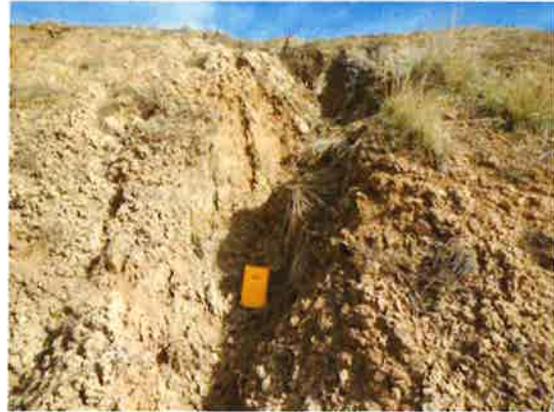
Erosion about 20 inches deep.

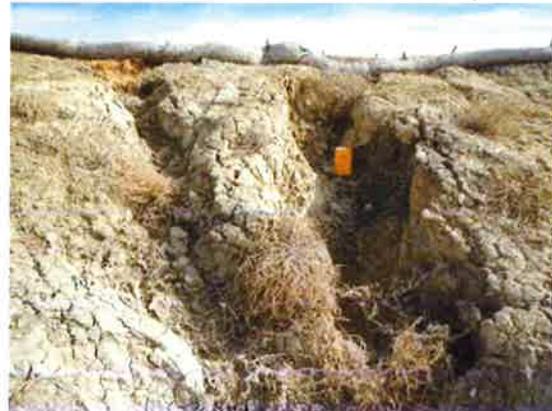
Erosion on L. Robinson slope to be repaired with surface roughening above and proper installation of excelsior logs.

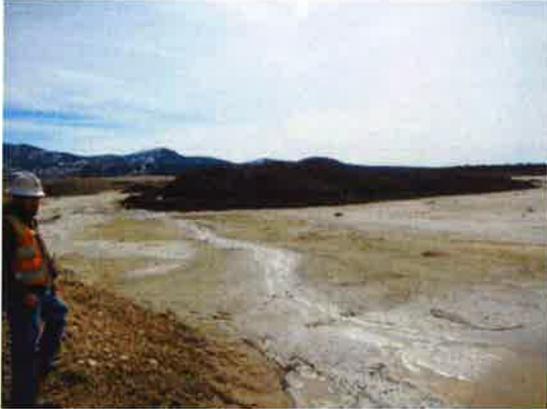
The B1 topsoil (topsoil pile #6 is bermed and a sign is at its base. The pile will be shaped to 3h:1v slopes and seeded when the topsoil pile is accessible. It is surrounded by very soft mud right now.

Above: topsoil pile 6

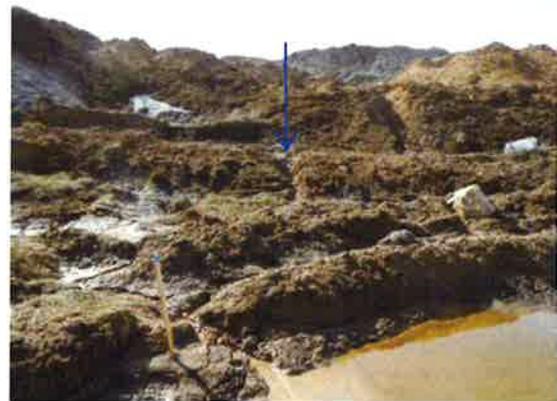
At the South Lease: The excess spoil topsoil berm is breeched on the downhill side. A trickle of flow is feeding into B-1T-L. This breech requires maintenance, but the surrounding area is saturated for equipment.

Breach in excess spoil topsoil berm

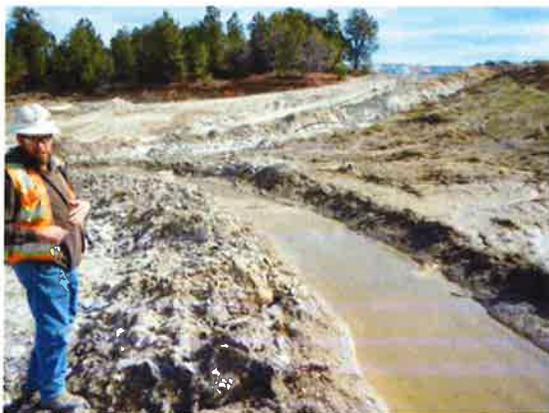
Ditch B-T1-L stagnant needs maintenance

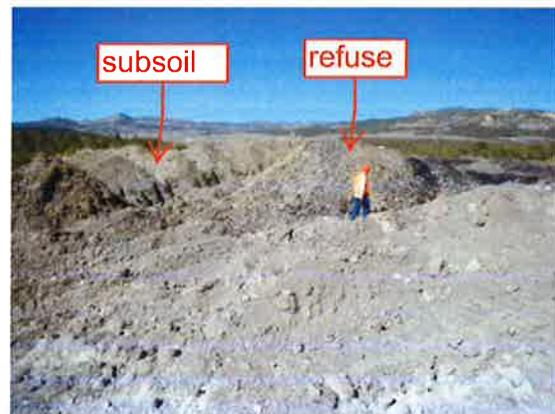
Looking N at subsoil pile W of pit B1. And Wayne next to small refuse pile.

Small piles of coal mine waste and refuse will be returned to Pit B1.

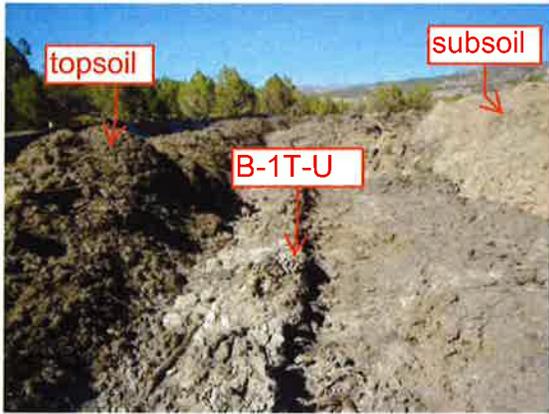
Looking N at topsoil piled along siltfence and subsoil pile berm and ditch B-1T-U

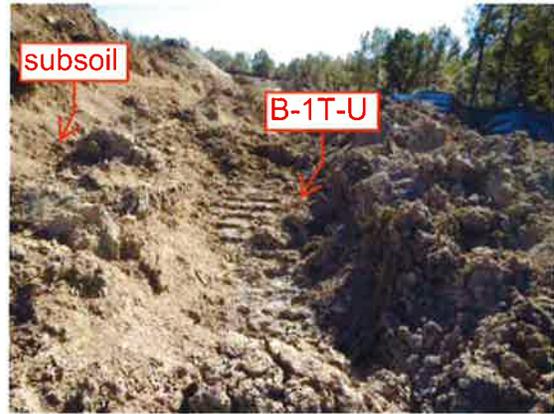
Subsoil berm and ditch B-1T-U merge

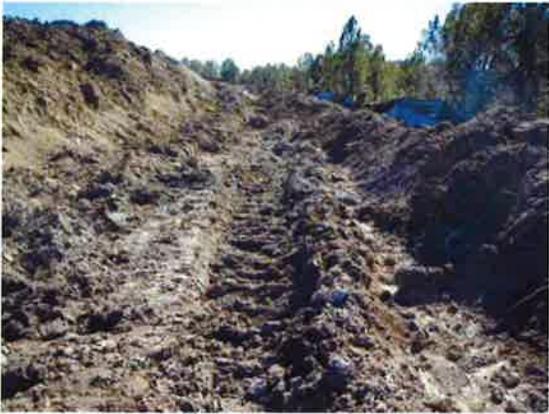
Equipment tread in ditch B-1T-U

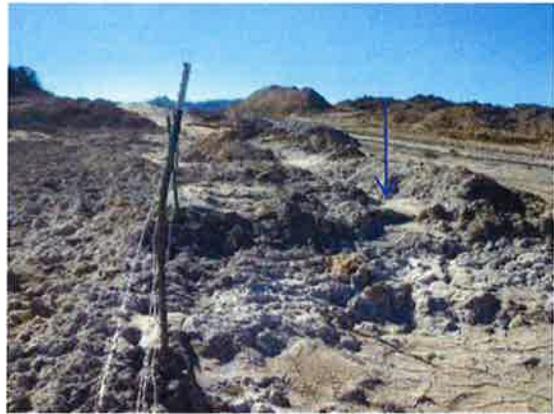
NL Ditch D9 needs maintenance

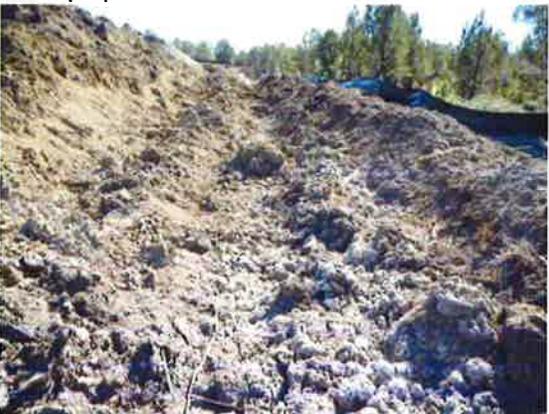
Ditch B-1T-U affected by subsoil berm construction

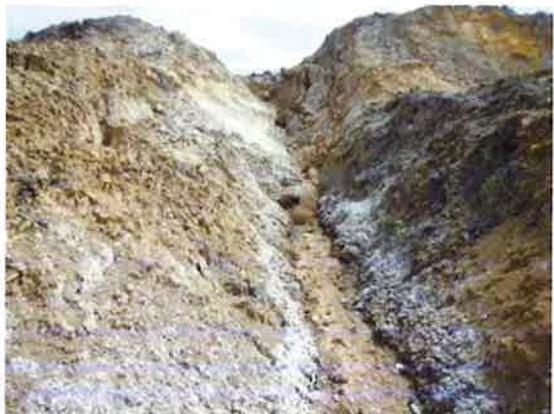
The haul road is being maintained by scrapers, but is not yet restored to design standards. Culverts in the repair yard and along the haul road were unobstructed, except C11 which is more than 50% plugged with sediment. Mud on the haul road blocks the flow towards C16, but is not inside the culvert.

SI Lease C 11 more than 50% plugged needs maintenance.

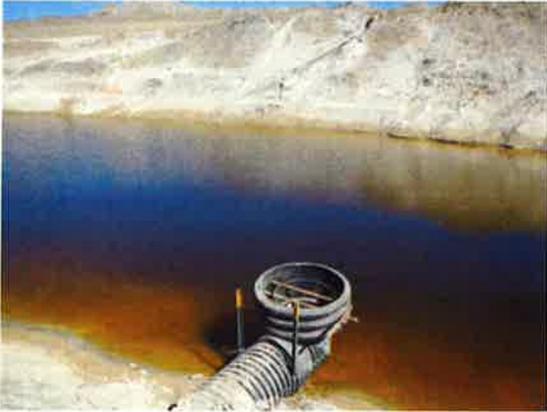
The operator has repaired structural damage to the primary spillways of Ponds 1, 1B, and 5. None of these ponds were discharging.

Pond 5 primary spillway repaired

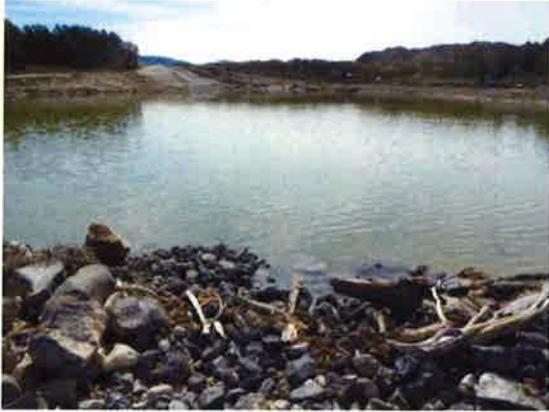
Pond 3 has been decanting at 55 gpm for several weeks is still at elevation of the spillway

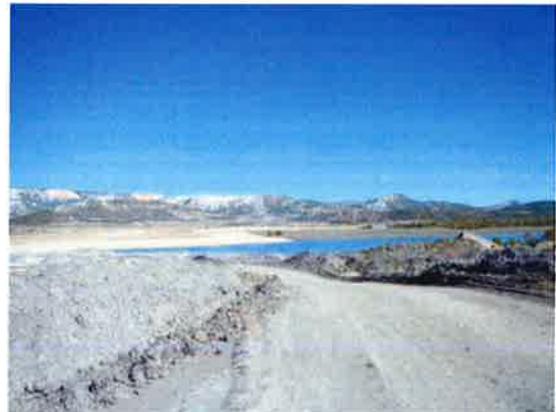
Miscellaneous pond crosses boundary disturbed and undisturbed East of Pit B1

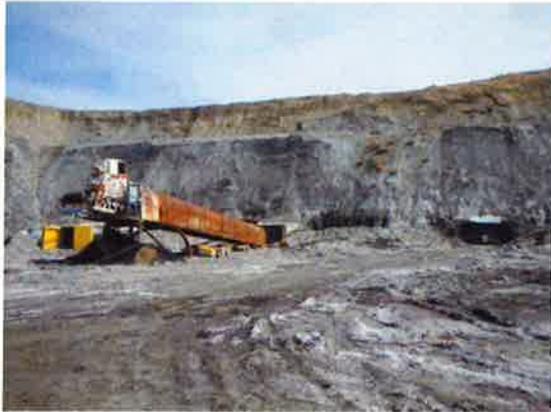
The three UG portals had temporary block seals in place. There is no backfill inby or in front of the stoppings. Power is off and the fan is down.

Portals sealed

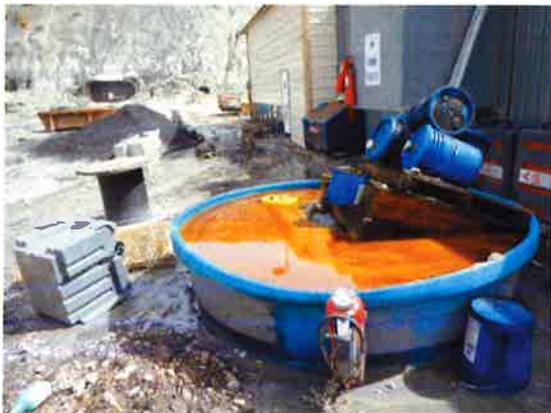
The oil storage containment structure was tidy and dry. A rogue oil storage tank (a cattle watering tank) was discovered full to the brim with water and oil emulsion and containers at the underground mine. NOV 21193 was written for failure to place oil and grease in the designated area of the mine.

oil storage resulting in NOV 21193

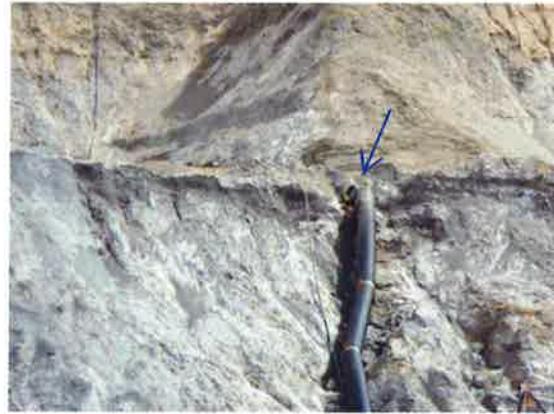
Culverts P10-07, P10-03, P10-04, P10-05, P10-06, P10-08 were plugged at both ends. Drop pipe P10-09 was disconnected at the upper elbow. The embankment of Ditch P10-SO3 has fallen in and blocked the ditch, just above the bathhouse. NOV 21194 was written for failure to maintain these diversions.

P10-09 disconnected NOV 21194

Action(s) required: Yes No
Maintain sediment control at the underground mine as depicted on DWG 5-3C. Drain upper sump. Repair gravel dyke. Unplug all culverts*. Unplug 36" culvert P10-07. Riprap P10-R04 ditch. Reconnect P10-09. Clear Ditch P10-S03.
*Culverts = P10-07, P10-03, P10-04, P10-05, P10-06, P10-08

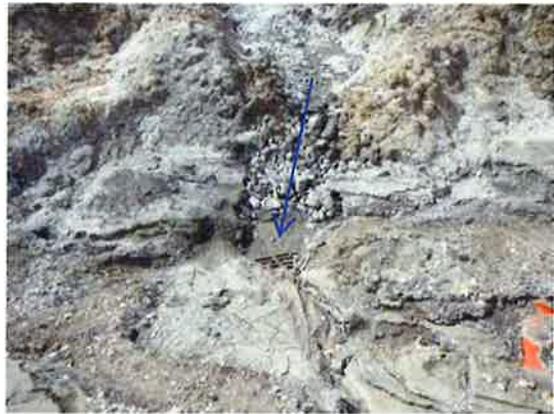
Primary haul road drainage control shown on Dwg 5-C has not been maintained and NOV 21194 was issued. Culvert P10-08 is plugged at both ends and riprap in ditch P10-R04 has not been installed as designed in the bottom of the ditch, along the full length of the ditch. The inlet to P10-07 was clogged with sediment. The outlet of P10-07 was buried in sediment in the sump.

Inlet P10-07 NOV 21194 50% plugged

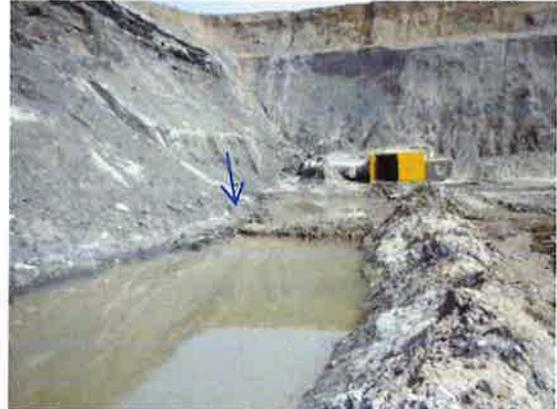
The sump is full of sediment on the east side and the gravel barrier between east and west sides is breeched. Water from this sump was pumped to Pond 3 last month, but has not been pumped this month. Repair of this sump is included as abatement of NOV 21194.

Unrepaired erosion of gravel dike allows bypass of water filtration
NOV 21194

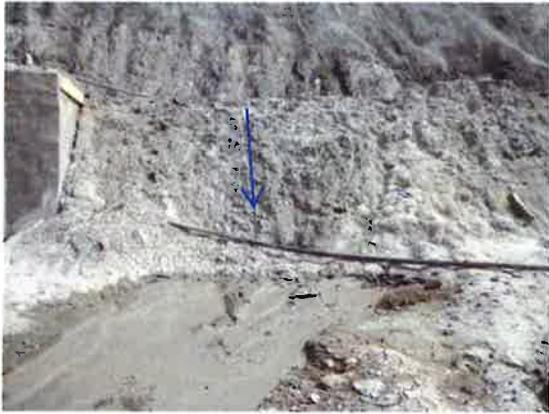
Roof bolt shows location of plugged P10-03, NOV 21194

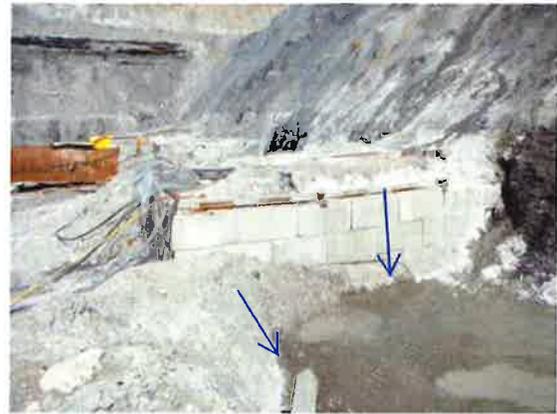
Inlet P10-05 and P10-06 plugged, NOV 21194

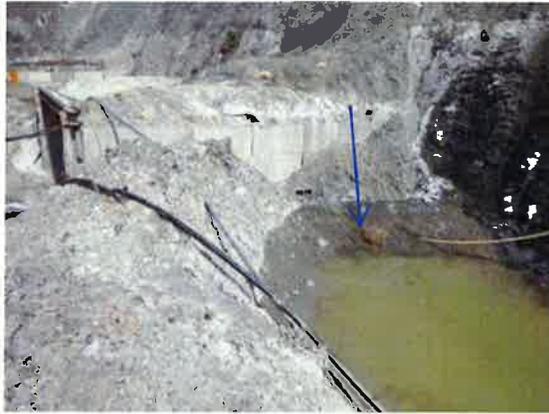
Inlet to P10-04 plugged and submerged.

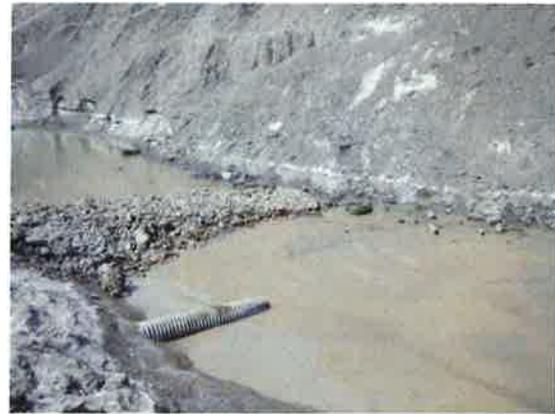
Recently placed culvert above plugged P10-07 culvert (36 inch) which is submerged and plugged. Sediment estimated to be 2 inches below surface, NOV 21194

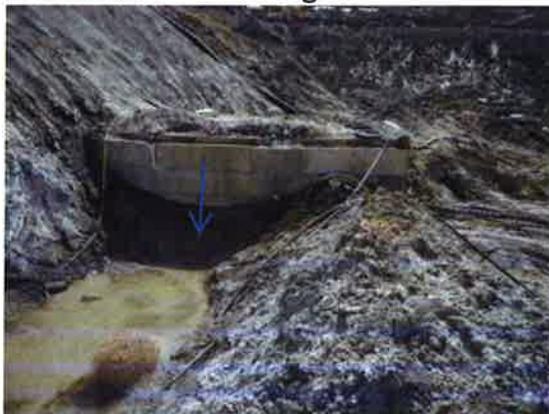
Outlet of P10-05 plugged submerged, NOV 21194

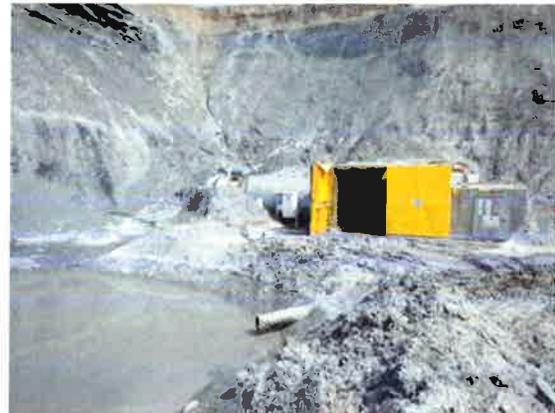
Culvert in place at East end sump not on Dwg 5-3 series.

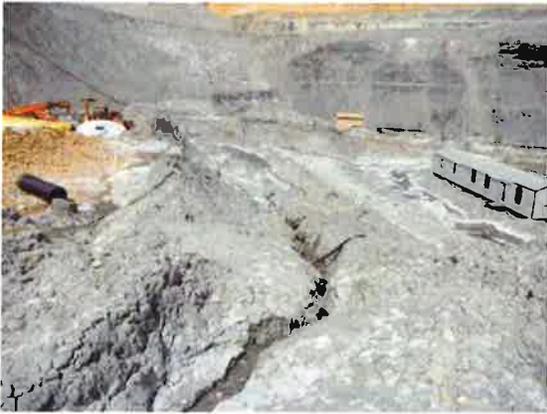
Ditch P10-S04 looks the same as in December when maintenance was requested, NOV 21194

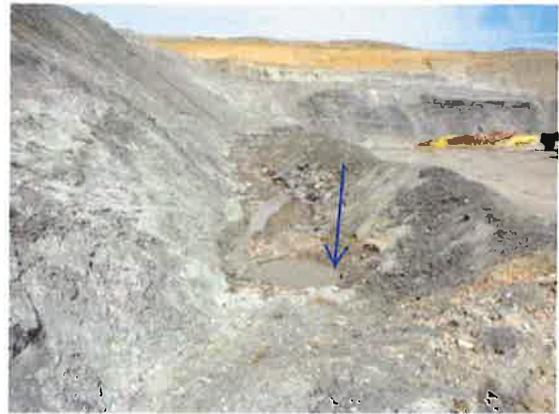
Buried outlet of P10-08 allows a trickle of flow, NOV 21194

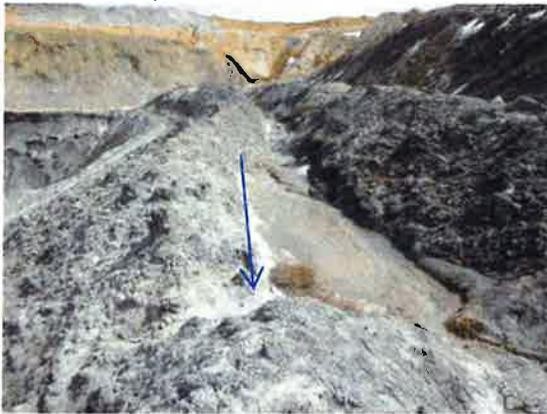
Ditch P10-S03 partially blocked caused overflow to P10-S04 below, NOV 21194

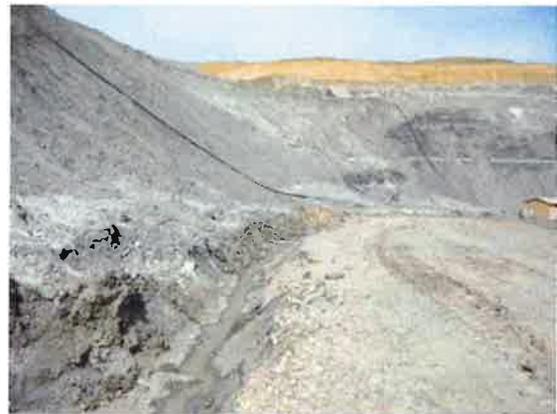
Inadequate riprap of P10-R04 noted and requested maintenance in December complete, NOV 21194

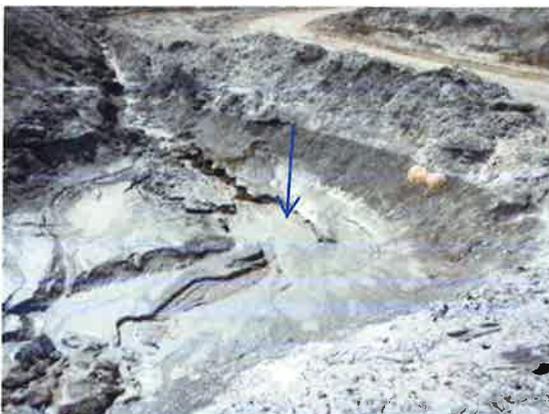
P10-S03 outlet to catch basin where sediment has buried the inlet to P10-08, NOV 21194

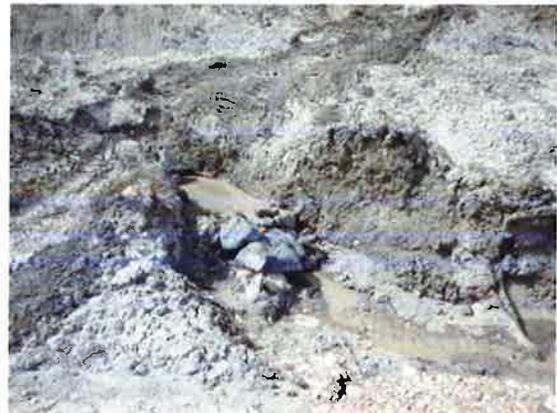
Inadequate riprap P10-R04.
