025005 November 2017 Coal Hollow Technical Inspection

Inspection Report

Permit Number:	C0250005
Inspection Type:	TECHNICAL
Inspection Date:	Tuesday, November 28, 2017
Start Date/Time:	11/28/2017 12:00:00 PM
End Date/Time:	11/28/2017 3:00:00 PM
Last Inspection:	Tuesday, November 7, 2017

Coal Hollow Inspection November 28, 2017

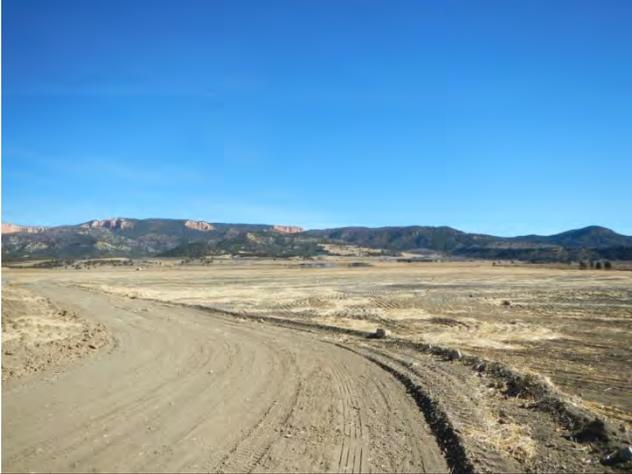
PHOTO 1 Looking East from pond 3 access road across the Interim Reclamation Area (former excess spoil storage area)

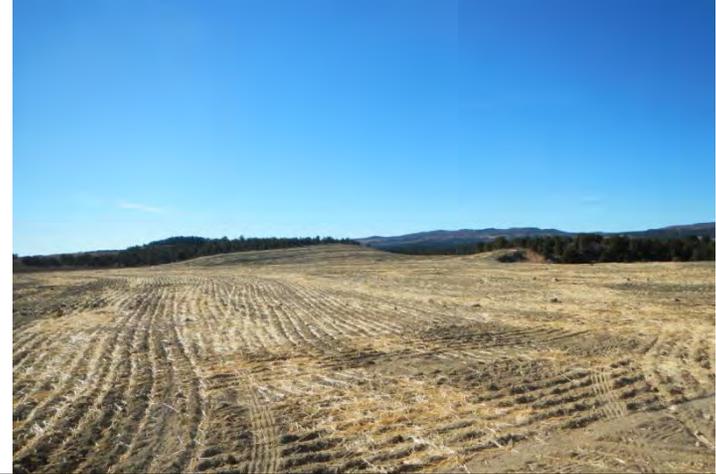
PHOTO 2 Looking South from pond 3 access road at BRP1-11 (Pit B1) and Interim Reclamation Area with subsoil surface

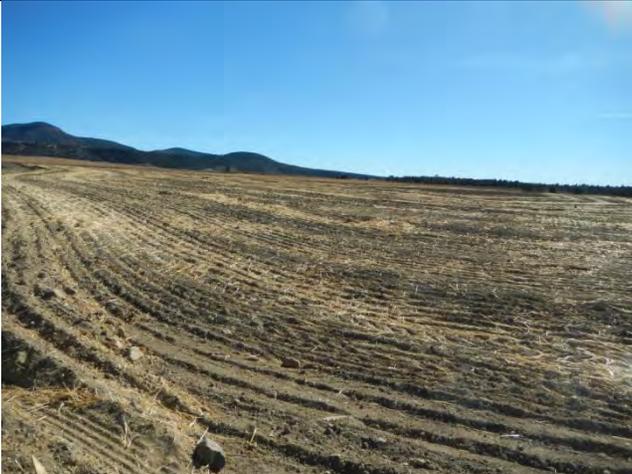
South lease topsoil pile #2 and subsoil pile #2 will not be needed again until final reclamation. They will be seeded with interim mix this fall. The profile of subsoil pile #2 will either be reduced or pocked to encourage vegetation establishment. Subsoil from subsoil pile #2 was recently used for reclamation of the access road to pond 3. The remaining volume of subsoil in subsoil pile #2 will be surveyed and reported in the 2017 Annual report. The MRP chapter 2 will be amended accordingly. Subsoil from Pit B1 was spread over the BRP1-11 and Interim Reclamation Area (total 36 acres) to generate substitute topsoil for reclamation. Topsoil pile #6 from Pit B1 Area was consumed in Phase 2 reclamation of Pits 1, 2, 4, 7 and 8 in the South Lease. (This area was part of the 2015 BRP1-1 bond release, Task 4965.) Consumption of topsoil pile #6 will be documented in the 2017 Annual Report and in the MRP narrative in Chapter 2. The sagebrush/grass mix was seeded on the South Lease Pits 1, 2, 4, 7, 8 area.

PHOTO 3 Topsoil from pile 6 was spread over the South half of BRP1-1(South Lease Pits 1, 2, 4, 7, 8).

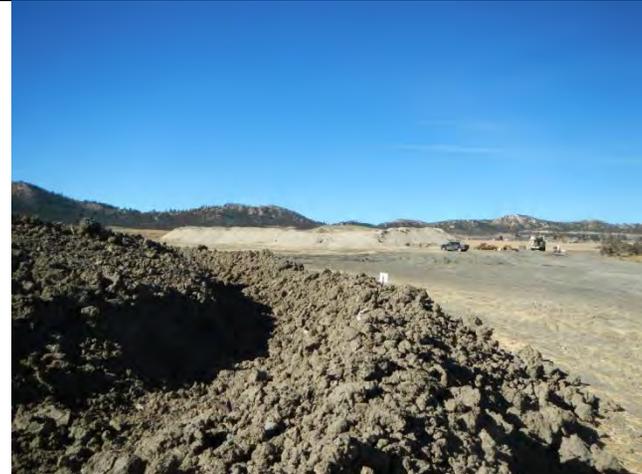
PHOTO 4 North Lease topsoil pile berm with subsoil stockpile in the distance

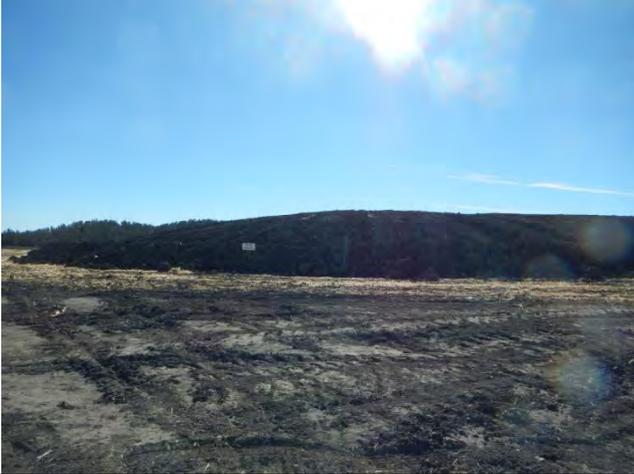
Topsoil pile at the North Lease Area was recently moved and covers 3 acres of BRP1-12. It includes topsoil recently salvaged from Pit 11. It will be shaped on its South and East sides and seeded with the interim mix. The subsoil pile at the North Lease is an active pile. Subsoil from Pit 12 has been cleared and is stored on the North, West and East sides of Pit 12. Mr. Nicholes has told equipment operators that it is not to be placed as backfill. It will either be live-hauled to Pits 7-10 or placed in the subsoil pile this year.

PHOTO 5 The North face of the North Lease topsoil pile

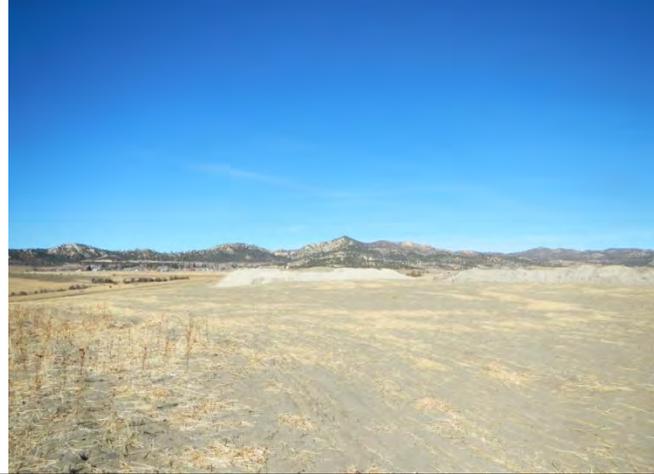
PHOTO 6 North Lease BRP1-10 (2016) on left with sunflower stalks and BRP1-12 (2017) on right

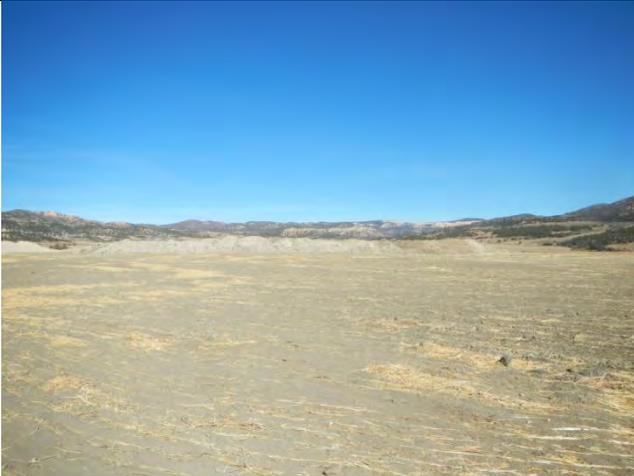
PHOTO 7
Looking across North Lease BRP1-12 at the West face of topsoil pile

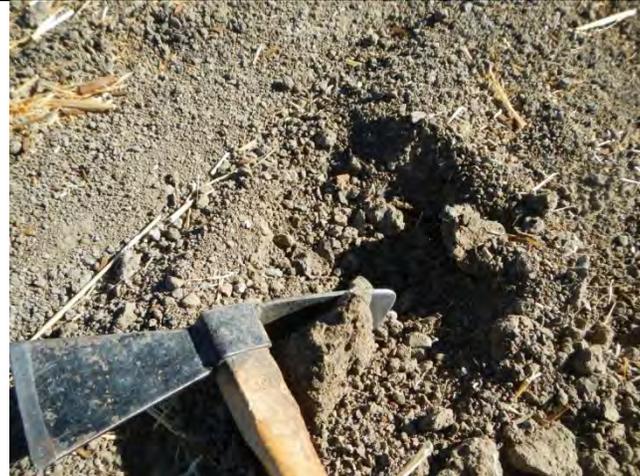
We noted BRP1-12 soils were compacted approximately 3 inches below the surface. We discussed allowing a year of freeze-thaw to reduce the compaction and concluded that there will be another opportunity to rip the entire BRP1-12 area during removal of the topsoil pile, if revegetation is not successful (or sooner, if erosion is not controlled). Ripping the surface prior to seeding is required by MRP Section 242.120.

Alton Coal's letter dated 10/13/2017 (received 10/17/2017) states that 18 inches of topsoil was applied over 24-30 inches of subsoil in BRP1-12 depending on the spoil quality. To confirm soil replacement depth, an attempt was made to auger through the topsoil and subsoil column in the BRP1-12 spoil sample locations 4 and 11, shown on Dwg 5-76. The auger could penetrate only 3 -4 inches. Beneath this depth, a compacted clay soils could be broken only with effort. Earlier this fall, Mr. Nicholes had a trackhoe dig a trench to confirm the depth of cover over the spoil, but stated that it was difficult to distinguish the redistributed clay soil from the shale spoil and impossible to see a demarcation of topsoil over subsoil. The loose 3-4 inch surface of BRP1-12 had been seeded and mulched, but the compact layer had not been ripped prior to the seeding. Ripping the compacted surface is required (MRP Section 242.120). We compared the loose structure of the adjacent 2016 bond release area (North Lease BRP1-10 (Pits 1, 2 and portion of 3) where the surface six inches was loose and the auger easily penetrated soil column. Mr. Nicholes suggested that after a winter of freeze and thaw, the soil over pits 3-6 in BRP1-12 would also become loose and granular.

PHOTO 8
BRP1-12 has a 3 inch deep loose surface over compacted soil.

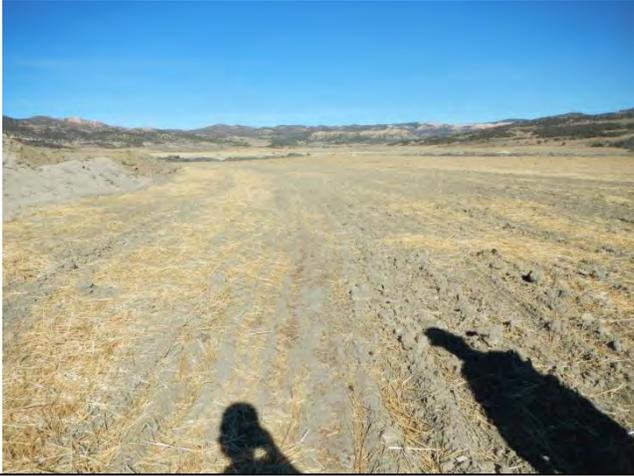
PHOTO 9 North Lease BRP1-12 (2017) mulched and seeded surface over compacted soils.

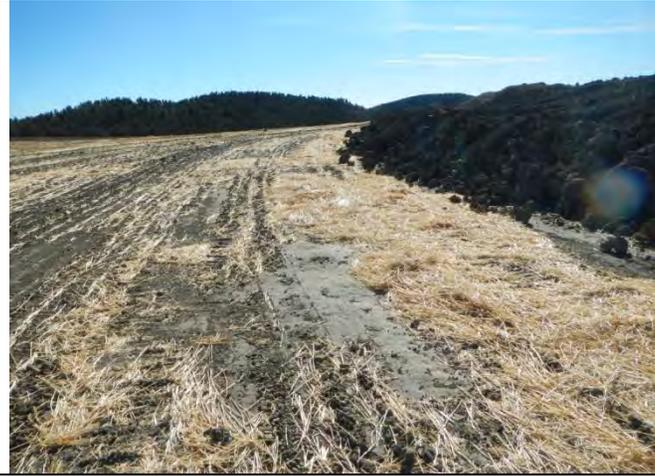
On the East side of the recently placed North Lease topsoil pile, where truck traffic was concentrated, ripping was completed by the reclamation contractor. This area still had sizeable, slick compacted areas. The MRP clearly states that compacted areas will be ripped. If revegetation suffers due to compaction, there will be another opportunity to rip the entire BRP1-12 area during final reclamation when the topsoil

pile is replaced.

PHOTO 10 North Lease BRP1-12 visible compaction near recently placed topsoil pile

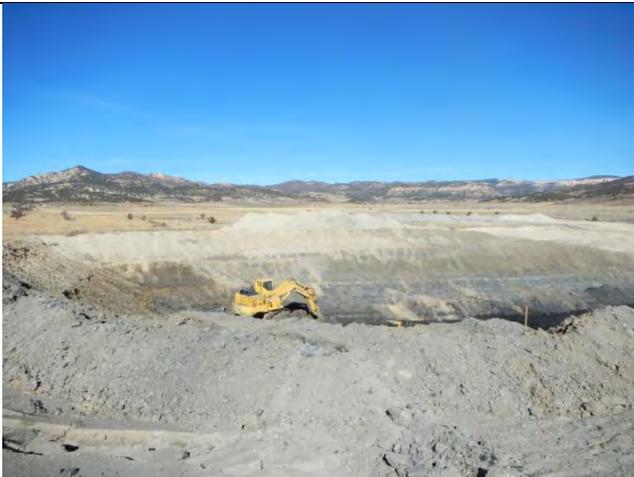
PHOTO 11

North Lease West end of Pit 11 mining and subsoil on West, North and East. Darker topsoil on North

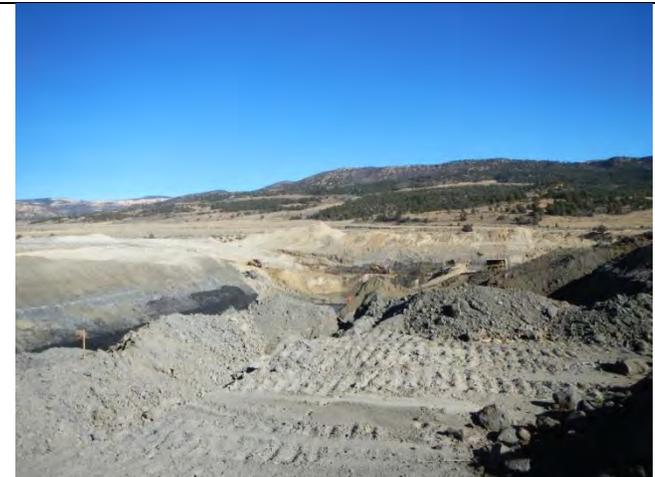
PHOTO 12

Mining is ongoing in the North Lease on the West end of Pit 11. Topsoil and subsoil is stored in stockpiles in the North, East and West of Pit 12. Two dozer operators were backfilling the East end of Pit 11 with alluvium and shale from Pit 12.

North Lease East end of Pit 11, dozer pushing alluvium from Pit 12 into Pit 11.

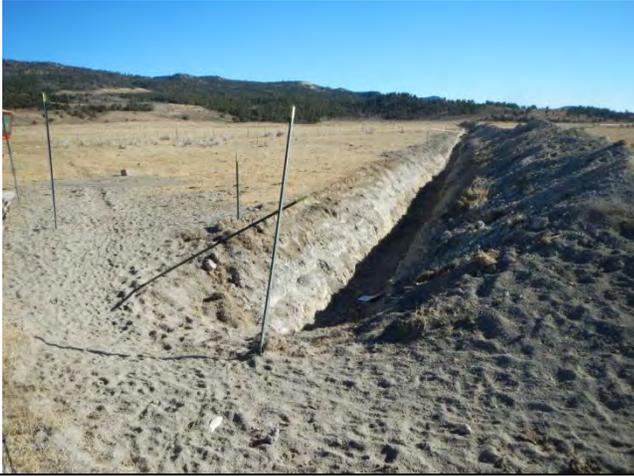
UD-14 has been installed on the East side of Area 2 on Ferril and Dorothy Heaton property. The ditch will require further work to function as designed. Construction of this ditch exposed the surface 0-4 ft of soil. The white clay subsoil has yellow-orange mottling.

PHOTO 13 North Lease ditch UD 14 looking Southeast

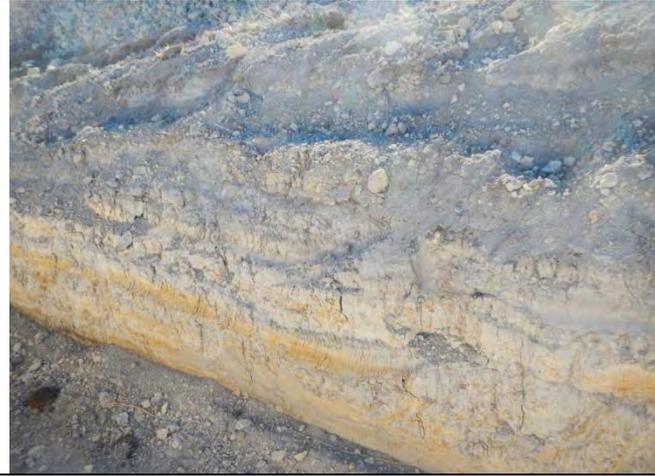
PHOTO 14 Atlatl family soils. Ditch UD-14 is in the vicinity of soil sample location 12AS025

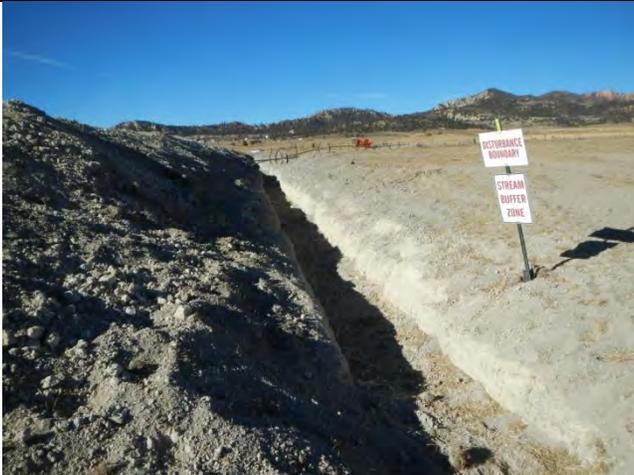
PHOTO 15
North Lease UD 14 is on Ferril and Dorothy Heaton property.

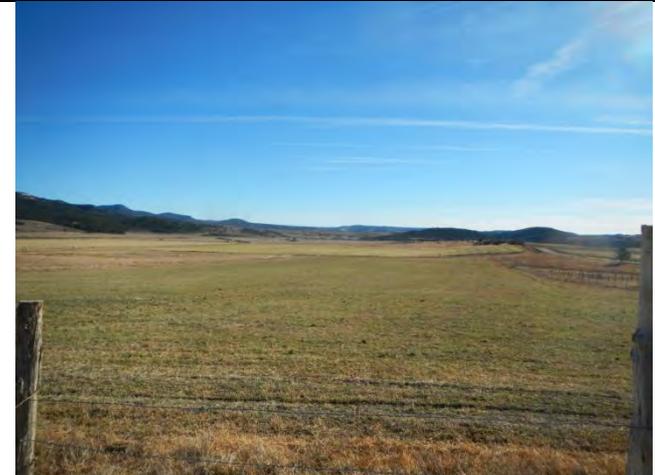
PHOTO 16
North Lease looking North across prime farmland towards Pit 12
