INSPECTION MEMO TO COAL FILE.

Inspection Memo to  
Coal File:

RE: Southern Utah Fuel Company  
Convulsion Canyon Mine  
ACT/041/002  
Folder No. 7  
Sevier County, Utah

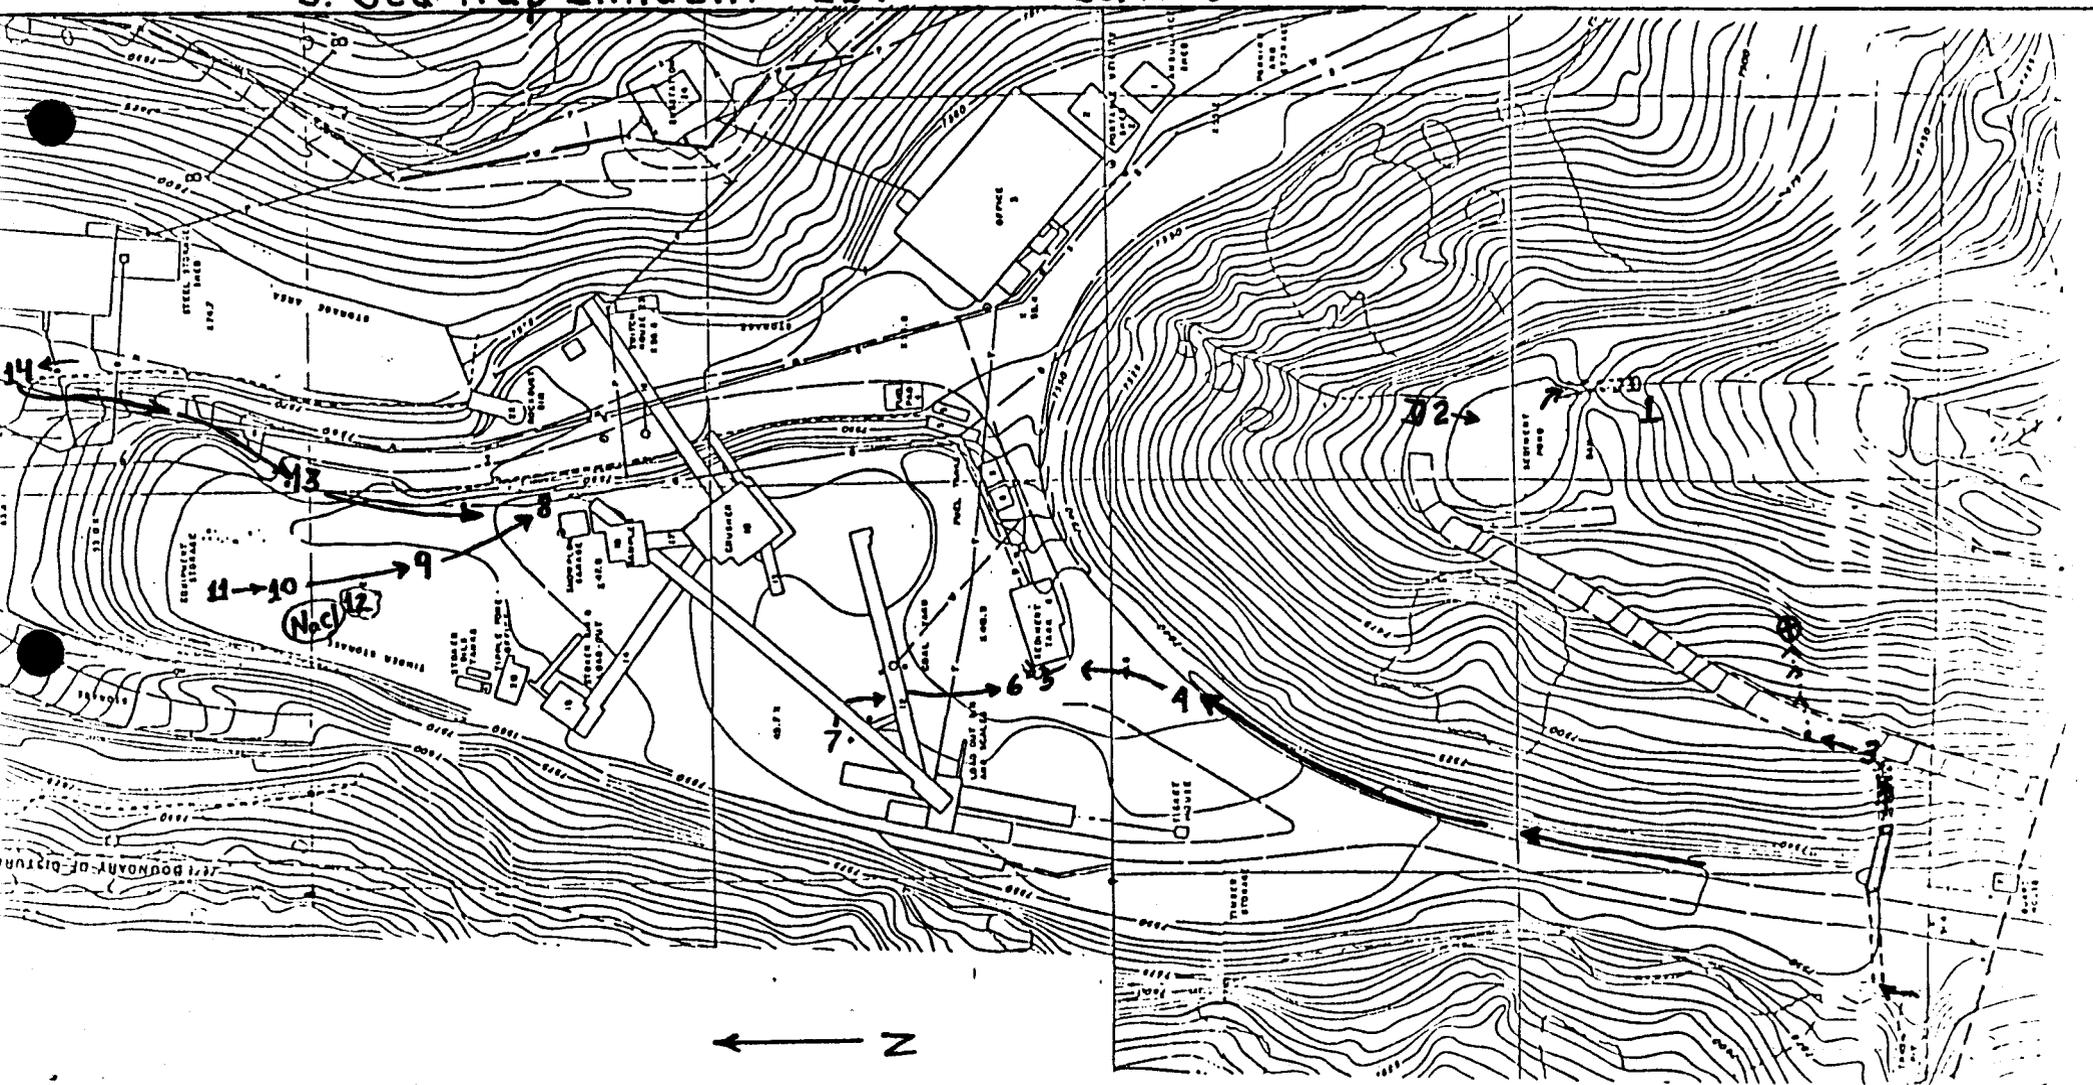
Upon closer examination of attachment #1, it appears that dissolved ion concentrations increase as water passes through the sediment pond. Possibly some TDS source lies in the sediment pond. Another increase, although minimal, was observed between the influent and effluent of the pond on January 11, 1983 (see memo to coal file dated January 21, 1983). A second increase in dissolved ions occurs between point 7 and point 6, this is the area of the truck loading and truck turnaround. The area adjacent to the salt stockpile shows significant increases from above the salt pile (point 11) to below the salt pile (point 9). A puddle directly adjacent to the salt pile had a conductance of 85,000 (point 12). This water tasted very salty. Finally an increase was observed along the road to the upper pad (from point 14 to point 13) this increase could possibly be attributed to salt applications on this road for snow removal purposes.

Water was noticed flowing quite readily at the top of the access road but none was reaching the sediment pond. Closer observation revealed water piping down into the ground approximately 20 feet below the point where the non-coal waste area water is culverted down onto the sediment pond access road. Upon further investigation water was observed flowing out over the cliff face, therefore bypassing the sediment pond. The area of the violation is shown on attachment #1 marked by X. NOV N83-7-2-1 was issued as follows for this violation.

# Relative Conductances ( $\mu\text{mhos/cm}$ )

1. Sed Pond Discharge: 1900

2. Sed Pond Influent: 1300

3. Non Coal Waste Drainage: 650

4. Road Runoff 660:

5. Sed Trap Influent: 1290

6. Coal Loading Drainage: 2300

7. Scale House Drainage: 1550

8. Culvert Inlet: 1850

9. Below Salt Pile: 2500

10. At Salt Pile: 1380

11. Above Salt: 650

12. Puddle: 85,000

13. Drainage: 100

14. Pad Drainage: 500

Channel all disturbed area runoff into the sediment pond. Prevent further undercutting of access road.
