**Southern Utah
Fuel Company**

March 28, 1984

1983 SUBSIDENCE REPORT
SOUTHERN UTAH FUEL COMPANY (SUFCO)
CONVULSION CANYON MINE

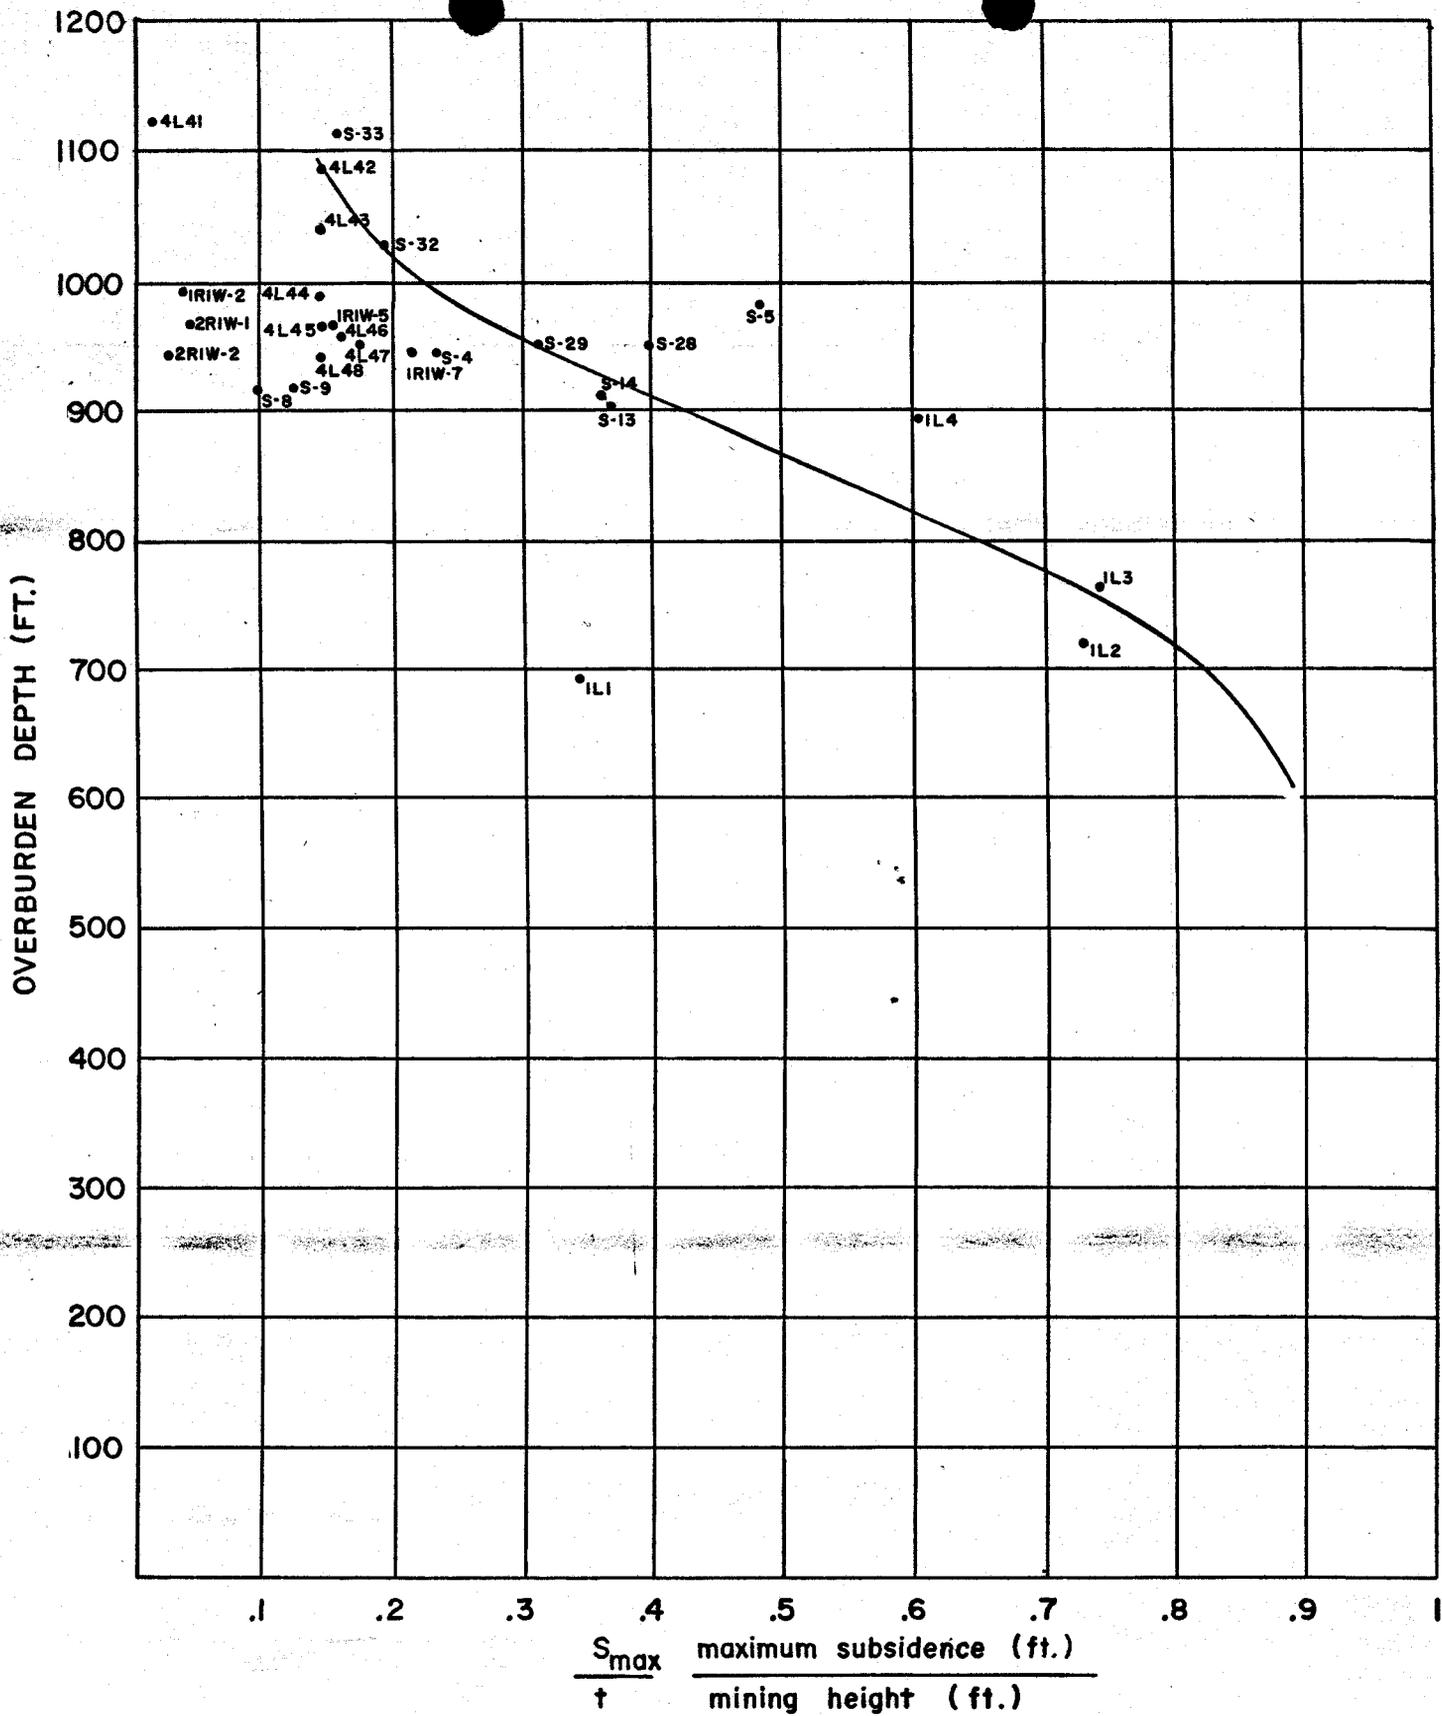
FIG. 1
SUBSIDENCE / MINING HEIGHT vs OVERBURDEN DEPTH
 (After fig. 4 in Mining and Reclamation Plan, Subsidence Section)

Current data indicates less subsidence, with overburden depths greater than 900 feet, than previously anticipated. Figure 1, included in SUFCO's Mining and Reclamation Plan as Figure 4, has been revised and included in this report. Assuming an average 10 feet mining height and 1,000 feet of overburden, current data would indicate an average subsidence of roughly 2.1 feet while previous data indicated nearly 3.0 feet. Insufficient data is available to indicate any modification of the original Figure 4 where overburden depths are less than 900 feet. Therefore, no change in this range was made on Figure 1.

The considerable number of points to the left of the plot in the 900 to 1,000 foot overburden range would indicate further shallowing of the curve above 900 feet. However, the 1R1W and 2R1W points have not yet fully subsided and would therefore, for plotting purposes, not carry the weight of the other points. It is anticipated that additional subsidence will shift these points to the right and more in line with the projected curve.

NOTE: Only those subsidence stations positioned over good recovery areas in full extraction panels are used for this plot.
