Southern Utah Fuel Company

ANNUAL WASTE ROCK DISPOSAL SITE
CERTIFICATION -- 1990

ANNUAL MINESITE SEDIMENTATION POND
CERTIFICATION -- 1990

ANNUAL WASTE ROCK SEDIMENTATION POND
CERTIFICATION -- 1990

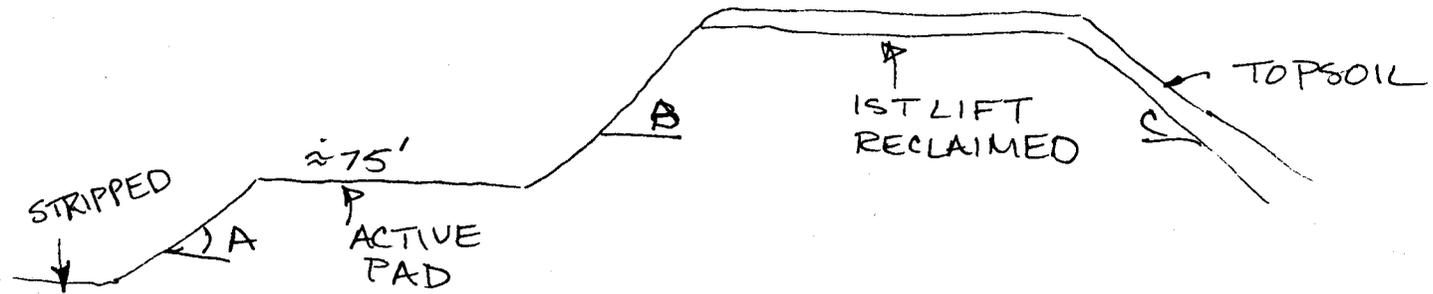
All final and intermediate construction slopes were less than the design 1v:2h which corresponds to a slope of 26°33'. Slopes are constructed such that water cannot pond against the toe. Steepening of the slope was evident on the active pad area where the MSHA required berm was in place.

<u>A</u>	<u>B</u>
17° 30' North	20° 45' South
19° 30' center	20° 45' center
21° 15' South	18° 15' North
20° South	
Above Terrace	
Below terrace	
23° 45' South	
Below terrace	
@ edge

<u>A</u>
18° EAST, SOUTH FACE
20° CENTER; SOUTH FACE
21° WEST, SOUTH FACE
15° 30' SOUTH, WEST FACE
21° CENTER; WEST FACE
23° NORTH; WEST FACE

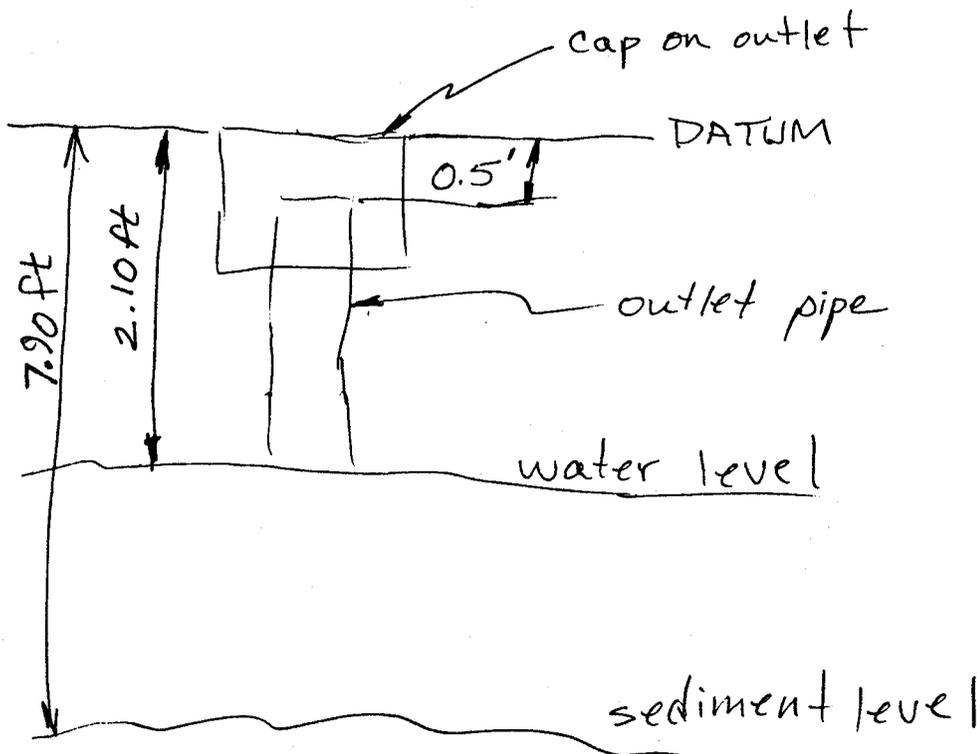
The water level in the pond was at 7415.40 feet which is 1.6 feet below the standpipe spillway elevation. An additional 0.536 acre ft of storage volume is available in the pond. The sediment level in the pond was at 7409.50 feet which corresponds to a sediment volume of 0.453 acre-ft based on a level sediment surface and as built pond volume. This is 68% of the maximum sediment volume. The pond needs to be decanted to check the actual sediment surface.

Some sediment stored on NW end of pond.

Water level in pond

Sediment level in pond.

Inlet delta (sediment) has been cleaned
since last year. Sediment stored on NW end.
