Dalen
041/002 #6

**ANNUAL MINESITE SEDIMENTATION POND
CERTIFICATION -- 1993**

**ANNUAL WASTE ROCK SEDIMENTATION POND
CERTIFICATION -- 1993**

**ANNUAL WASTE ROCK DISPOSAL SITE
CERTIFICATION -- 1993**

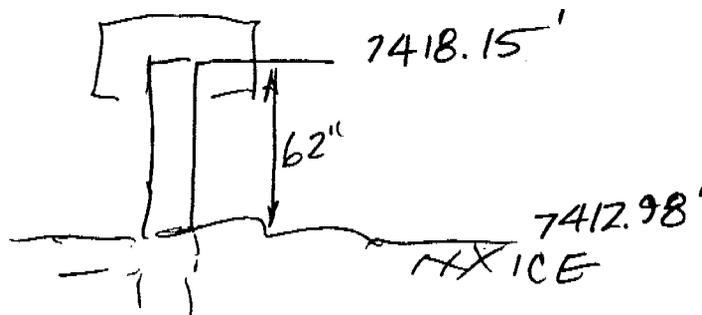
2. Major Erosion Problems Yes No
Some ^{erosion} on fill slope above pond.
Rive lets 4-12" deep in places

ICE LEVEL 62" below stand pipe out flow level
Note: Pond cleaned in sept-oct.

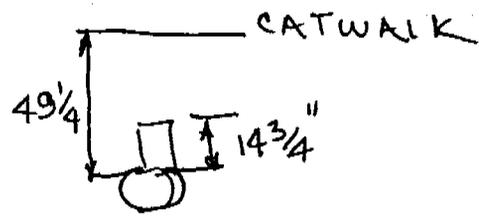
35"
66"
101"
SED LEVEL
101" BELOW CATWALK

Decant impoundment
No cracks
No sloughing
No bulging
NO appearance of instability, structural weakness,
or other hazardous conditions
No water in impoundment.
