Canyon Fuel Company, LLC
SUFCO Mine
397 South 800 West
Salina, Utah 84654
(435) 637-4880 Fax: (435) 636-4499

**ANNUAL MINESITE SEDIMENTATION POND
CERTIFICATION -- 1998**

**ANNUAL WASTE ROCK SEDIMENTATION POND
CERTIFICATION -- 1998**

**ANNUAL WASTE ROCK DISPOSAL SITE
CERTIFICATION -- 1998**

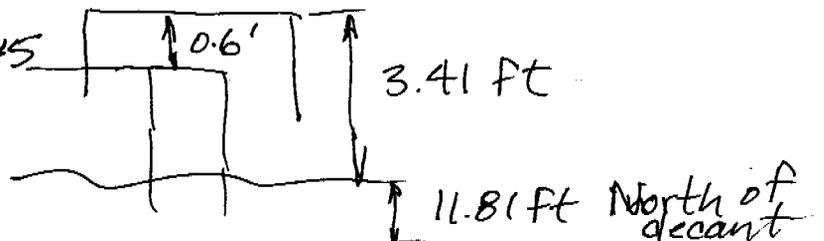
water level 7415.34
sediment level 7463.53
Just north of
decant
