From: "Mike Davis" <mdavis@sisna.com>
To: <CHansen@archcoal.com>, <CHilton@archcoal.com>, <daronhaddock@utah.gov>, <davedarby@utah.gov>, <peter@relia.net>, <jerriannernstsen@utah.gov>, <KMay@archcoal.com>, <MBunnell@archcoal.com>, <Pamgrubaughlittig@utah.gov>, <petehess@utah.gov>, <stevefluke@utah.gov>, <susanwhite@utah.gov>
Date: 12/30/03 5:46AM
Subject: East Fork Box Canyon Monitoring 12/22&24/03

| Canyon Fuel Company, LLC SUFCO Mine | |
| EAST FORK OF BOX CANYON WEEKLY MONITORING | |

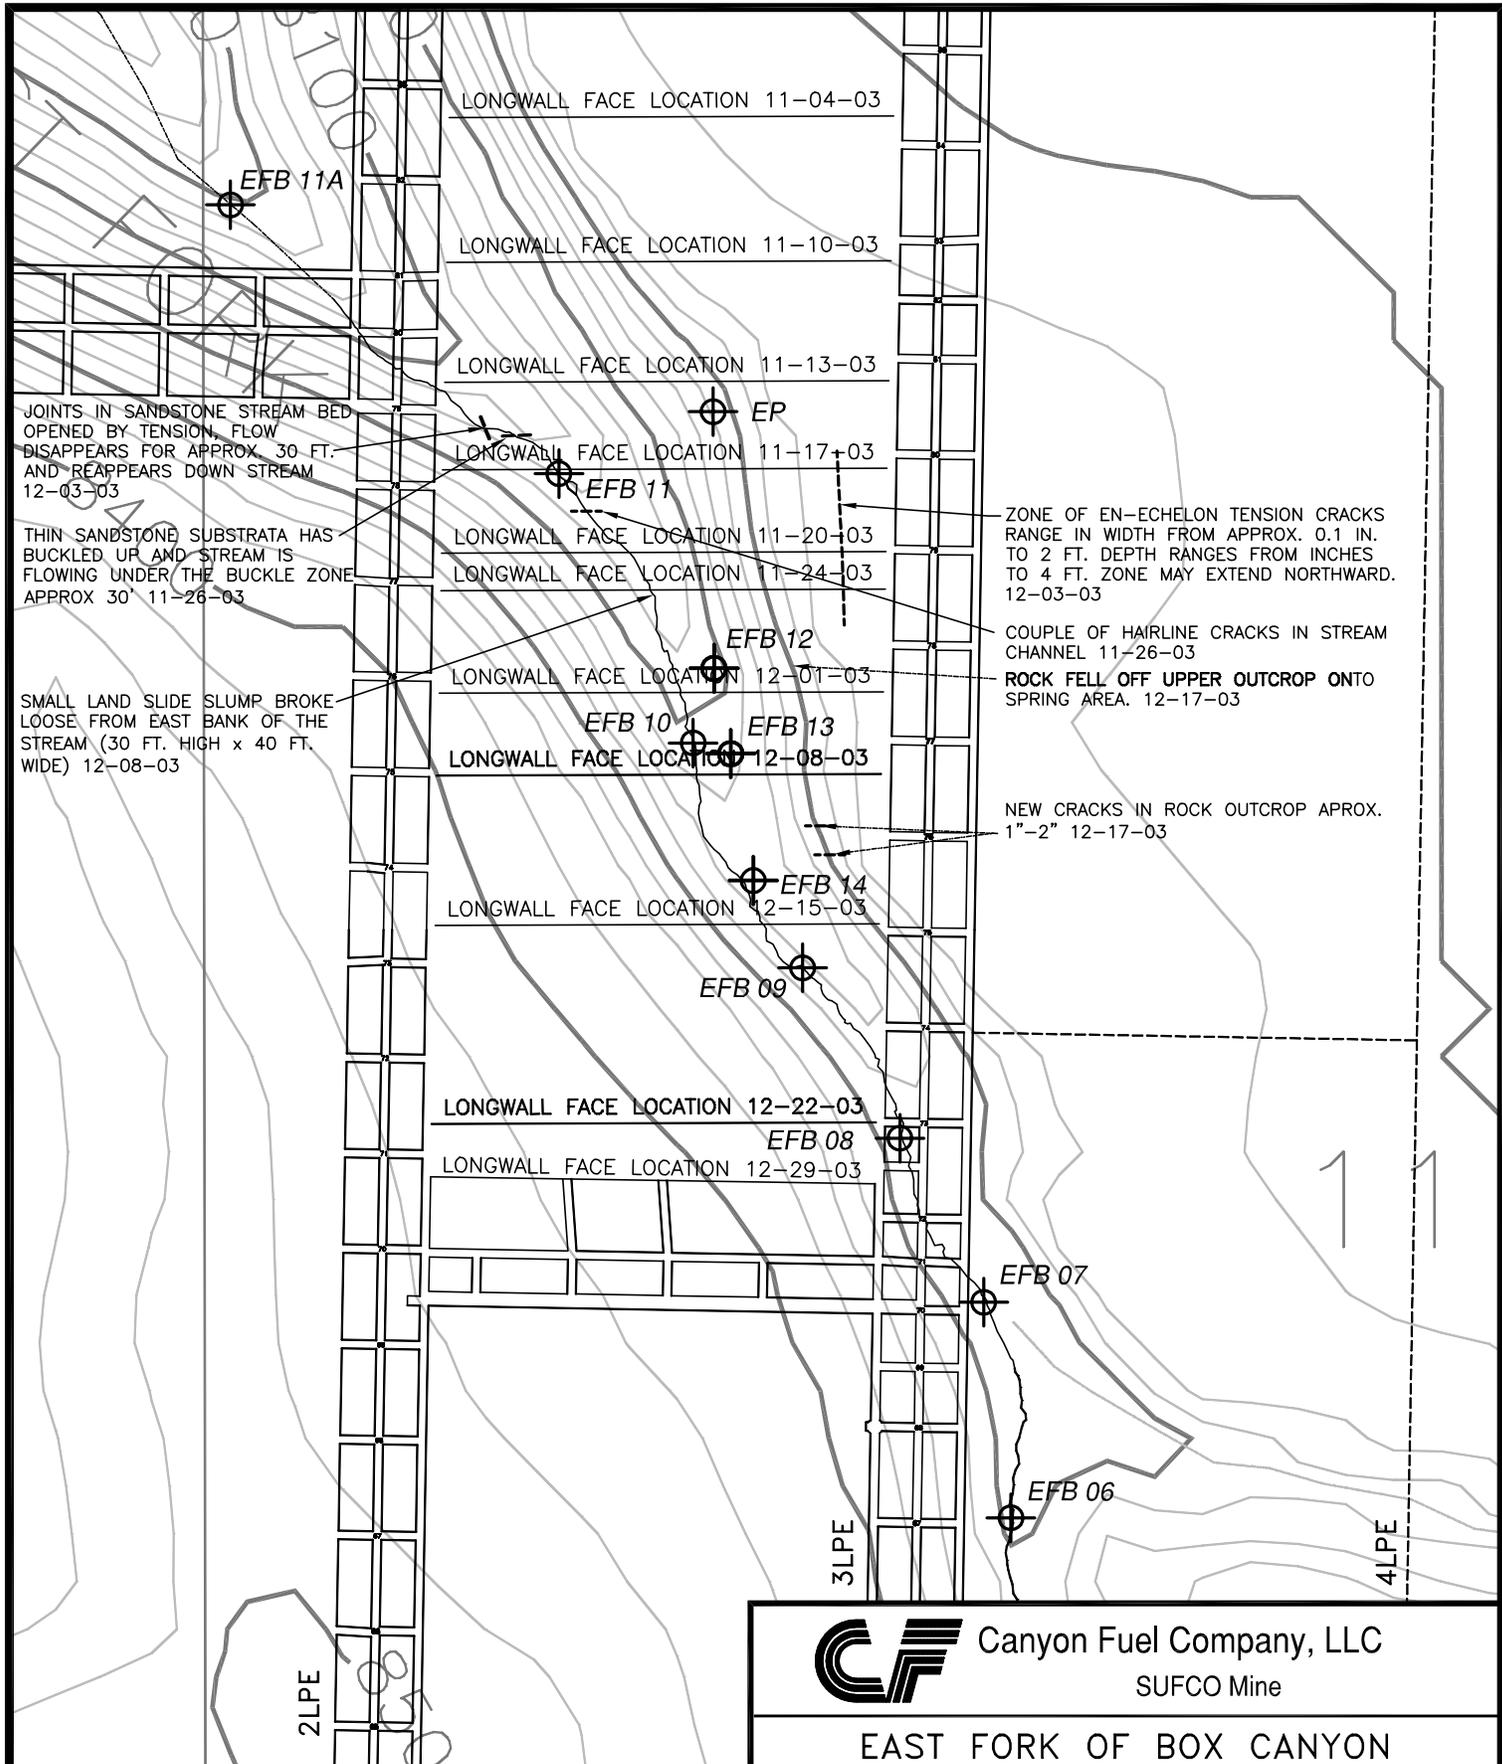
Observed some fractures in the stream channel approximately 40 yards below EFB-10. The fractures occur in thin-bedded silty sandstone in the channel bottom. All of the stream flow infiltrated into the fracture system at that point. The stream channel was dry to a point approximately 35 feet below the fracture. At that point the water (apparently all) reemerged into the stream channel. Because this reach of the stream was frozen during previous monitoring events, we could not determine if the fractures and stream infiltration are recent occurrences.

The slump between EFB-10 and EFB-11 is essentially unchanged. The slump material is mostly frozen. Did not observe groundwater discharge from the slump material as occurred immediately after the slump occurred. The small pool created by the slump material in the stream channel appears unchanged from the previous monitoring event.
