Re: Joint Permit Application for repair of subsidence cracks on the East Fork of Box Canyon  
in Sevier County

**JOINT PERMIT APPLICATION FORM**  
**U.S. ARMY CORPS OF ENGINEERS - FOR SECTIONS 404 AND 10**  
**UTAH STATE ENGINEER'S OFFICE - FOR NATURAL STREAM CHANNELS**

Location: 038° 58' 50.3" N 111° 18' 18.1" W  
 Caption: Stream Alteration Permit - East Fork Box Canyon

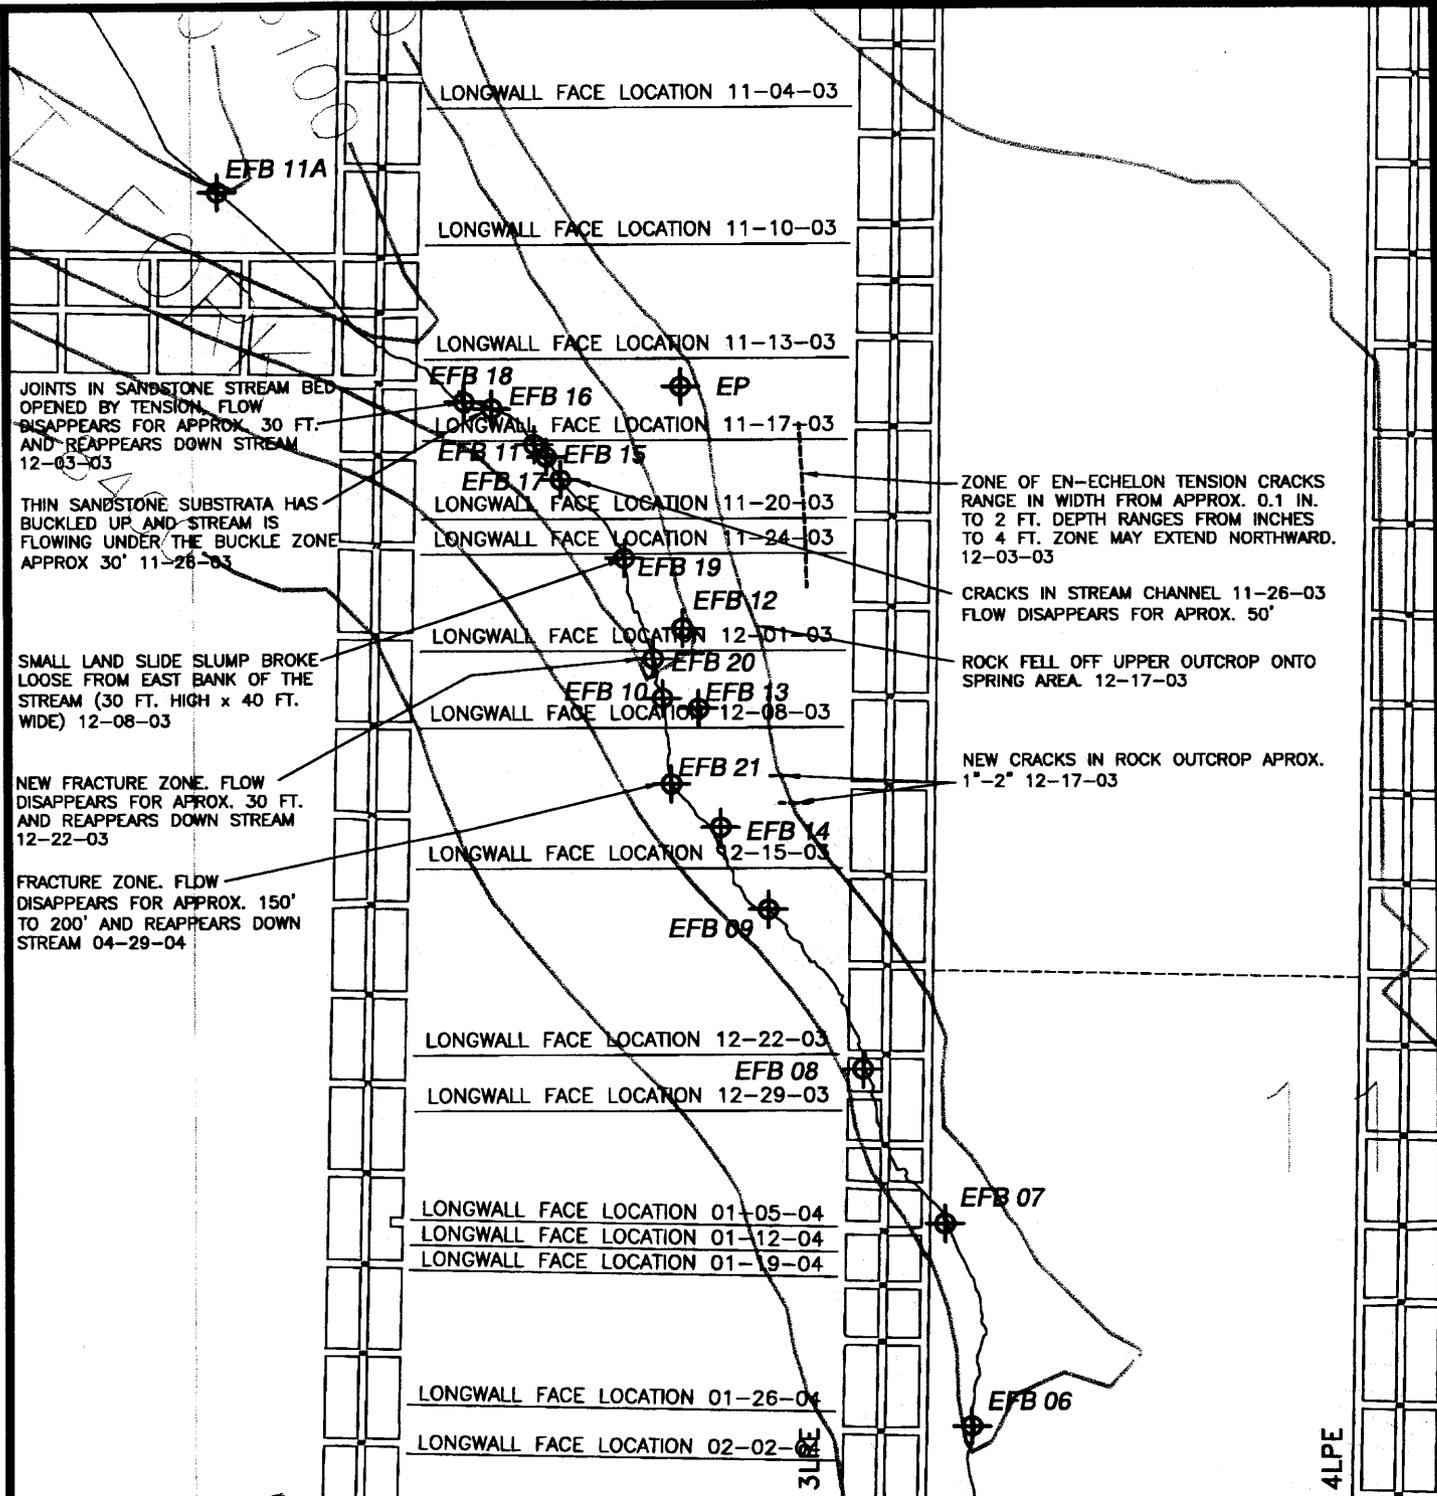
- APPROXIMATE CRACK LOCATION
- SURVEYED CRACK LOCATION
- EFB MONITORING LOCATION

<b>Canyon Fuel Company, LLC</b> SUFCO Mine	
<b>EAST FORK OF BOX CANYON          WEEKLY MONITORING</b>	
DATE: APRIL 29, 2004	SCALE: 1" = 400'
397 SOUTH 800 WEST SALINA, UTAH 84654	DRAWN BY: BDH
FILENAME: H:\DWG\DOGM\EAST FORK BOX\3LPE WEEKLY MONITORING

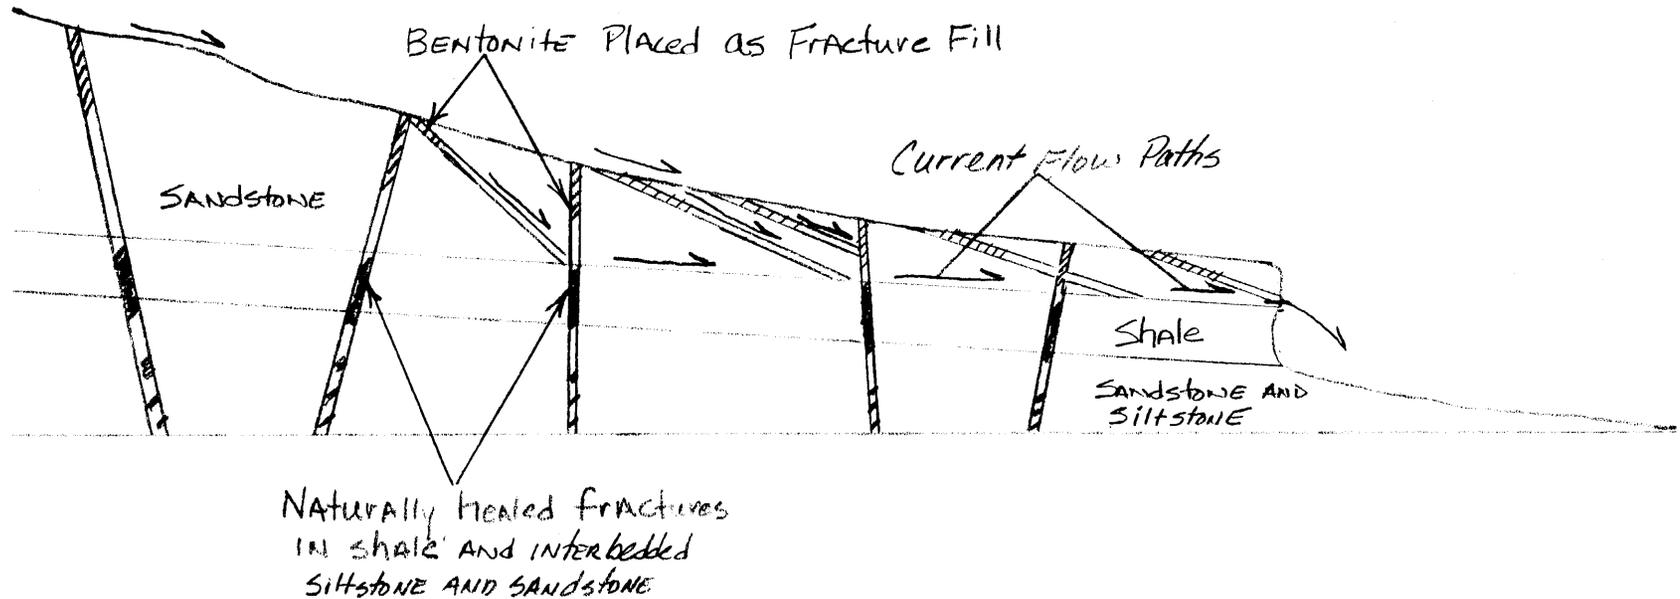
# CROSS-SECTION THRU STREAM GRADIENT

NOTE: Fracture aperture exaggerated for illustrative purposes
