Canyon Fuel Company, LLC

SUFCO Mine

RE: East Fork of Box Canyon Rim Subsidence Crack Repair
Proposed Scope of Work

SUBSIDENCE CRACK REPAIR PROJECT EAST FORK OF BOX CANYON RIM

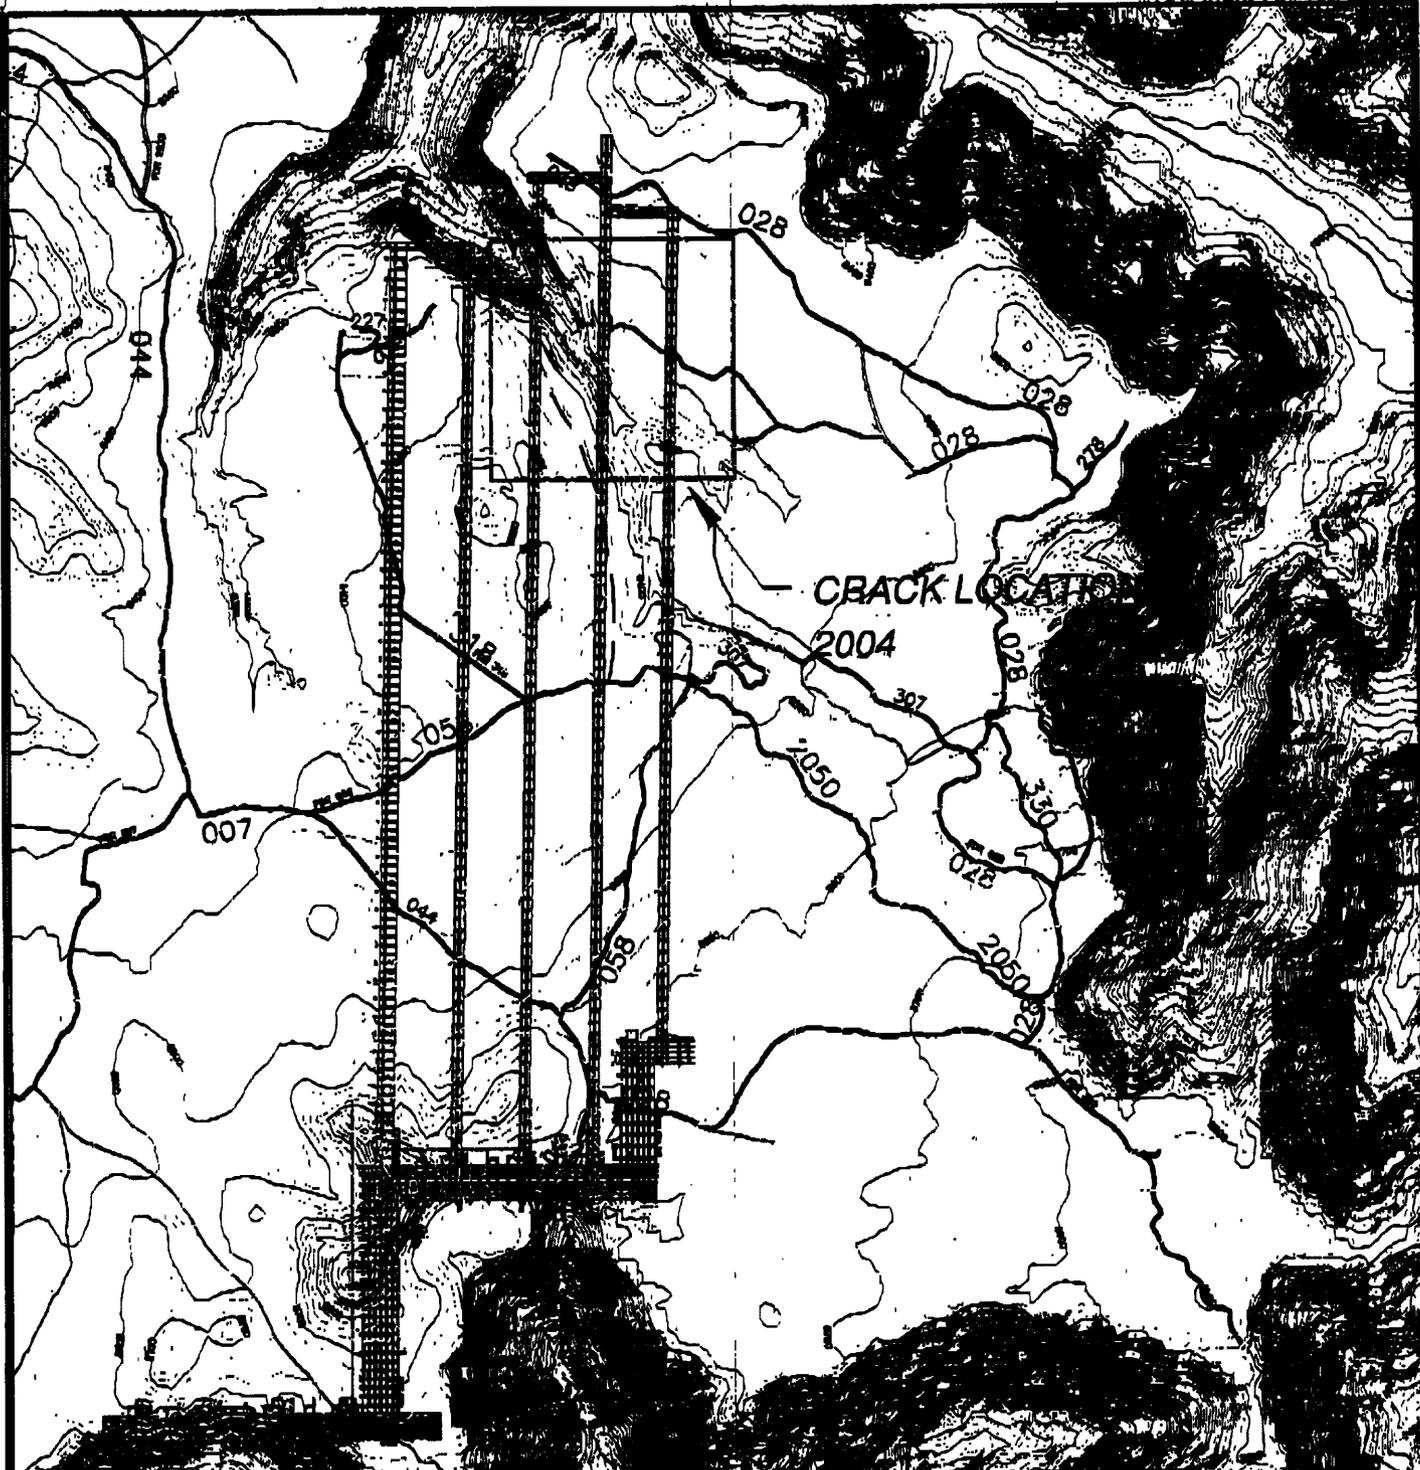
MAP: FIGURE 1

EAST FORK BOX CANYON
LOCATION OF SUBSIDENCE CRACKS

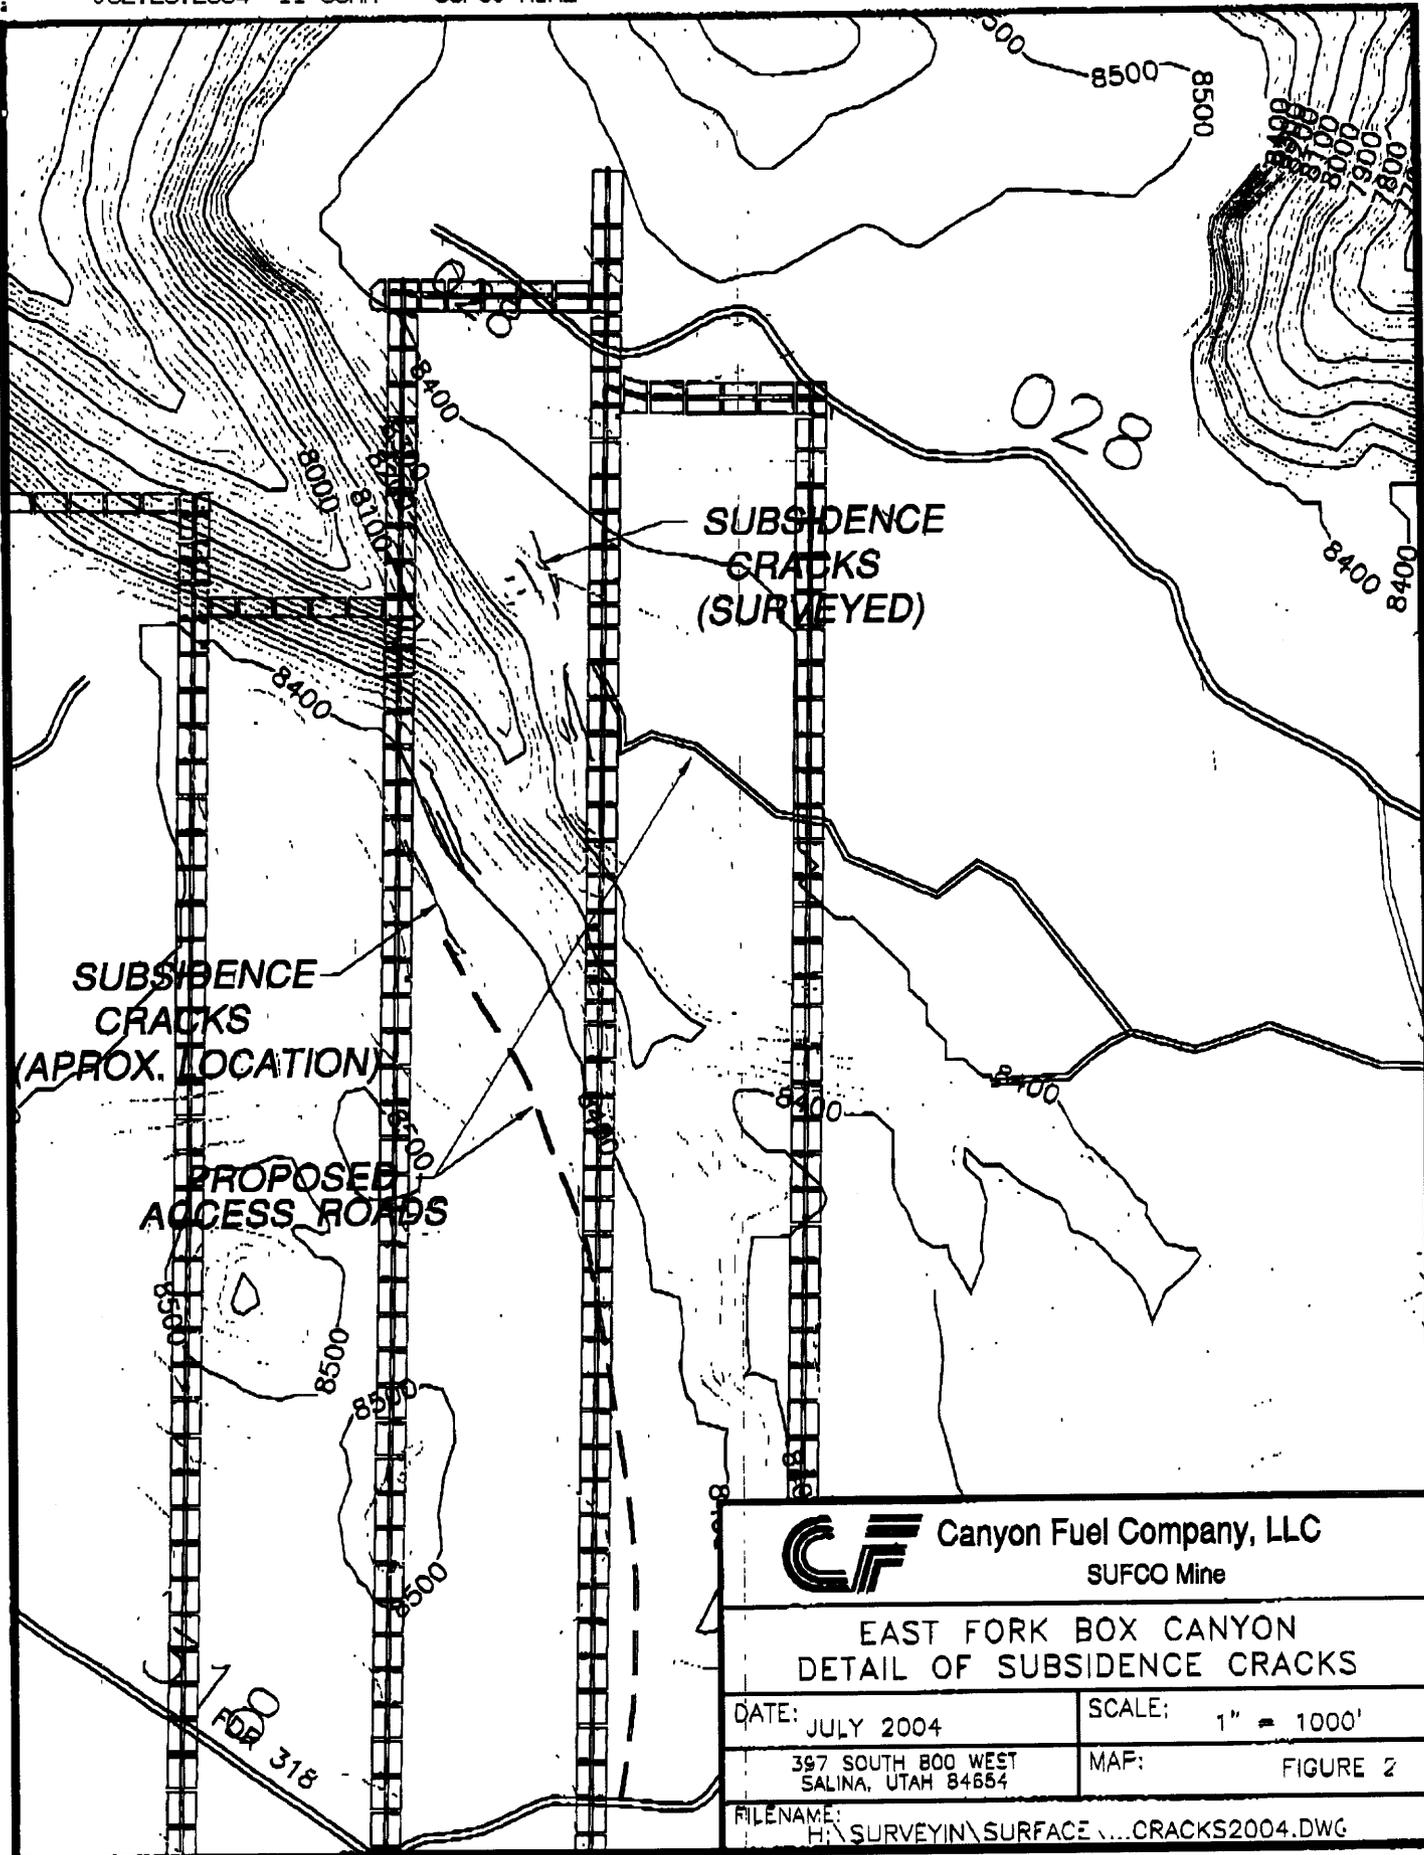
MAP: FIGURE 2

EAST FORK BOX CANYON
DETAIL OF SUBSIDENCE CRACKS
