**Canyon Fuel Company, LLC**  
SUFCO Mine  
397 South 800 West  
Salina, Utah 84654  
(435) 637-4880 Fax: (435) 636-4499

**ANNUAL MINESITE SEDIMENTATION POND  
CERTIFICATION -- 2004**

**ANNUAL WASTE ROCK SEDIMENTATION POND  
CERTIFICATION -- 2004**

**ANNUAL WASTE ROCK DISPOSAL SITE  
CERTIFICATION -- 2004**

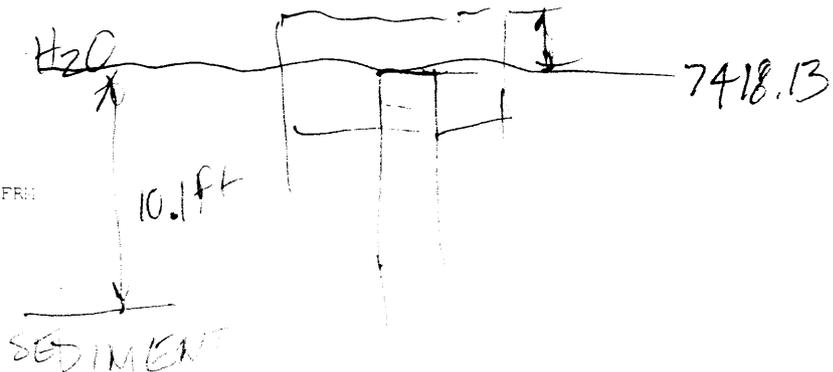
Weir level

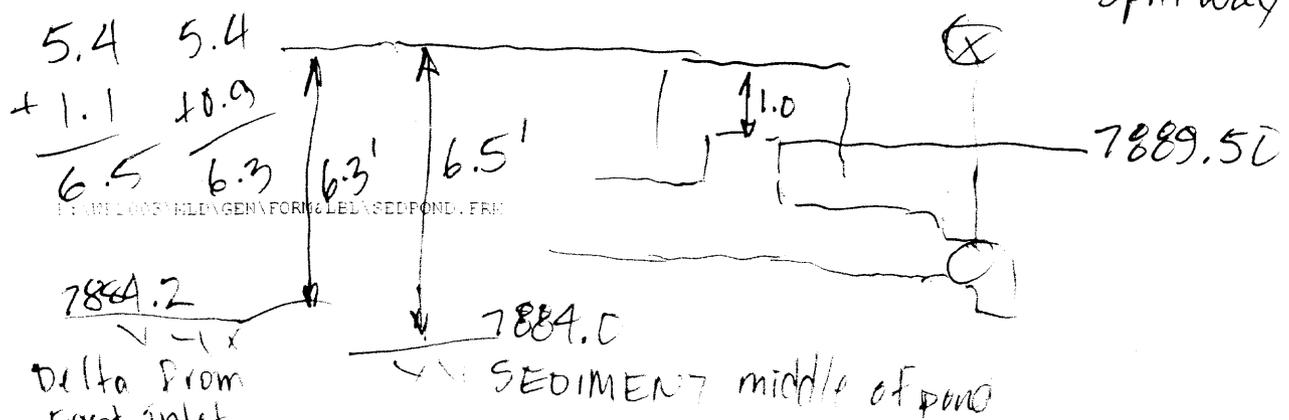
Delta from East inlet
