**Canyon Fuel Company, LLC**  
SUFCO Mine  
397 South 800 West  
Salina, Utah 84654  
(435) 286-4880 Fax: (435) 286-4499

**ANNUAL MINESITE SEDIMENTATION POND  
CERTIFICATION -- 2005**

**ANNUAL WASTE ROCK SEDIMENTATION POND  
CERTIFICATION -- 2005**

**ANNUAL WASTE ROCK DISPOSAL SITE  
CERTIFICATION -- 2005**

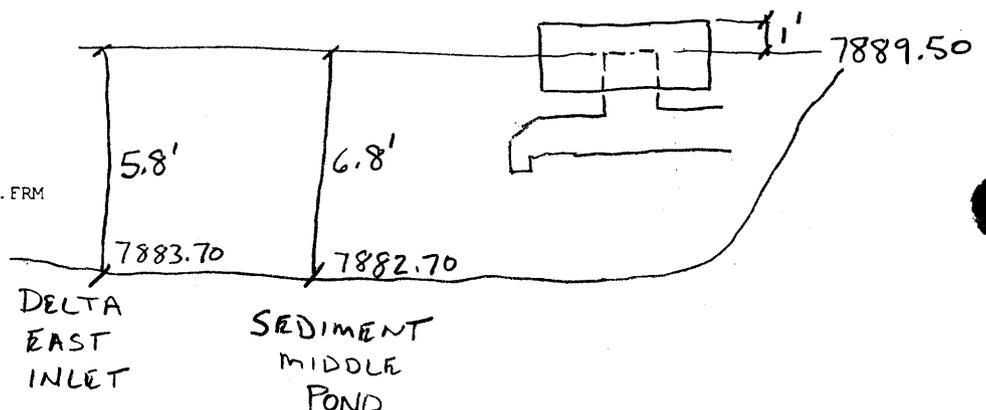
Rock Waste Sediment Pond <sup>Annual</sup>~~Quarterly~~ Inspection Report

1. Dam Structural Weakness
  - A. Cracks or scarps on crest  Yes  No  
None observed
  - B. Cracks or scarps on slope  Yes  No  
None observed
  - C. Sloughing or bulging on slope  Yes  No  
None observed
2. Major Erosion Problems  Yes  No  
None observed
3. Surface Movements of Surrounding Slopes  Yes  No  
None observed
4. Visible Sumps or Sinkholes in Slurry Surface  Yes  No  
Small amount of water from south end of pond.
5. Clogging
  - A. Spillway channels and pipes  Yes  No  
Clear never used.

Depositional delta in pond east ditch

Pond looks good no evidence of discharge. Decent pond okay. No erosion, No structural weakness, spillway clear - need to spray rabbit brush in spillway
