Canyon Fuel
Company, LLC.
Sufco Mine

RE: East Fork of the East Fork of Box Canyon Rim Subsidence Crack Repair
Proposed Scope of Work

SUBSIDENCE CRACK REPAIR PROJECT EAST FORK OF THE EAST FORK OF BOX CANYON RIM

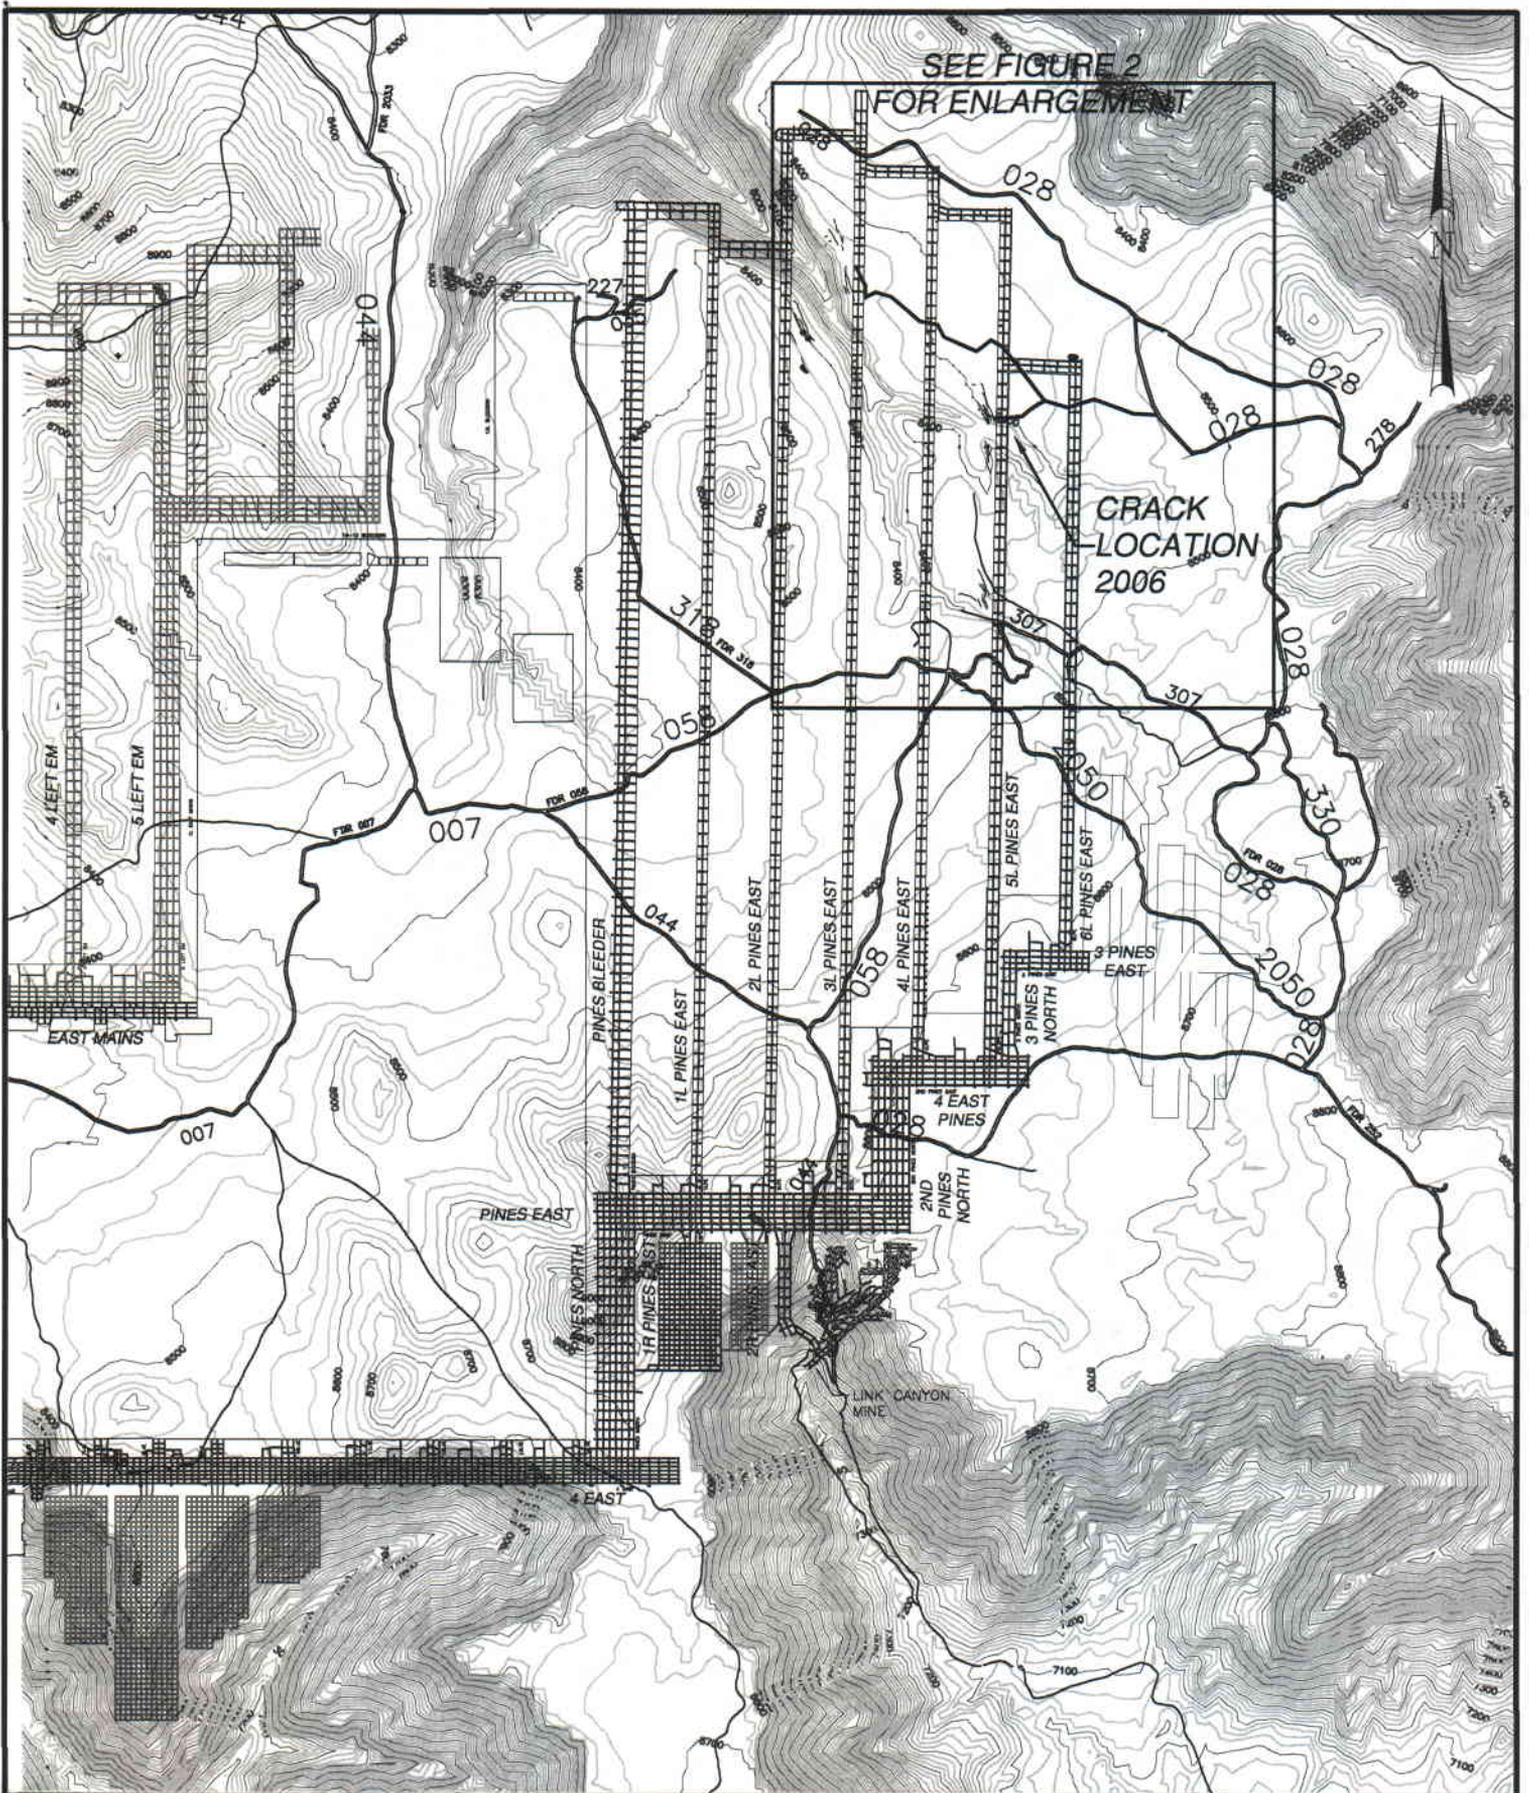
SHEET NO.
Figure 1

Several open subsidence cracks were formed on the North rim of the East Fork of the East Fork of Box Canyon as a result of longwall mining of the 5 Left Pines panel in late 2005 and early 2006. The cracks are located on Manti-LaSal National Forest lands in the SE1/4 of Section 11, and NE1/4 of Section 14, T12S, R5E, SLM. Portions of these cracks are open enough to be considered hazardous to humans and wildlife. Therefore, Canyon Fuel Company, LLC, SUFCO Mine proposes to repair the open cracks using the methods described within this project description.

Laborers will be present to operate the equipment and perform other duties as needed. It is anticipated the cracks with large openings will first be partially filled with rock or Omega blocks. The rocks and/or blocks will be used to bridge the opening at the point where the crack becomes too narrow for the rock or blocks to fall farther downward. The rocks used may be, in part, generated by knocking loose rock from the upper edges of the open crack using either the bucket of the track or backhoe or a hydraulic hammer attachment. Rocks, or other available material, will be used to bridge smaller cracks at depth. Once the bridging material is in place, expanding polyurethane foam will be placed on top of the bridge and to within one to two feet of the ground surface. After a suitable time for curing of the polyurethane foam, soils from the area on either side of the cracks will be scraped into the remaining void. The placed soils will be left in a roughened state then seeded using the reclamation seed mix approved for the drill site disturbances that are located in the same general area (01-11-1 and 01-11-2).
