2007 ANNUAL REPORT

CANYON FUEL COMPANY, LLC SUFCO MINE ACT/041/002

Re: 2007 Annual Report for Canyon Fuel Company LLC, SUFCO Mine
C/041/002, Sevier County, Utah

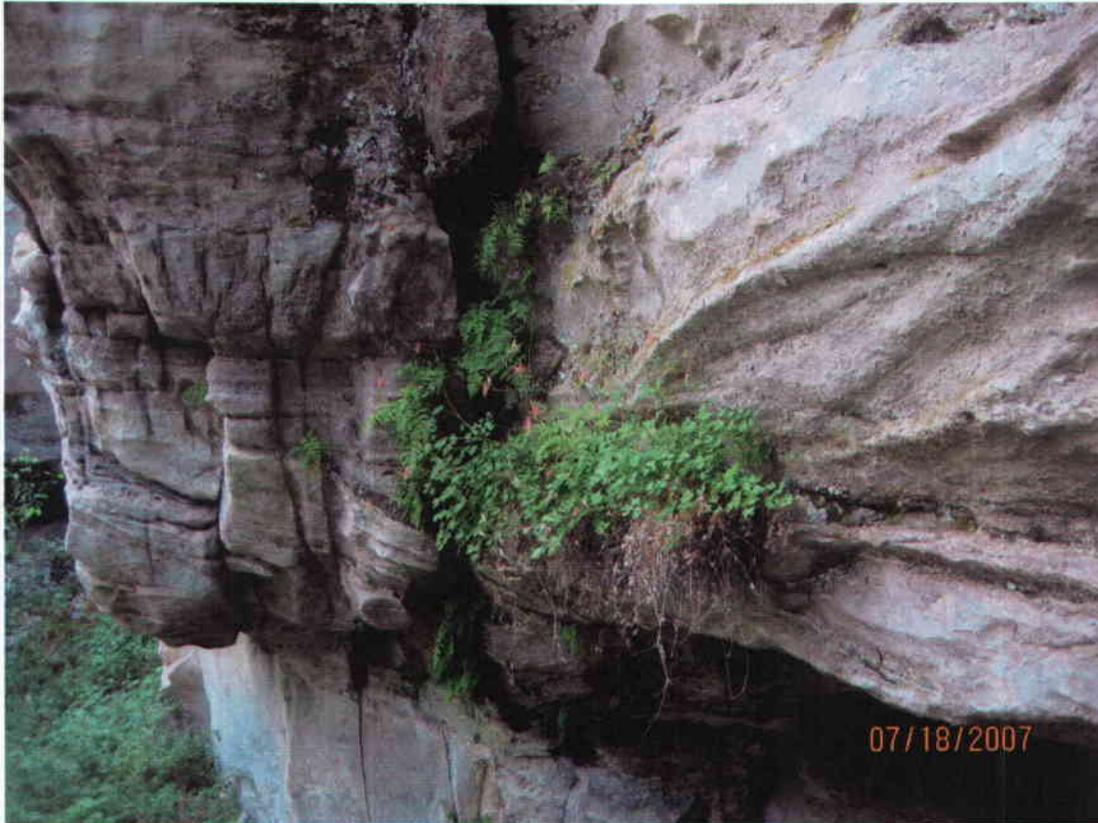
Photo Point 1a

At photo point 1a there is still one plant growing. It has a few inflorescences that are 18-24 inches in length. There are fewer inflorescences than last year. The vigor is good.

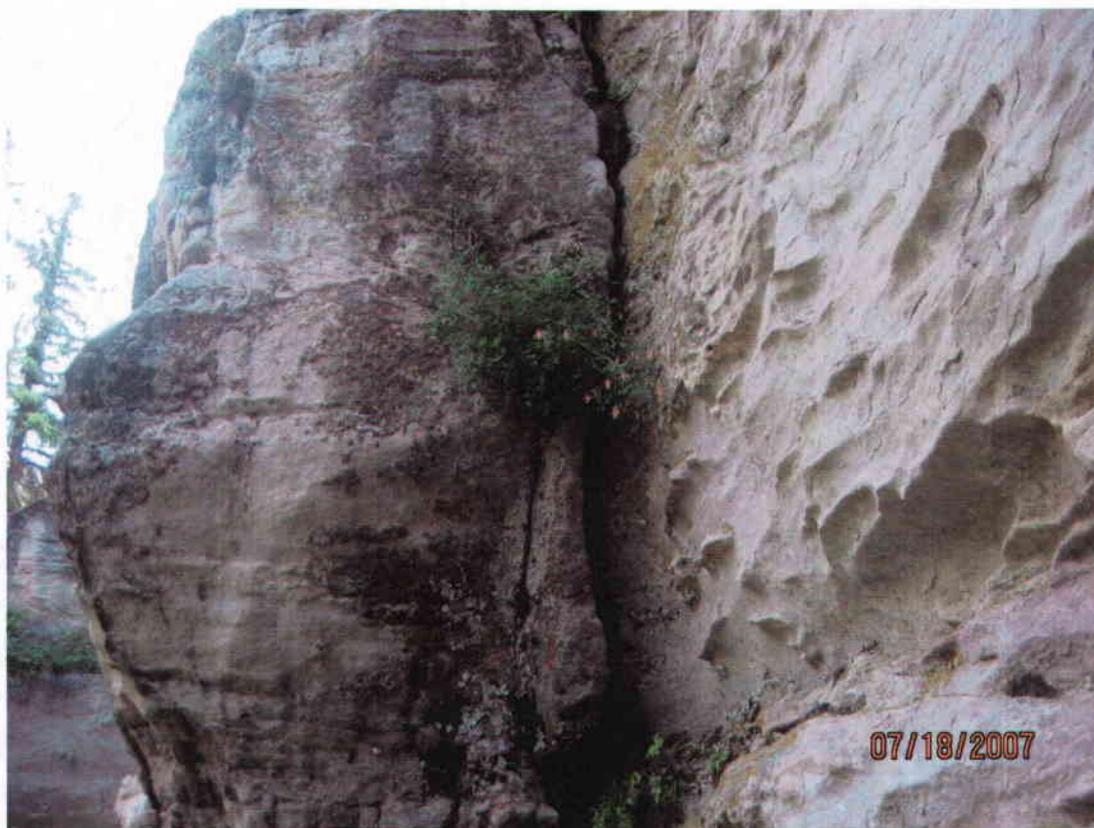
Photo Point 1b

At photo point 1b there are two columbine plants. One plant appears to be dying while the other plant is healthy and has good vigor. Only the healthy plant has any inflorescence and it is approximately 24 inches in length, exact measurements cannot be made due to the location of the plants. These plants appear to be getting some moisture from the rock fractures that they are growing in.

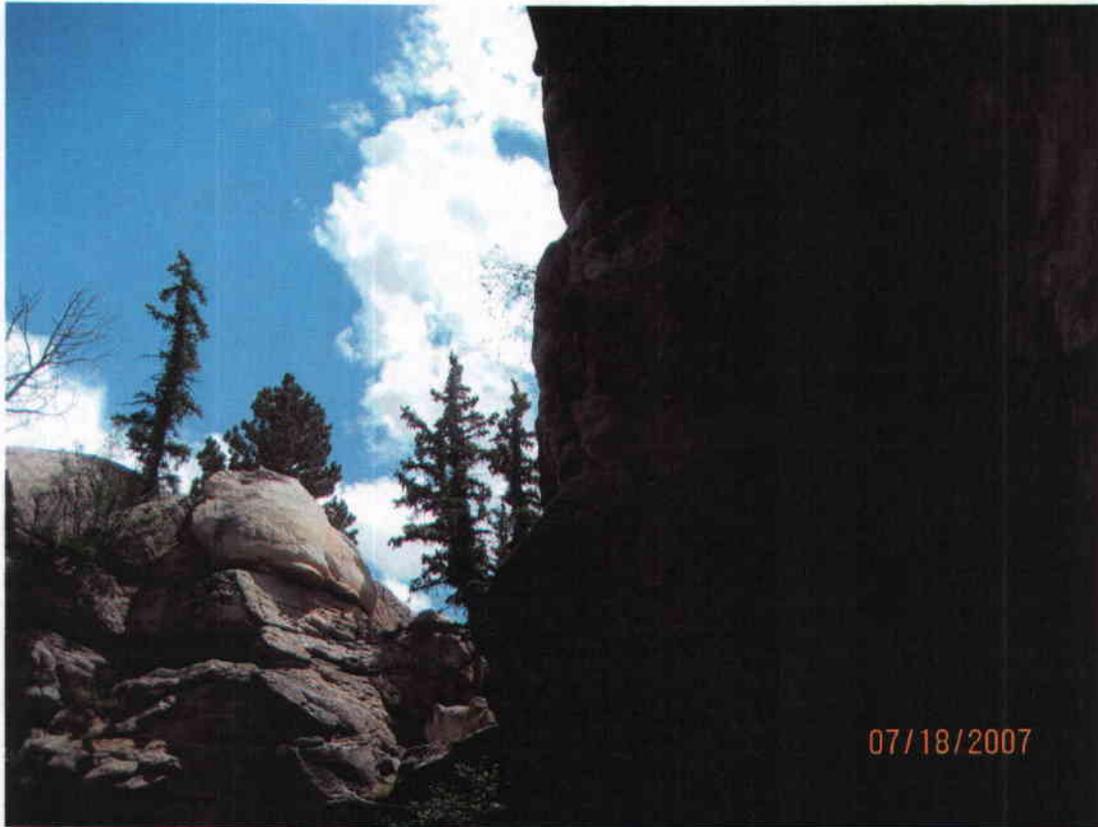
Photo Point 1c

At photo point 1c there is only one columbine plant and it is located approximately 20-25 feet up on the cliff face, so exact measurements cannot be made. It appears that there is still only one plant at this site. The columbine plant only has one inflorescence that is approximately 18 inches in length. The plant appears to be in good vigor. This plant is probably also getting some moisture from the rock fracture that it is growing in. Due to the location of this plant and the position of the sun it is difficult to get a good picture of this site.

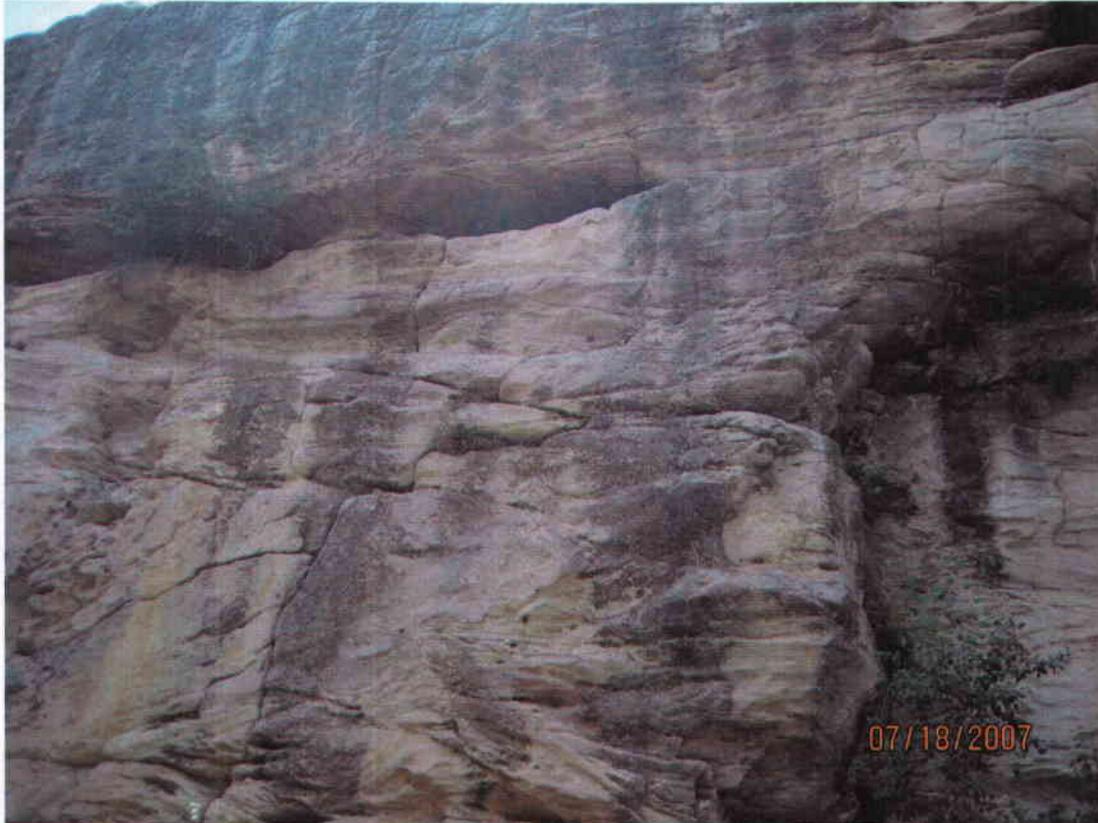
Photo Point 2

At photographic point 2 the columbine plants are located approximately 20-25 feet up on the cliff face, so exact measurements can't be made. There appears to be three plants at the site, one that is dead, one that is dying and one that is in fair vigor. The inflorescence on the living plant appears to be sparse and 10-12 inches long.

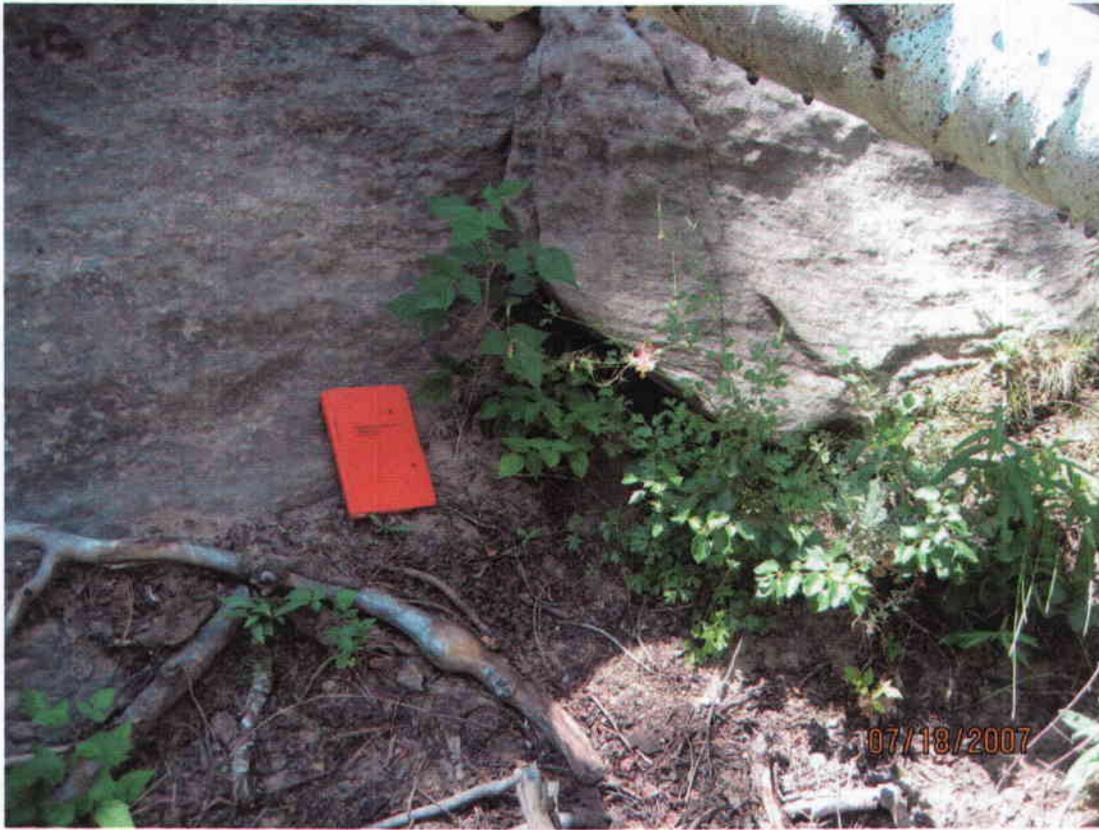
Photo Point 3

At photographic point 3 there are two columbine plants, one small immature plant and one mature plant. The mature plant has an 18 inch inflorescence and most of the flowers have set seed. There is no inflorescence on the immature plant. The vigor of both plants is considered fair.

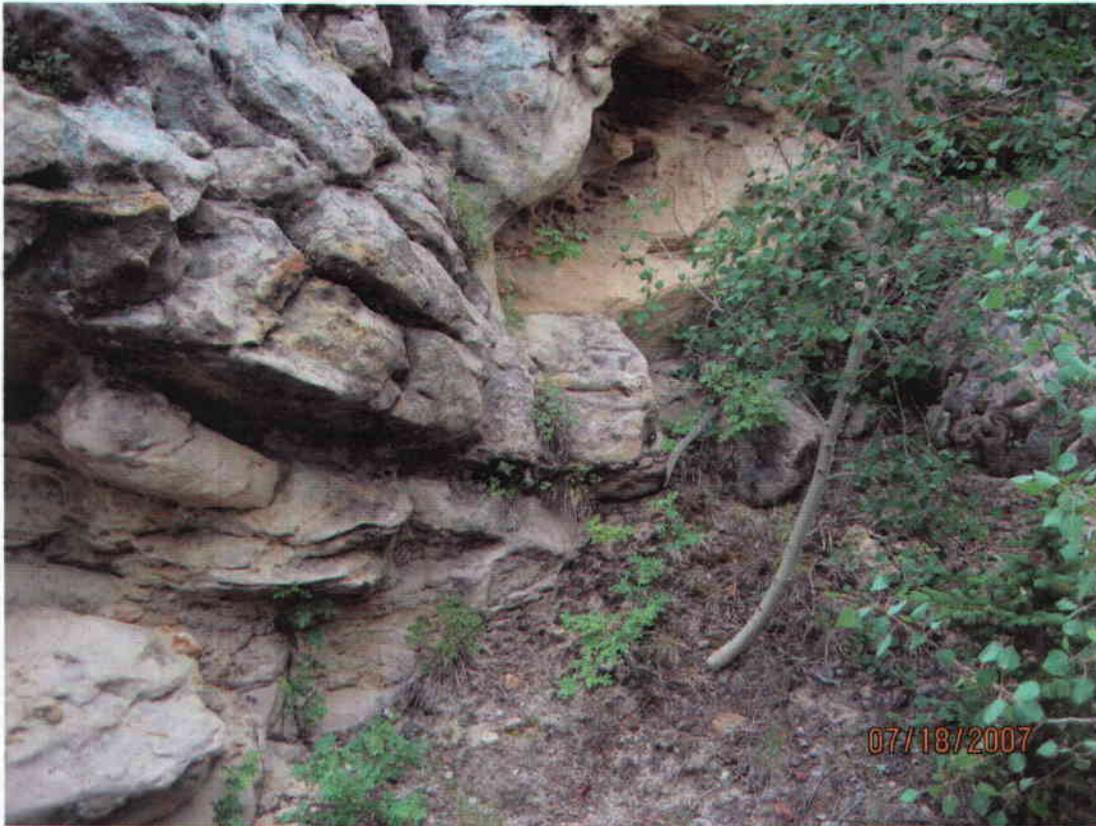
Photo Point 4

At photographic point 4 there are several columbine plants. Most of the plants have no inflorescence. There are two columbine plants with inflorescence that are 8-10 inches high and have poor vigor. The *Carex* plants have a basal growth of 2-3 inches with no seed heads. Woods Rose has new twig growth of 1-2 inches and no flowers or seed heads. Aspen has a new twig growth of 2-3 inches. There is one *Potentilla* plant and it has new growth of 4-6 inches. This is a very dry site and all of the plants are showing low vigor which is probably due to the lack of moisture. The site has not been grazed.

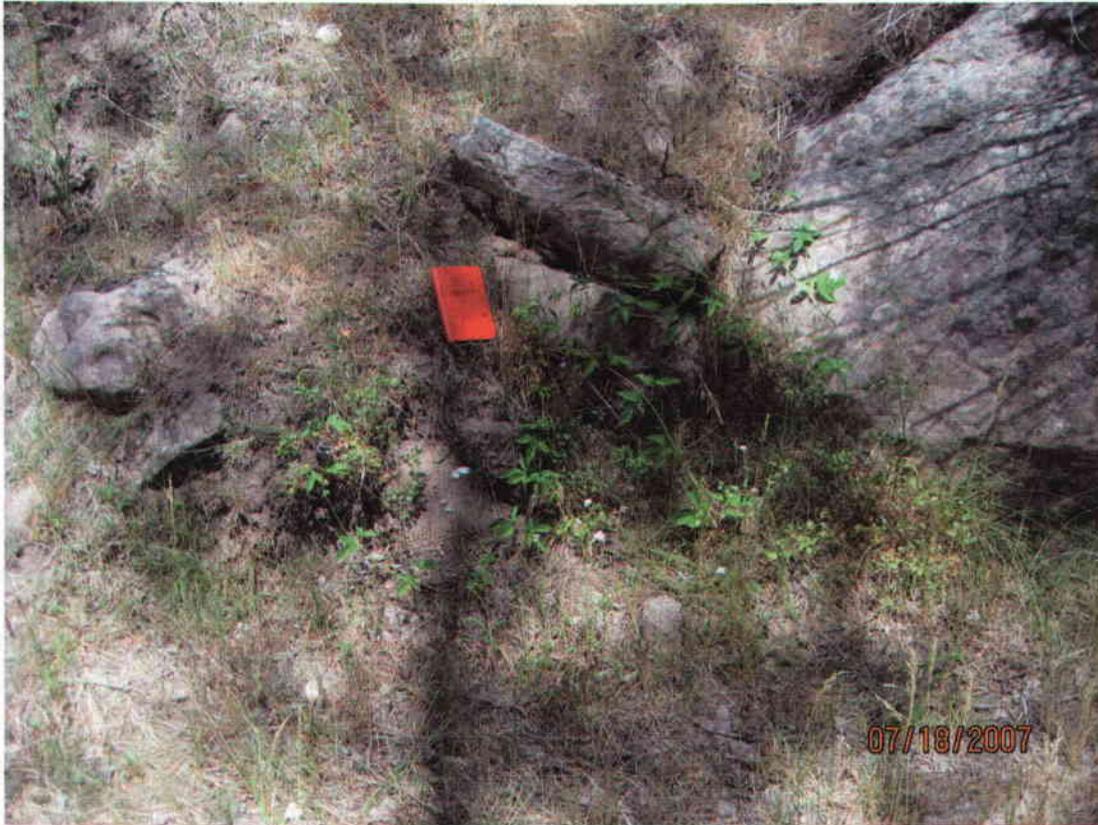
Photo Point 5

At photographic point 5 there are three columbine plants. All plants are in bloom and have set some seed. One plant has an inflorescence of 12 inches, one plant has an inflorescence of 18 inches and the third plant has an inflorescence of 24 inches. The Bluegrass has set seed with a few seed heads 12-16 inches high. The basal growth of the bluegrass is 4-6 inches and is going dormant. The Hairgrass is dormant with no new growth this year. Carex has no seed heads with a basal growth of 6-8 inches. Yarrow is in bloom and is 12-16 inches high. There is no water in the creek drainage. The site is dry and has not been grazed this year. Overall vigor is considered fair.

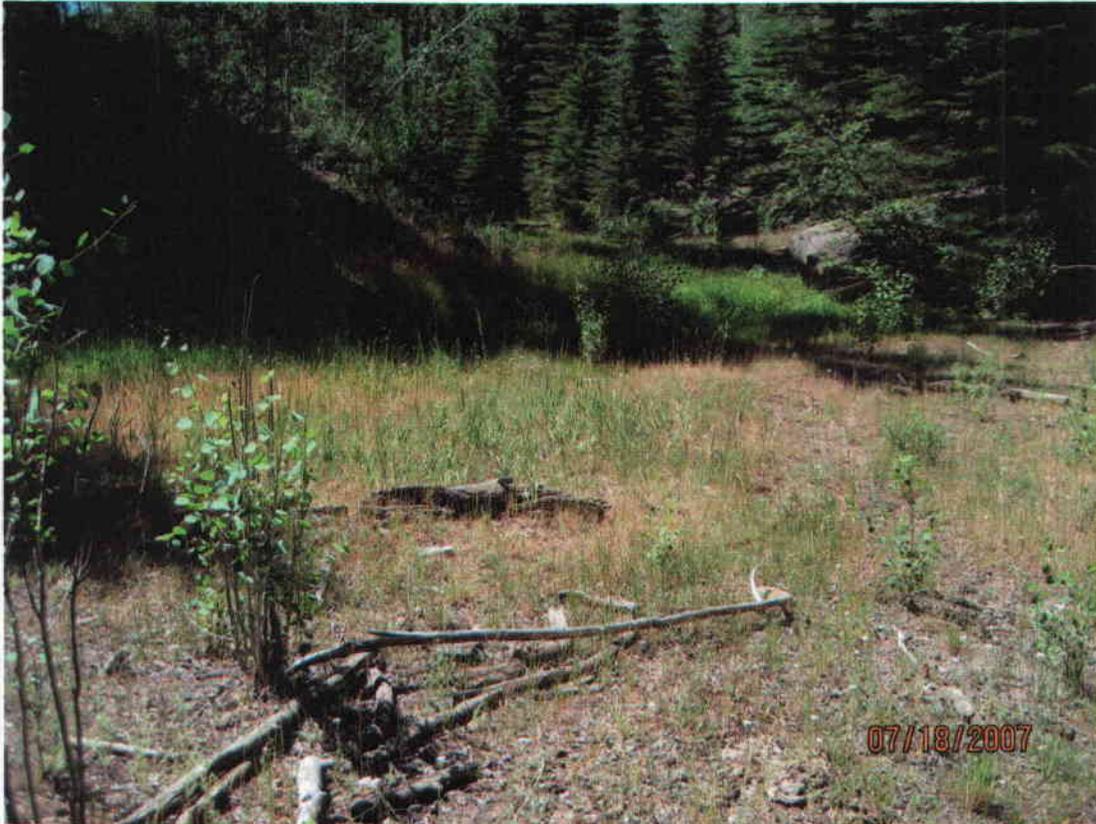
Photo Point 6

At photographic point 6 the site is dry and has not been grazed this year. Aspen has a new twig growth of 12-18 inches. Wood Rose has 4-6 inches of new twig growth but has no blooms and no seed heads. Yarrow is in bloom and is 12-14 inches high. Bluegrass has 4-6 inches of basal growth with seed heads on approximately 30% of the plants. The bluegrass density is low. The Herbaceous Sage is 10-12 inches high and is just coming into bloom. Carex has new basal growth of 4-6 inches and approximately 50% of the plants have gone dormant. Wiregrass is 10-12 inches high with very few plants on the site. Ocular estimate show the site to have 25-30% bare ground. The overall vigor of the site is low fair to poor. At the wet riparian site along the edge of the creek channel the Carex is 12-14 inches high with good vigor. There is no water in the creek channel.

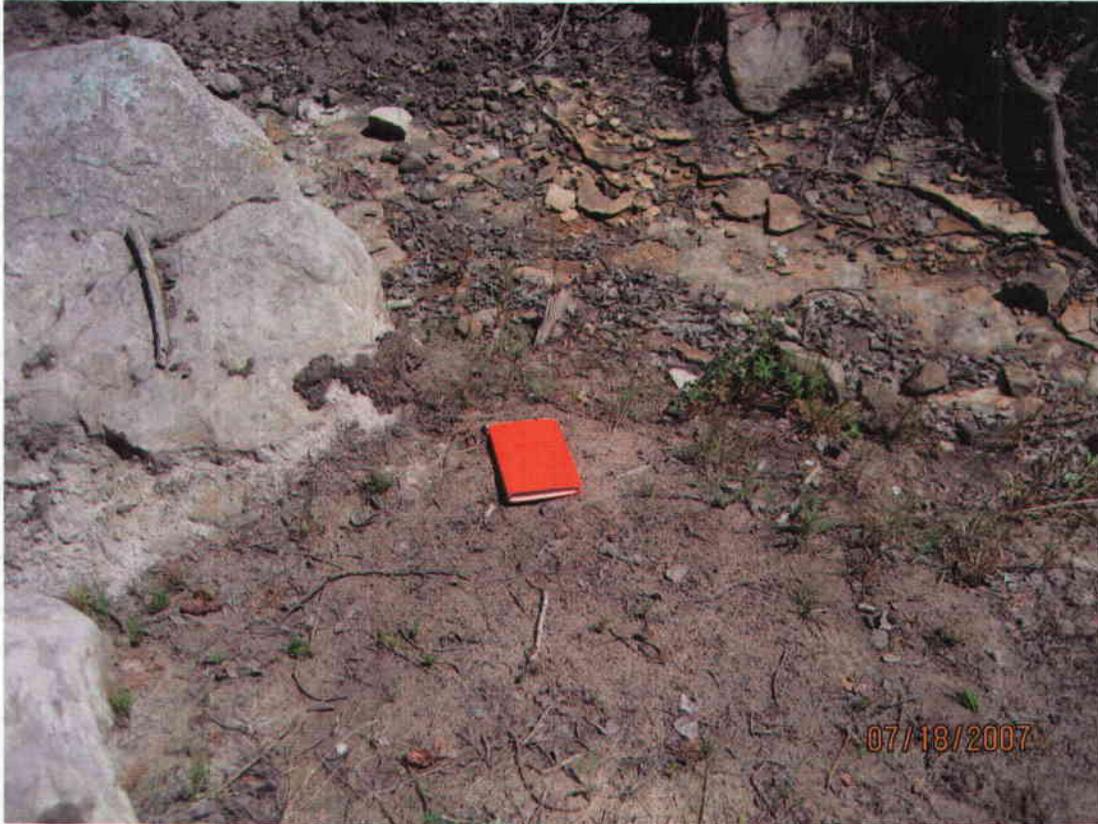
Photo Point 7

At photographic point 7 there are still no columbine plants. The site has not been grazed and there is no water in the creek bed. The Geranium plant is in bloom and has an inflorescence of 11 inches high. Yarrow has a basal growth of 2-3 inches with very few seed heads that are 5-6 inches high. Carex has a basal growth of 5-6 inches with no seed heads. There are a few Horsetail plants that are 1-2 inches high. There are a few bluegrass plants with 10-12 inch seed heads. Bluegrass density is very low. Ocular estimates indicate the site to have 80-85 % bare ground. Overall plant vigor is poor.

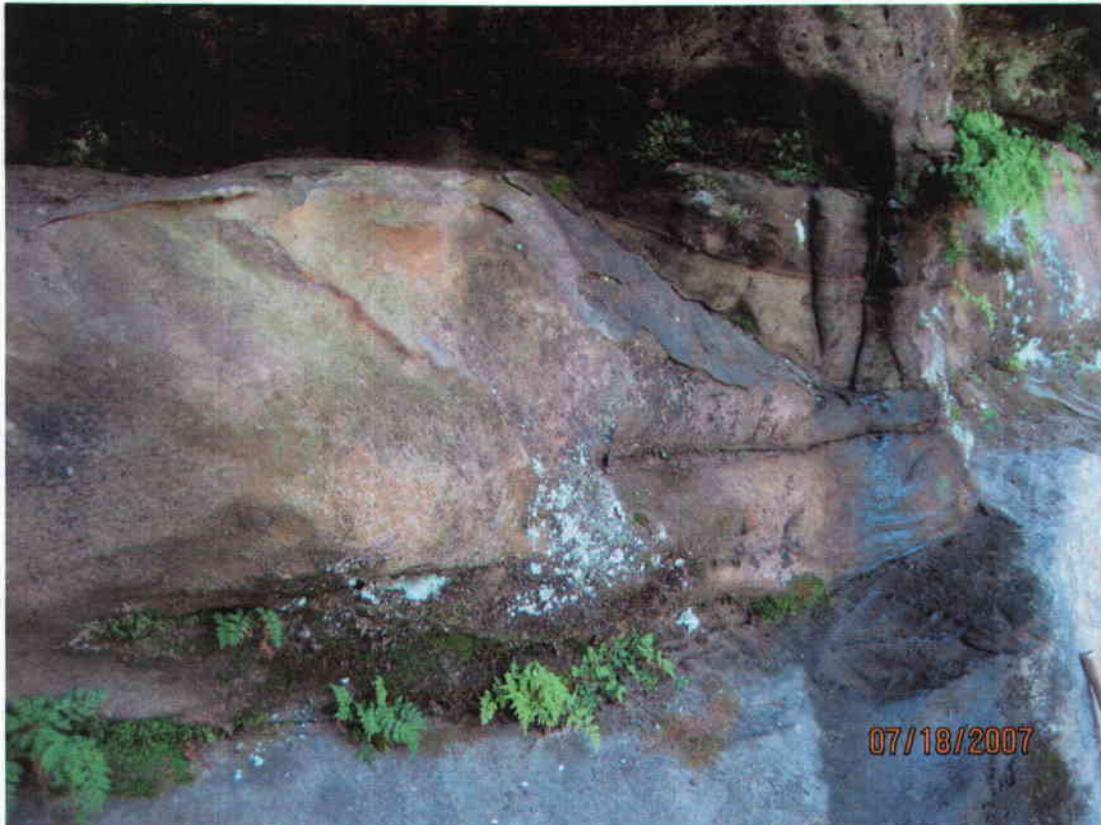
Photo Point 8

Photographic point 8 is a hanging fern area located in the Grotto area. The ferns and the lichens receive moisture coming from the fractures in the cliff face. It does not appear to be as much moisture as last year. The ferns are not as dense as last year and have a current growth of 4-8 inches. There are very few new small ferns or lichens. There are some dead ferns.

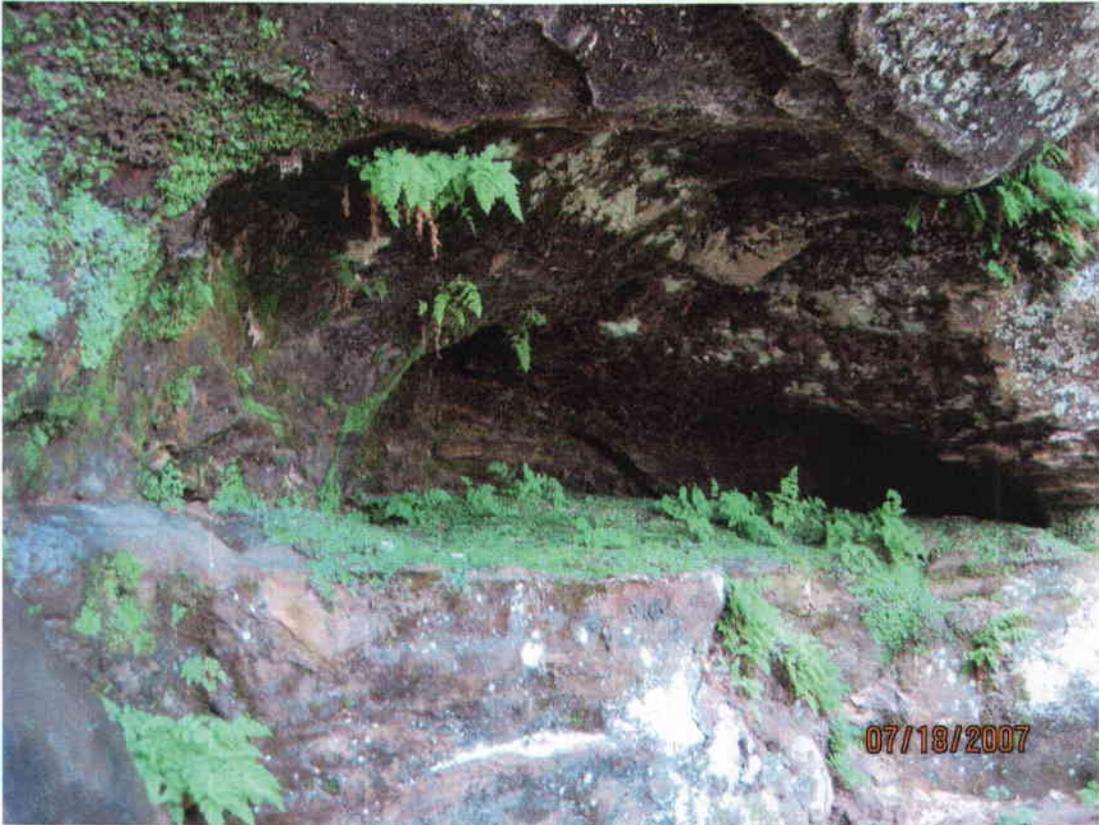
Photo Point 9a

Photographic point 9a is located in the Grotto Area and there is moisture coming from the fractures in the cliff face. The ledge is covered with lichens. The ferns have a current growth of 4-6 inches.

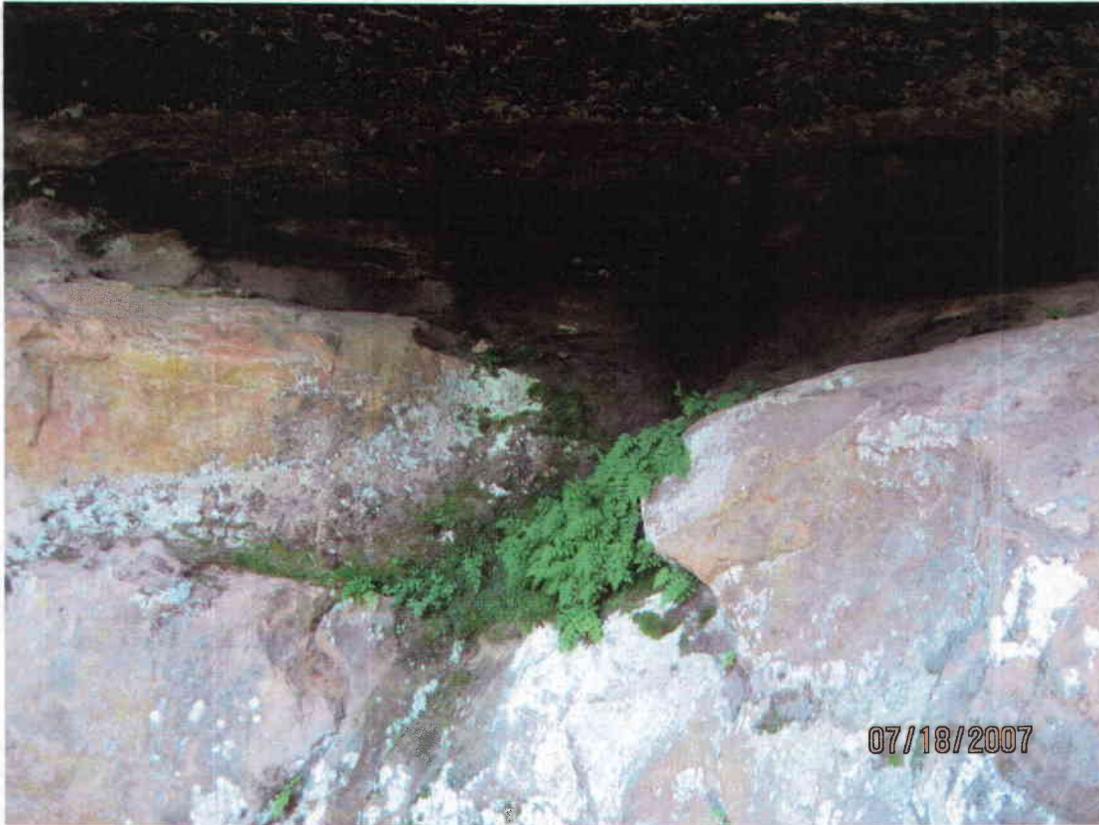
Photo Point 9b

Photographic point 9b is also located in the Grotto Area. There is moisture coming from the fractures in the cliff face. There is good lichen growth and good density of ferns but somewhat less than last year. The current growth of the ferns is 4-6 inches.

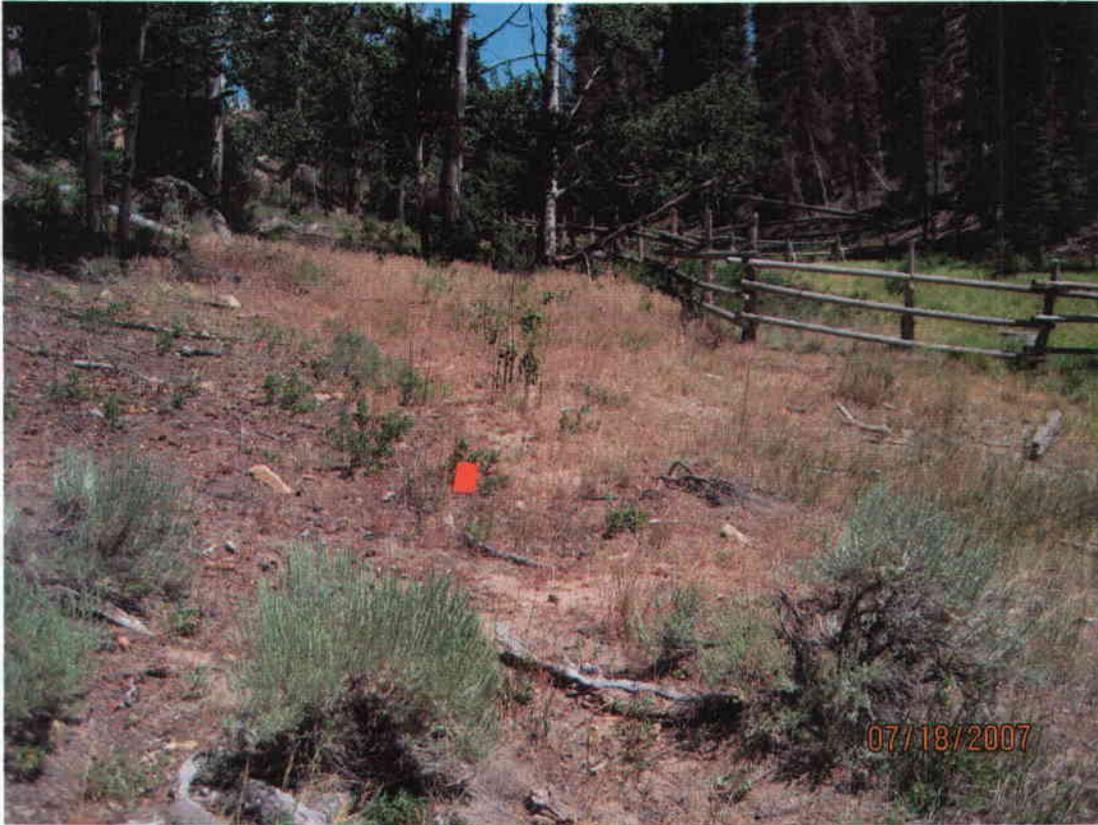
Photo Point 10

Photographic point 10 was originally a dry meadow site but it is becoming a dry sagebrush/grassland site. The site has not been grazed this year. The Aspen has a new growth of 6-8 inches. Woods Rose has a new twig growth of 1-2 inches with no flowers or seed heads. The sagebrush has a new twig growth of 4-6 inches. The sparse scattered wiregrass plants are 8-10 inches high with no seed heads. All of the grass species have gone dormant and have no current growth. Ocular estimate show the site to have 50-60% bare ground. Overall vigor at this site is poor.

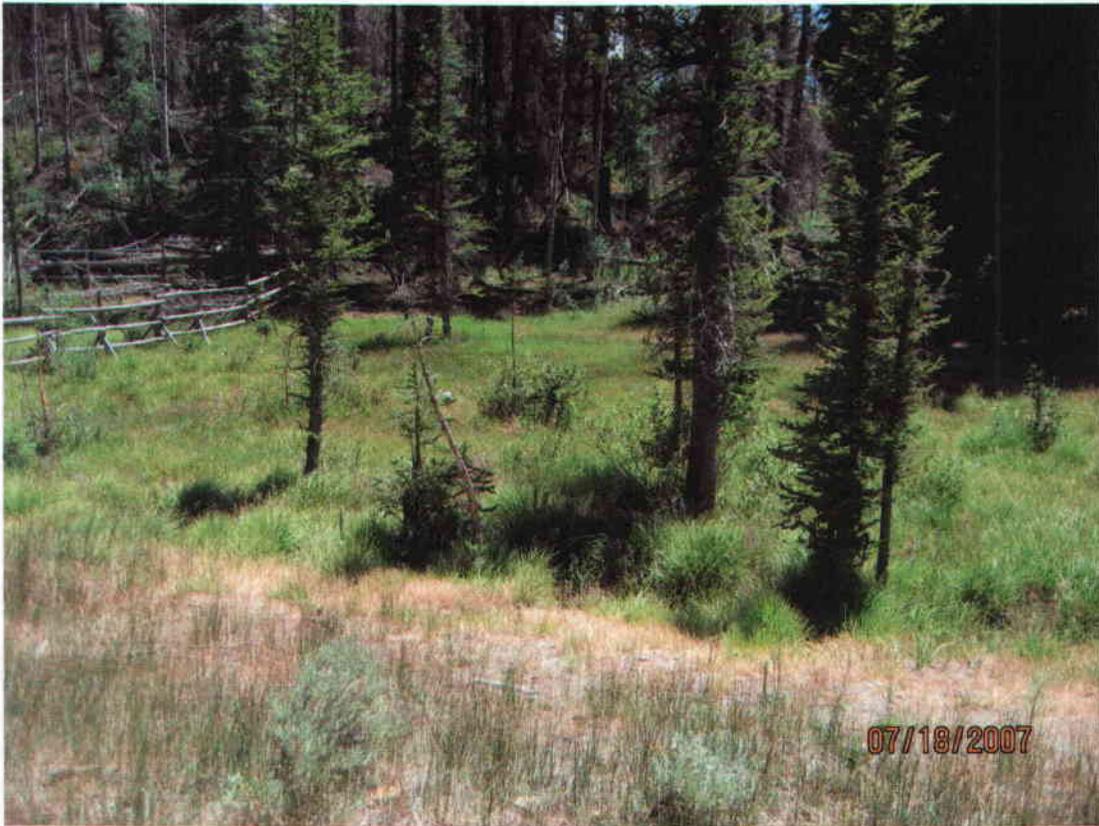
Riparian Area adjacent to Photo Point 10

The riparian area adjacent to Photo Point 10 is growing good with the Carex plants 12-14 inches high with good density and good vigor. Although the surface moisture has stopped the condition of the plants indicate that there is good sub-surface moisture available to these plants.

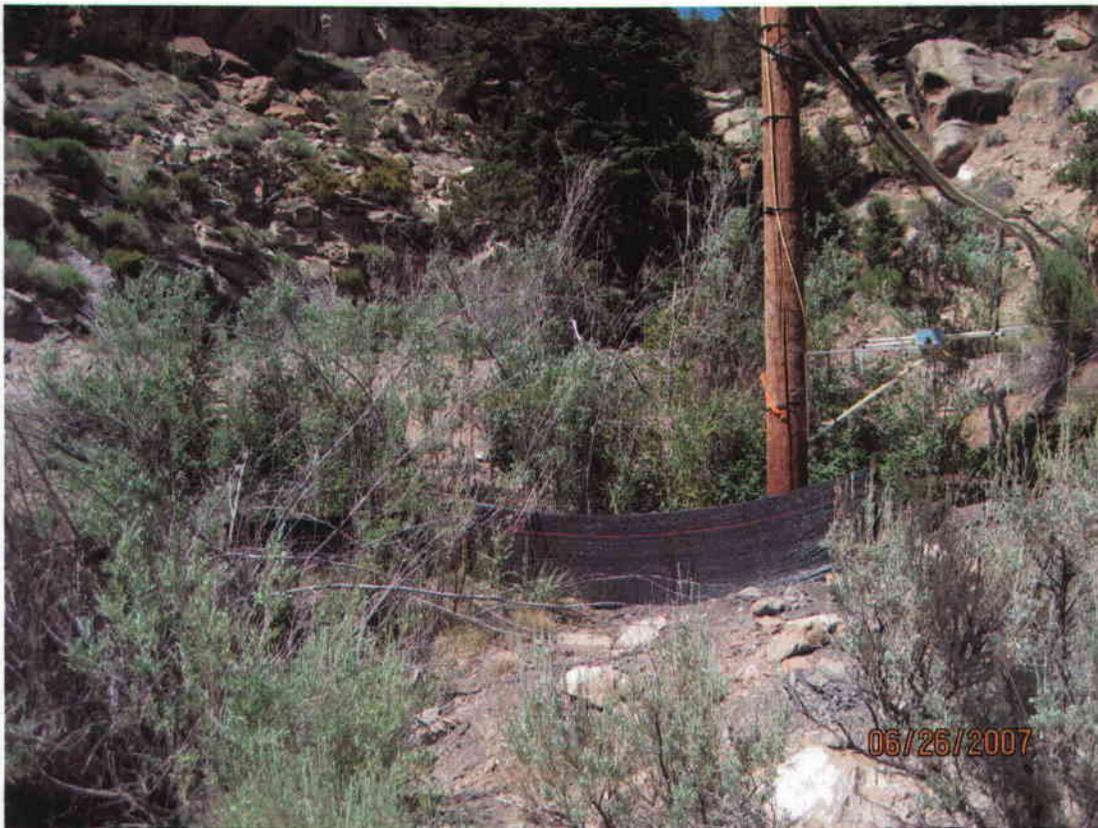
Link Canyon West Portal Photo Point

There is no water discharge from this portal and there is no evidence that there has been any. The Willow (*Salix spp.*) has bloomed. There are insects galls on all most of the

seed heads. The Willow has 2-4 inches of new growth. Woods Rose (*Rosa woodsii*) has bloomed but did not set any seed. It has 2-3 inches of new growth. Bluegrass (*Poa pratensis*) has all gone into dormancy and produced no seed heads or growth this year. Density is low. The density of wiregrass (*Juncus balticus*) is low. The new growth on the wire grass is 10-12 inches with very few seed heads. Clematis (*Clematis liqusticifolia*) has fair growth. The Squawbush (*Rhus aromatica* var. *trilobata*) has flowered and set some seed, and has new growth of 2-5 inches twig growth. The overall growth and vigor at this portal is down from last year.

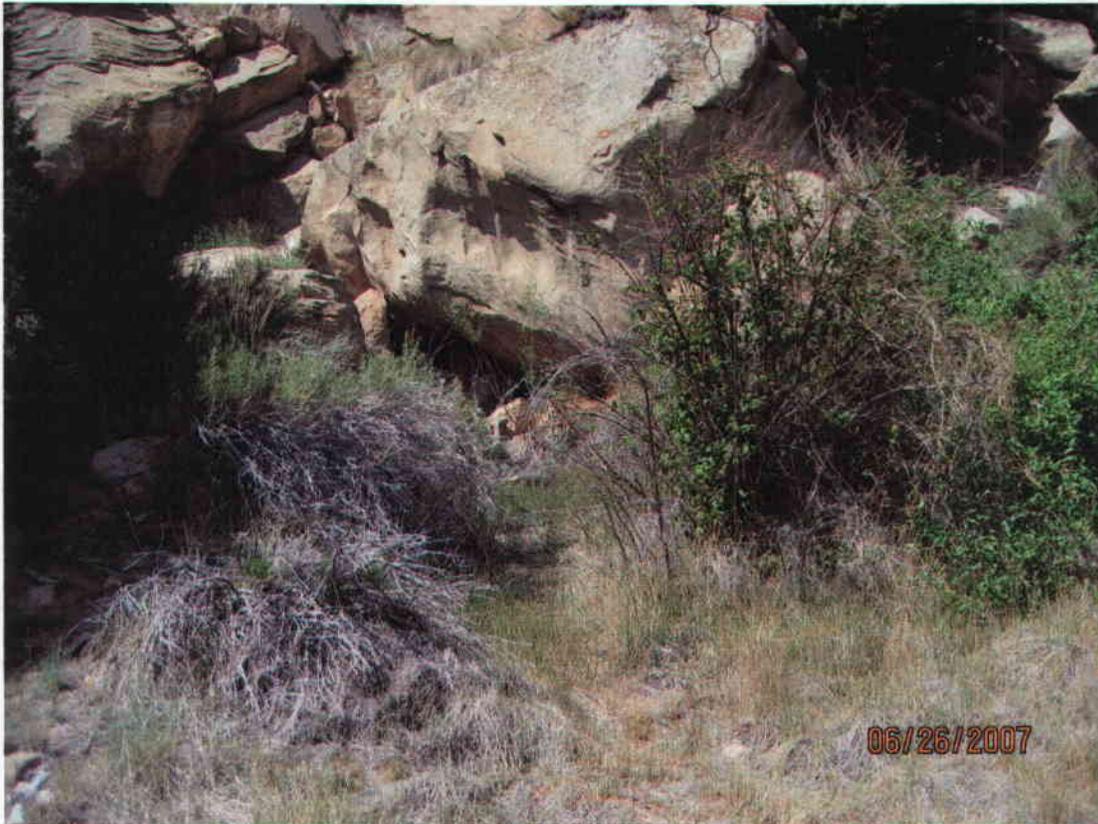
Link Canyon East Portal Photo Point

There is no water discharge from this portal and no evidence that there has been any. Due to the dry condition of the site much of the ground vegetation has gone into dormancy. The Dogwood bush (*Cornus stolonifera*) continues to have additional die back. It shows no indication of having bloomed. It has 2-3 inches of new twig growth, and the vigor is considered poor to fair. The Clematis has fair growth and vigor. The gooseberry plant (*Ribes spp.*) has 4-6 inches of new growth. On the lower part of the site the Wiregrass has gone into dormancy while there is some growth on the upper part of the site with 8-10 inches of new growth with very few seed heads. The overall vigor

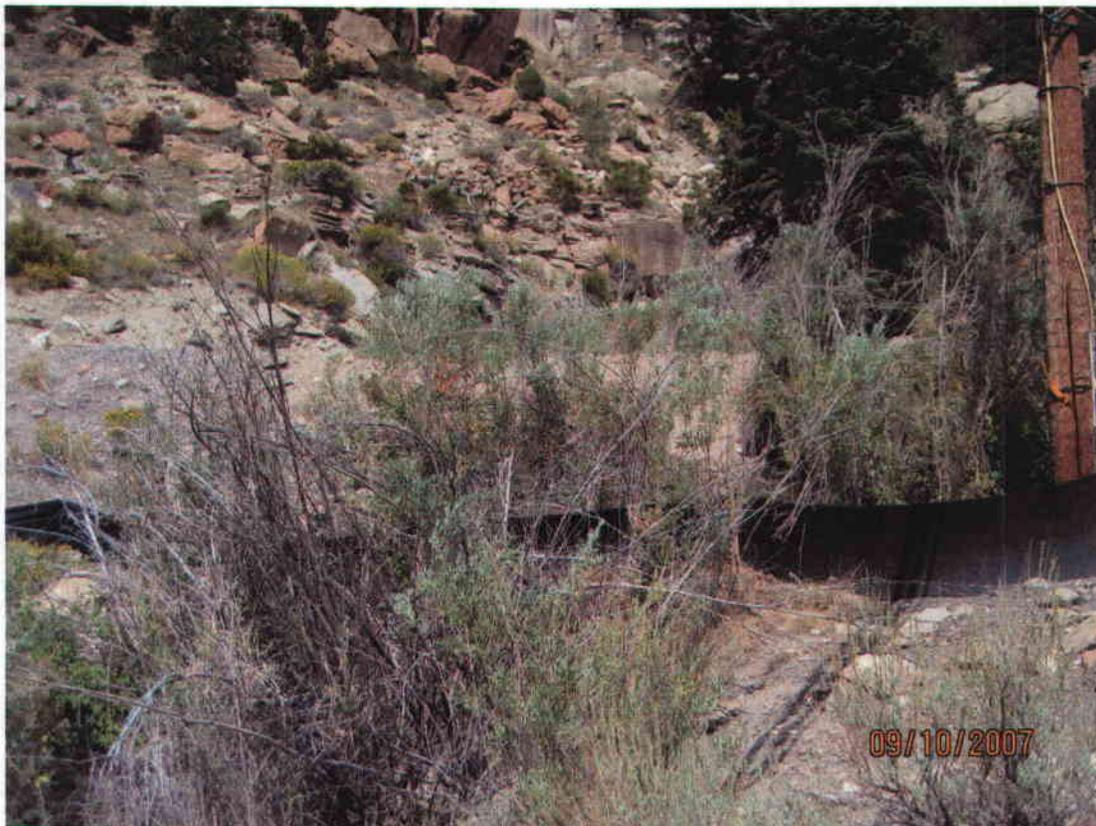
Link Canyon West Portal Photo Point

None of the plants have any additional growth since the last photographs were taken in June 2007. The insect galls that were present on the Salix earlier this year are all gone. All of the ground vegetation is dormant and shows no evidence of growth this year. There are no seeds present on the Woods Rose, Squaw Bush or Clematis plants. The site continues to be very dry and overall condition appears to continue to be downward. There is no water discharge from this portal.

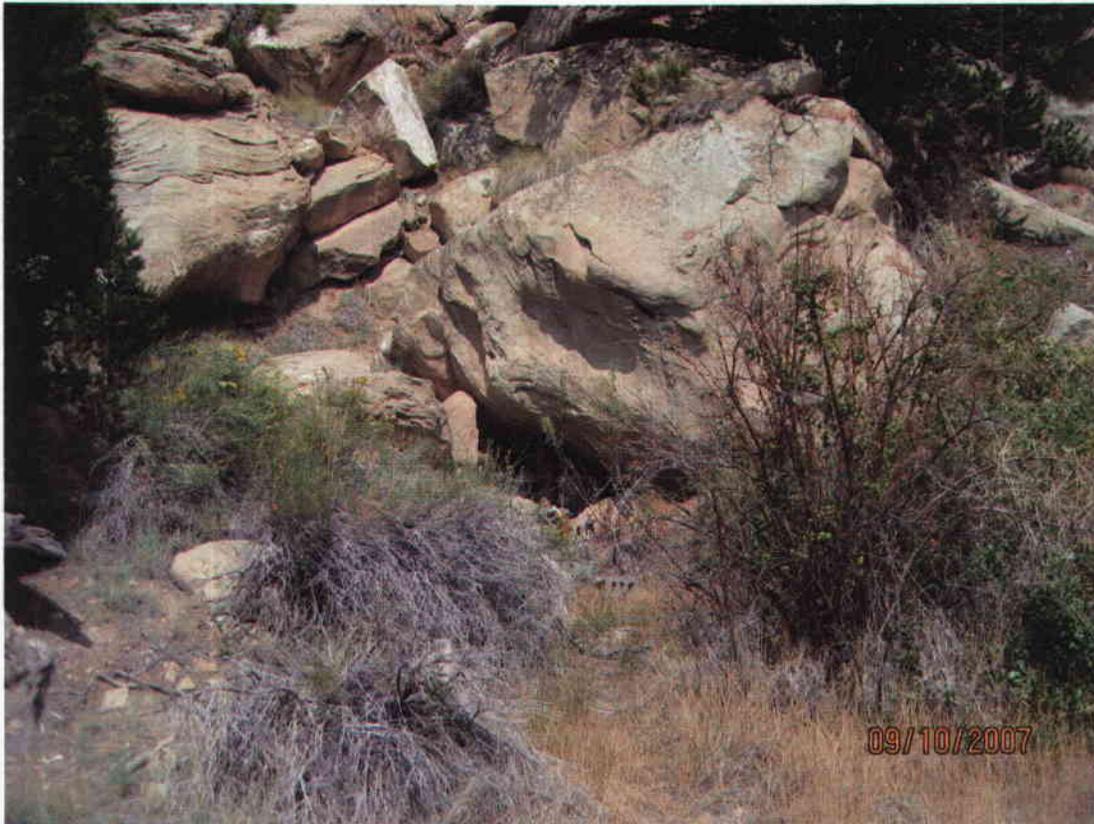
Link Canyon East Portal Photo Point

There is no additional growth on any of the plants since the photographs were taken in June 2007. The ground vegetation is basically dormant, with all the grass species, and forbs totally dormant and the Juncus being approximately 80% dormant. There is no seed on the Dogwood, or Clematis plants. Most of the current years new growth on the Dogwood has died. The Clematis still has good vigor. The Rabbitbrush is in full bloom. The site continues to be very dry and in an apparent downward trend. There is no water being discharged from this portal.

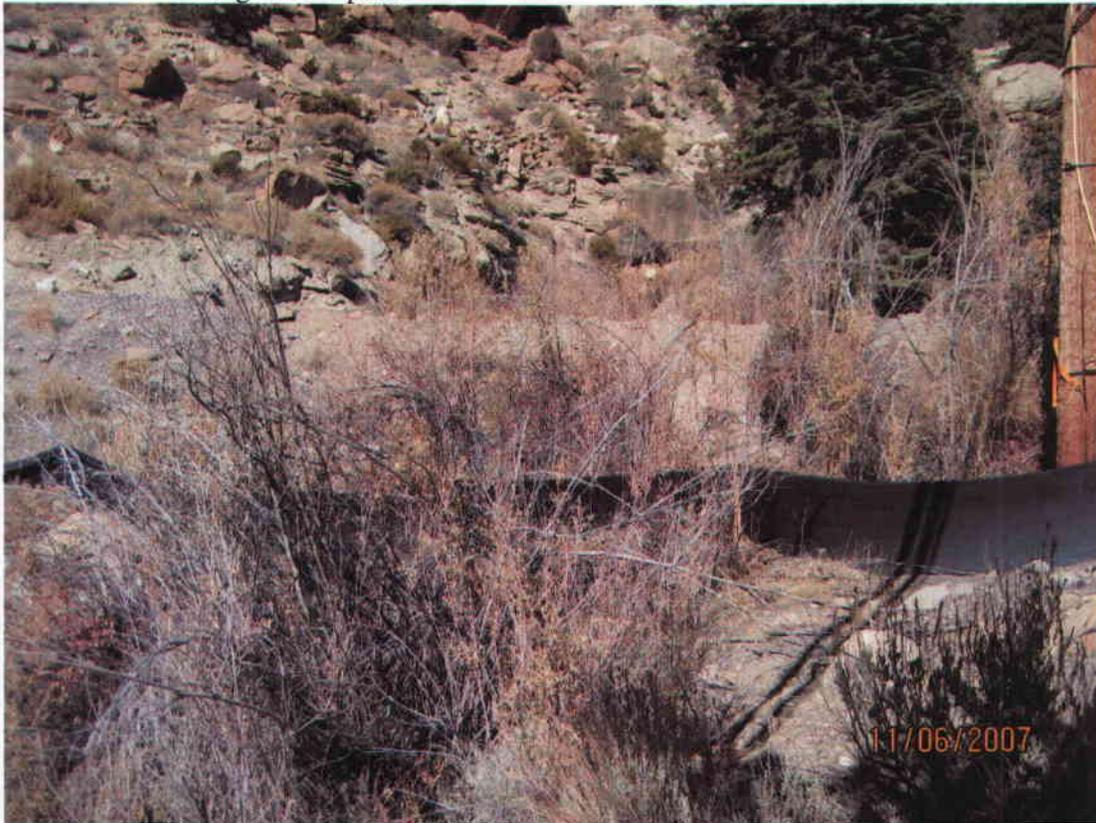
Link Canyon West Portal Photo Point

The site is completely dormant and almost all of the leaves have been shed. The site continues to be very dry. The area only received 77 percent of normal moisture for 2006/2007 water year and only .66 inches of moisture during the month of October 2007. There is not water being discharged from this portal. Some of the current years growth appears to be dead. This cannot be verified until next spring.

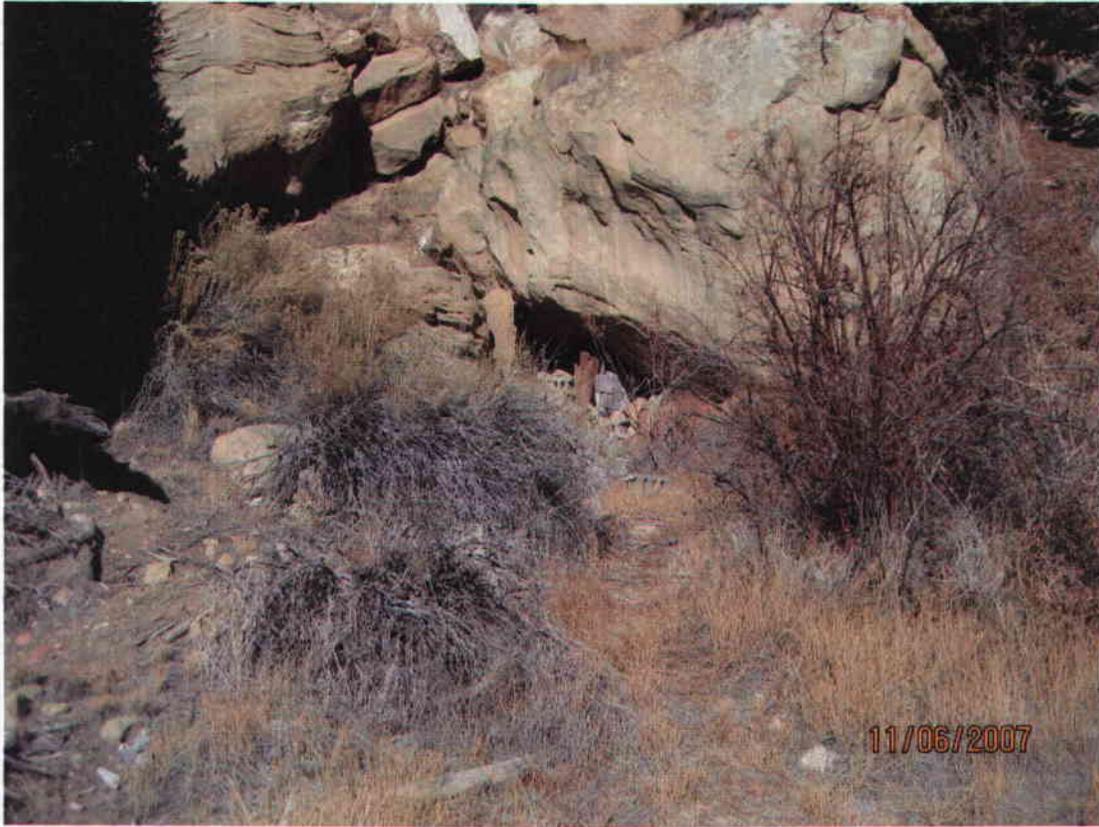
Link Canyon East Portal Area

This site is also completely dormant. The Rabbitbrush has some sparse seed heads present. None of the other species have any seed. There is no water being discharged from this portal. The site is in a downward trend.

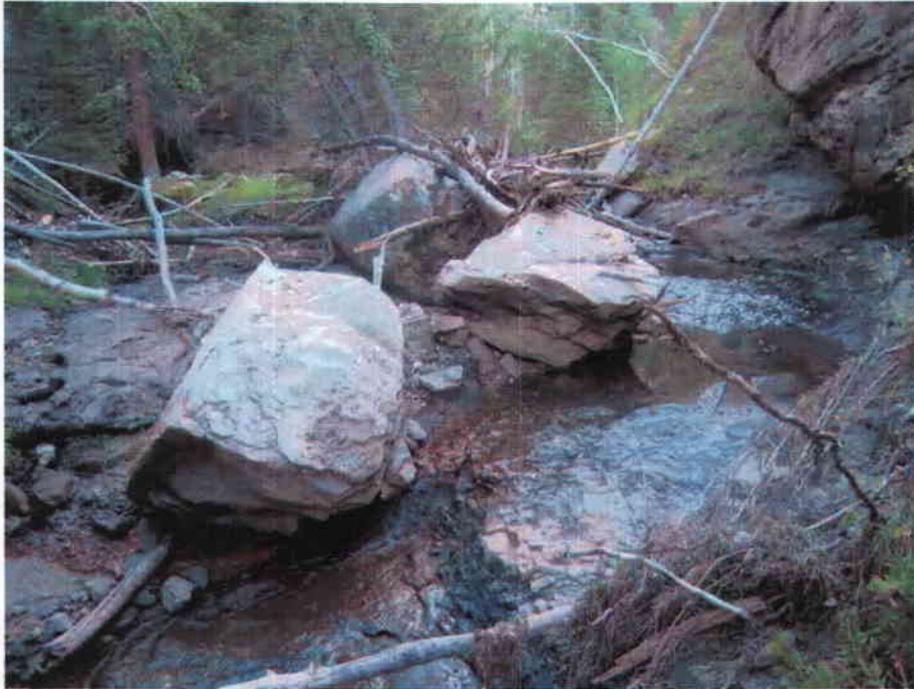
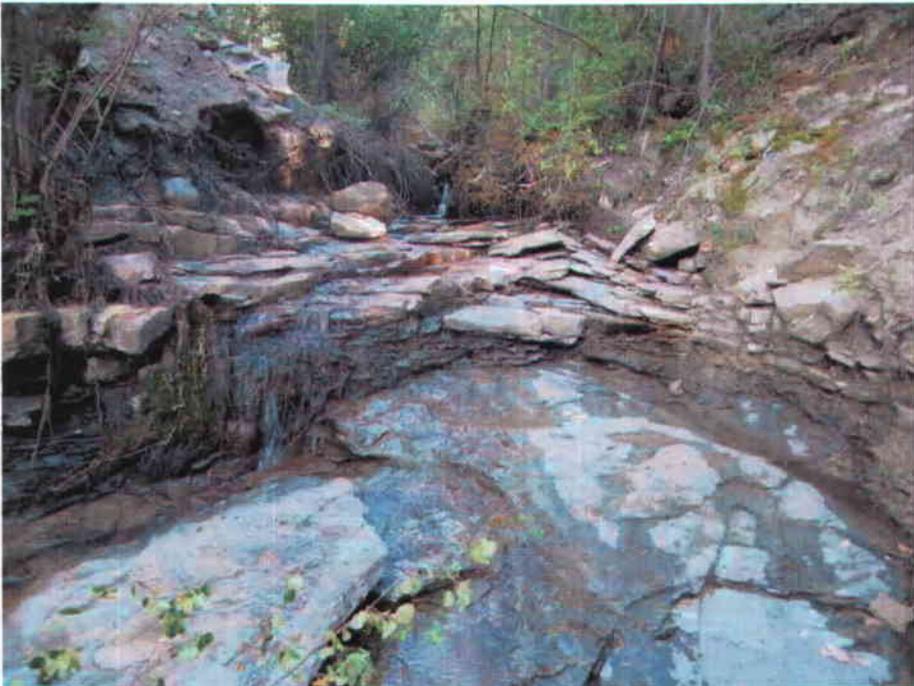
Stream channel at EFB-8

Stream channel below EFB-11

Figure 7 Photographs of the East Fork stream channel after the 19 July 2006 torrential thunderstorm runoff event.
