2007 ANNUAL REPORT

CANYON FUEL COMPANY, LLC SUFCO MINE ACT/041/002

Re: 2007 Annual Report for Canyon Fuel Company LLC, SUFCO Mine
C/041/002, Sevier County, Utah

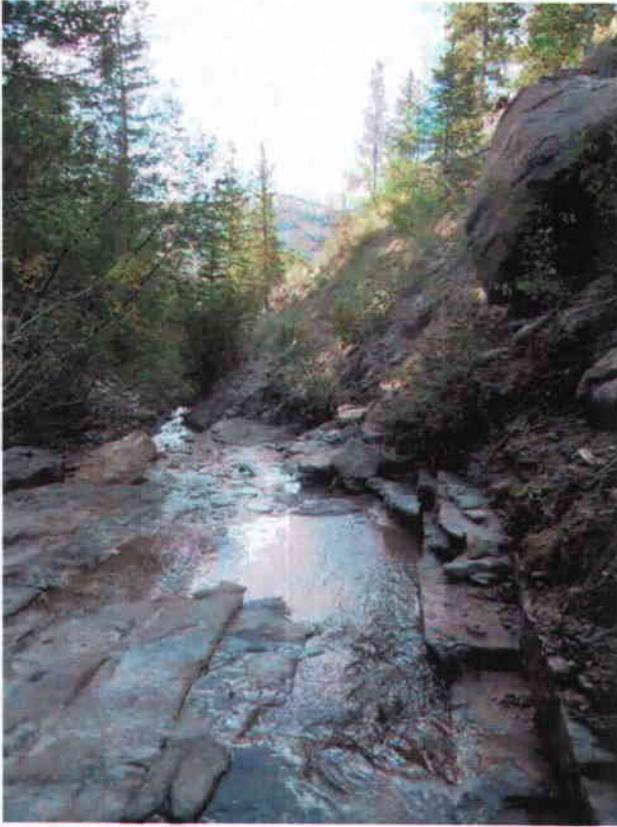
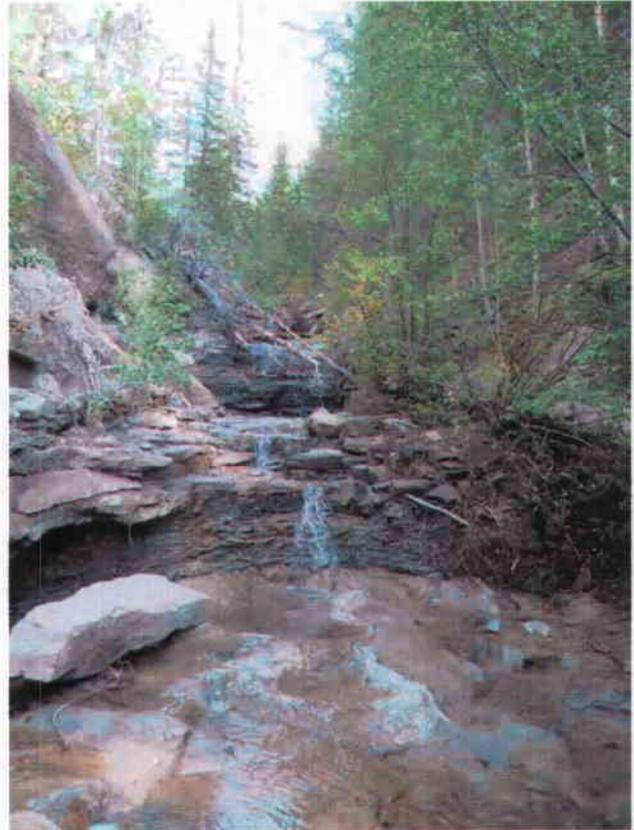
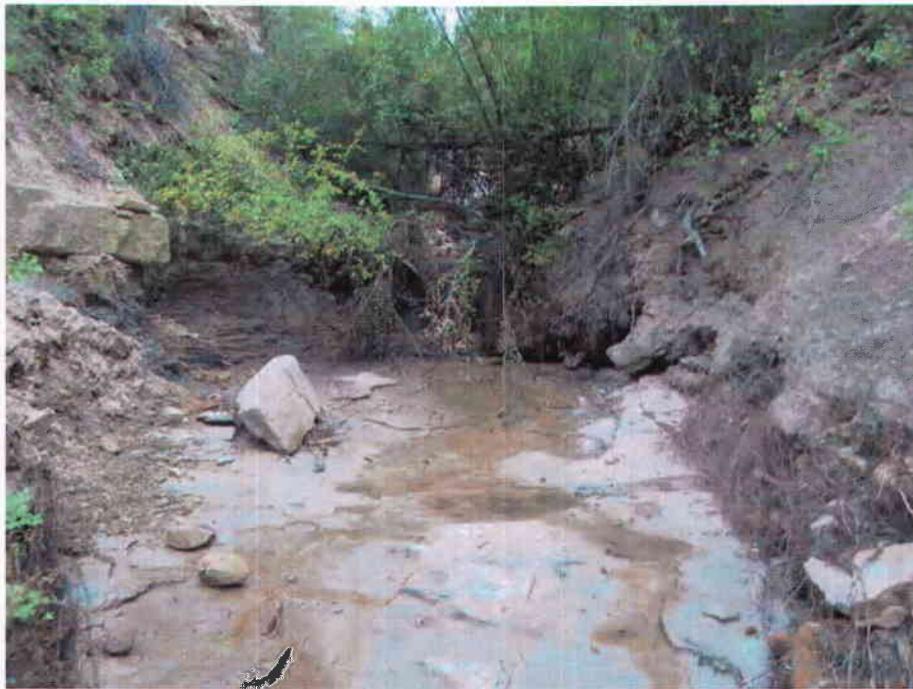
Figure 7 continued.

Stream channel below EFB-11

Stream channel near EFB-11A
