WATER QUALITY MEMORANDUM

Utah Coal Regulatory Program

February 29, 2008

RE: 2007 Third Quarter Water Monitoring, Canyon Fuel Company, LLC, SUFCO Mine, C/041/0002-WQ07-3 Task ID #2607

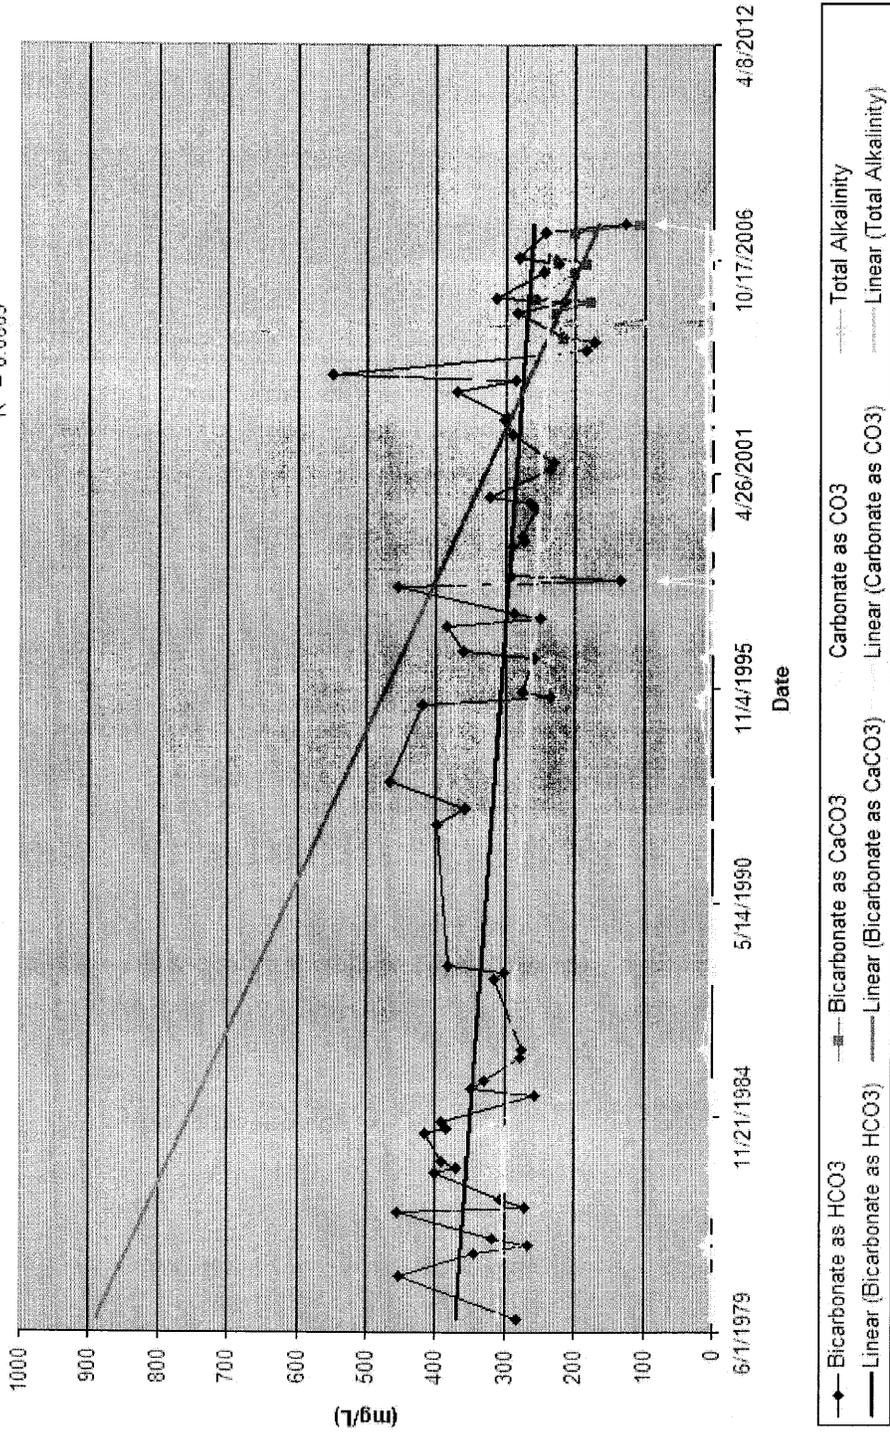
Carbonate and Bicarbonate at SUFCO 006

The bicarbonate as CaCO₃, and as HCO₃ was unusually low at SUFCO 006; while the

carbonate as CO_3 was unusually high. The correlation between total alkalinity and bicarbonate is 0.937, and carbonate is usually absent. The alkalinity is usually bicarbonate based and the trends in the two values are expectedly similar, but this quarter some carbonate was present. Alkalinity and pH values remained within expected limits.

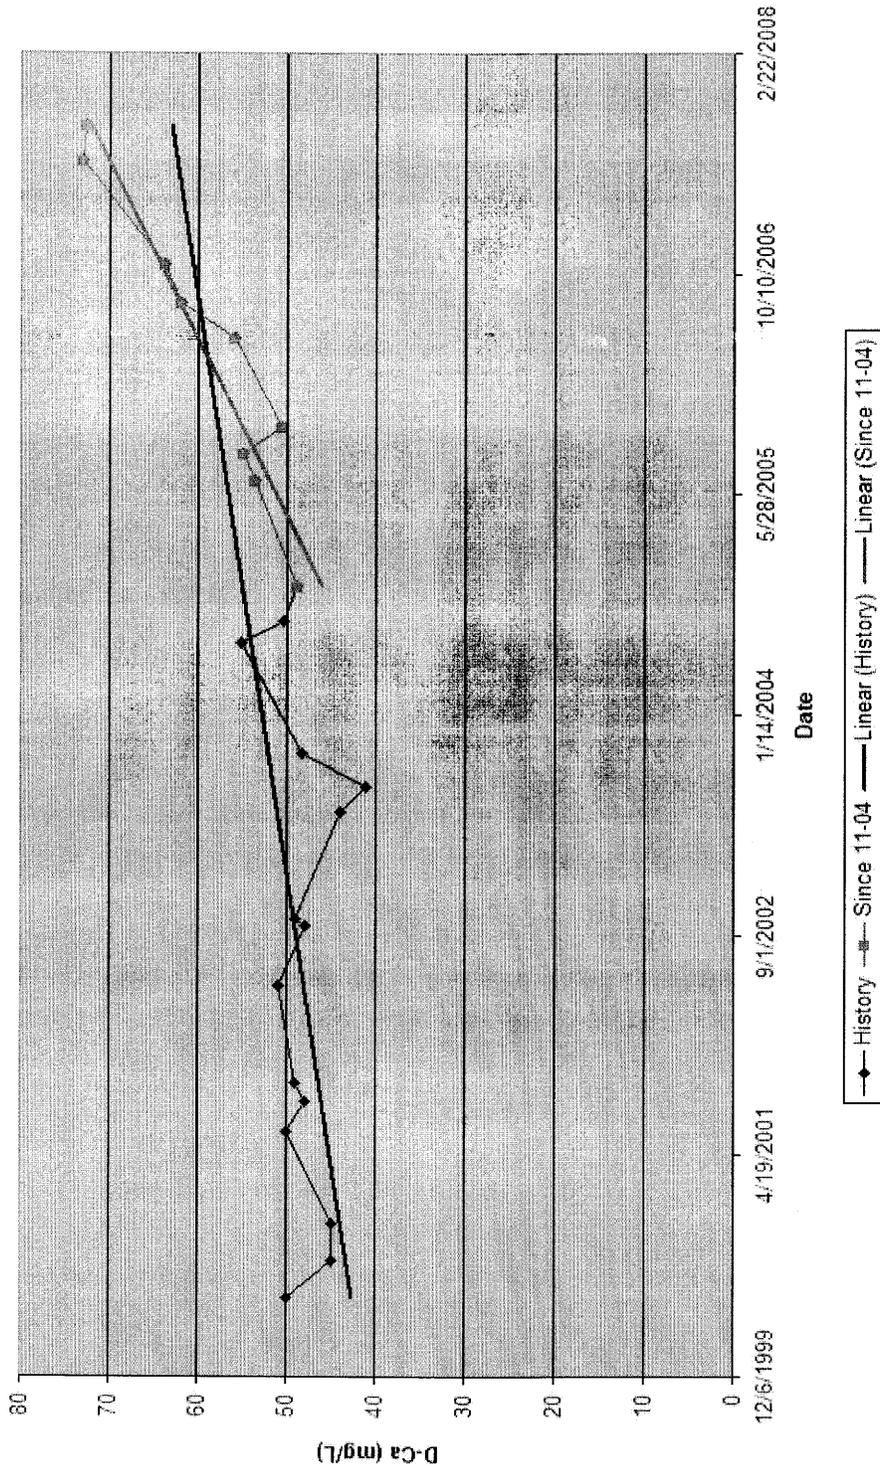
Dissolved Calcium
Pines 106

Dissolved calcium and dissolved magnesium both have fairly strong upward trends at Pines 106 ($R^2 = 0.5817$, and 0.4858), which are very strong since undermining occurred ($R^2 = 0.9099$, and 0.9239 since 11-04). Dissolved calcium has no real correlation to flow ($R^2 = 0.05$), and dissolved magnesium has a weak negative correlation to flow ($R^2 = 0.12$). The concentration of these two constituents has come down slightly since last quarter. There are no criteria for these metals, but they do contribute to water hardness. The total hardness at Pines 106 also has a somewhat strong upward trend ($R^2 = 0.5308$, 0.9235 since undermining), with no correlation to flow ($R^2 = 0.08$). The hardness at this site has always fallen into the hard (150-300 mg/l) classification, and continues to be in that range.

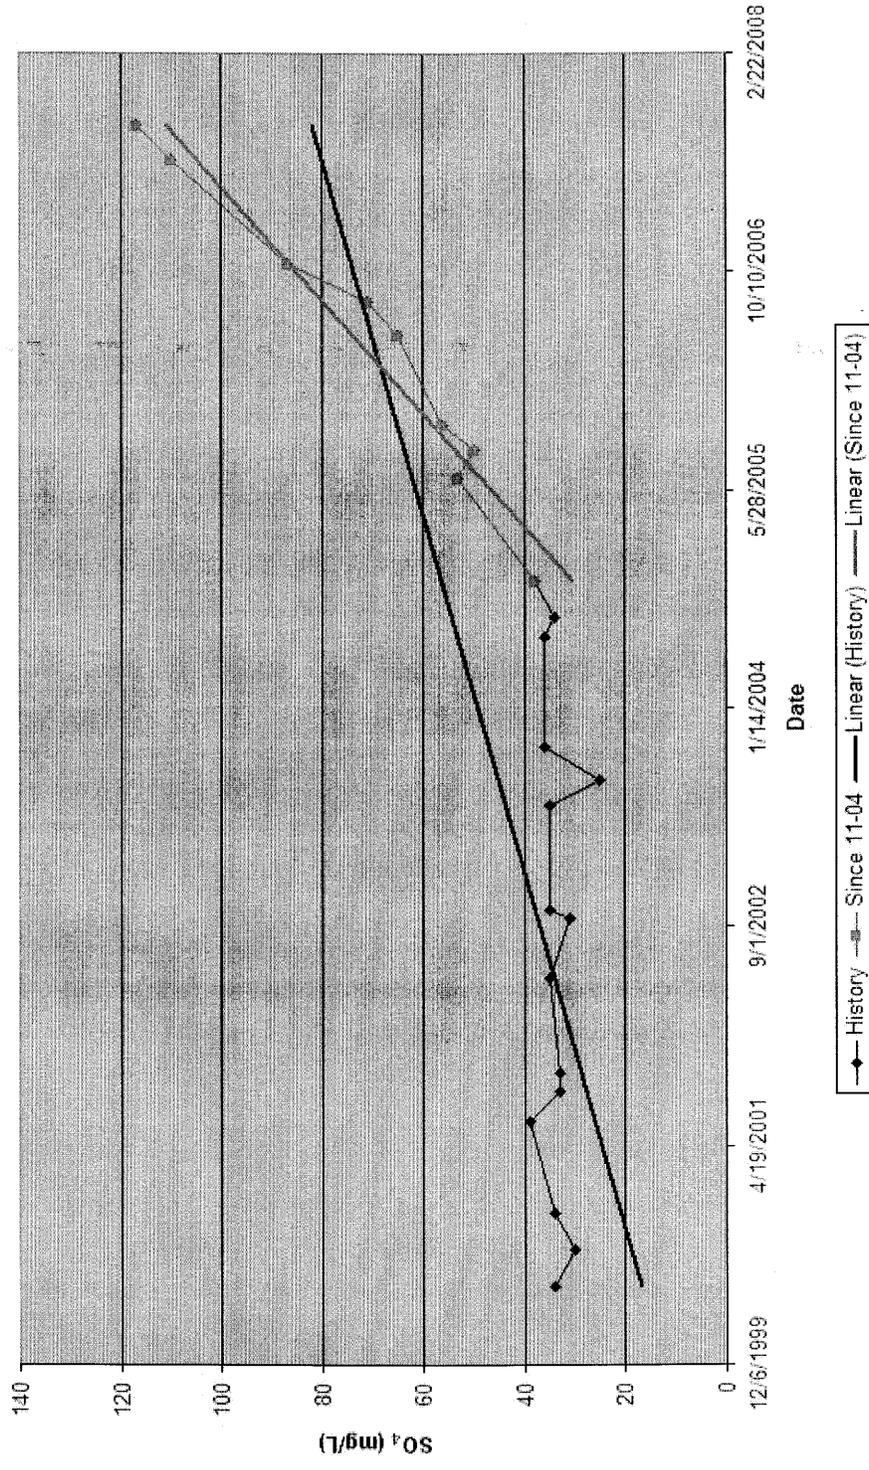
Sulfate
Pines 106

There is a strong upward trend in sulfate at Pines 106 ($R^2 = .634$), a very strong upward trend since 11-04 ($R^2 = 0.9475$), and no real correlation to flow. Sulfate is not toxic to plants or animals (even at very high concentration), but has a cathartic effect on humans in concentrations over 500 mg/L. For this reason, the EPA has set the secondary standard as 250 mg/L. The sulfate at Pines 106 has always been less than 120 mg/L.

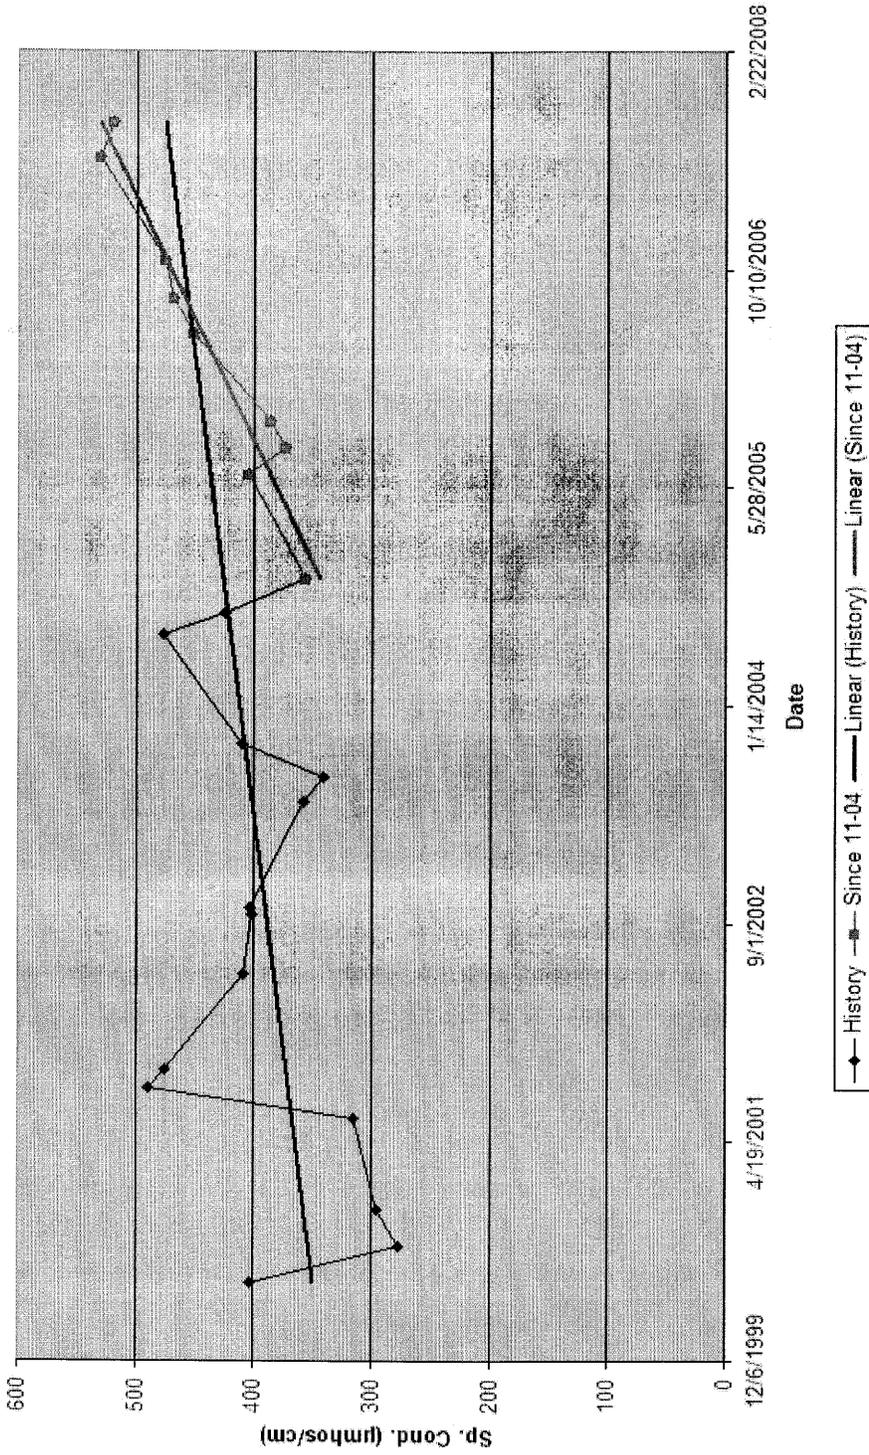
Specific Conductivity
Pines 106

There is a weak upward trend in the specific conductivity at Pines 106 ($R^2 = 0.3283$), and a very strong upward trend since undermining ($R^2 = 0.9363$), with no real correlation to flow. There is no standard for specific conductivity, but it is closely related to total dissolved solids (TDS).

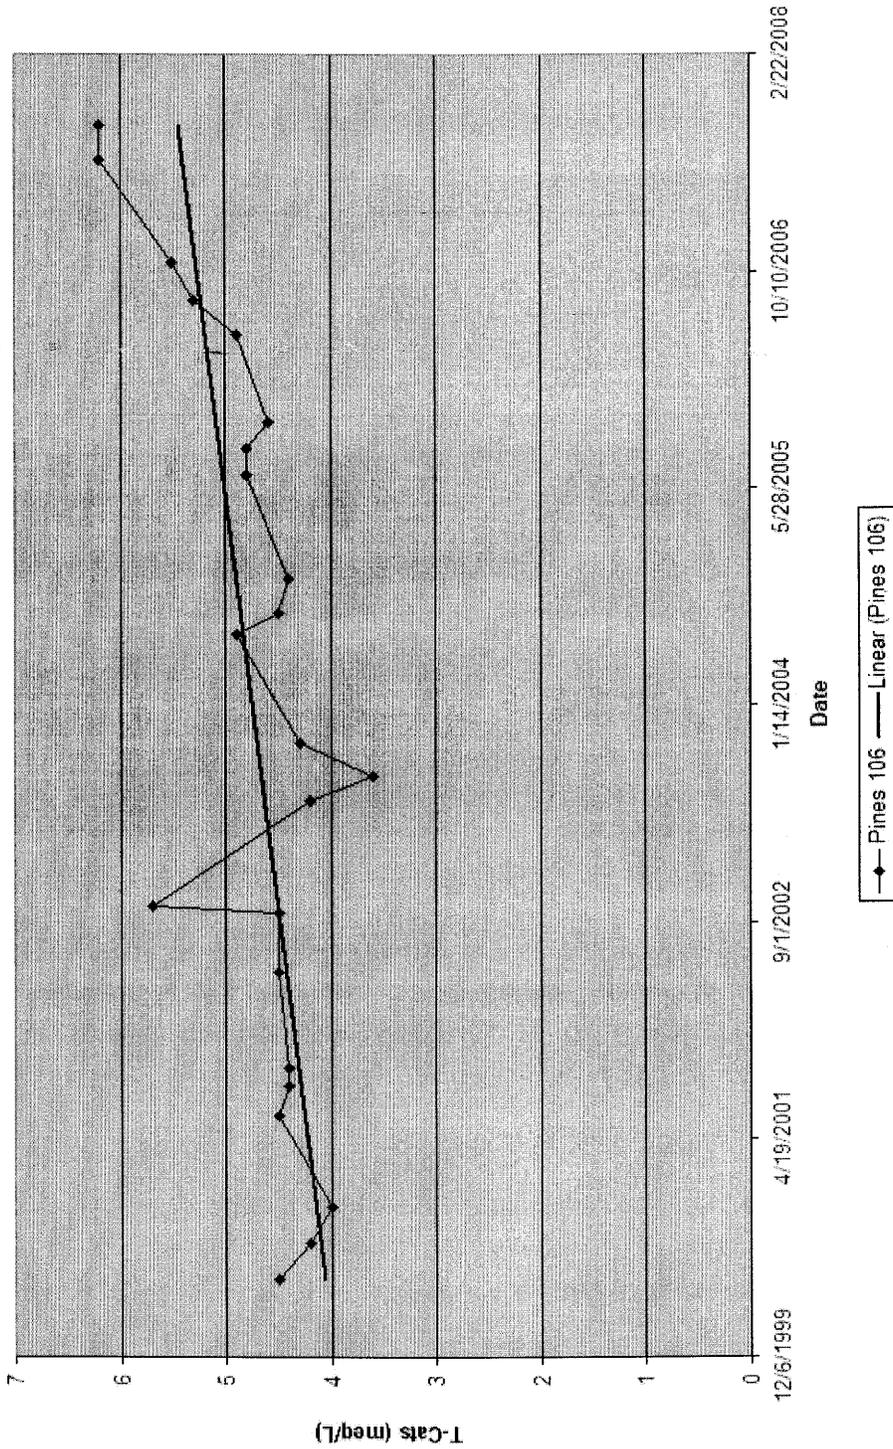
Total Cations

There is also a weak upward trend in total cations at Pines 106 ($R^2 = 0.4373$), with no real correlation to flow. The cation/anion balance is within the 5% recommended limit. The number of cations also relates to the total dissolved solids in the water sample.

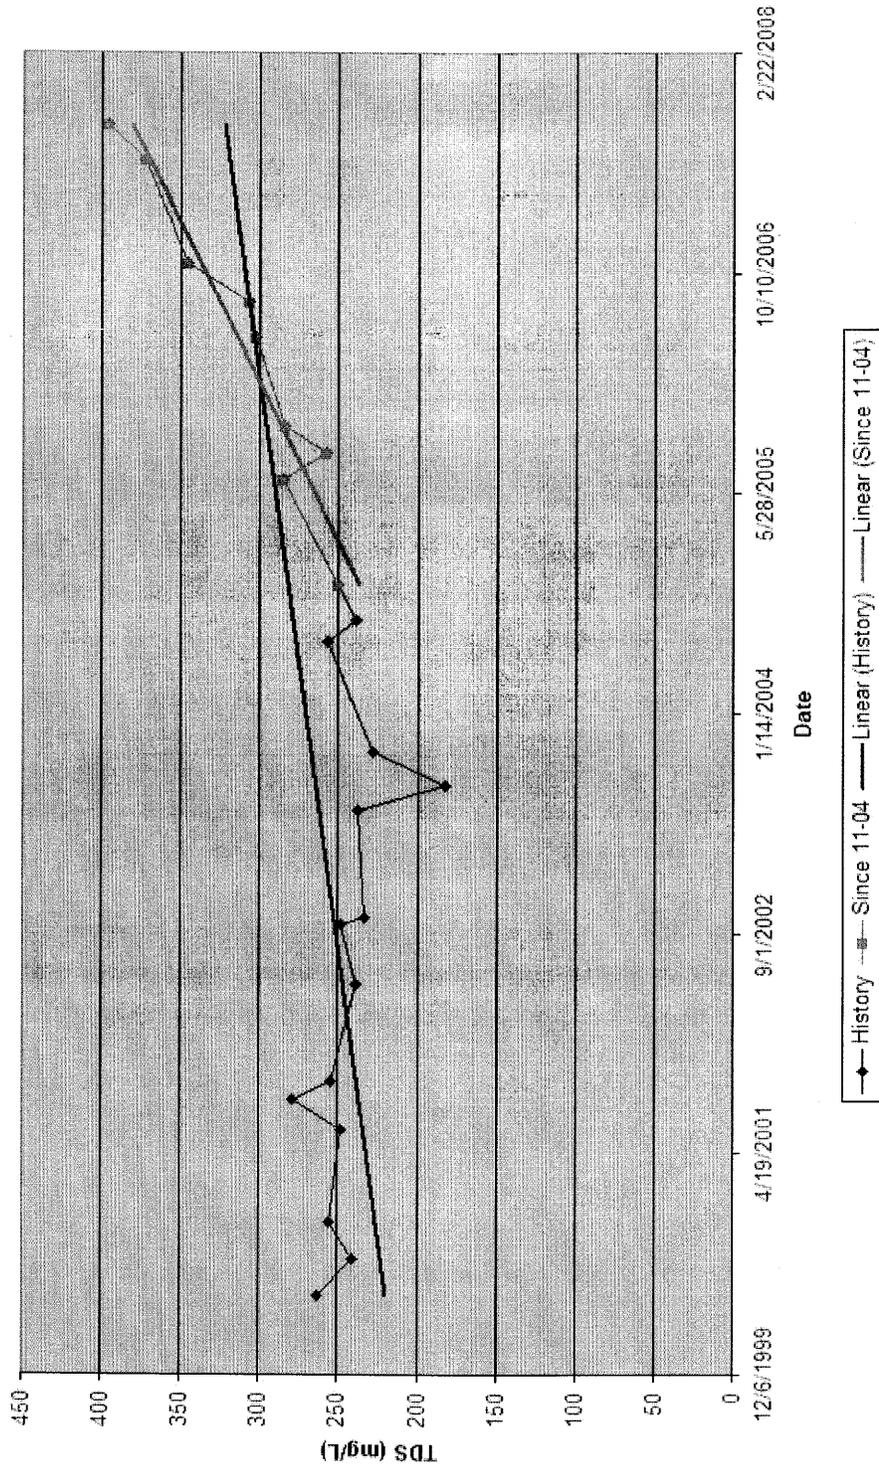
Total Dissolved Solids
Pines 106

There is a weak upward trend in TDS at Pines 106 ($R^2 = 0.4475$), and a very strong upward trend since 11-04 ($R^2 = 0.9173$, with a very weak negative correlation to flow ($R^2 = 0.12$). The TDS at Pines 106 has always been below the secondary drinking water standard of 500 mg/L and periods of high TDS have generally been followed by periods of low TDS,

but the TDS level does seem to be rising since undermining occurred.
