2009 ANNUAL REPORT			Page 2

On July 15, 2009, the Pines Tract Area was visited by Keith W. Zobell (Environmental Specialist), Mike Davis (Mining Engineer for Canyon Fuel Company, SUFCO Mine), and Leland Roberts (Environmental Engineer for Canyon Fuel Company, SUFCO Mine). The purpose of this trip was to revisit all of the original photographic points that have been established and to retake photographs at each of the sites and to determine the general vegetative growth, plant vigor, and plant condition at each of the established photographic sites. These sites are revisited each year at approximately the same date each year, so as to reduce any possible seasonal variations. Photographs of each site are identified and included in this report.

LINK CANYON MINE PORTAL VEGETATION STUDY

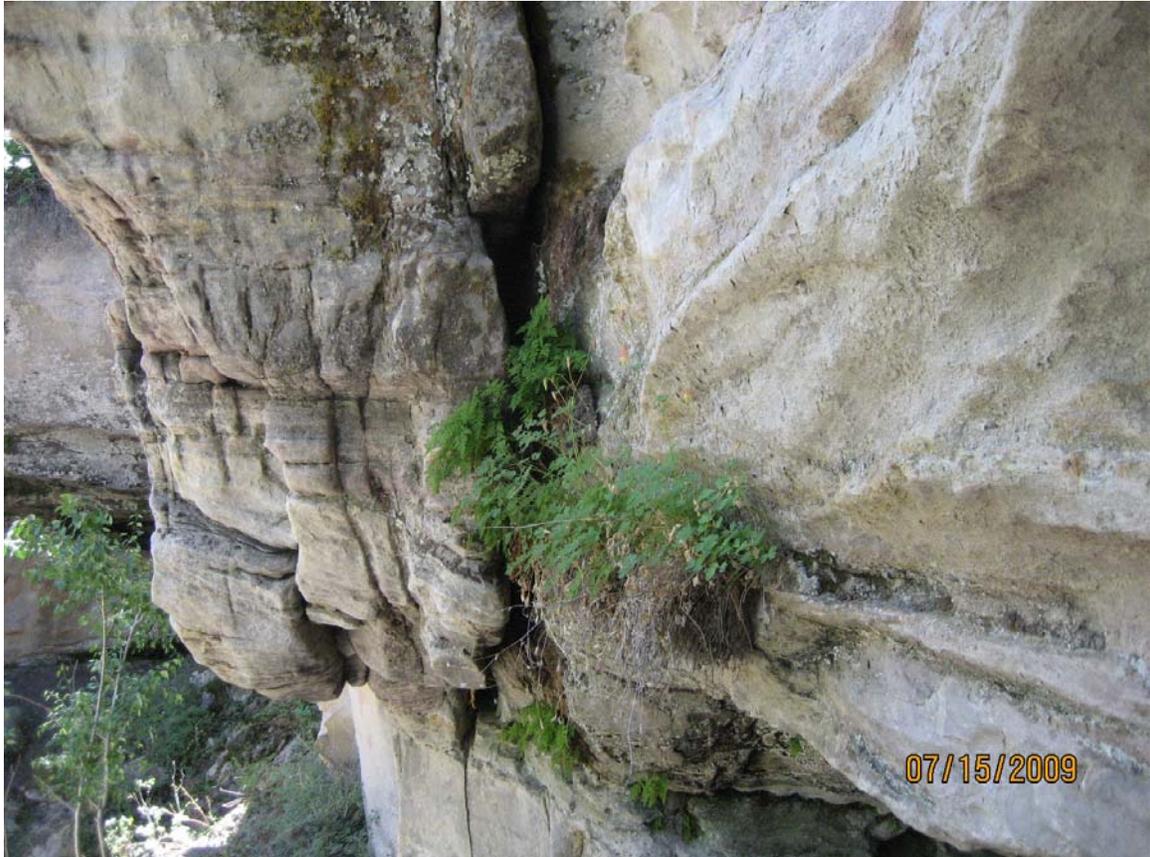
Photo Point 1a

There are three columbine plants at this site. The plants have fair vigor. Two plants have some inflorescences, which are 10-12 inches in length,

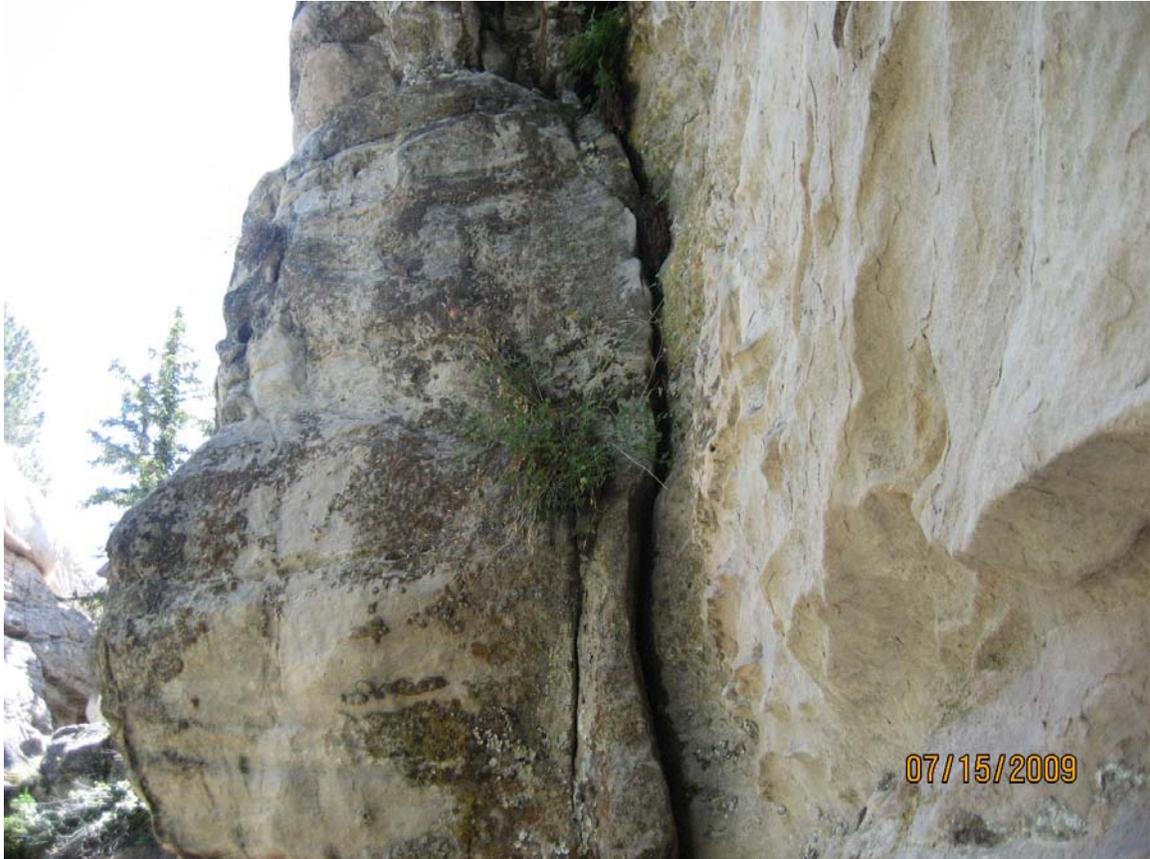
Photo Point 1b

At photo point 1b there are still two columbine plants. One plant is in very poor condition and only has one small live branch. The second plant is healthy and has good vigor and has an inflorescence of 10-12 inches in length. These plants appear to be getting some moisture from the rock fractures that they are growing in.

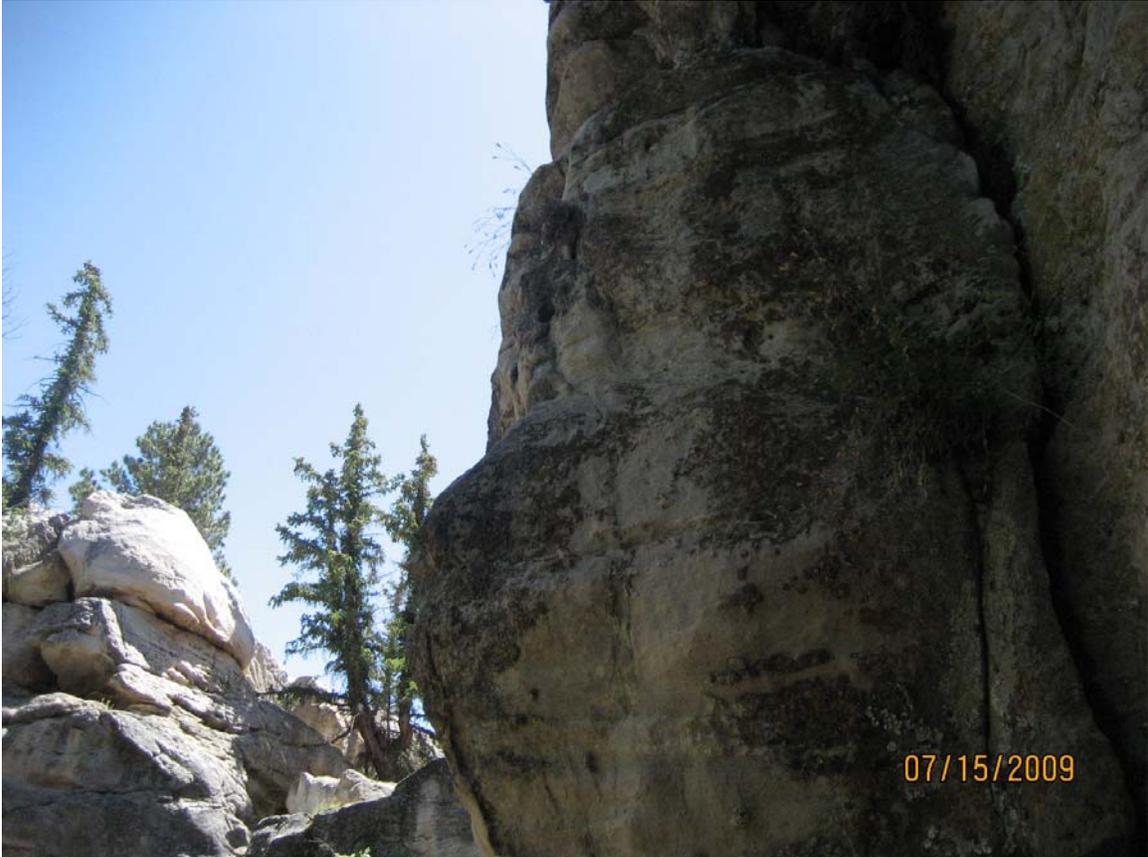
Photo Point 1c

At this photo point there is only one columbine plant and it is located approximately 20-25 feet up on the cliff face, so not measurements can be made. There has only been one plant at this site in the past and it now appears that the plant may be dead.

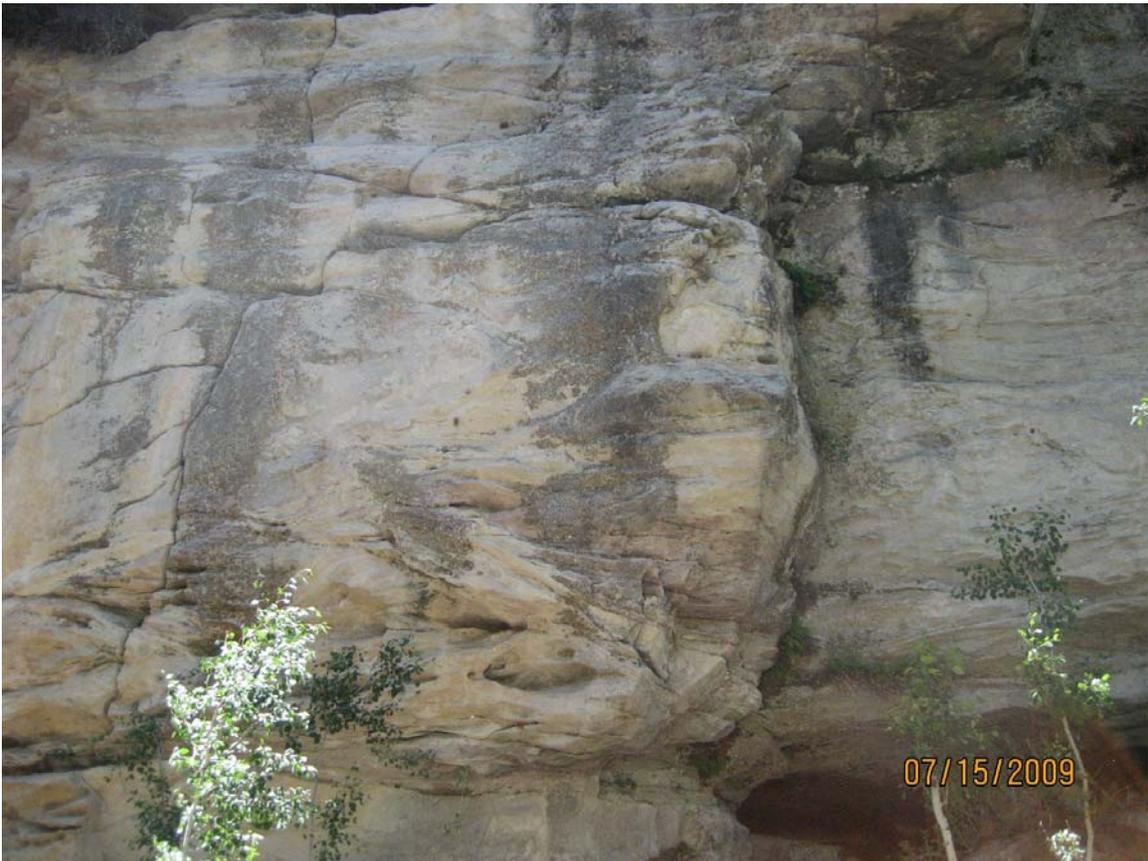
Photo Point 2

At this photo point there is only one plant still alive. Originally there were three. The one plant this is still alive is small and has poor vigor, with no inflorescence. The plant is located approximately 20-25 feet up on the cliff face so exact measurements cannot be made. There does not appear to be any moisture coming from the rock fracture where the plant is located. The lack of moisture is probably the cause of these plants dieing.

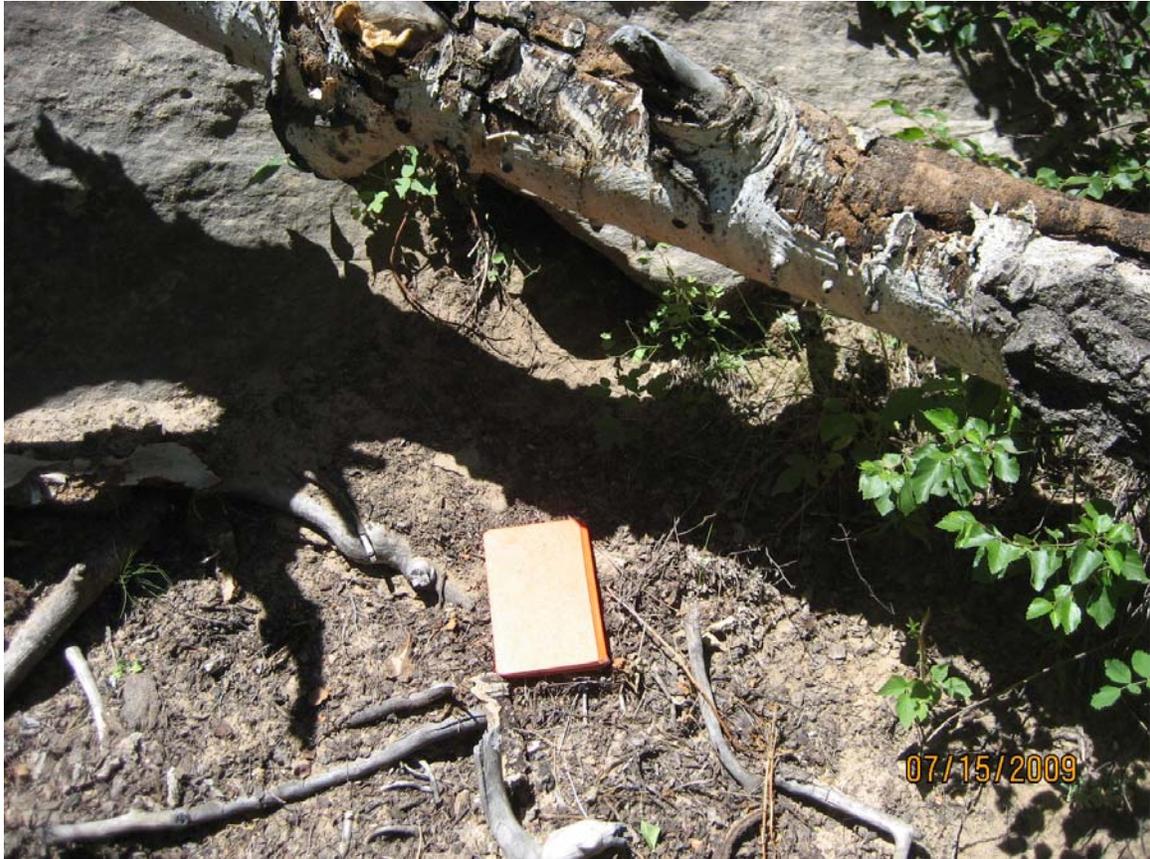
Photo Point 3

At this photo point there is still one small columbine plant growing. Last year this plant appeared to be a seedling. This year it is still small but has an inflorescence 8 inches long.

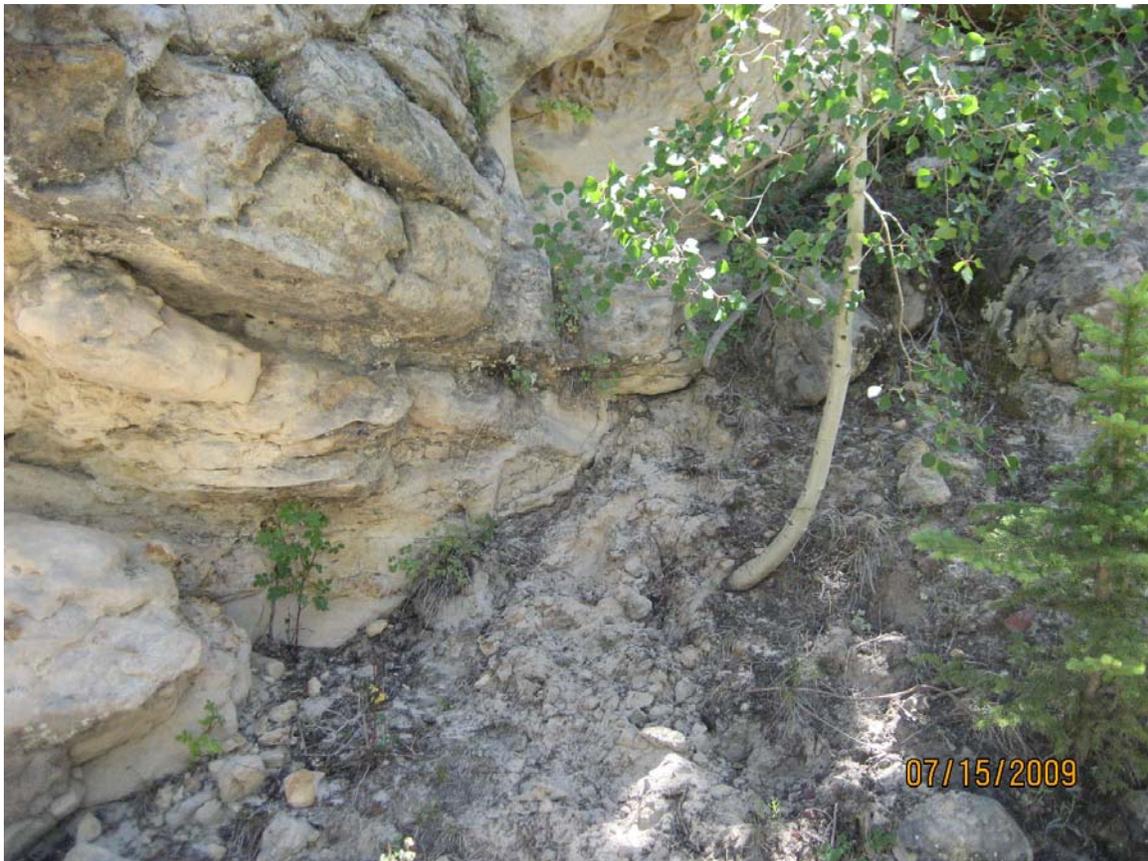
Photo Point 4

At this photo point there are still several columbine plants. Only one of the columbine plants has inflorescence which is 7 inches long. All of the other columbine plants have been grazed. This is the first time we have observed grazing at this site. The ungrazed plant has fair vigor. *Carex* plants continue to be sparse and have been grazed, and have regrowth of 1 inch. Wood Rose has new twig growth of 1-1/2 inches with no flower or seed heads. The *Potentilla* plant has new growth of 2-3 inches. The Aspen has a current growth 1-2 inches. This is a very dry site and the overall site has low vigor, which is probably due to lack of moisture.

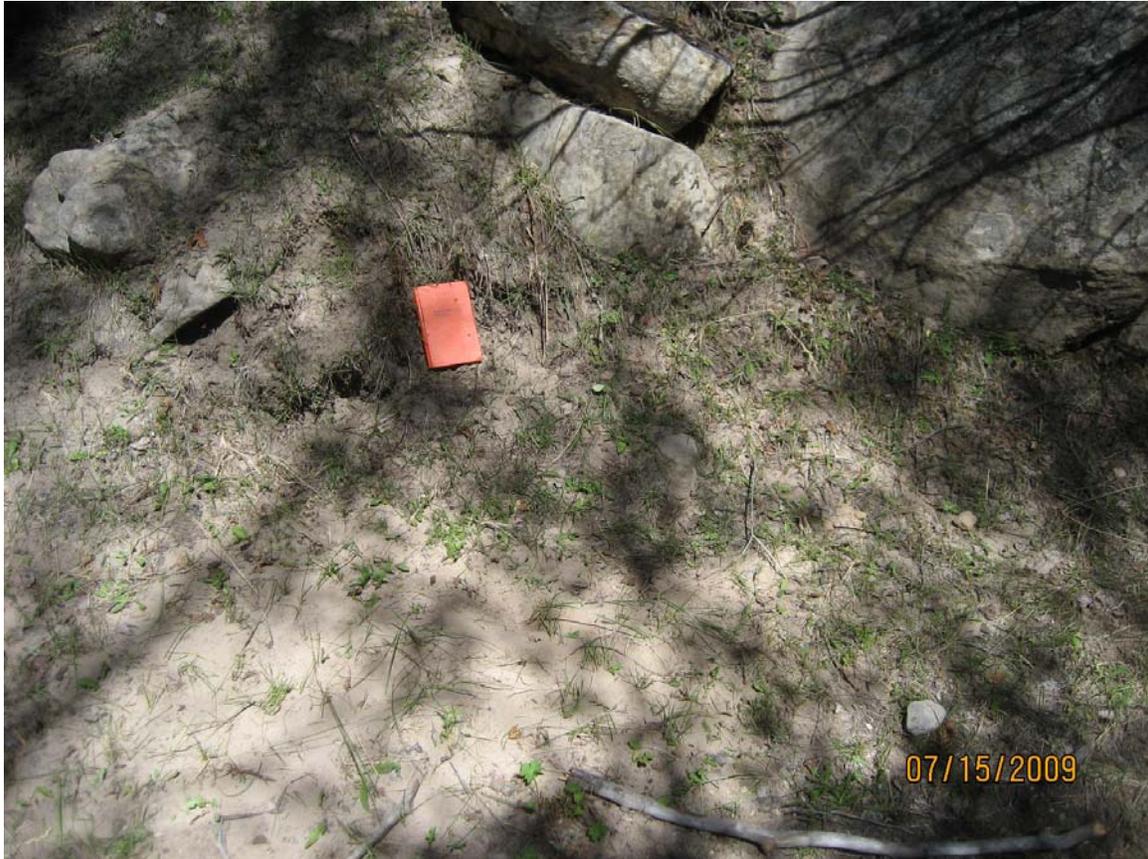
Photo Point 5

At this photo point there are still three columbine plants. All three of the columbine plants have been grazed down to ground level. The columbine plants have a regrowth of 3-4 inches with no inflorescence. Bluegrass is sparse and has been grazed down to ground level and has a regrowth of 3-4 inches. *Carex* has been heavily grazed and has a regrowth of 2-3 inches. Yarrow has a basal growth of 3-4 inches with no inflorescence. Hairgrass is sparse and has been heavily grazed with a regrowth of 4-5 inches with no seed heads. Geranium has 3 inches of regrowth. All of the plants at this site have been heavily grazed and are in poor condition. The site has 40% bare ground with very little litter on the ground. There is no water in the creek at this site.

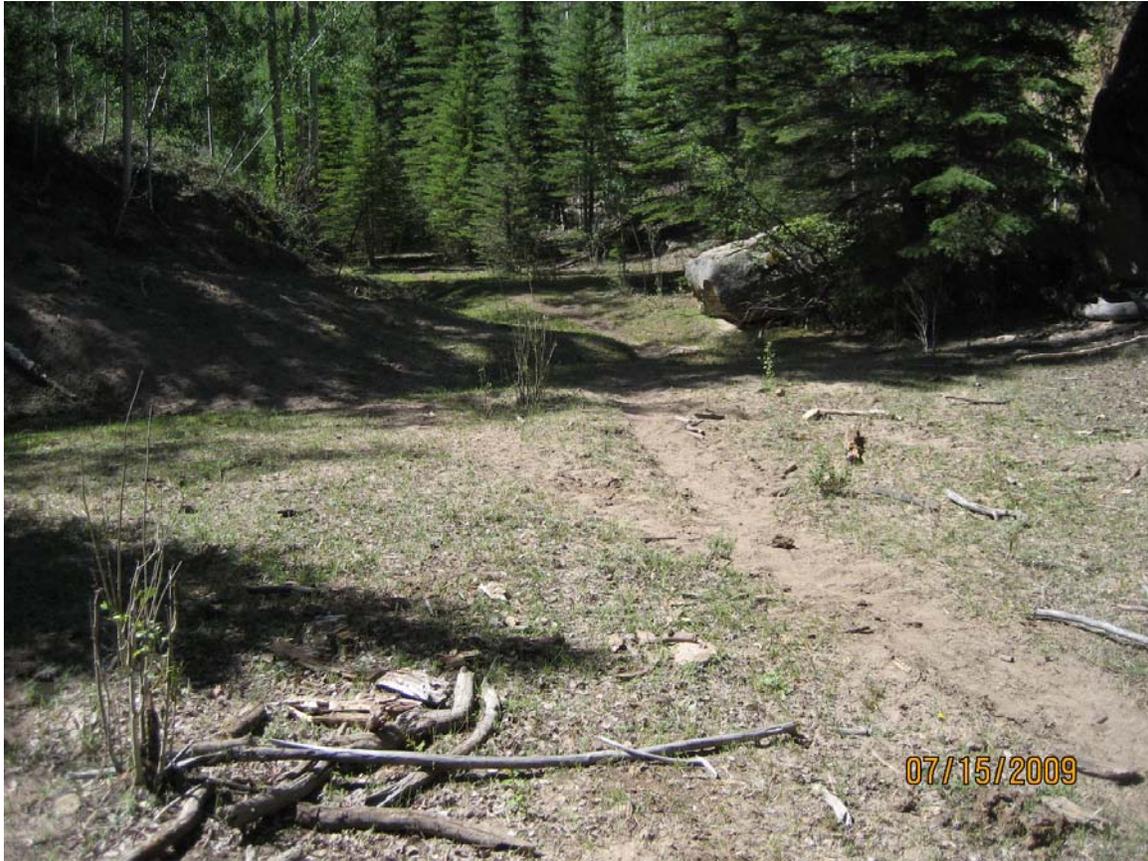
Photo Point 6

At this photo point the site is very dry and has been heavily grazed by livestock. Ocular estimate shows that the site to have approximate 40-50% bare ground with very little ground litter. The Aspen has been heavily grazed and has 2-3 inches of regrowth. There are some 10 inch basal sprouts on some of the Aspen plants. Blue grass has regrowth of 4-6 inches. *Carex* has a regrowth of 2-3 inches. Yarrow has 3 inch basal leaves with no seed heads. Big Sage has current growth of 2-3 inches. Geranium has basal leaves of 2-3 inches, Wiregrass has regrowth of 4 inches, Herbaceous sage has regrowth of 3-4 inches. Over all condition of this site is very poor. There is no water in the creek.

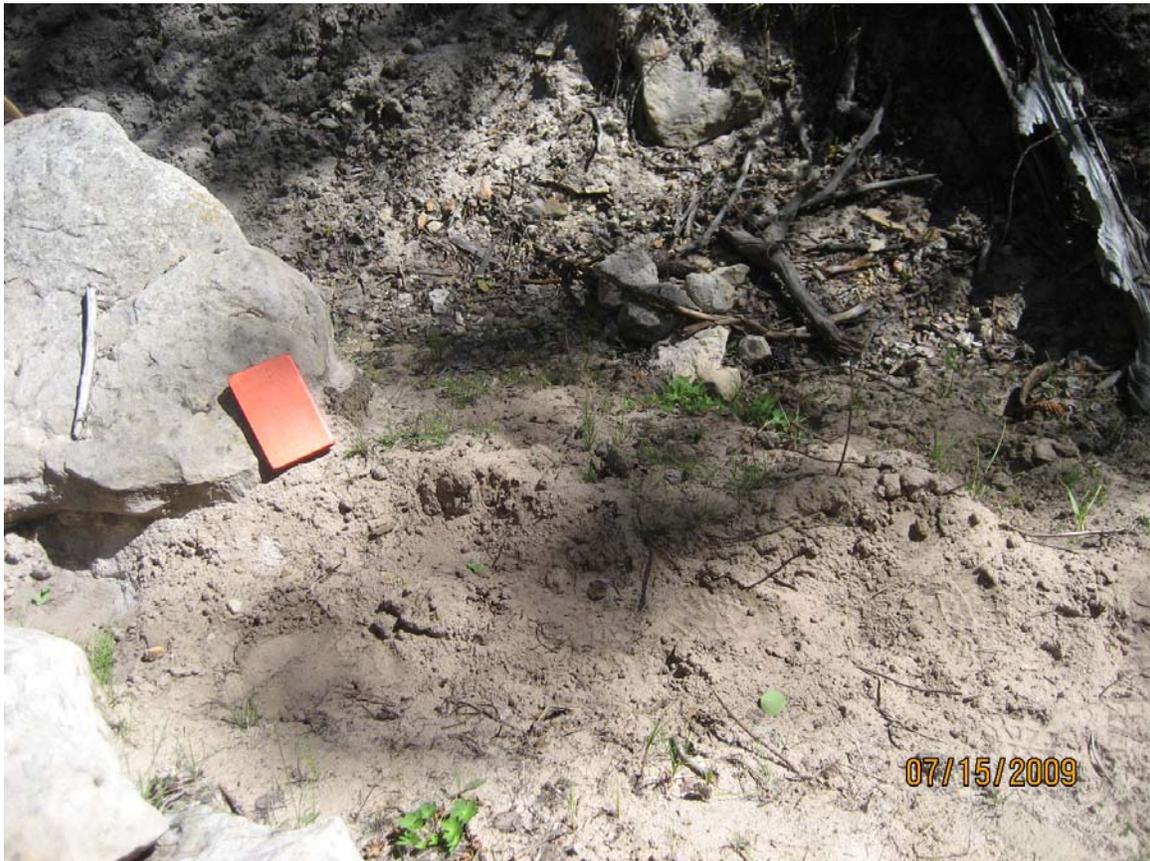
Photo Point 7

At this photo point there are still no columbine plants. The site has been heavily grazed by livestock, with none of the existing plants having any inflorescence. Geranium has 2-3 inches of basal growth, Yarrow has 2-3 inches of regrowth, and *Carex* has 2 inches of regrowth. There is no bluegrass. The site has 90% bare ground with no litter. There is no water in the creek at this site.

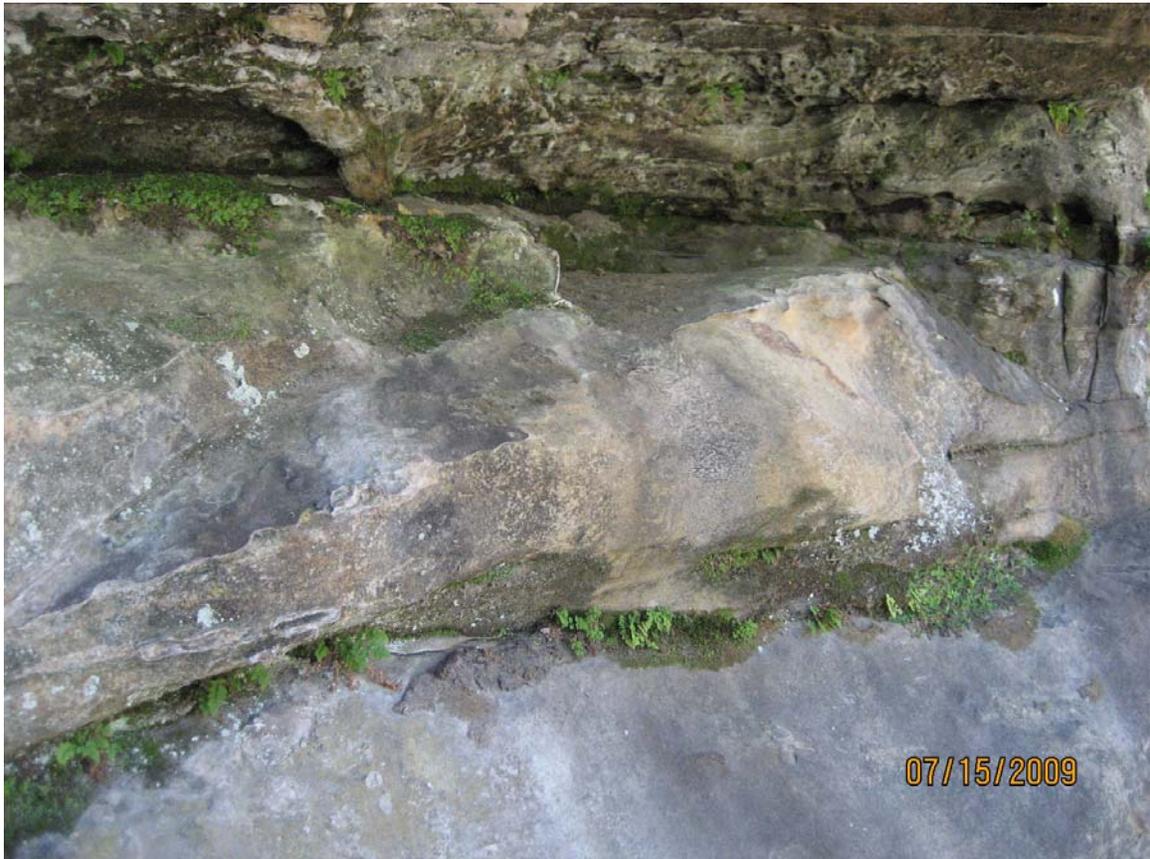
Photo Point 8

This photo point is hanging fern garden area located in the “Grotto” area. The ferns and the lichens receive moisture that is coming from the fractures in the cliff face. The fern and lichen density is less than that of last year. The current fern growth is 2-3 inches. There is some moisture of the face of the cliff face but no flowing or dripping moisture.

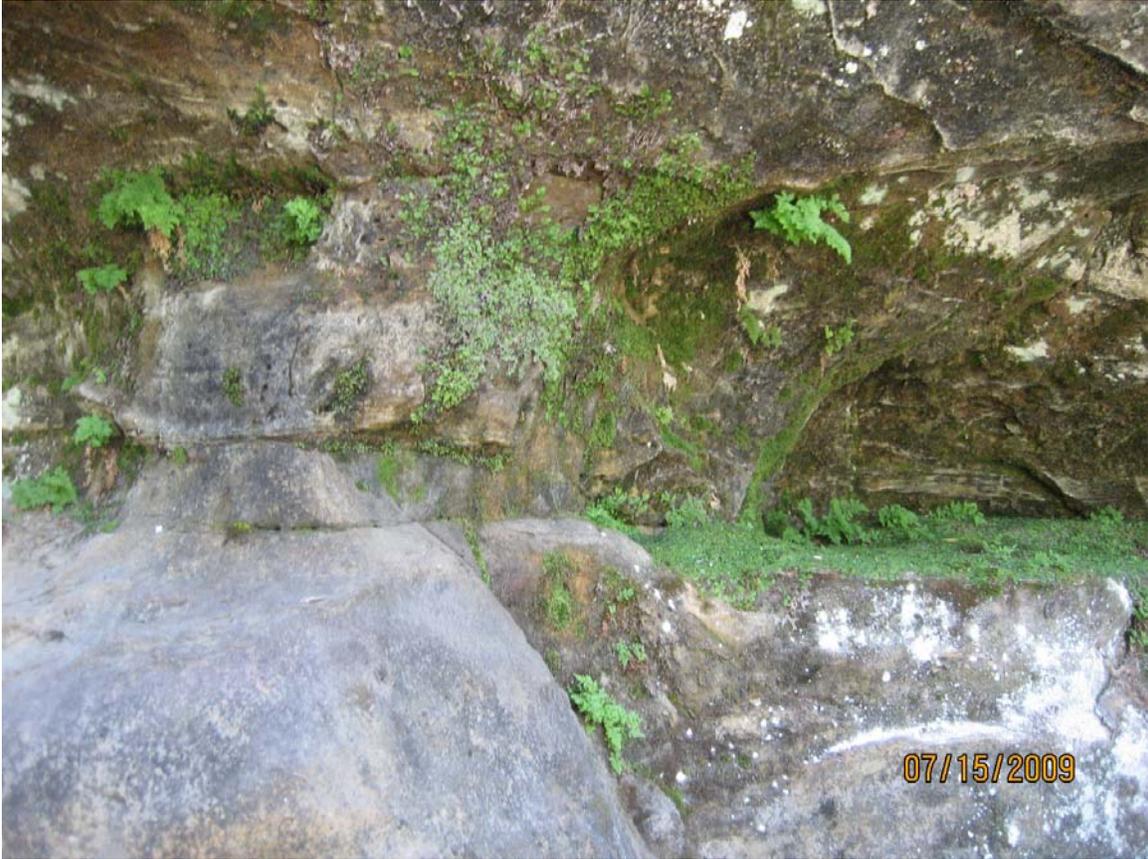
Photo Point 9a

At this photo point there is no dripping or flowing moisture in the cliff faces. The cliff face is moist and is considerably less than last year. There is good lichen growth. The ferns have a current growth of 4-6 inches.

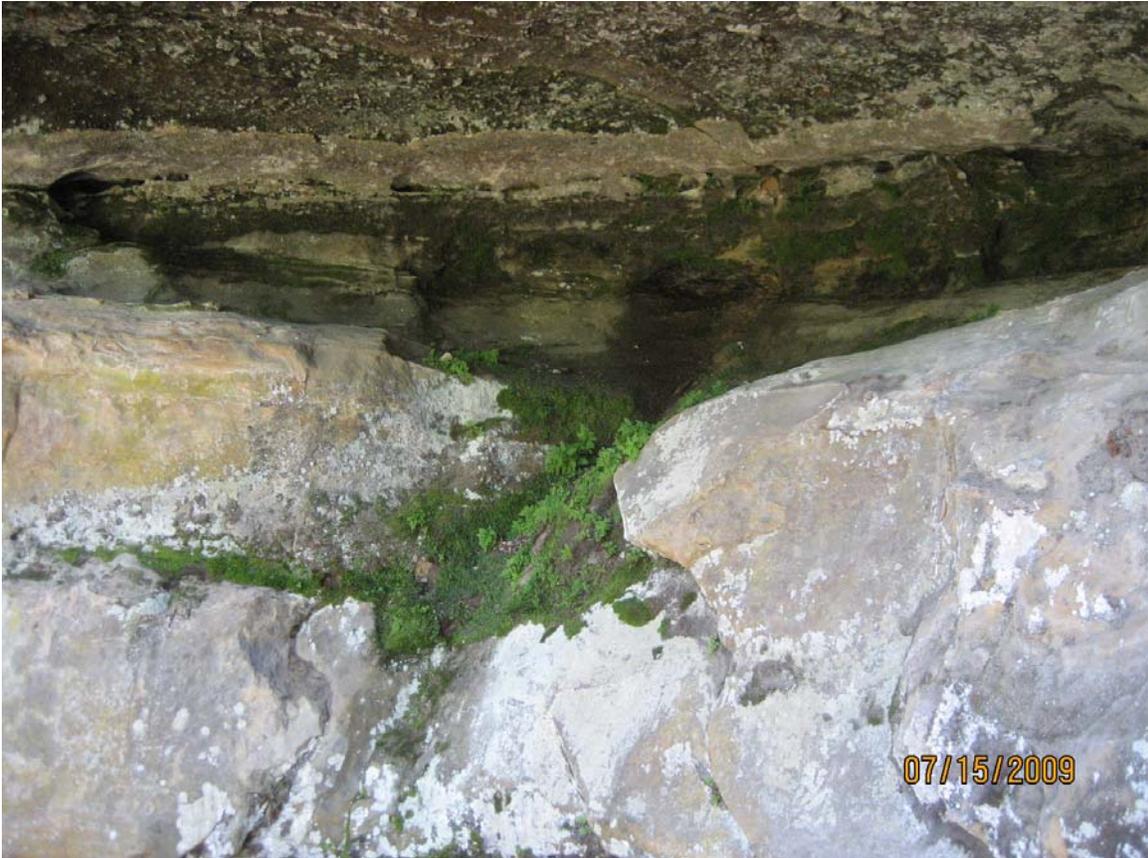
Photo Point 9b

At this photo point the rock faces are moist but there is no flowing or dripping water as there was last year. Both the lichen and fern density is less than last year. The current fern growth is 4-6 inches.

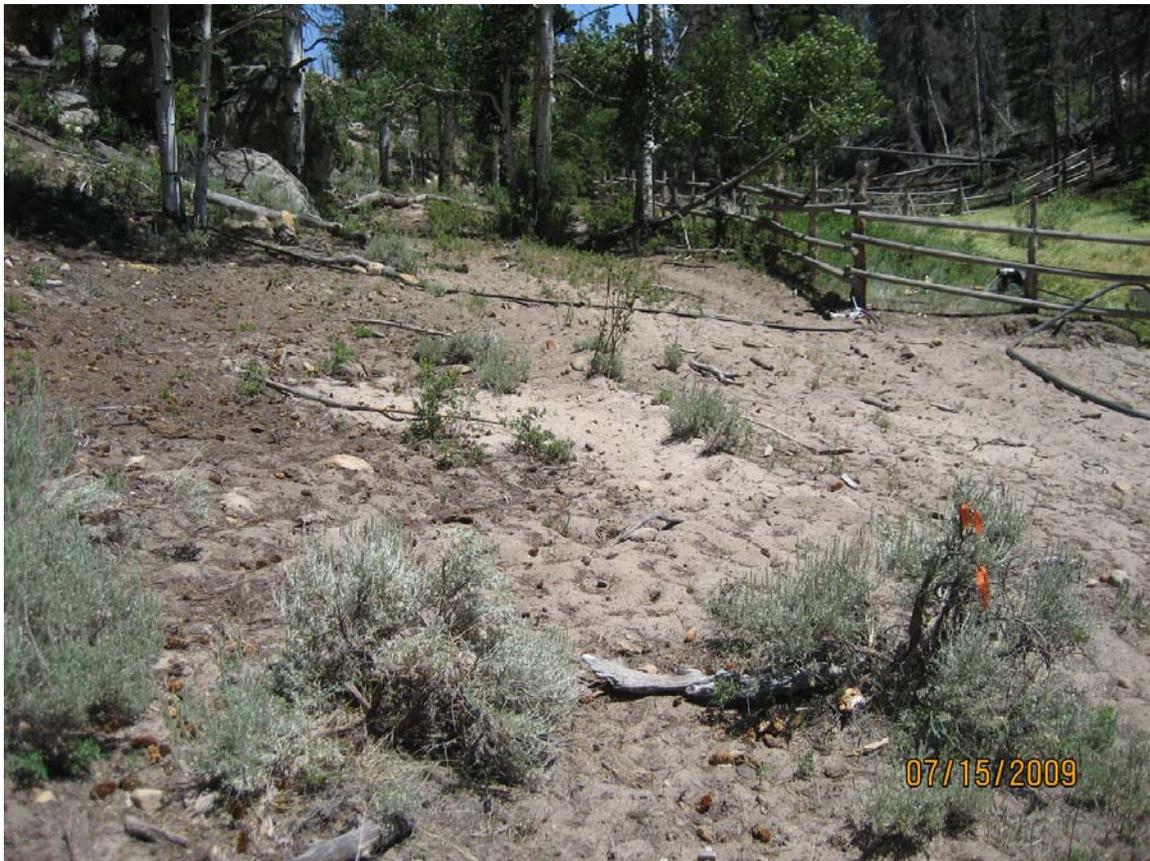
Photo Point 10

At this photo point the overall vegetative condition and vigor is very poor. The trend for the site continues to be down. This site has been heavily grazed. The site has 95% bare ground with very little (if any) ground litter. The Aspen has been heavily grazed and has no regrowth. Big Sage has 3-5 inches of new growth, Woods Rose has 1-2 inches of regrowth, and Wire grass is sparse and has 3-5 inches of growth.

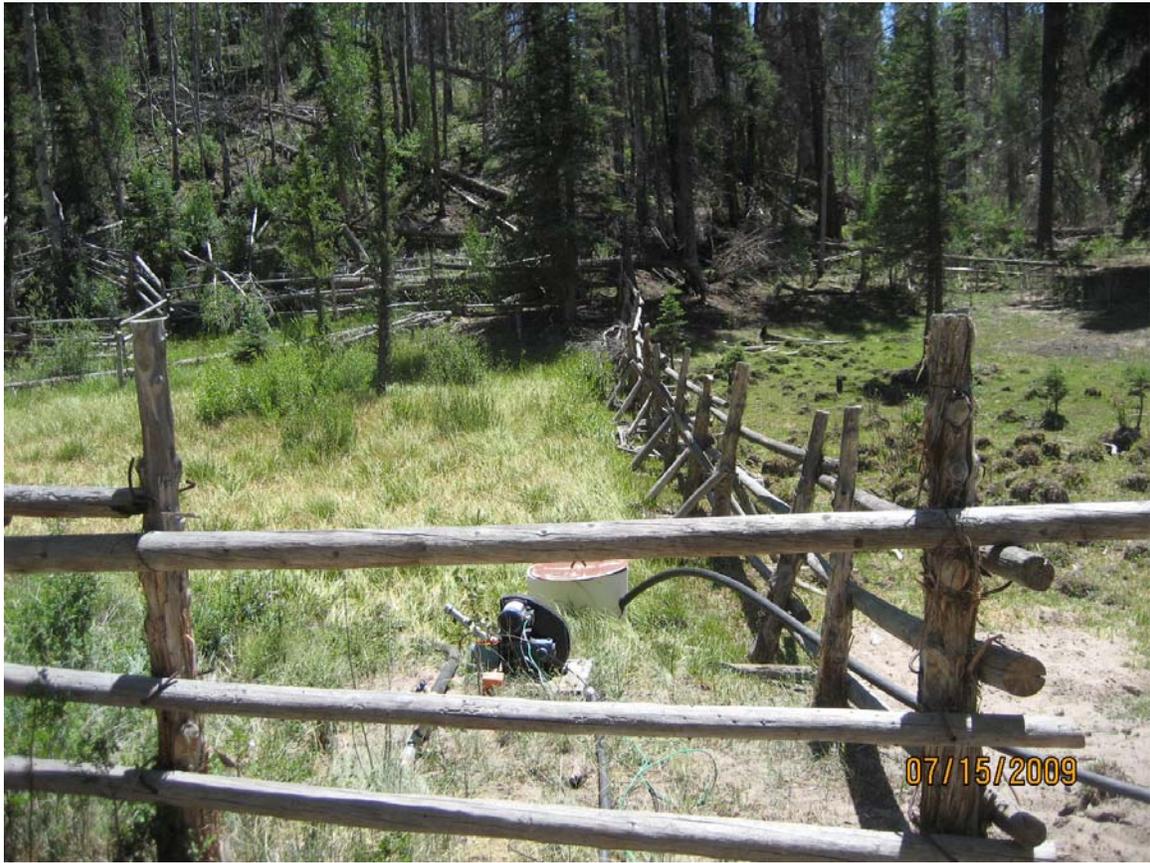
Riparian Area adjacent to Photo Point 10

This photo shows a fence line contrast between the protected area and the grazed area. The grazed area has had 95-100% utilization. The livestock were removed from the area July 1-4. Since that time the riparian area has 4-6 inches of regrowth. Although spring "Pines 105" is not flowing the riparian area is still remaining green and showing good vigor and density in the protected area.

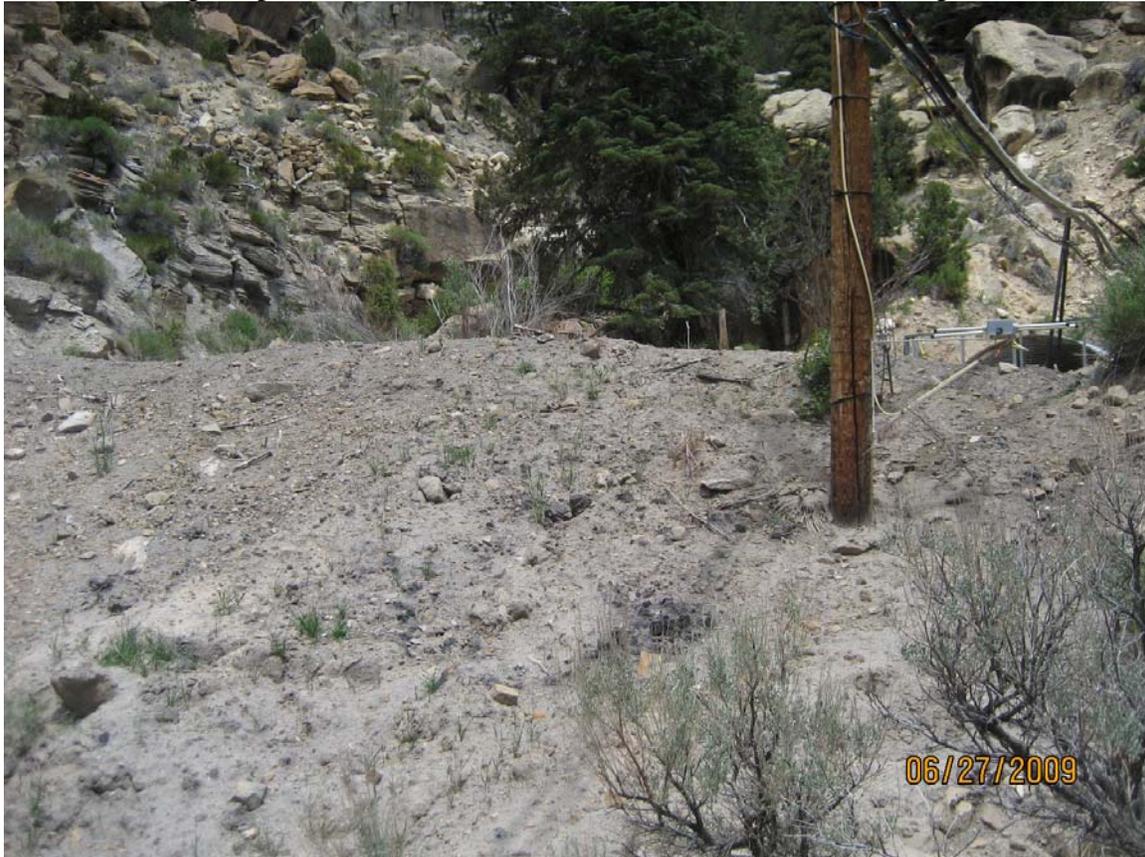
Link Canyon West Portal Photo Point

There is no water discharging from this portal and there is no evidence that there has been any this spring. The only plants that are still surviving of the original vegetation is the

Squawbush (*Rhus aramatica var trilobata*), and one willow plant (*Salix spp.*). The squawbush is sprouting from the base of the plant and has 5-6 inches of new growth. There is one willow sprout coming from the base of the original plant and has 10 inches of new growth. There is one small current bush (*Ribes spp.*) growing on the site with 4 inches of new growth. This current bush was not observed in earlier examinations. Some of the grass that was seeded last year is starting to germination on the disturbed area. It is estimated that there is only poor to fair germination at this time. This could improve over time.

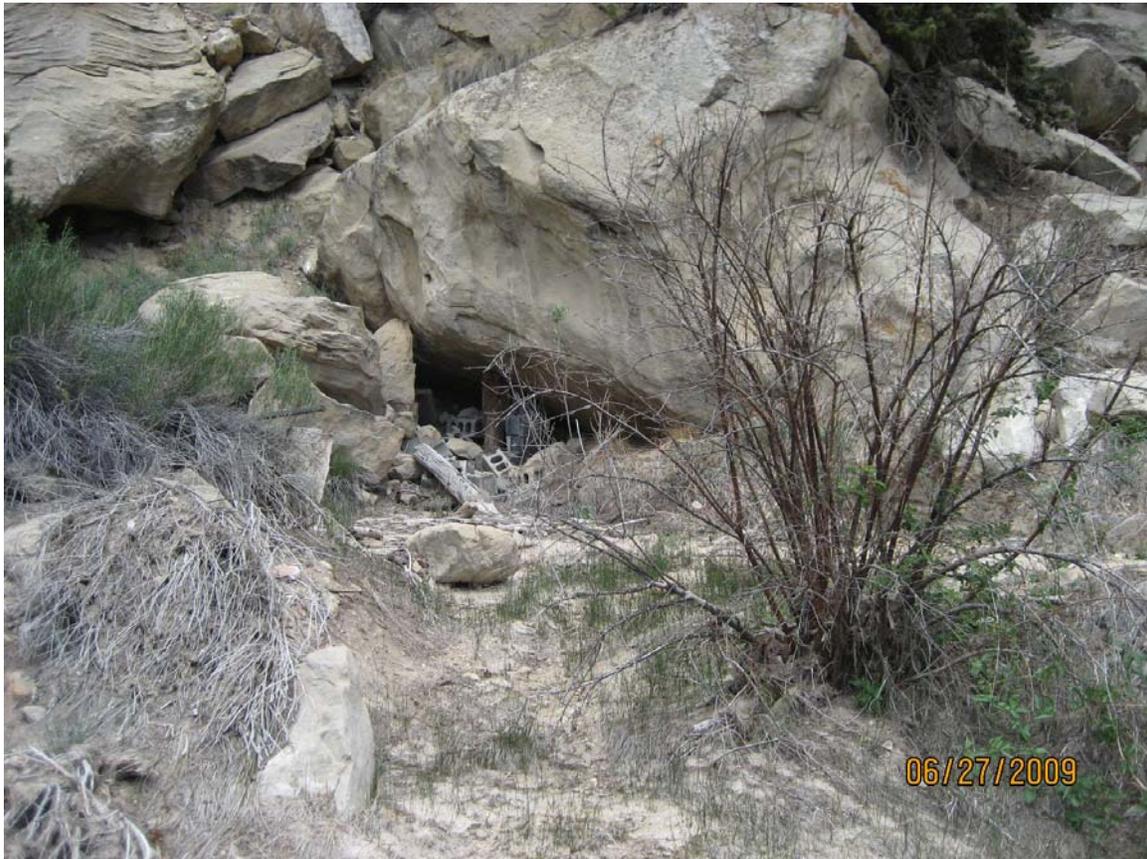
Link Canyon East Portal Photo Point

There is no water discharging from this portal and there is no evidence that there has been any this spring. The wiregrass (*Juncus balticus*) is starting to recover from last years flood. The wiregrass area has approximately 50% ground cover with 8-9 inches of new growth. Only one branch of the Dogwood bush (*Cornus stolonifera*) is still alive. However there are numerous sprouts coming up from the base of the bush with 4-5 inches of new growth. The Clematis (*Clematis liquisticifolia*) is just starting to grow with 3-4 inches of new growth. The Rabbitbrush (*Chrysothamnus nauseosus*) has 3-4 inches of new growth. There is no evidence of any Bluegrass plants. There some Cheatgrass (*Bromus tectorum*) growing on the site. Both sites continue to be very dry.

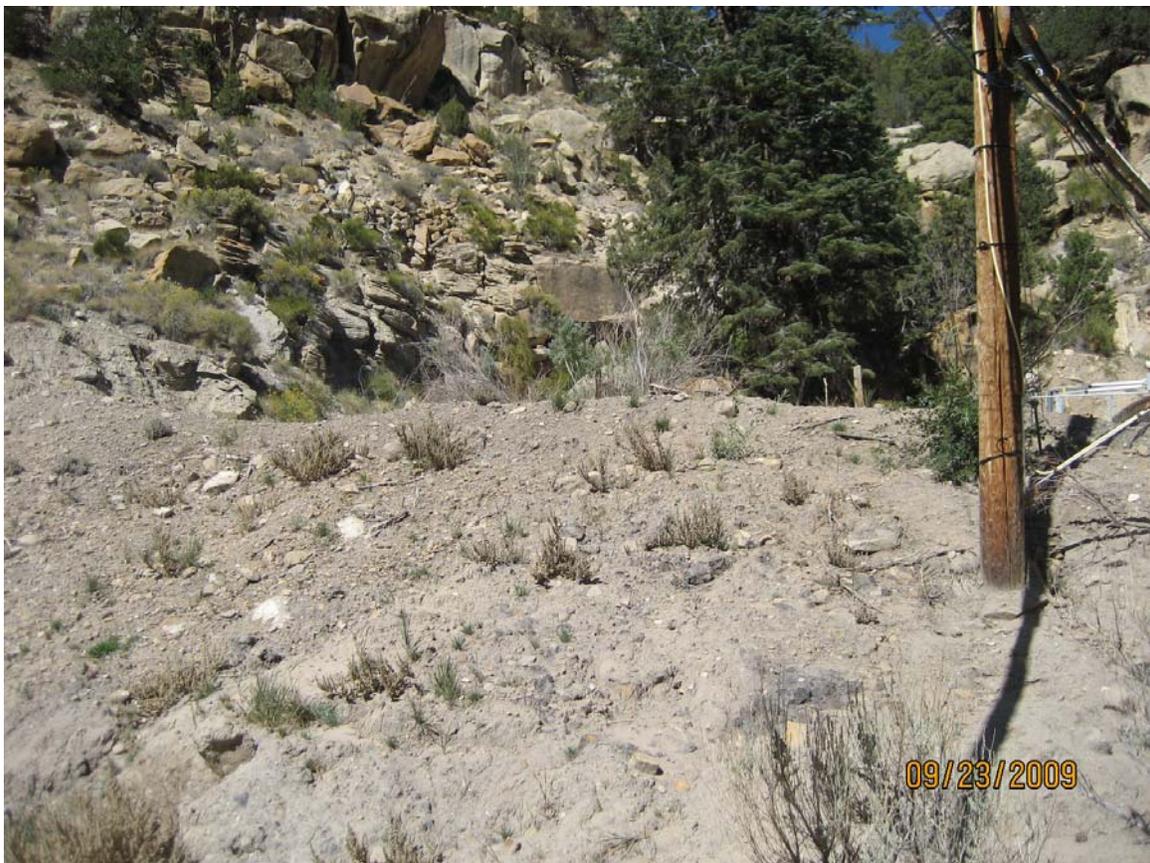
Link Canyon West Portal Photo Point

There is no water discharging from this portal and there is no evidence that there has been any this summer. At this point in time there is only fair germination of the seeded species that were broadcast on the disturbed area a year ago. The surviving Squawbush plant (*Rhus aramatica* var. *trilobata*) has good growth with current growth of 18 to 24 inches. The surviving willow plant (*Salix spp.*) also has good growth of 30 to 36 inches.

A second willow plant has come up this summer and has good growth of 18 to 24 inches. The current growth of the seeded grasses is 4 to 6 inches. There are several Halogeton (*Halogeton glomeratus*) plants growing on the revegetation area. The Halogeton plants are also growing on other areas within the permitted area.

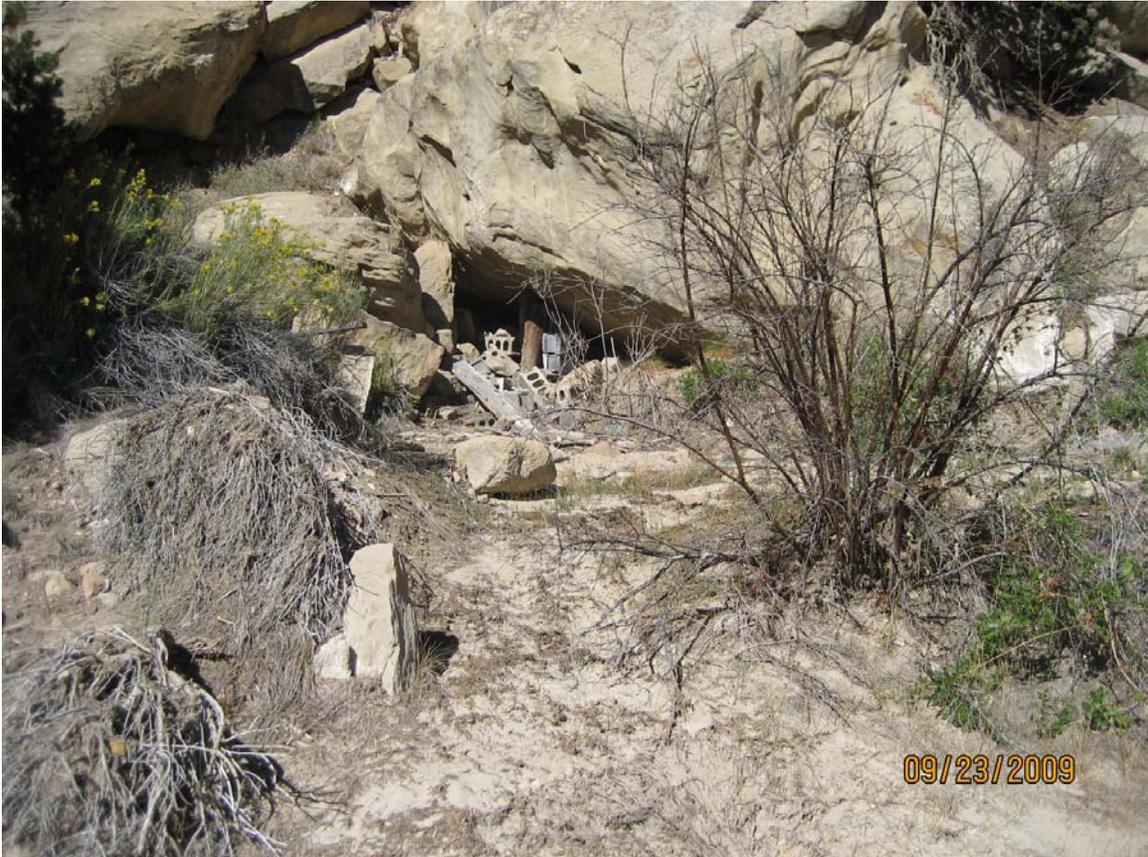
Link Canyon East Portal Photo Point

There is no water discharging from this portal and there is no evidence that there has been any this summer. The Wiregrass (*Juncus balticus*) continues to struggle. The area has approximately 30% density of wiregrass and has a current growth of 6 to 8 inches. The old Dogwood bush (*Cornus stolonifera*) continues to sprout from the base and has current growth of 6 to 8 inches. Some of the Clematis (*Clematis liquisticifolia*) has survived last years flood and has some seed heads on it. There is still no evidence of any Bluegrass plants. There is one willow plant at the mouth of the portal. It has poor vigor with 4 to 6 inches of new growth.

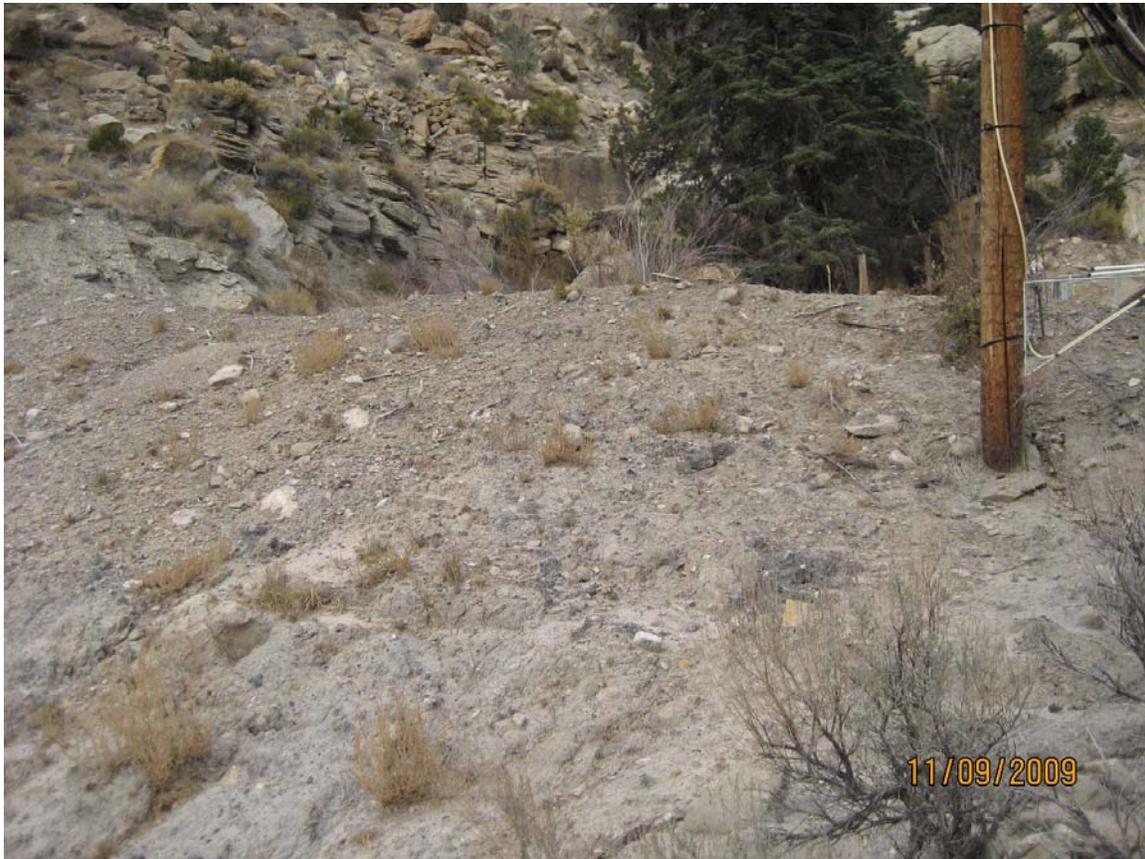
Link Canyon West Portal Photographic Point

The site is completely dormant and almost all of the leaves of the vegetation have been shed. The site continues to be very dry. There is no water discharging from this portal.

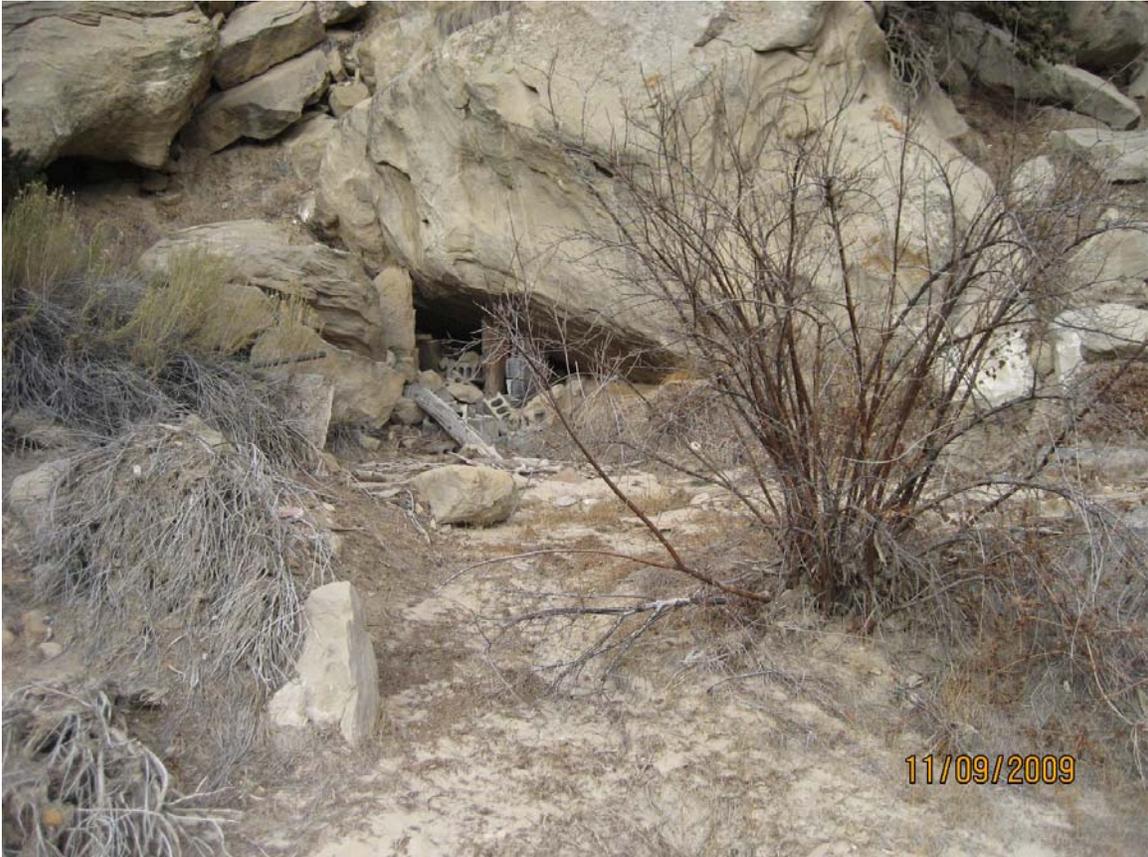
Link Canyon East Portal Photographic Point

All the vegetation at this site is dormant. The Rabbitbrush and the Clematis plants did set some seeds. Most of these seeds have been disseminated. There is no water being discharged from this portal.
