2009 ANNUAL REPORT			Page 2

On July 15, 2009, the Pines Tract Area was visited by Keith W. Zobell (Environmental Specialist), Mike Davis (Mining Engineer for Canyon Fuel Company, SUFCO Mine), and Leland Roberts (Environmental Engineer for Canyon Fuel Company, SUFCO Mine). The purpose of this trip was to revisit all of the original photographic points that have been established and to retake photographs at each of the sites and to determine the general vegetative growth, plant vigor, and plant condition at each of the established photographic sites. These sites are revisited each year at approximately the same date each year, so as to reduce any possible seasonal variations. Photographs of each site are identified and included in this report.

LINK CANYON MINE PORTAL VEGETATION STUDY

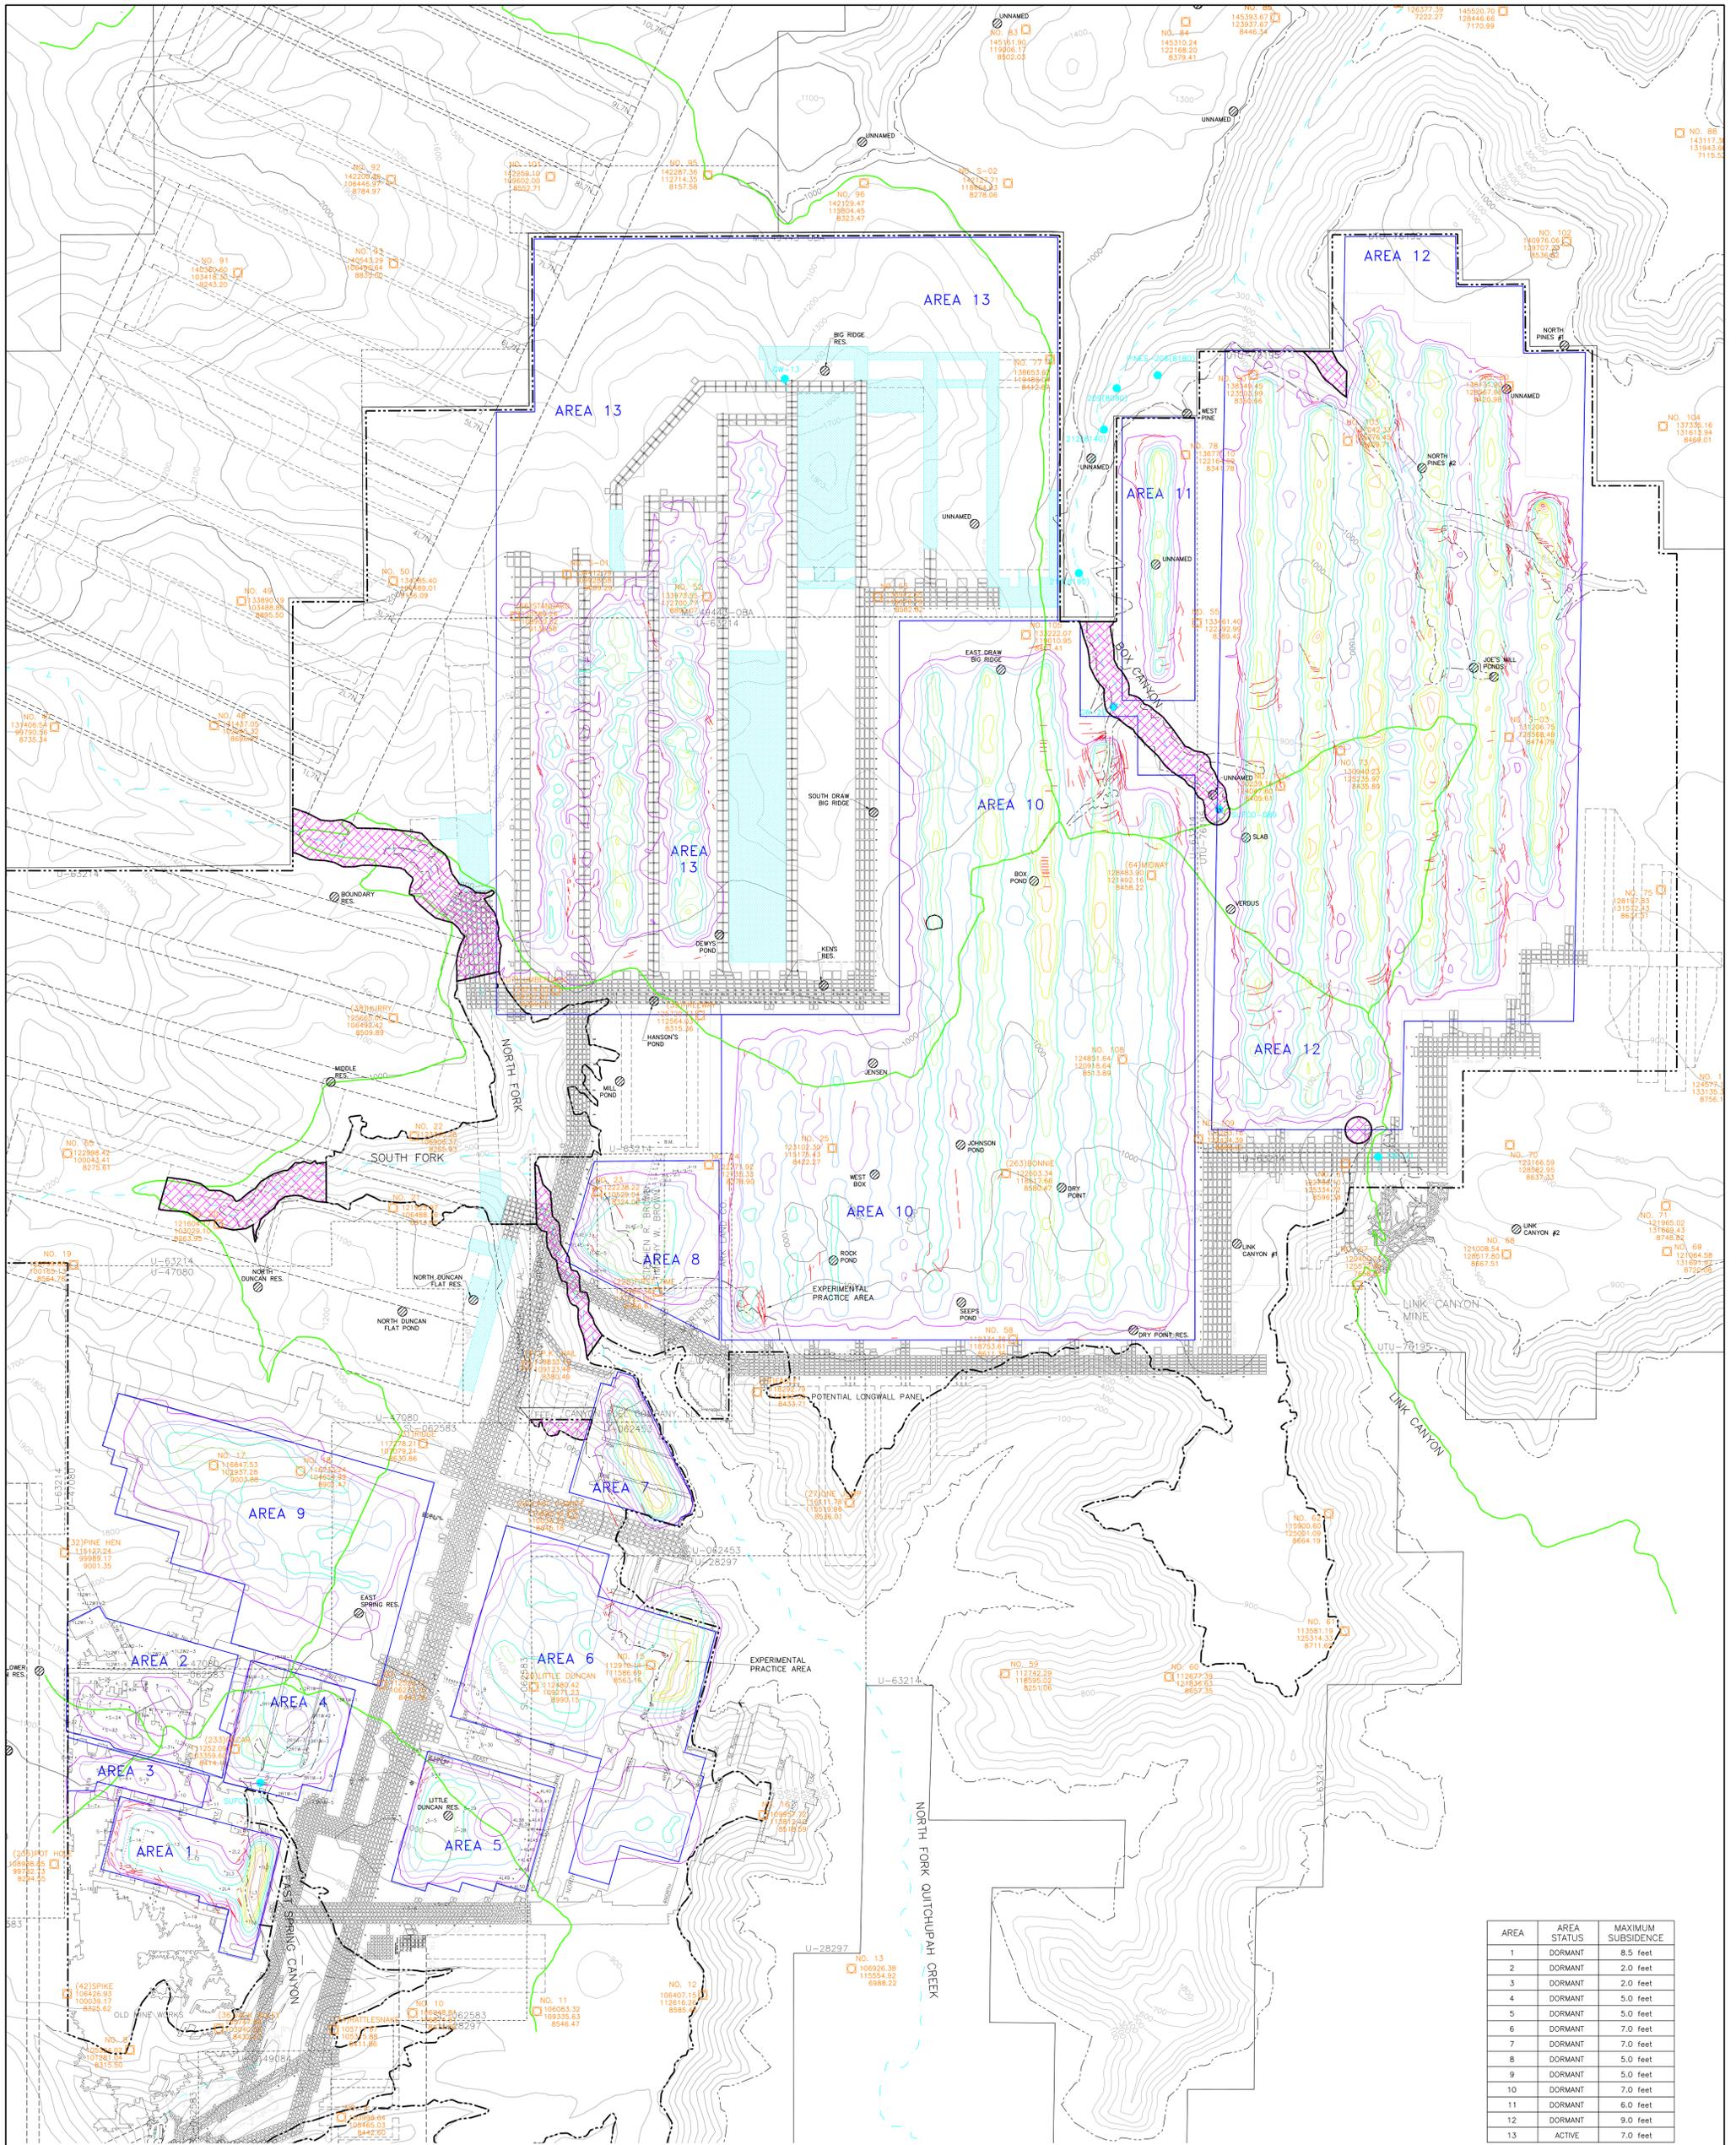
SUFCO Mine
Subsidence Map

AREA	AREA STATUS	MAXIMUM SUBSIDENCE
1	DORMANT	8.5 feet
2	DORMANT	2.0 feet
3	DORMANT	2.0 feet
4	DORMANT	5.0 feet
5	DORMANT	5.0 feet
6	DORMANT	7.0 feet
7	DORMANT	7.0 feet
8	DORMANT	5.0 feet
9	DORMANT	5.0 feet
10	DORMANT	7.0 feet
11	DORMANT	6.0 feet
12	DORMANT	9.0 feet
13	ACTIVE	7.0 feet
