Outgoing
CO410002
OK**OGMCOAL - SUFCO Mine 4th Quarter 2009 Water Quality Report**

WATER QUALITY MEMORANDUM

RE: 2009 Fourth Quarter Water Monitoring, Canyon Fuel Company, LLC, SUFCO Mine, C/041/0002, WQ09-4, Task ID #3443

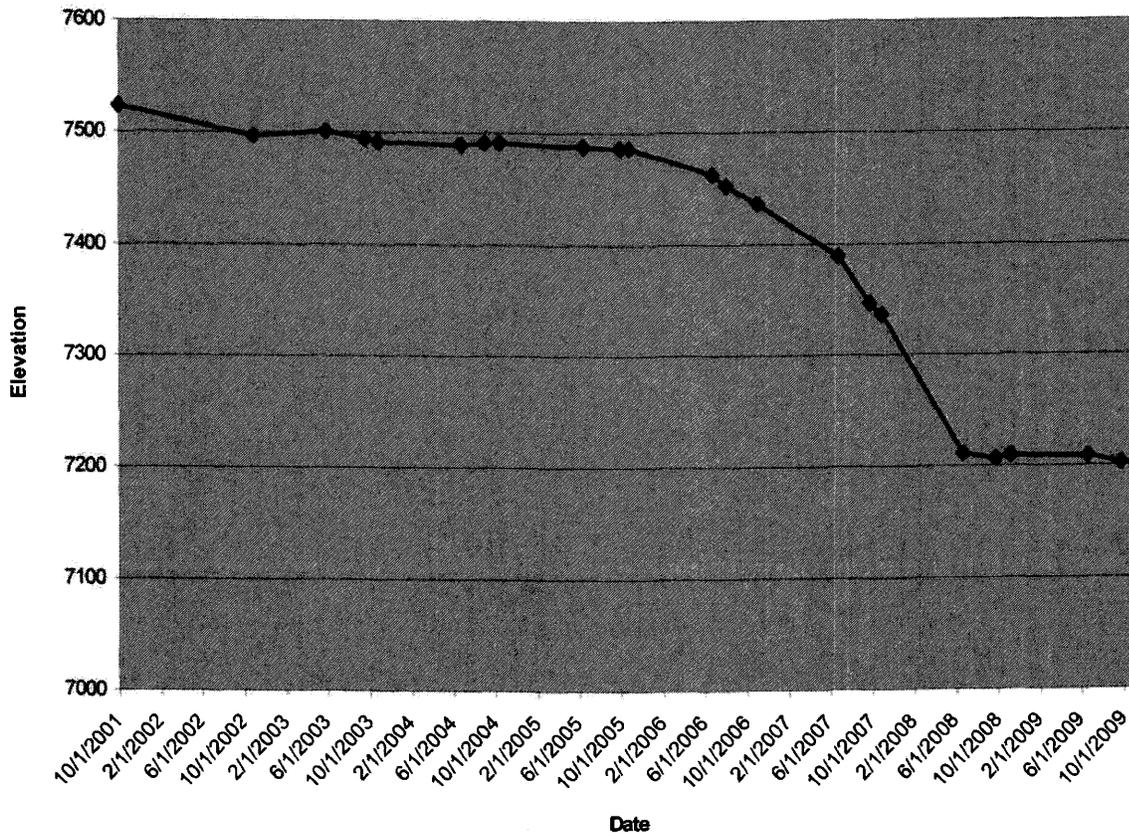
Groundwater Elevation for Well 01-8-1

The Permittee submitted all required samples for the wells. Groundwater elevations for well 01-08-1 have been submitted since 2001 monitoring the groundwater in the SITLA Muddy Lease tract. As can be seen in the chart, there was a decline in groundwater elevations of approximately 275 feet evident from the period between October 2005 and June 2008 while this area was being actively mined. Groundwater levels have begun to stabilize but it is not apparent as of yet if groundwater elevations will rebound to pre-mining levels.
