Enclosed are annual certification reports for Canyon Fuel Company's SUFCO Mine: Minesite Primary Sedimentation Pond, Minesite Sedimentation Overflow Pond, Waste Rock Disposal Site and the associated Waste Rock Sedimentation Pond.

**ANNUAL MINESITE PRIMARY SEDIMENTATION POND  
CERTIFICATION -- 2011**

John D. Byars, P.E. on September 30, 2011, conducted an inspection of Canyon Fuel Company's SUFCO Minesite Primary Sediment Pond.

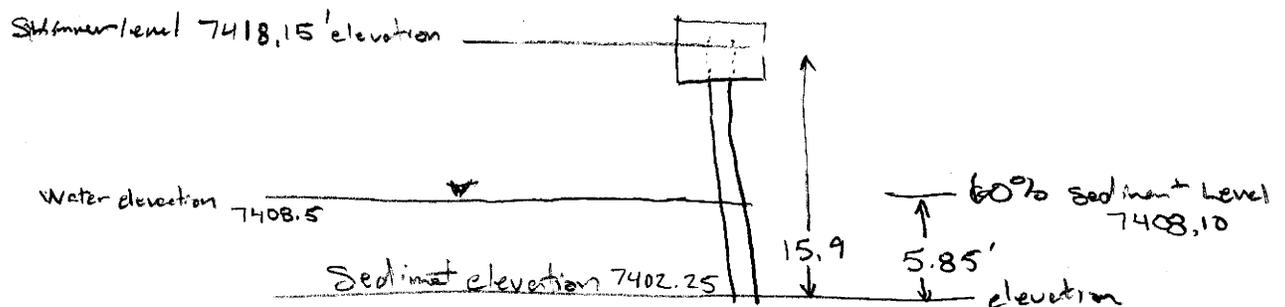
10. Drawing

minor gullies forming on west slope

The pond was just cleaned in september. The pond is currently filling.

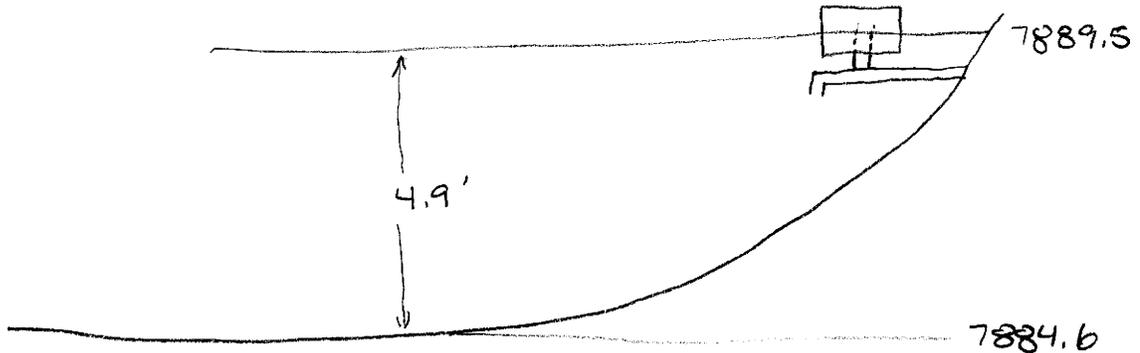
10. Drawing

Pond is planned to be clean in October.
