Enclosed are annual certification reports for Canyon Fuel Company's SUFCO Mine: Minesite Primary Sedimentation Pond, Minesite Sedimentation Overflow Pond, Waste Rock Disposal Site and the associated Waste Rock Sedimentation Pond.

**ANNUAL MINESITE SEDIMENTATION OVERFLOW POND  
CERTIFICATION -- 2012**

CANYON FUEL COMPANY - SUFCO MINE

Minesite Sediment Overflow Pond Annual Inspection Report

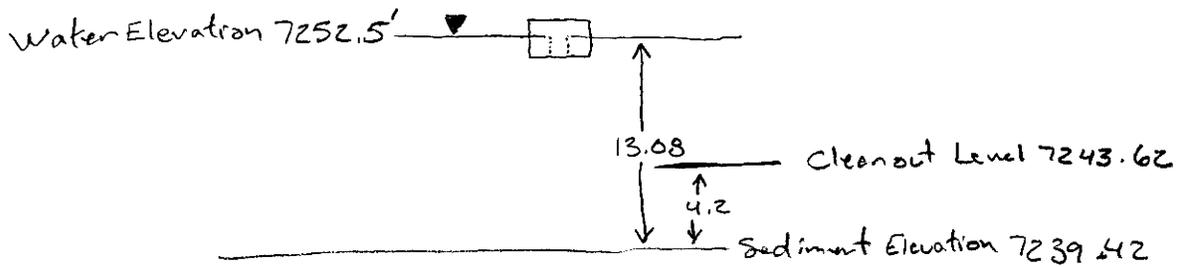
10. Drawing

9. Other Comments  
Everything appears to be in the normal operating condition

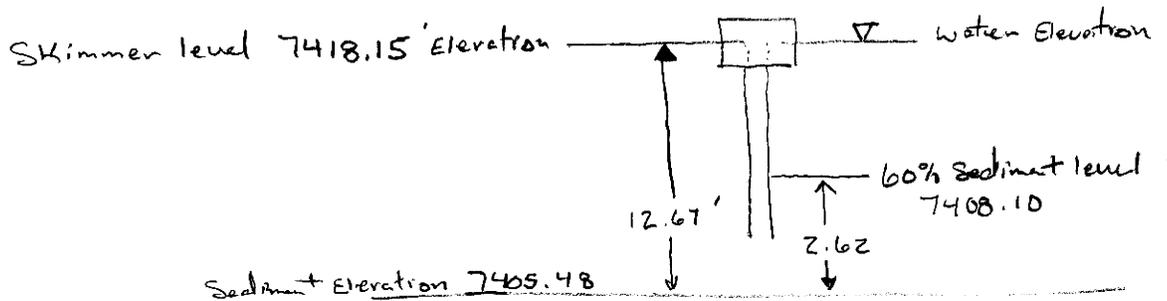
10. Drawing

Everything appears to be in normal operating condition

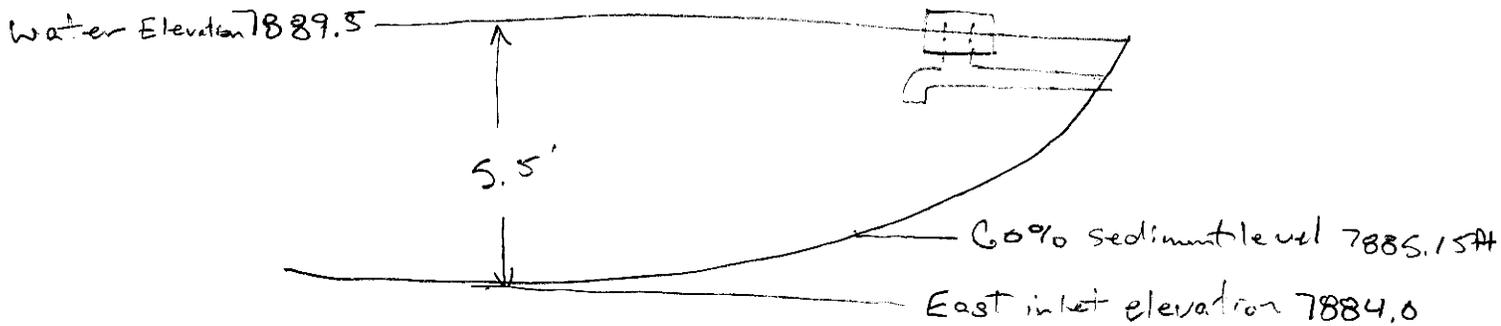
10. Drawing

Everything appears to be in normal operating condition.
