**ANNUAL MINESITE SEDIMENTATION OVERFLOW POND
CERTIFICATION -- 2013**

**ANNUAL MINESITE PRIMARY SEDIMENTATION POND
CERTIFICATION -- 2013**

**ANNUAL WASTE ROCK SEDIMENTATION POND
CERTIFICATION -- 2013**

**ANNUAL WASTE ROCK DISPOSAL SITE
CERTIFICATION -- 2013**

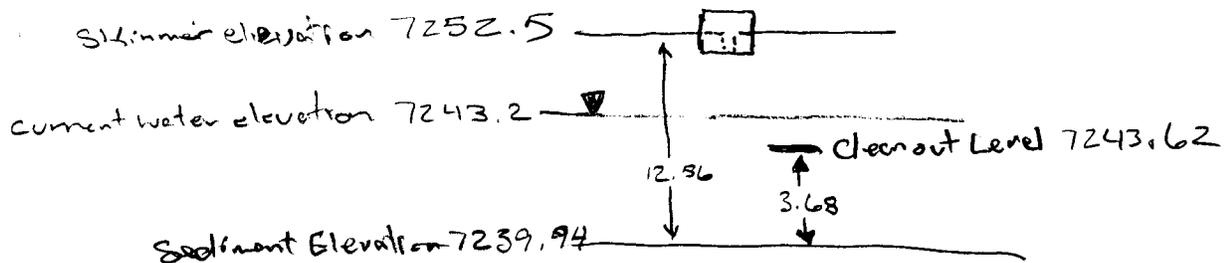
10. Drawing

There were no signs of structural weakness in the area of the sediment pond.

The fill slope above the pond was eroded with some minor gullies in random locations. There were no signs of instability of the fill slope.

The decant structure appeared to be functional and the decant valve was locked.

The water in the pond was at an elevation of 7,252.5, which is at the standpipe spillway elevation. The sediment level in the pond just north of the decant structure was at 7,239.94. This elevation is 3.68 ft. below the 60% sediment level.

Everything appears to be in normal operating condition.

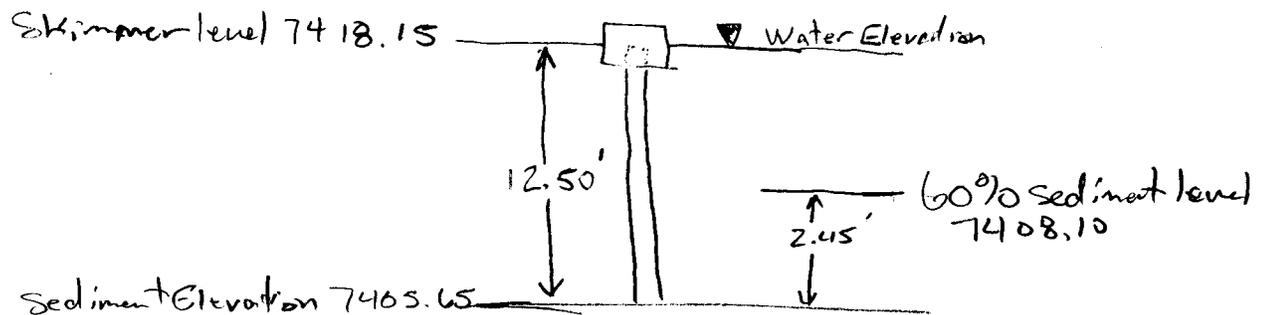
10. Drawing

There were no signs of structural weakness in the area of the sediment pond.

The fill slope above the pond was eroded with some minor gullies in random locations. There were no signs of instability of the fill slope.

The decant structure appeared to be functional and the decant valve was locked.

The standpipe spillway in the pond is at an elevation of 7,418.15. The water elevation is at 7,418.15. Approximately an additional 0.29 acre-ft. of storage volume was available in the pond above the current standpipe spillway level. The sediment level in the pond just north of the decant structure was at 7,405.65. This elevation is 2.45 ft. below the 60% sediment level.

Everything appears to be in normal operating condition
This pond was cleaned this year.

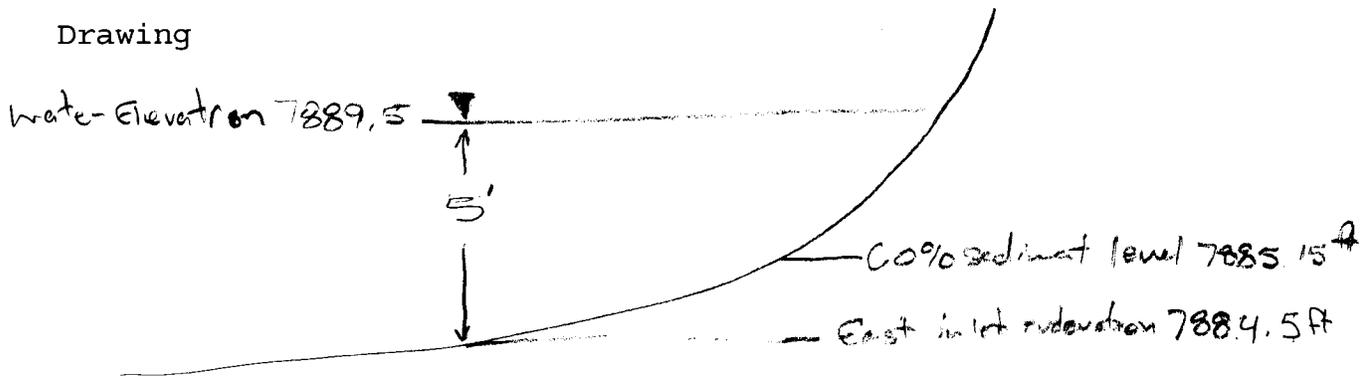
10. Drawing

No signs of structural weakness of the sediment pond dam or decant impoundment dam were observed.

The spillways and decant devices are in good condition and are functional.

The sediment level at the east inlet of the pond was at an elevation of 7,884.5 ft. The 60% sediment level for the pond is at 7885.15 ft. There is an additional 0.65 ft. of depth in the pond before the clean out level is reached.

An additional 5.00 ft. of depth is available in the pond before it would discharge through the primary spillway.

No sediment or water was observed in the decant impoundment.

Everything appears to be in normal operation condition.
