INTERUPTION OF FLOW – SOUTH FORK OF QUITCHUPAH CREEK

Area Undermined: Dec 2013 - Jan 2014

Per commitments in Sufco's approved "Monitoring and Mitigation Plan for Undermining the South Fork of Quitchupah 2R2S Block "A" and 3R2S Block "B". We have prepared a summary report describing recent monitoring and subsequent mitigation activities.

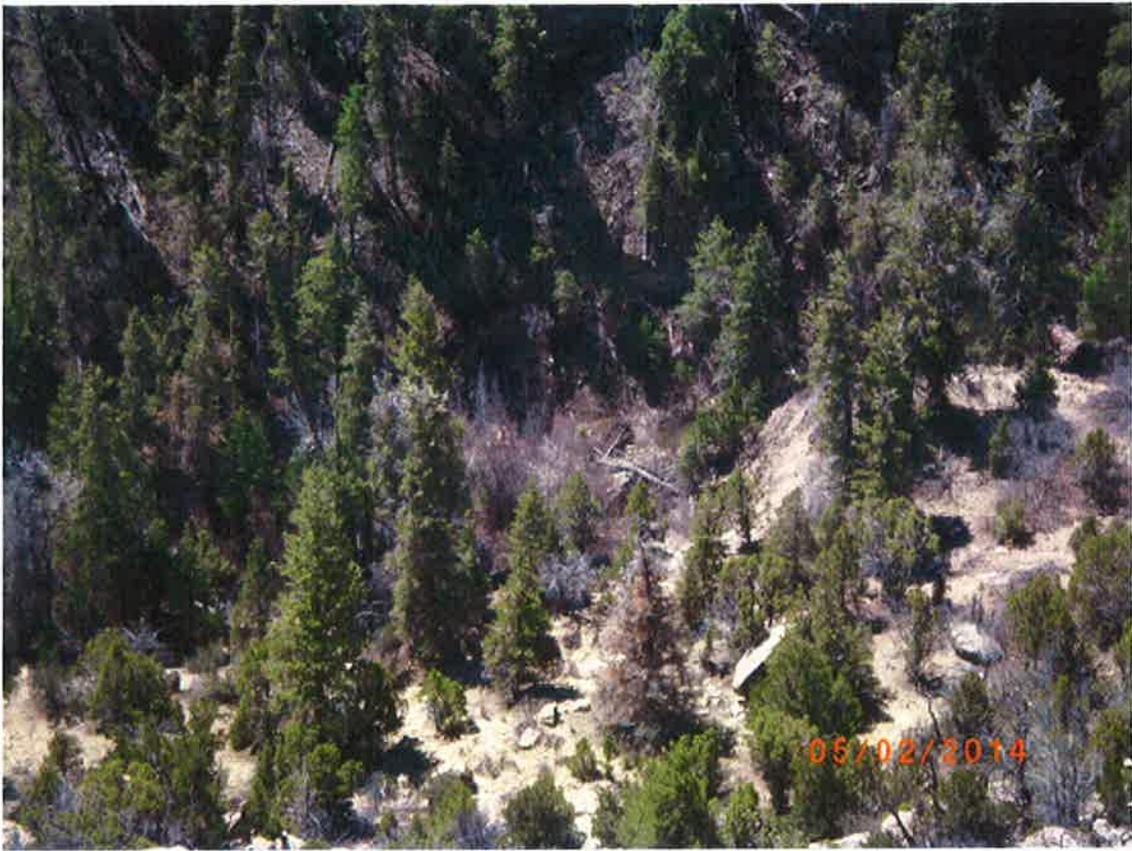
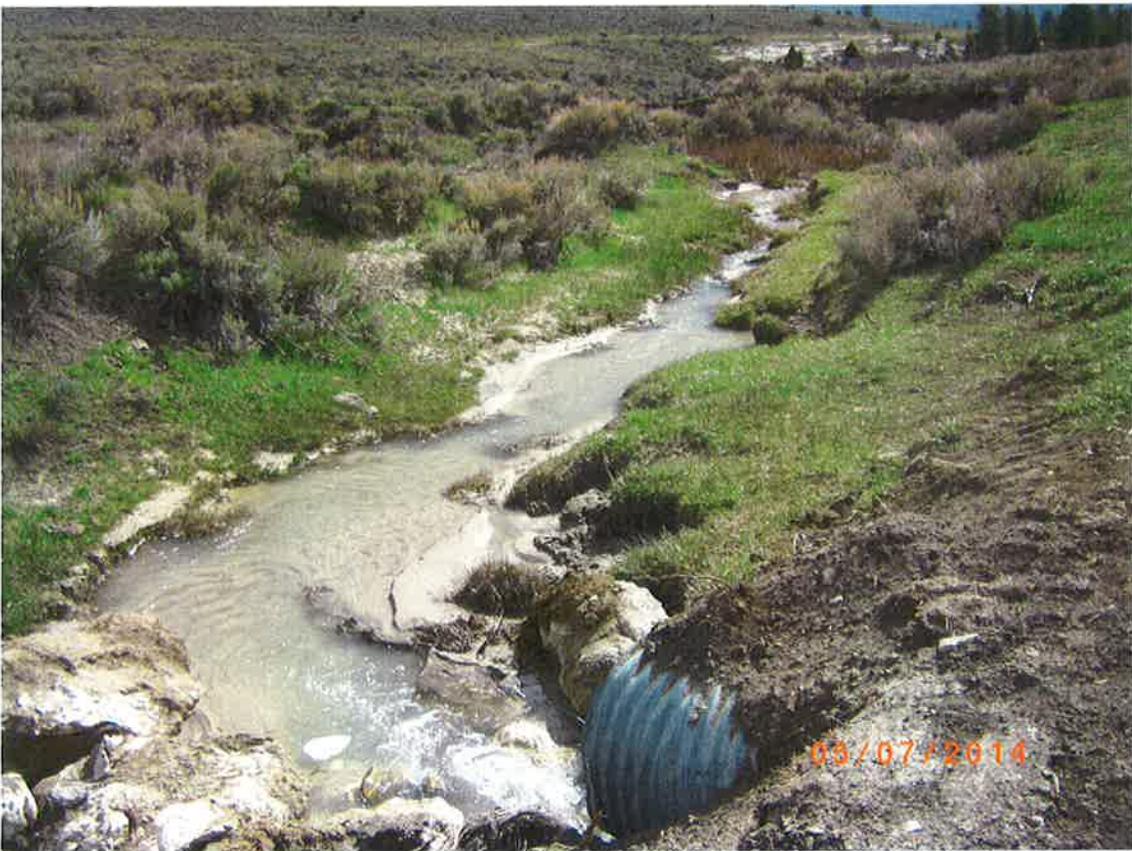
Water
flowing
fine

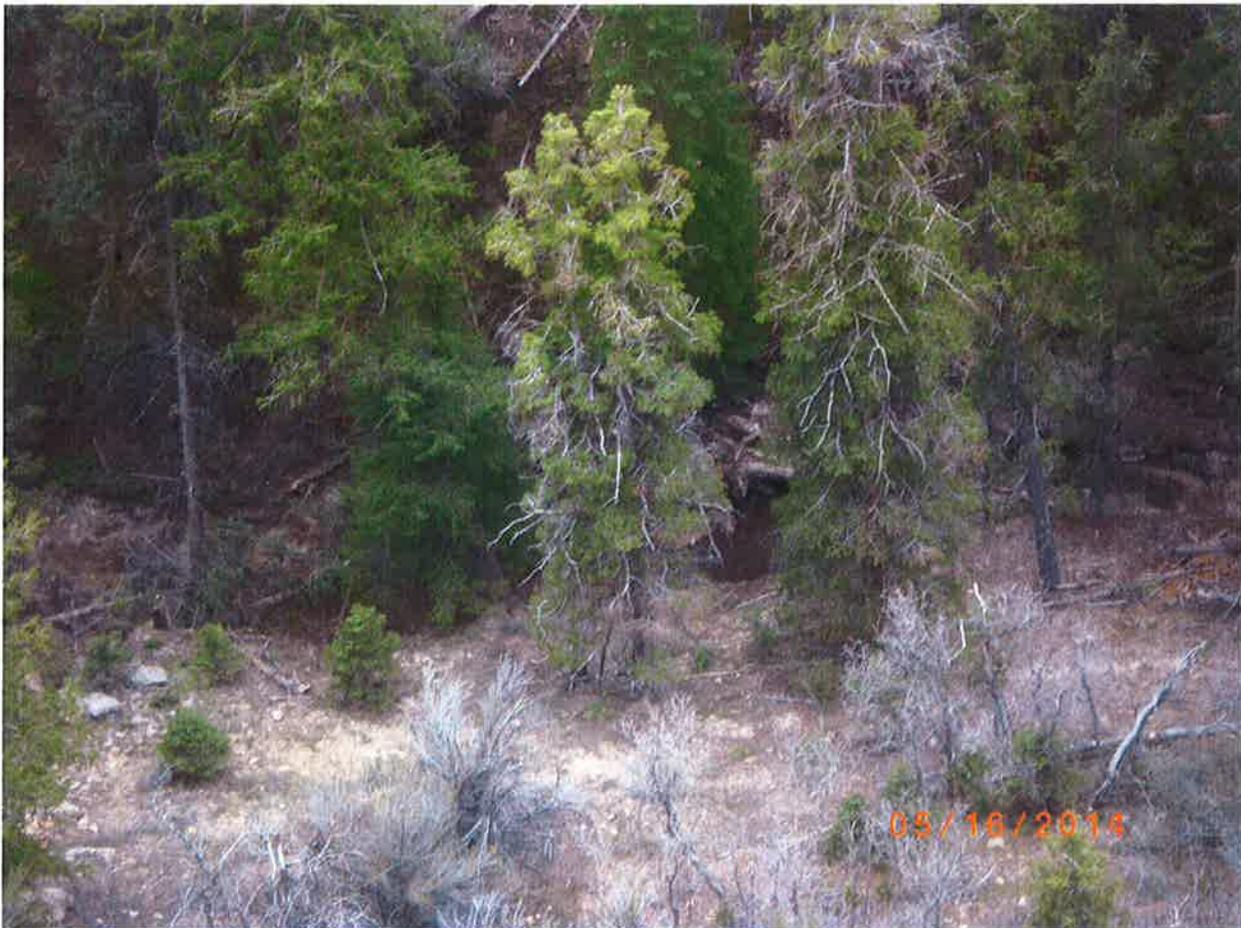
On May 16, 2014 during bi-weekly monitoring of the South Fork of Quitchupah Creek it was noted that flowing water could not be observed from a rim monitoring location, but was observed running downstream. The canyon rim between the two locations was walked to determine why and exactly where the flow stopped and where it returned to the stream channel. Approximate locations were marked, however to determine exact location would require hiking into the canyon. Hiking into the canyon by a single individual is not considered safe, so plans were made to hike into the canyon the following Monday, May 19th.

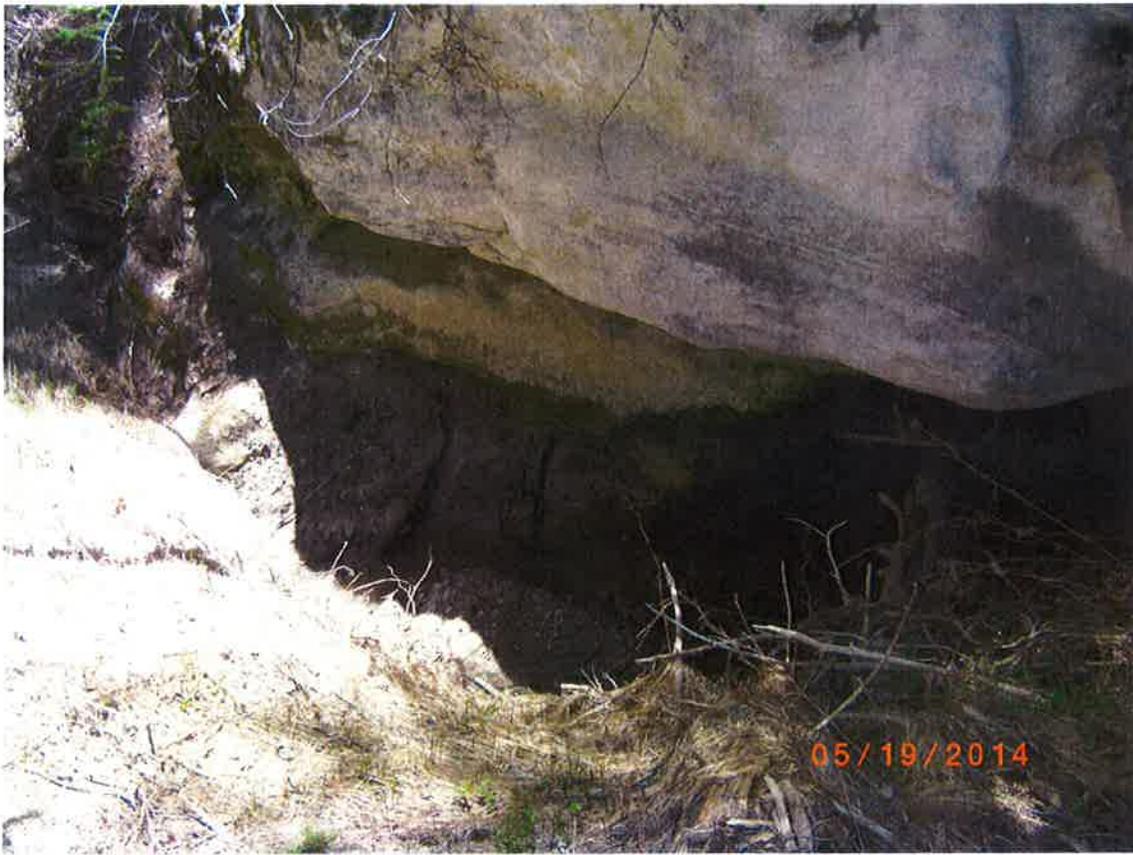
On May 19, 2014 mine personnel hiked into the canyon to determine the cause for the lack of flow. Water was seen running into a cracks beneath a rock overhang. Mine personnel shoveled native material into the cracks which forced the water to flow downstream. Bentonite was ordered and equipment was gathered following the hike to facilitate a more permanent repair the following day.

-Cracks
-flow had
stopped
at this point

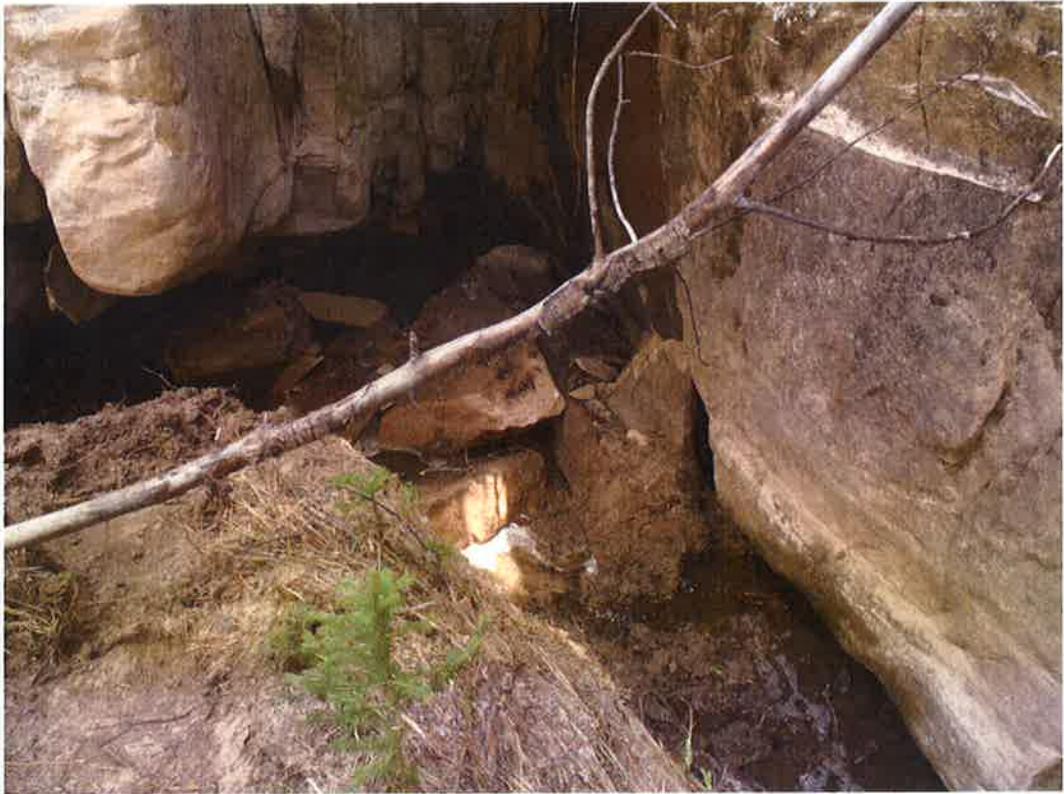
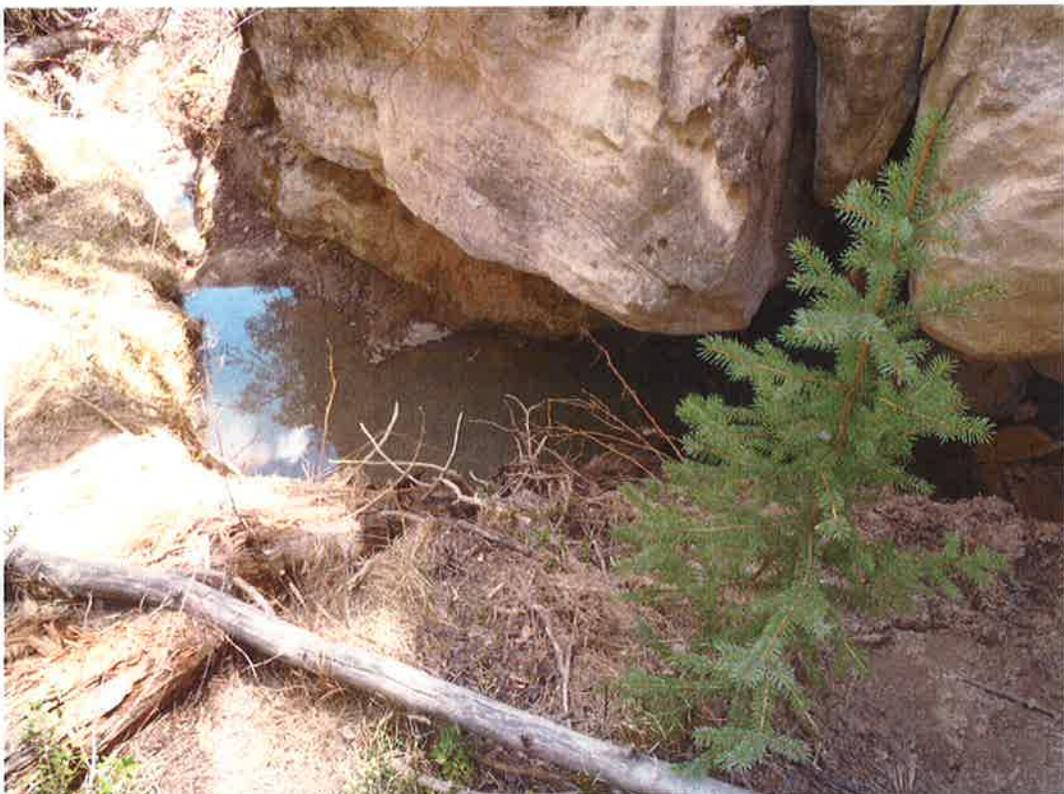
May 20 - The water was bypassing the area where the cracks had been repaired (with native material) and proceeding downstream.

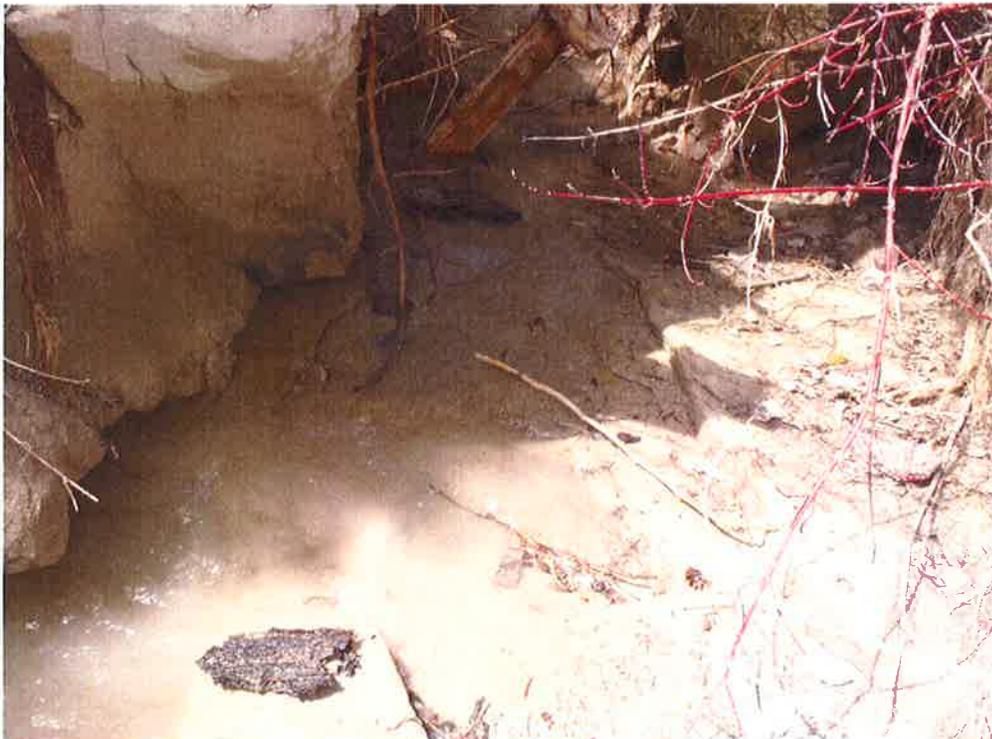
Downstream location of two additional cracks

May 21 & 22 - Bentonite was placed in the first three cracks and in addition two cracks approximately 50 feet downstream. Nineteen (19) 50# Bags of bentonite were used to fill the five cracks. Water was observed to be flowing to below stream monitoring location 006C on the 22nd.

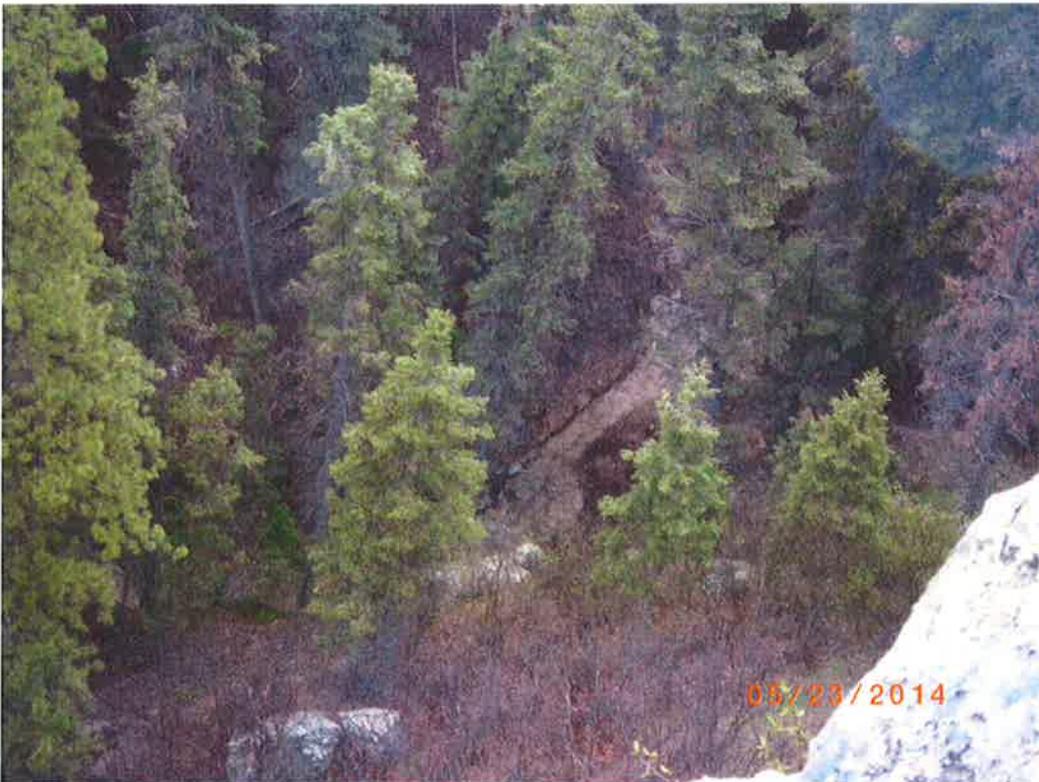
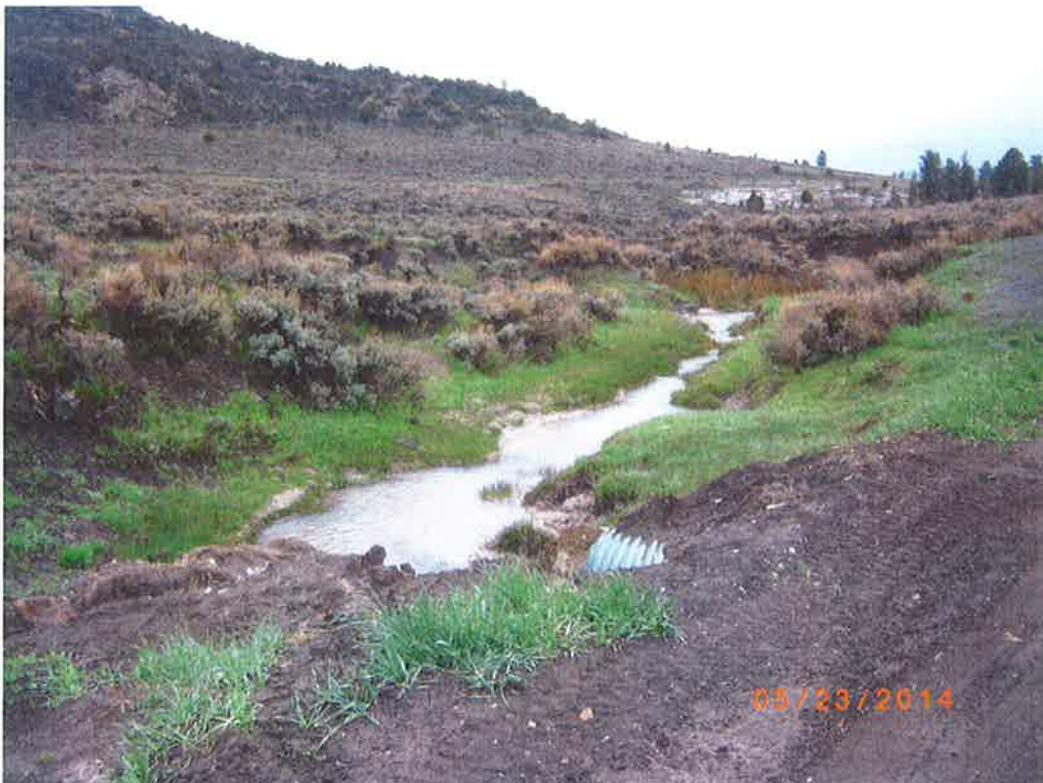
May 23 - Flow was observed to be consistent from stream monitoring locations 006A to below 006C. Heavy rains prevented access to lowest stream monitoring location.

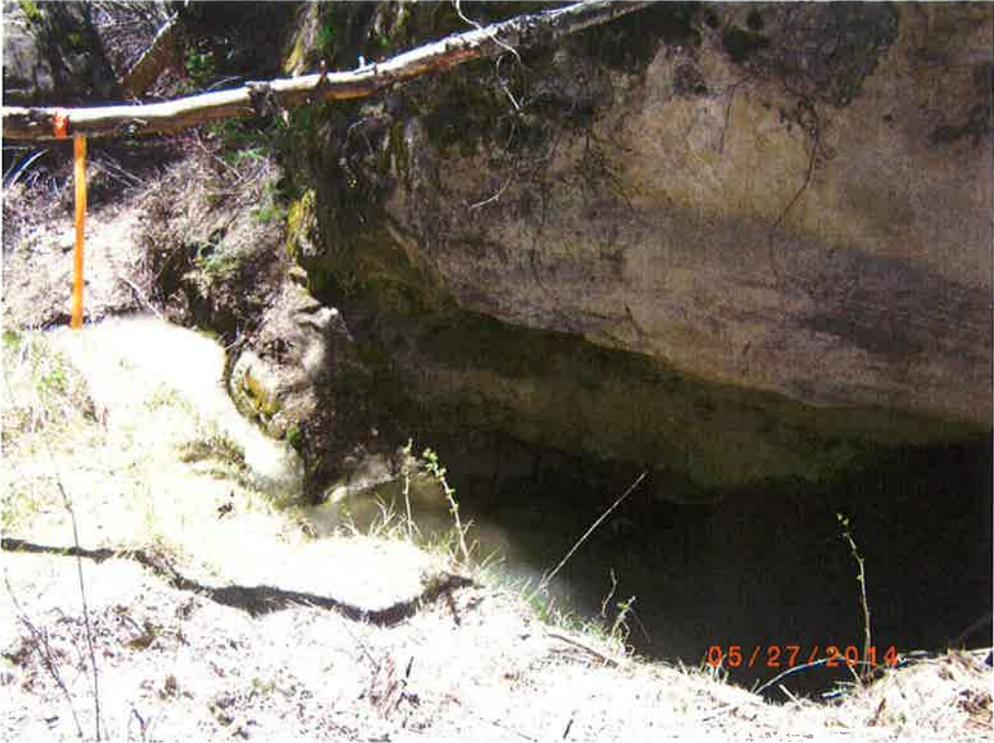
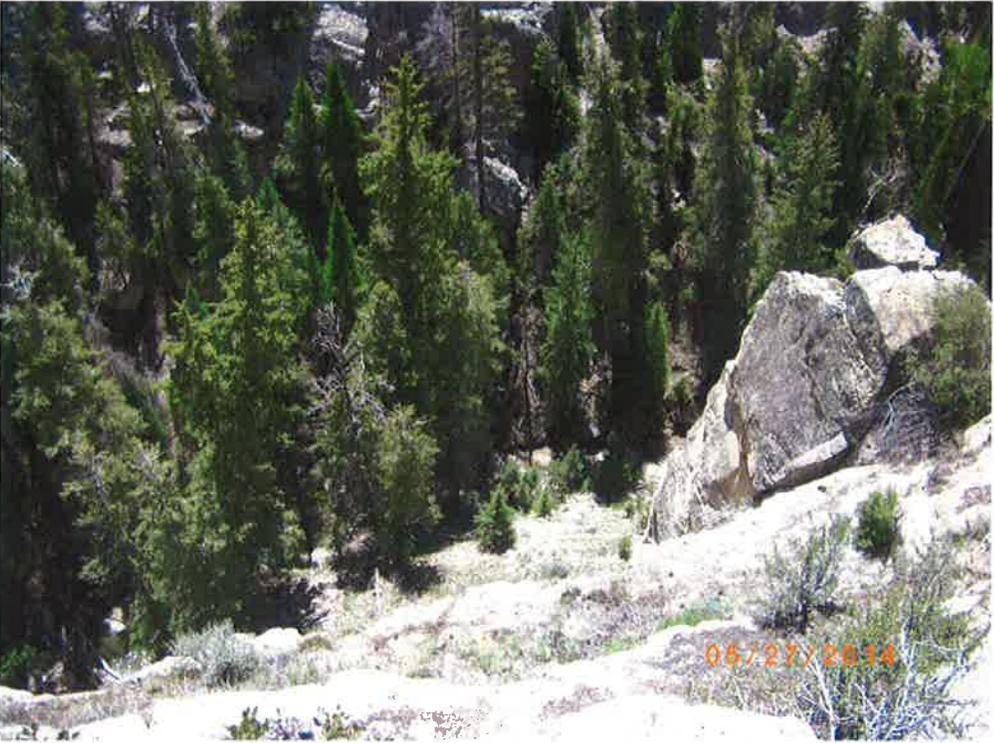
May 27 - A DOGM inspector and mine personnel observed uninterrupted flow in the South Fork of Quitchupah Creek, from above the location of the repaired crack to the area of 006D.

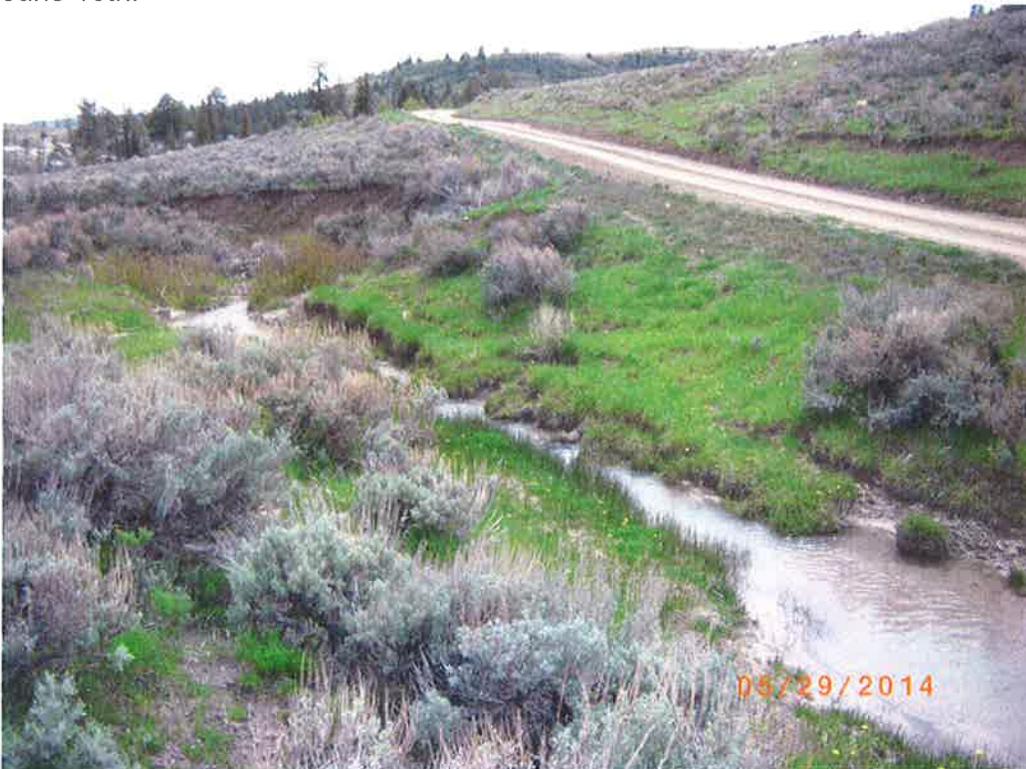
May 29 - The creek was observed to be flowing from monitoring point 006A to the confluence of the North and South Forks of Quitcupah Creek. Estimated flow was +/- 300 gpm at about 200 yards downstream from monitoring point 006A. On May 28th flow at 006C was measured at 276 gpm and at 006D was 321 gpm. Additional flow measurements by Petersen Hydrologic, LLC are scheduled for June 10th.

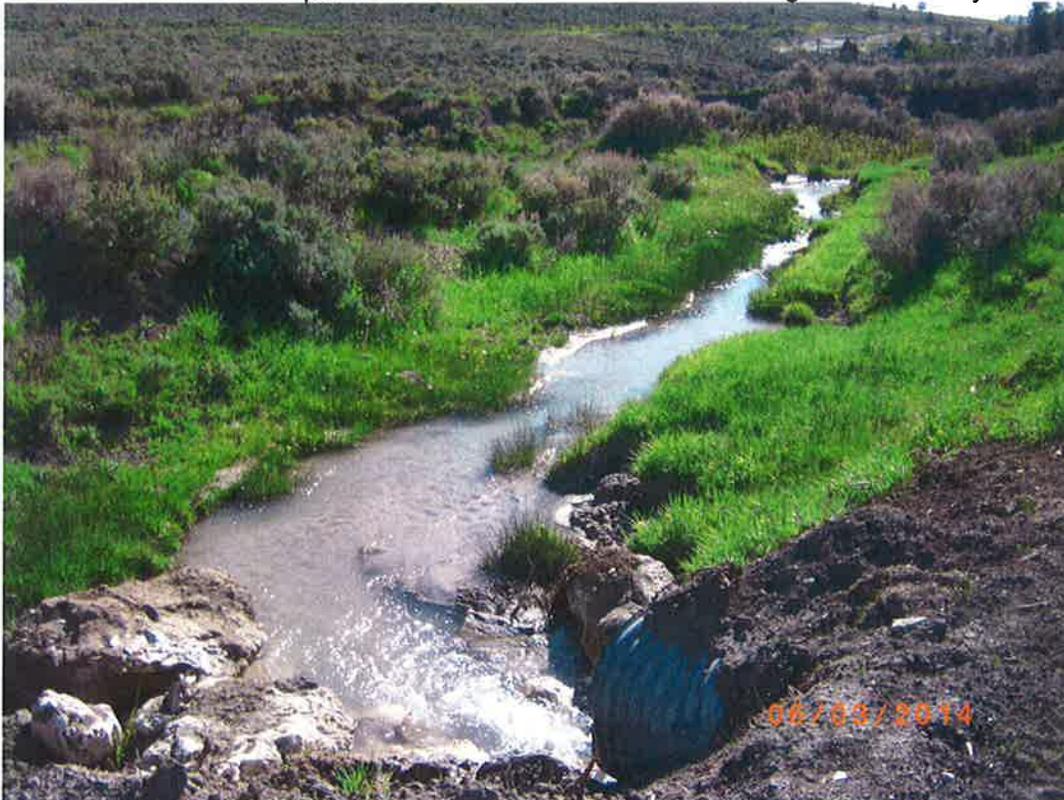
June 3 - A DOGM inspector and mine personnel hiked into the canyon, flow appeared similar at locations from 006A to Wedge Spring. Monitoring point 006D and the confluence of the North and South Forks of Quitchupah Creek was observed to be flowing from the canyon rim.
