## Monitoring Report South Fork of Quitchupah Creek

Mon, Aug 11, 2014 at 11:31 AM

During the past two weeks the flow in the South Fork of Quitchupah Creek fluctuated (160 – 350 gpm) due to rain storms. Water was observed to be flowing from Spring 006 (IMGP3834) to the confluence during the past weeks and the flow was estimated to be similar (IMPG3754 & 3822). The cattle population and impacts were estimated to be reduced by 70% during the two week period. The ponds listed in the mitigation plan were dry.

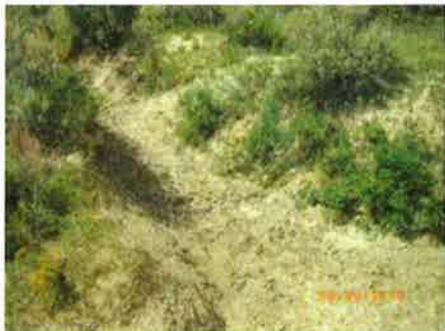
**IMGP3828.JPG**  
1893K

The channel was surveyed for cracks, no new cracks were found. Approximately 0.32 inches of rain fell in the two week period at the mine site, however there was evidence of more substantial rain falling in the vicinity of South Fork (IMGP3828). A drawing showing the location of mining is attached.
