Sufco Mine

**ANNUAL MINESITE SEDIMENTATION OVERFLOW POND
CERTIFICATION -- 2014**

**ANNUAL MINESITE PRIMARY SEDIMENTATION POND
CERTIFICATION -- 2014**

**ANNUAL WASTE ROCK SEDIMENTATION POND
CERTIFICATION -- 2014**

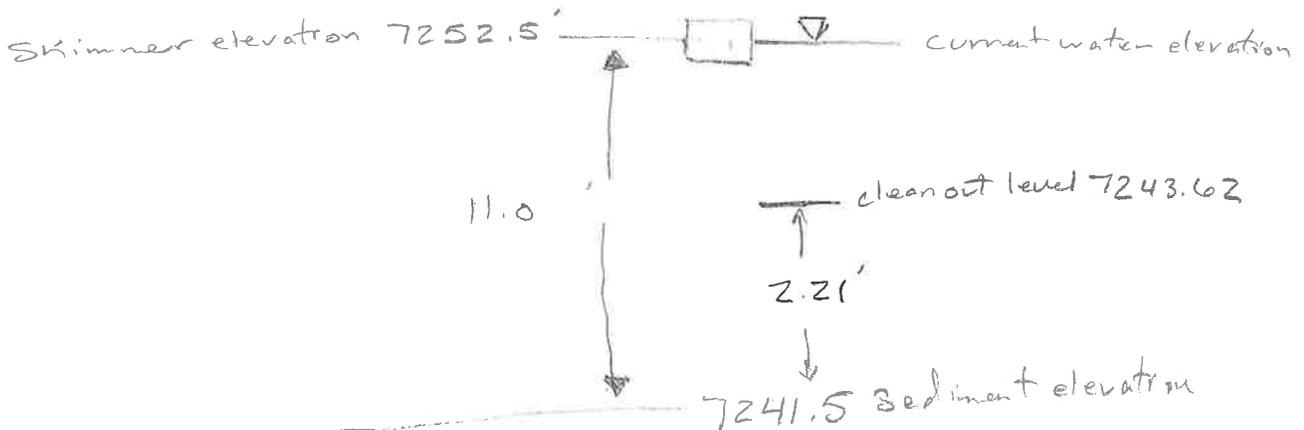
10. Drawing

Everything appears to be in normal operating condition

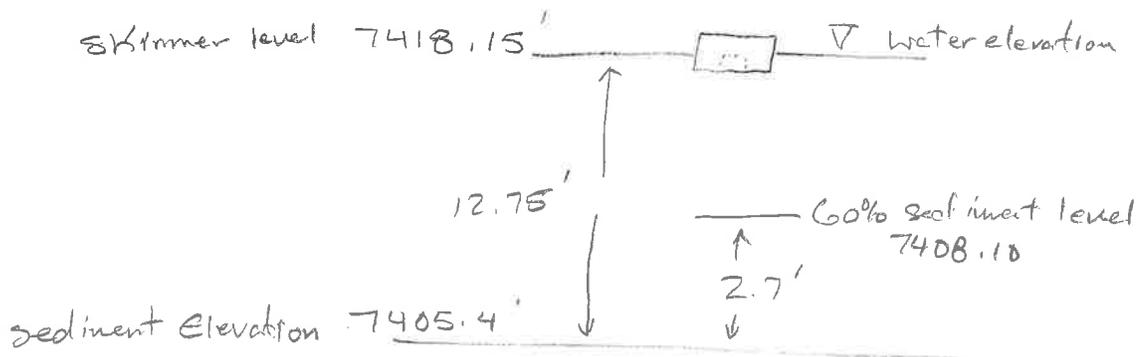
10. Drawing

Everything appears to be in normal operating condition

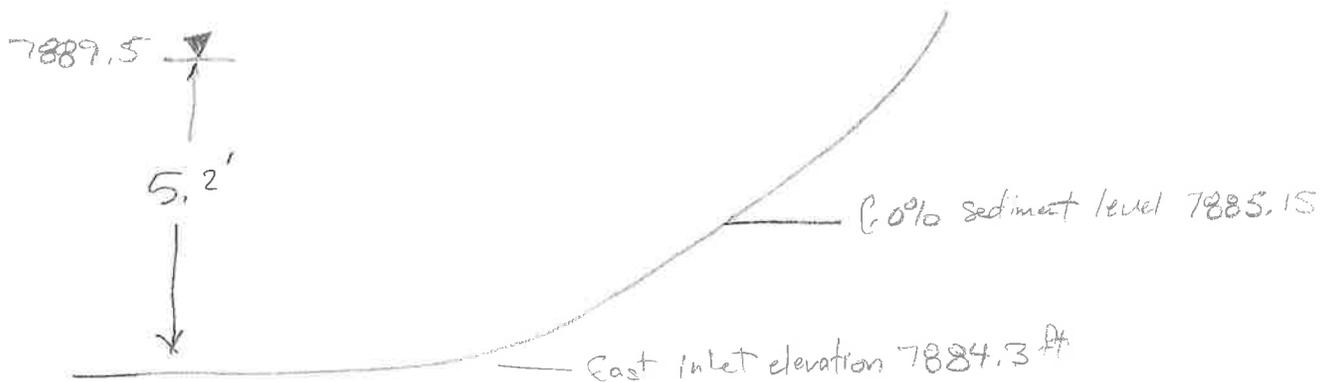
10. Drawing

Everything appears to be in normal operating condition
