FW: South Fork of Quitchupah Monitoring

Drawing showing the location of mining through July 26, 2015 has been attached. This report contains one week of creek survey information, since three weeks were reported on Monday July 20th.

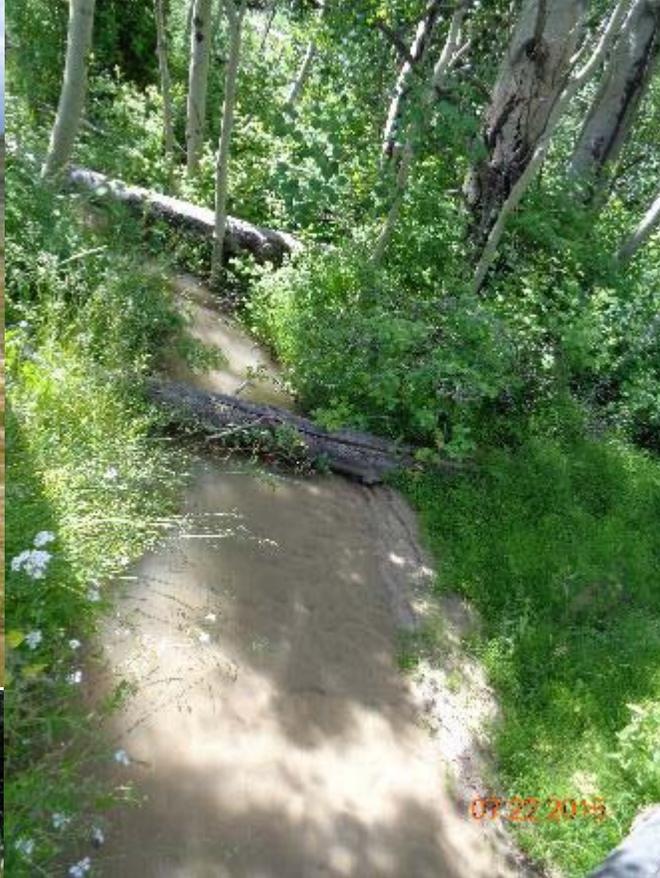
July 22 – There was some cattle activity on the creek late in the afternoon of this day below the road culvert creek crossing. The springs were flowing at a rate similar to the previous weeks measurement. The beaver pond previously reported has silted in with the recent storms. The sediment laden flow at the culvert road crossing is estimated at 60-70 gpm. All ponds were dry but with tall grasses covering the pond footprint. At the western most photo location on the canyon rim the flow appears to similar to the 60-70 gpm at the road crossing. The tall grasses obscure view of the creek in many locations.

Silted in Beaver Pond

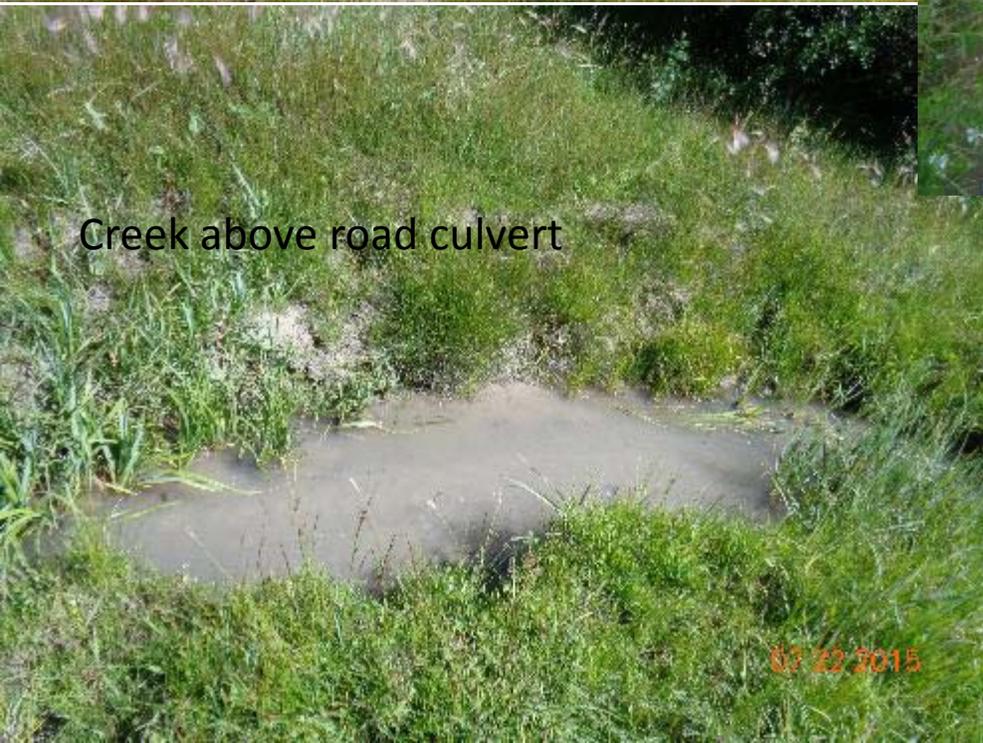
Creek above road culvert

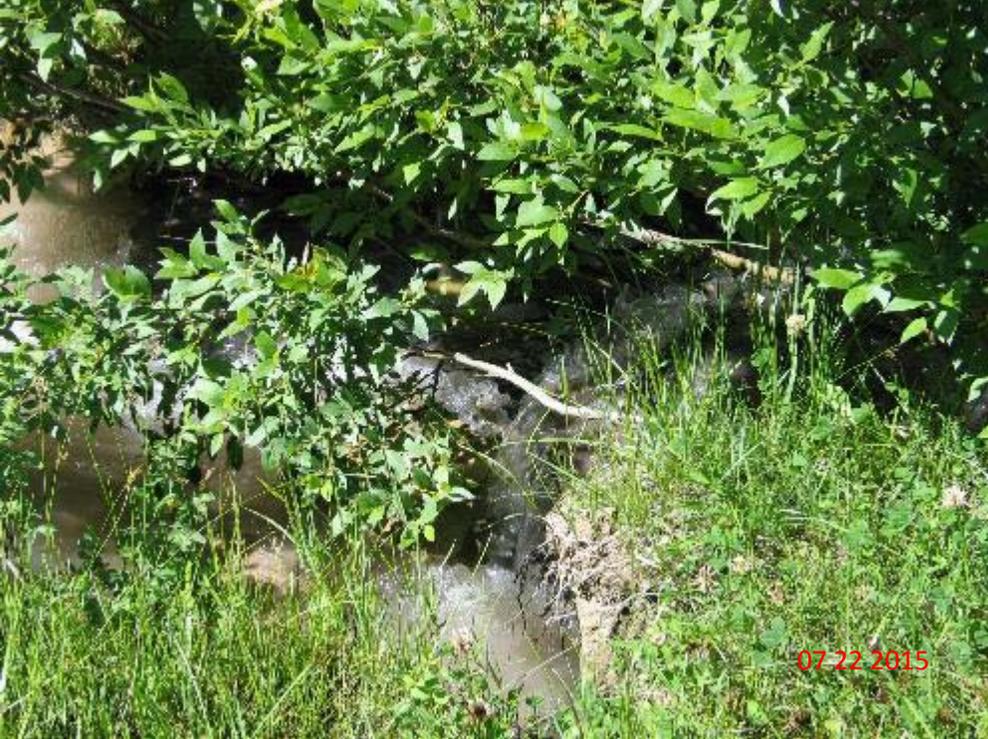
Creek just prior to dropping into canyon

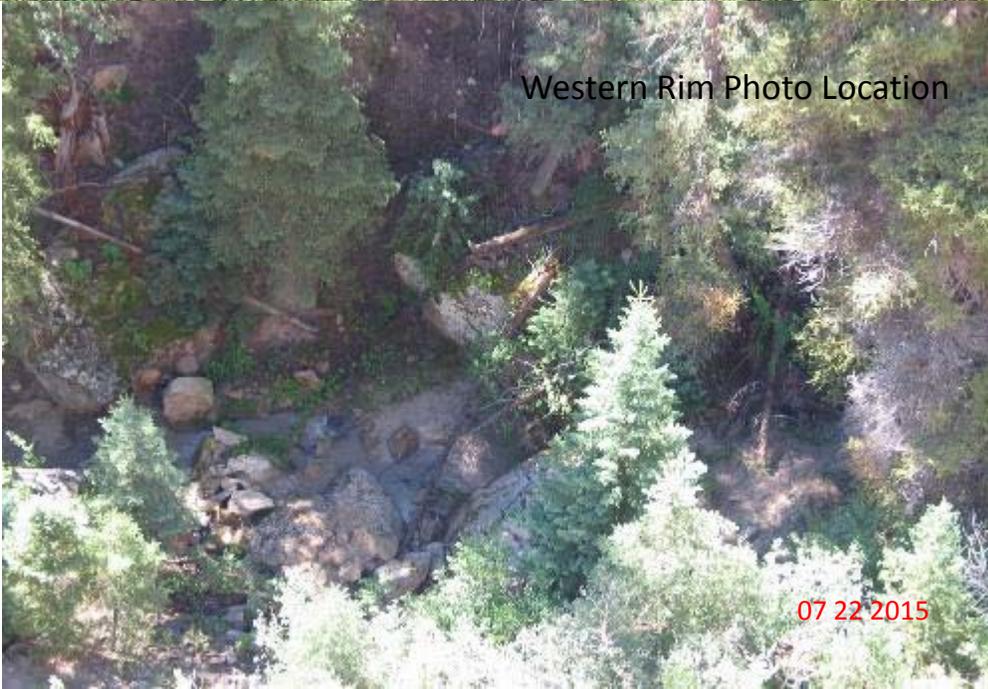
Western Rim Photo Location

July 23- Water observed flowing from the canyon rim at the western and middle photo locations, the flow appeared similar at both locations.

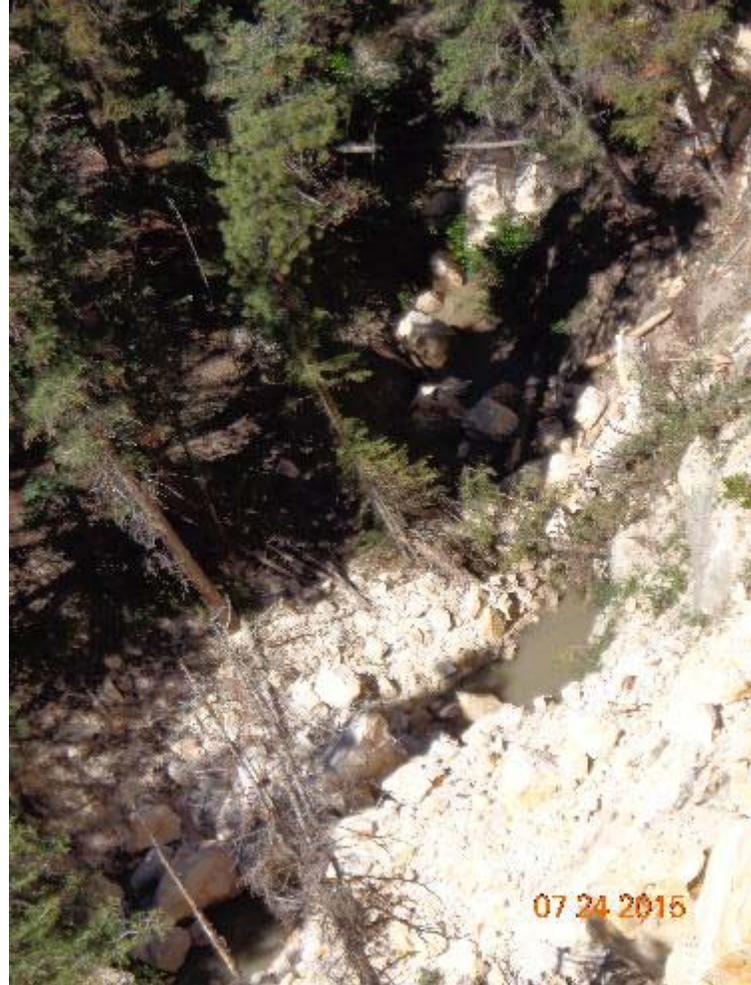
July 24- South Fork was flowing at 45-50 gpm, the water was muddy, likely from cattle drinking form the creek upstream. The water flowing through the rubble area was estimated to be similar to the flow at the road culvert creek crossing. Ponds were all dry with grass growing in the bottom.

Creek flow at Rubble Area
