## FW: South Fork of Quitchupah Monitoring

**Subject:** South Fork of Quitcupah Monitoring

WEST LEASE		
LONGWALL MINING SECTIONS		
SCALE: 1" = 1,000'	DATE: 3/30/2015	DRAWN BY: T.R.B.
ENGINEER:	CHECKED BY:	PROJ: ###
FILE NAME: H:\DRAWINGS\LONGWALL\WESTLEASE\LONGWALL_PANELS.dwg

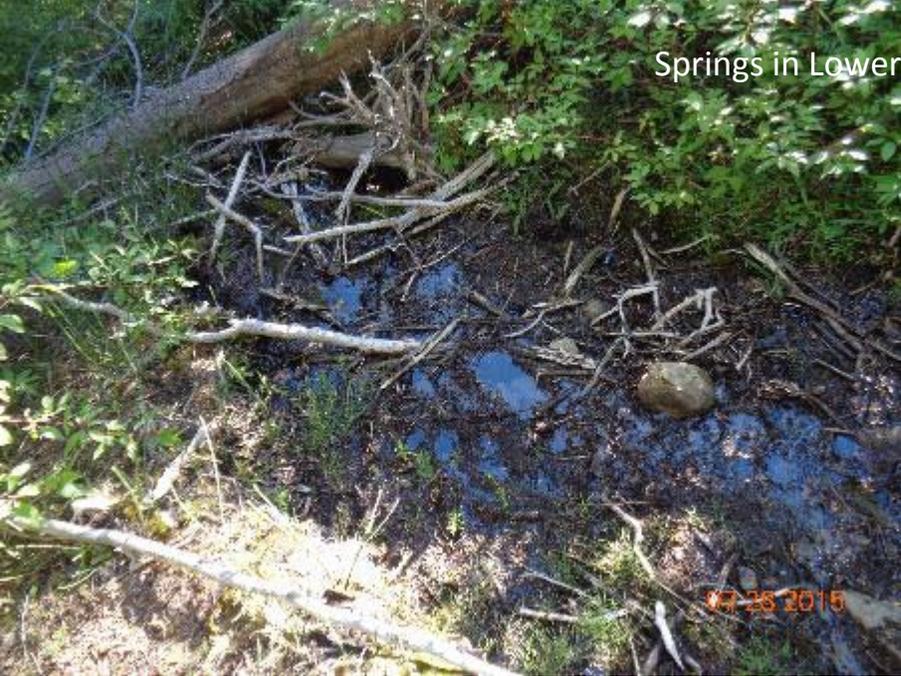
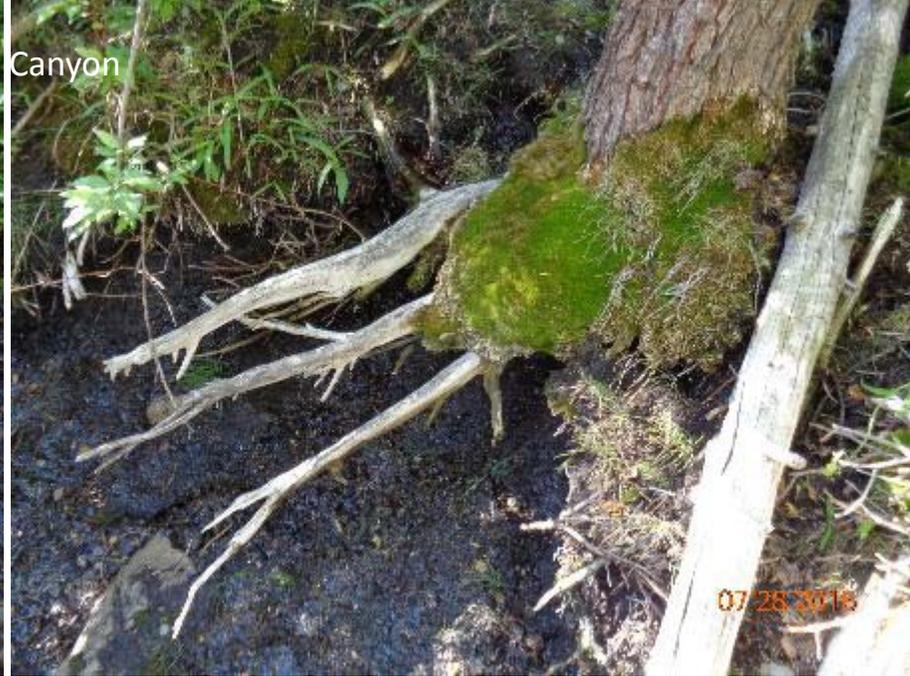
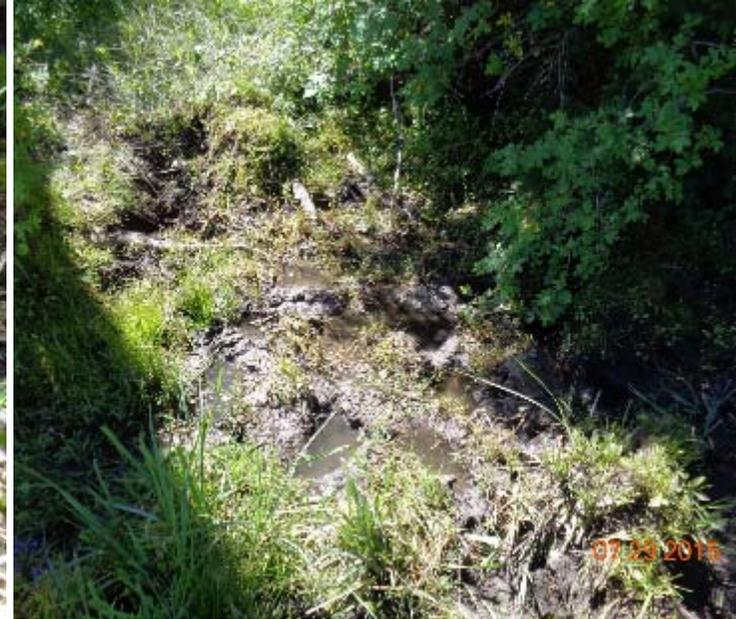
Springs in Lower Canyon

The approximately flow at Amanda Spring was 0.5 gpm and at the Wedge Spring it was 8 gpm. The source of Wedge Spring has relocated about 500' downstream.

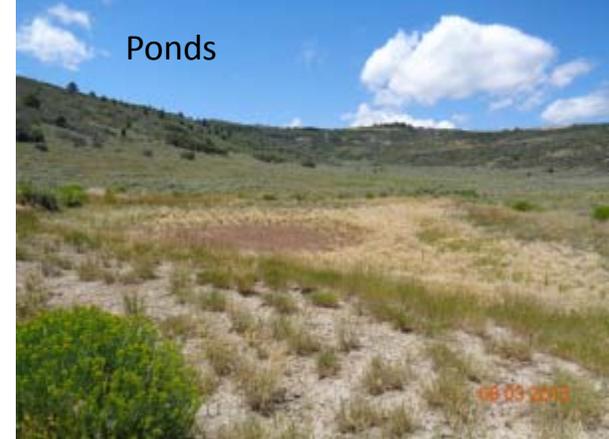
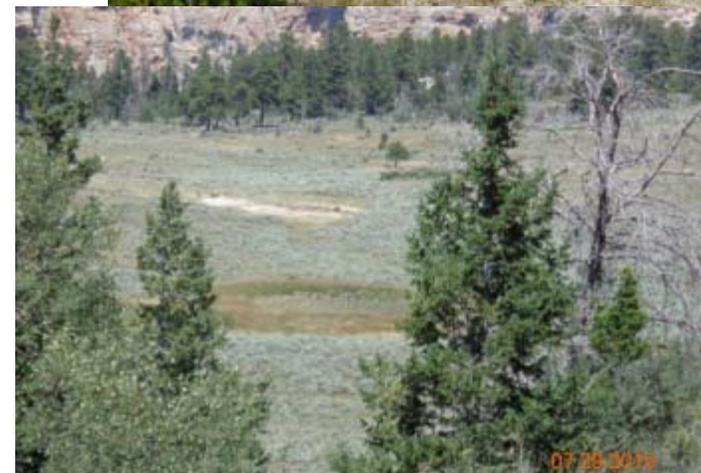
July 24- South Fork was flowing at 45-50 gpm, the water was muddy, likely from cattle drinking form the creek upstream. The water flowing through the rubble area was estimated to be similar to the flow at the road culvert creek crossing. Ponds were all dry with grass growing in the bottom.
