**ANNUAL MINESITE PRIMARY SEDIMENTATION POND
CERTIFICATION -- 2015**

Minesite Primary Sediment Pond Annual Inspection Report

**ANNUAL MINESITE SEDIMENTATION OVERFLOW POND
CERTIFICATION -- 2015**

**ANNUAL WASTE ROCK SEDIMENTATION POND
CERTIFICATION -- 2015**

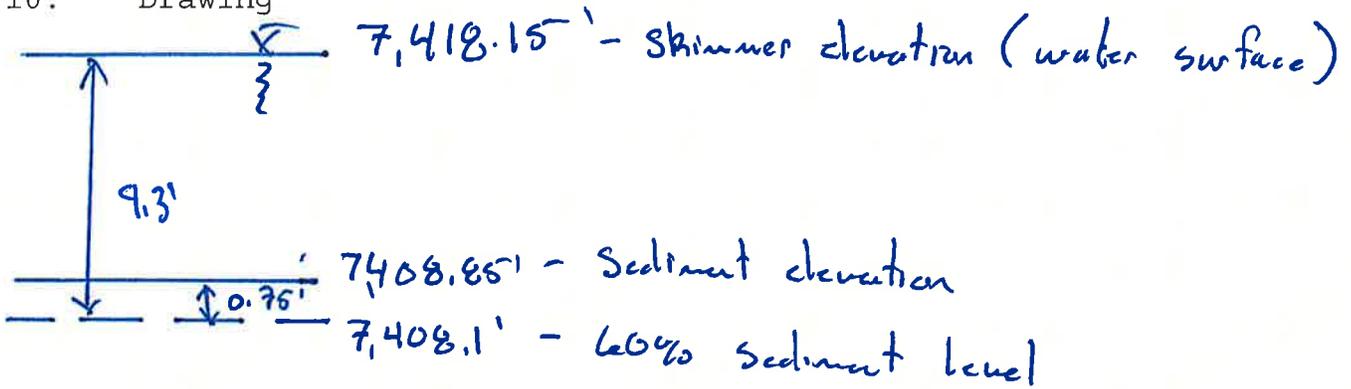
10. Drawing

Everything appears to be operating normally. The pond will need to be drained and cleaned in the spring.

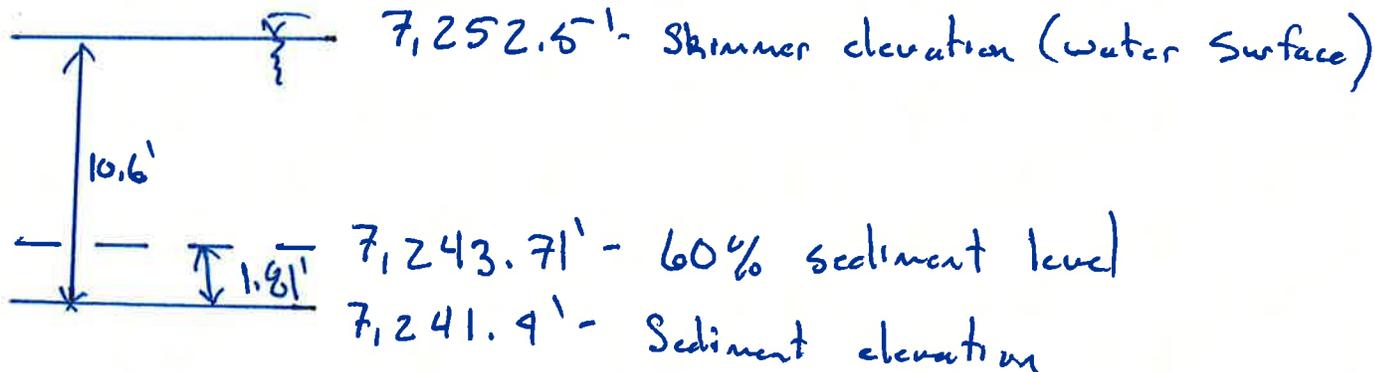
10. Drawing

Everything appears to be in normal operating condition.

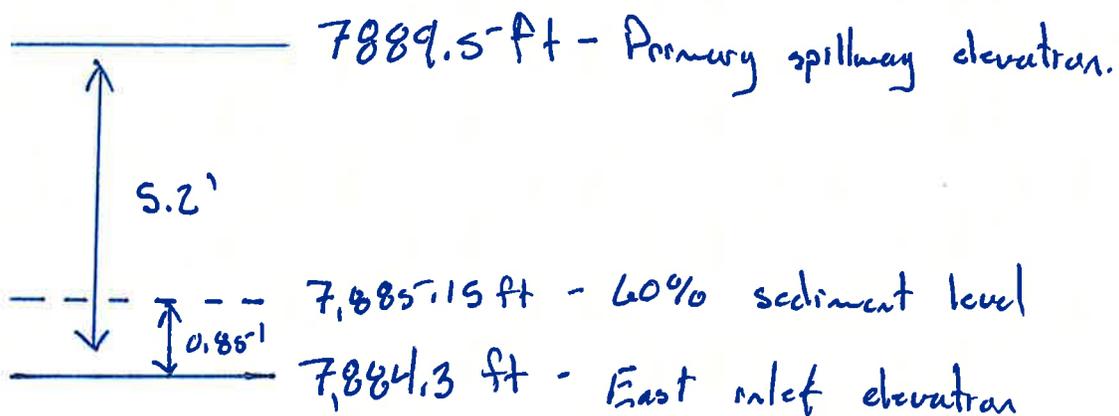
10. Drawing

Everything appears to be in normal operating condition.
