Enclosed are annual certification reports for Canyon Fuel Company's SUFCO Mine: Minesite Primary Sedimentation Pond, Minesite Sedimentation Overflow Pond, Waste Rock Disposal Site and the associated Waste Rock North and South Sedimentation Pond.

**ANNUAL MINE SITE PRIMARY SEDIMENTATION POND  
CERTIFICATION -- 2016**

## CANYON FUEL COMPANY - SUFCO MINE

## Mine Site Primary Sediment Pond Annual Inspection Report

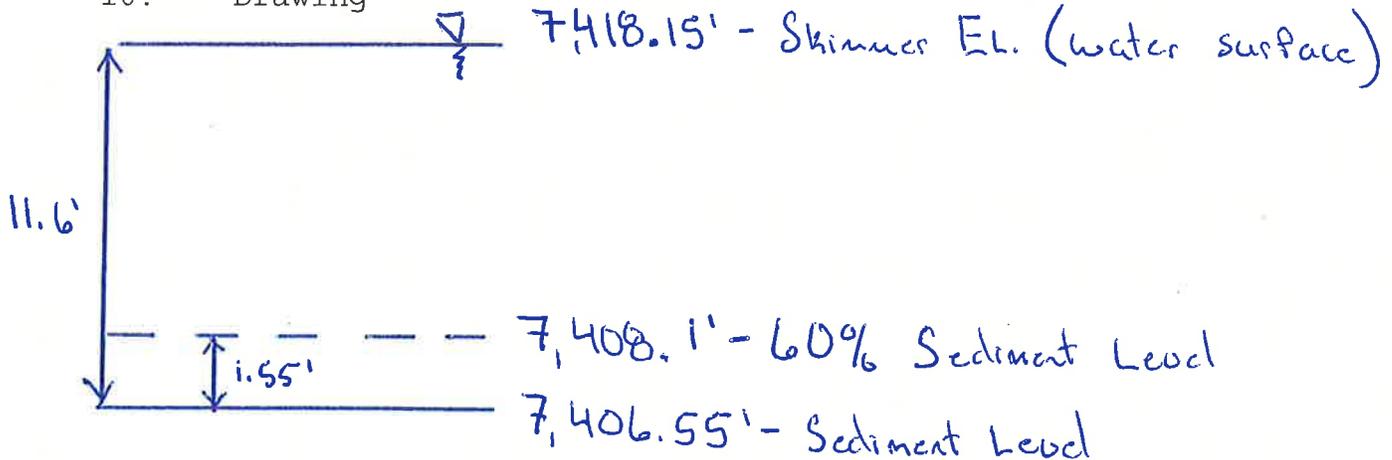
10. Drawing

The standpipe spillway in the pond is at an elevation of 7,418.15 feet. The water elevation is at 7,418.15 feet. Approximately an additional 0.29 acre-ft. of storage volume was available in the pond above the current standpipe spillway level. The sediment level in the pond just north of the decant structure was at 7,406.55 feet. This elevation is approximately 1.55 feet below the 60% sediment level.

The pond was cleaned earlier this year. Everything appears to be in normal operating condition.

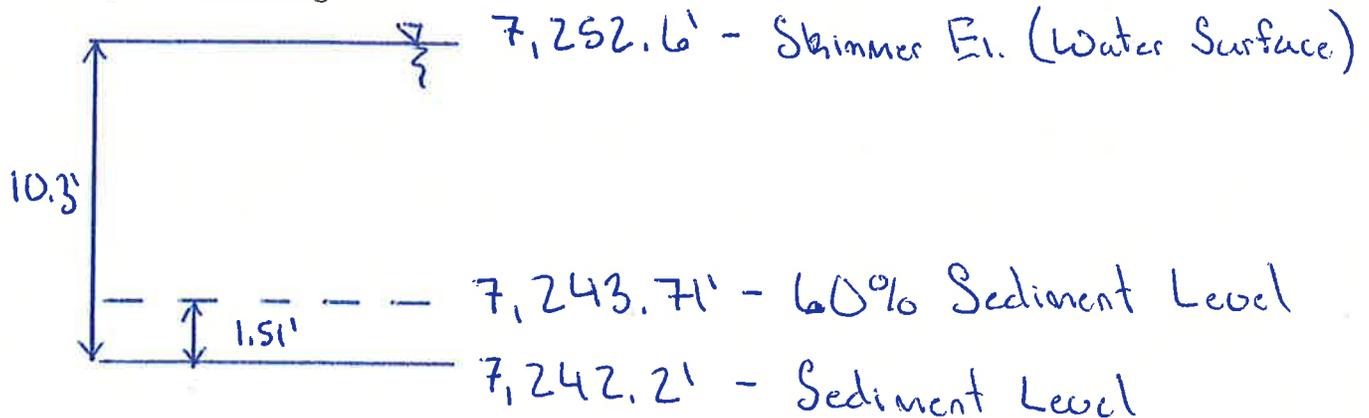
10. Drawing

The water in the pond was at an elevation of 7,252.5 feet, which is at the standpipe spillway elevation. The sediment level in the pond just north of the decant structure was at 7,242.2 feet. This elevation is 1.51 feet below the 60% sediment level.

Everything appears to be in normal operating condition.

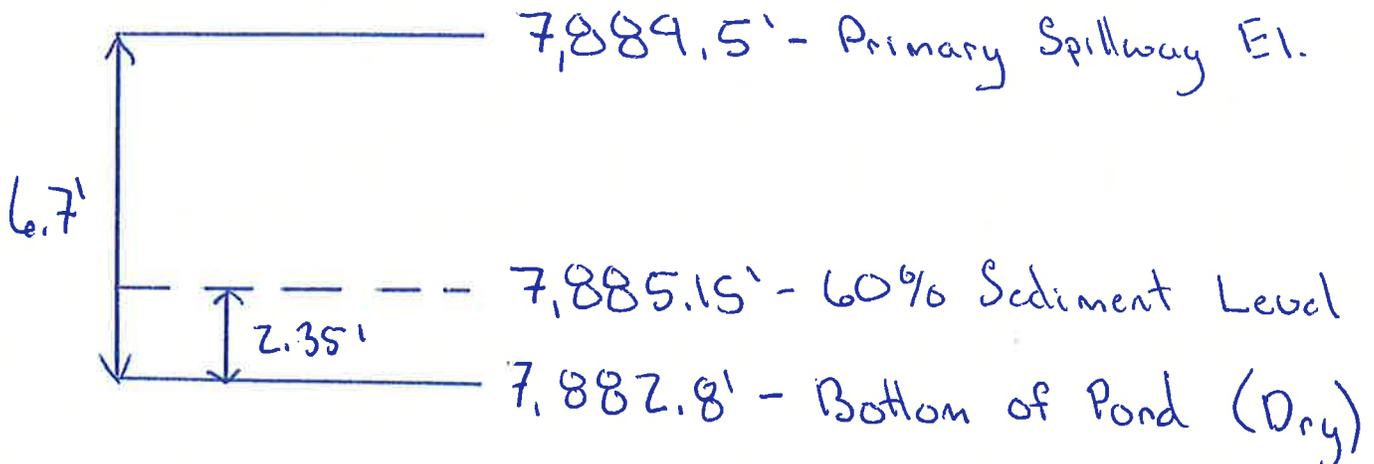
10. Drawing

The primary spillway elevation is 7,889.5 feet. The 60% sediment level for the pond is at 7885.15 feet. The pond is currently dry with a bottom elevation of 7,882.8 feet. Therefore, the pond has approximately 2.35 feet of sediment storage available before cleaning will be required.

Everything appears to be in normal operating condition.

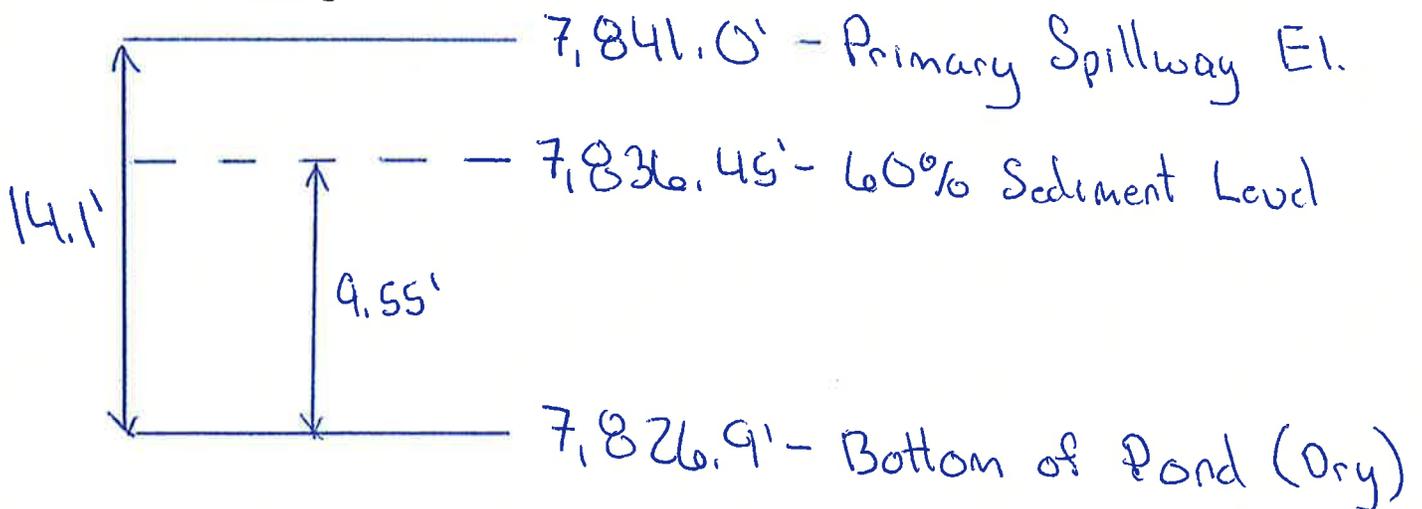
10. Drawing

The primary spillway elevation is 7,841.0 feet. The 60% sediment level for the pond is at 7,836.45 feet. The pond is currently dry with a bottom elevation of 7,826.9 feet. Therefore, the pond has approximately 9.55 feet of sediment storage available before cleaning will be required.

Sediment pond was constructed this year. Everything appears to be in normal operating condition.
