Canyon Fuel
Company, LLC

Sufco Mine
597 South SR24
Salina Utah 84654
(435) 286-4880
Fax (435) 286-4499

Enclosed are the Annual and the Quarterly inspection reports for Canyon Fuel Company's SUFCO Mine: Minesite Primary Sedimentation Pond, Minesite Sedimentation Overflow Pond, Waste Rock Disposal Site and the associated Waste Rock North and South Sedimentation Pond.

**ANNUAL MINE SITE PRIMARY SEDIMENTATION POND
CERTIFICATION -- 2017**

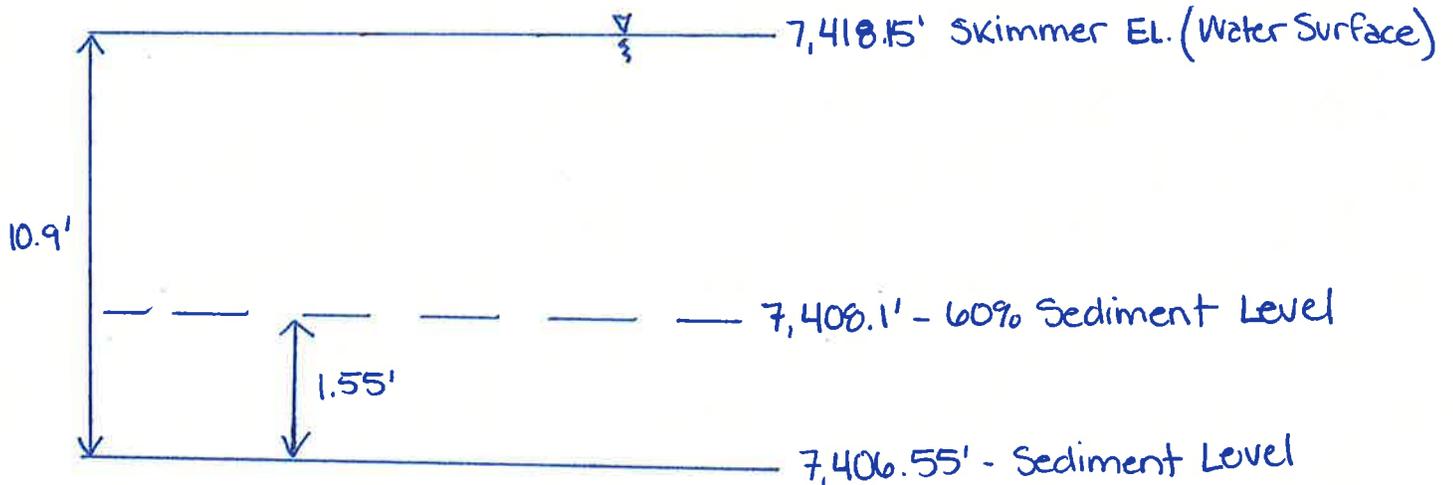
10. Drawing

The standpipe spillway in the pond is at an elevation of 7,418.15 feet. The water elevation is at 7,418.15 feet. Approximately an additional 0.29 acre-ft. of storage volume was available in the pond above the current standpipe spillway level. The sediment level in the pond just north of the decant structure was at 7,406.55 feet. This elevation is approximately 1.55 feet below the 60% sediment level.

The pond was cleaned in 2016. Everything appears to be in normal operating condition.

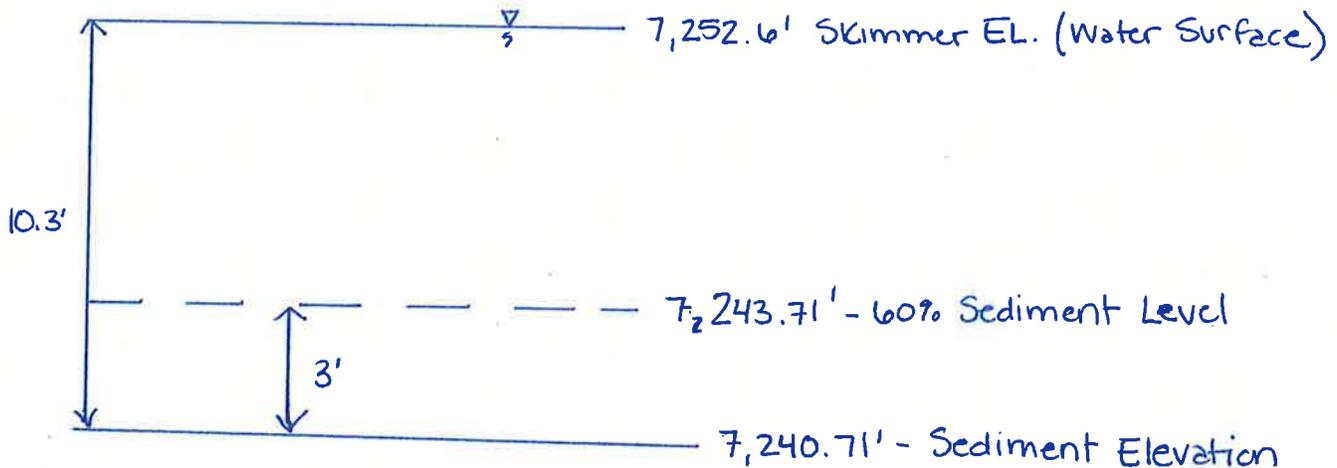
10. Drawing

The water in the pond was at an elevation of 7,252.6 feet, which is at the standpipe spillway elevation. The sediment level in the pond just north of the decant structure was at 7,240.71 feet. This elevation is 3 feet below the 60% sediment level.

Everything appears to be in normal operating condition. The overflow pond will be cleaned in 2018.

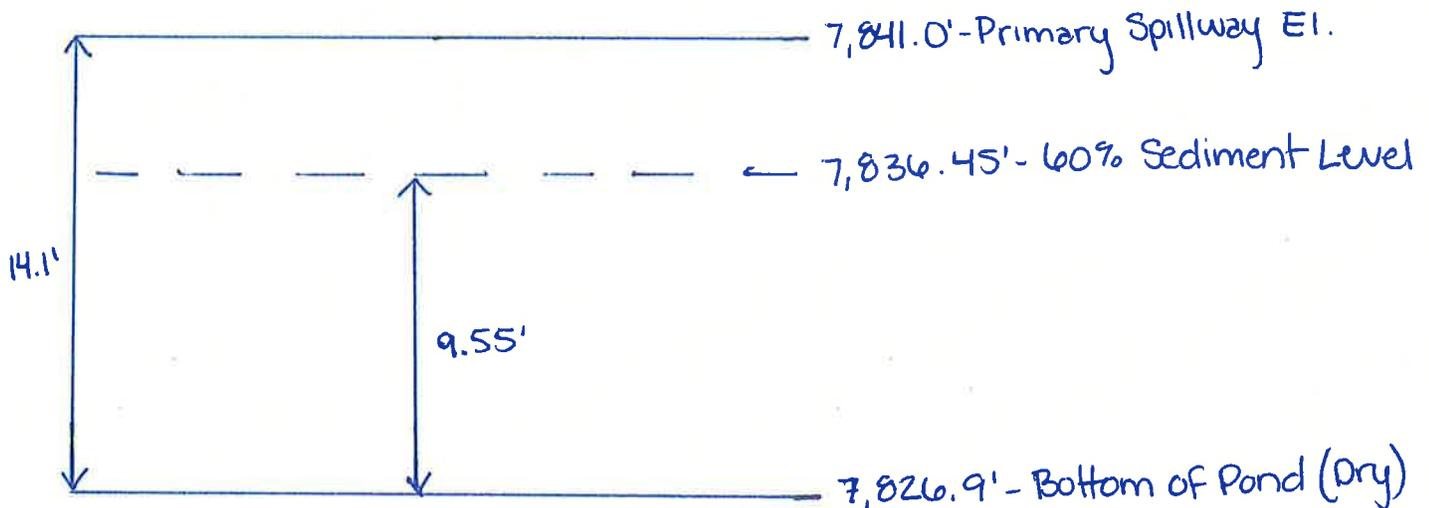
10. Drawing

The primary spillway elevation is 7,841.0 feet. The 60% sediment level for the pond is at 7,836.45 feet. The pond is currently dry with a bottom elevation of 7,826.9 feet. Therefore, the pond has approximately 9.55 feet of sediment storage available before cleaning will be required.

Sediment pond was constructed in 2016. Everything appears to be in normal operating condition.

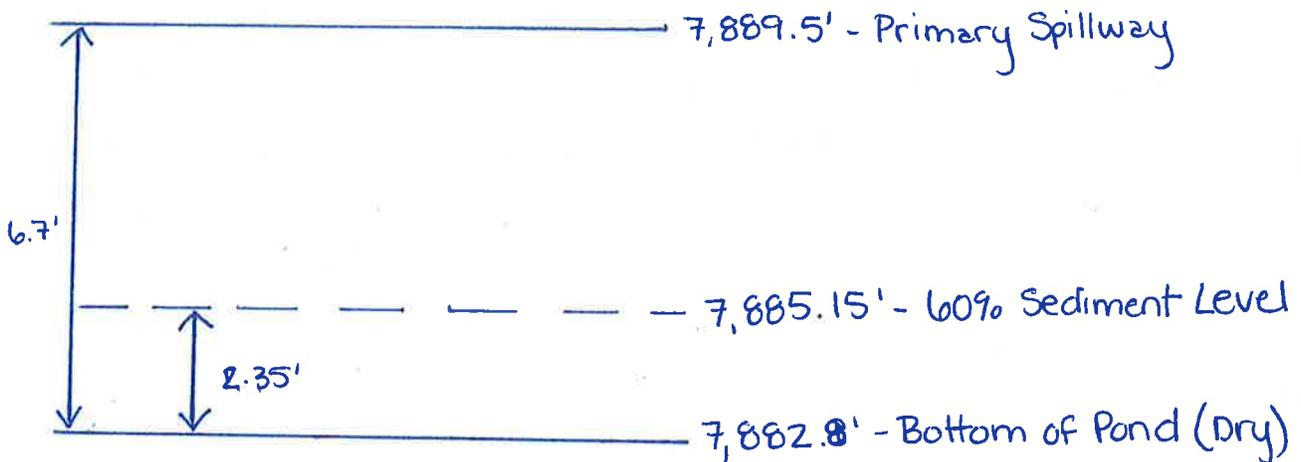
10. Drawing

The primary spillway elevation is 7,889.5 feet. The 60% sediment level for the pond is at 7885.15 feet. The pond is currently dry with a bottom elevation of 7,882.8 feet. Therefore, the pond has approximately 2.35 feet of sediment storage available before cleaning will be required.

Everything appears to be in normal operating condition.
