Enclosed are the Annual and the Quarterly inspection reports for Canyon Fuel Company's SUFCO Mine: Minesite Primary Sedimentation Pond, Minesite Sedimentation Overflow Pond, Waste Rock Disposal Site and the associated Waste Rock North and South Sedimentation Pond.

CANYON FUEL COMPANY - SUFCO MINE

**ANNUAL MINE SITE PRIMARY SEDIMENTATION POND
CERTIFICATION -- 2018**

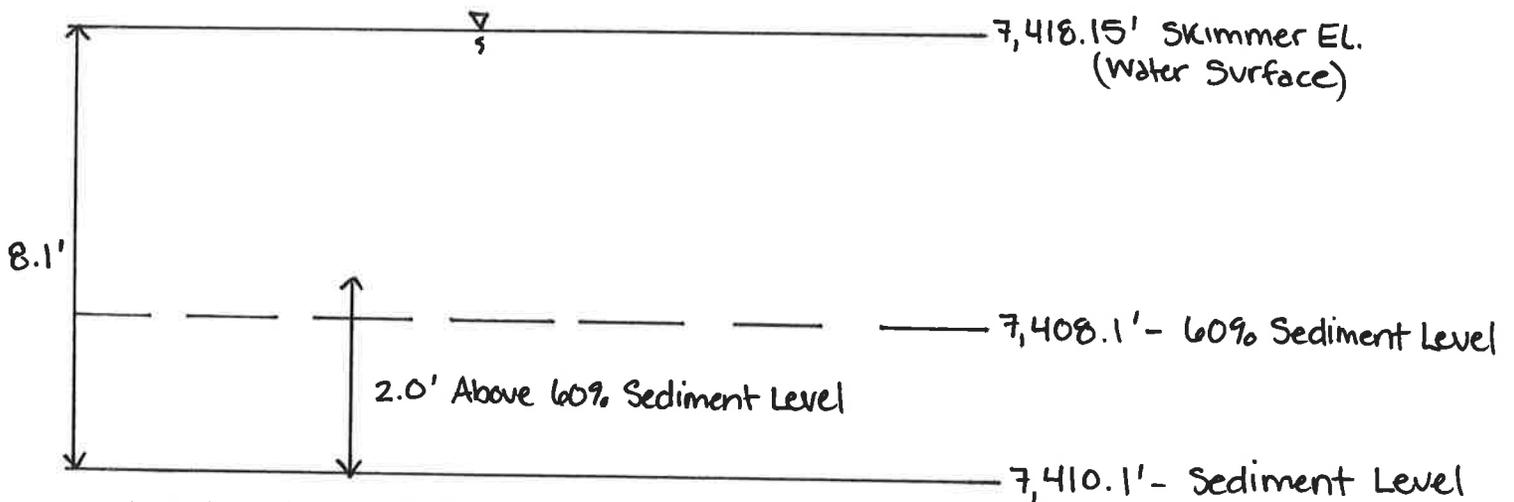
10. Drawing

The standpipe spillway in the pond is at an elevation of 7,418.15 feet. The water elevation is at 7,418.15 feet. Approximately an additional 0.29 acre-ft. of storage volume was available in the pond above the current standpipe spillway level. The sediment level in the pond just north of the decant structure was at 7,410.1 feet. This elevation is approximately 2.0 feet above the 60% sediment level.

Everything appears to be in normal operating condition. The primary pond will be cleaned in 2019.

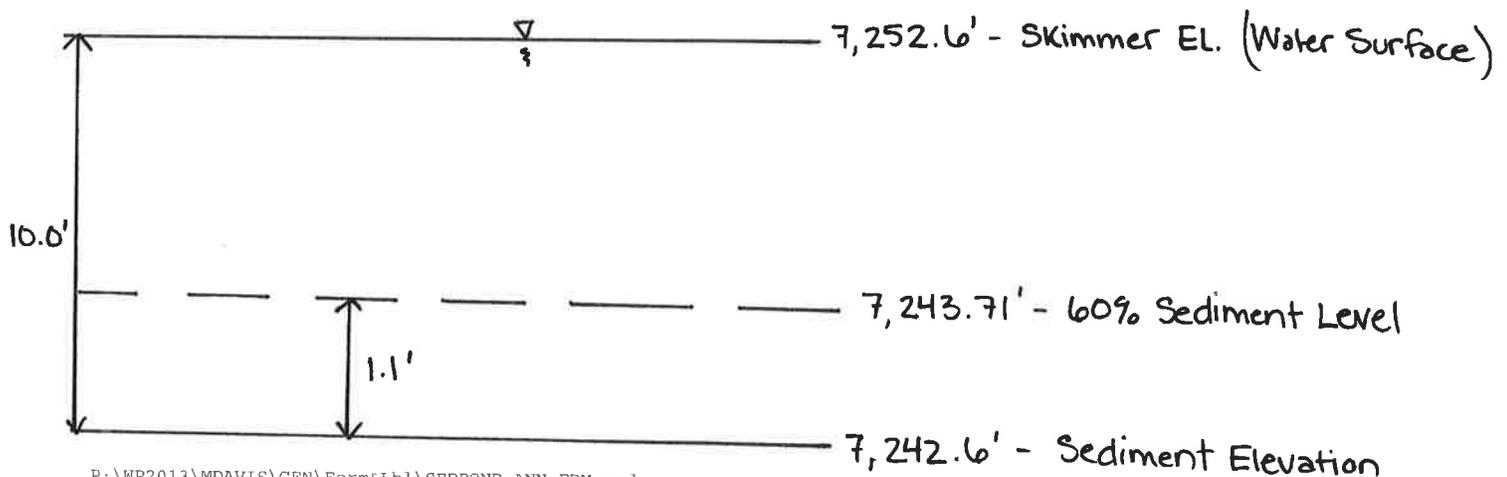
10. Drawing

The water in the pond was at an elevation of 7,252.6 feet, which is at the standpipe spillway elevation. The sediment level in the pond just north of the decant structure was at 7,242.6 feet. This elevation is 1.1 feet below the 60% sediment level.

Everything appears to be in normal operating condition. The overflow pond will be cleaned in 2019.

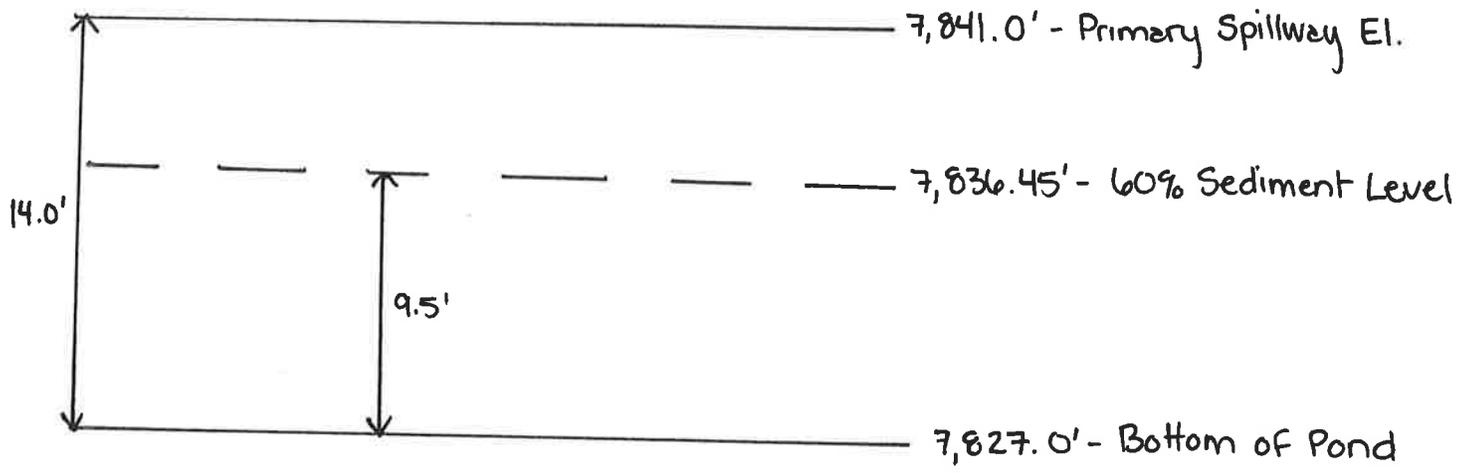
10. Drawing

The primary spillway elevation is 7,841.0 feet. The 60% sediment level for the pond is at 7,836.45 feet. The pond is currently dry with a bottom elevation of 7,827.0 feet. Therefore, the pond has approximately 9.5 feet of sediment storage available before cleaning will be required.

Some water was in the bottom of the pond. Everything appears to Be in normal operating condition.

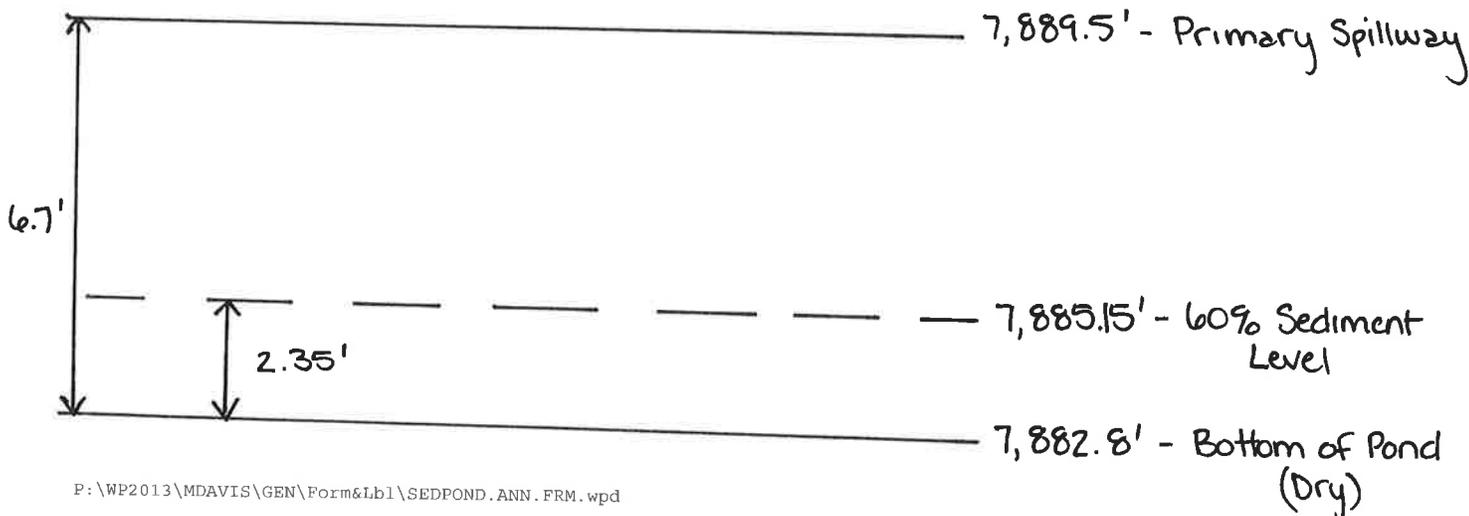
10. Drawing

The primary spillway elevation is 7,889.5 feet. The 60% sediment level for the pond is at 7885.15 feet. The pond is currently dry with a bottom elevation of 7,882.8 feet. Therefore, the pond has approximately 2.35 feet of sediment storage available before cleaning will be required.

Everything appears to be in normal operating condition.
