**Canyon Fuel
Company, LLC**

Sufco Mine

**ANNUAL MINE SITE PRIMARY SEDIMENTATION POND
CERTIFICATION -- 2019**

Mine Site Primary Sediment Pond Annual Inspection Report

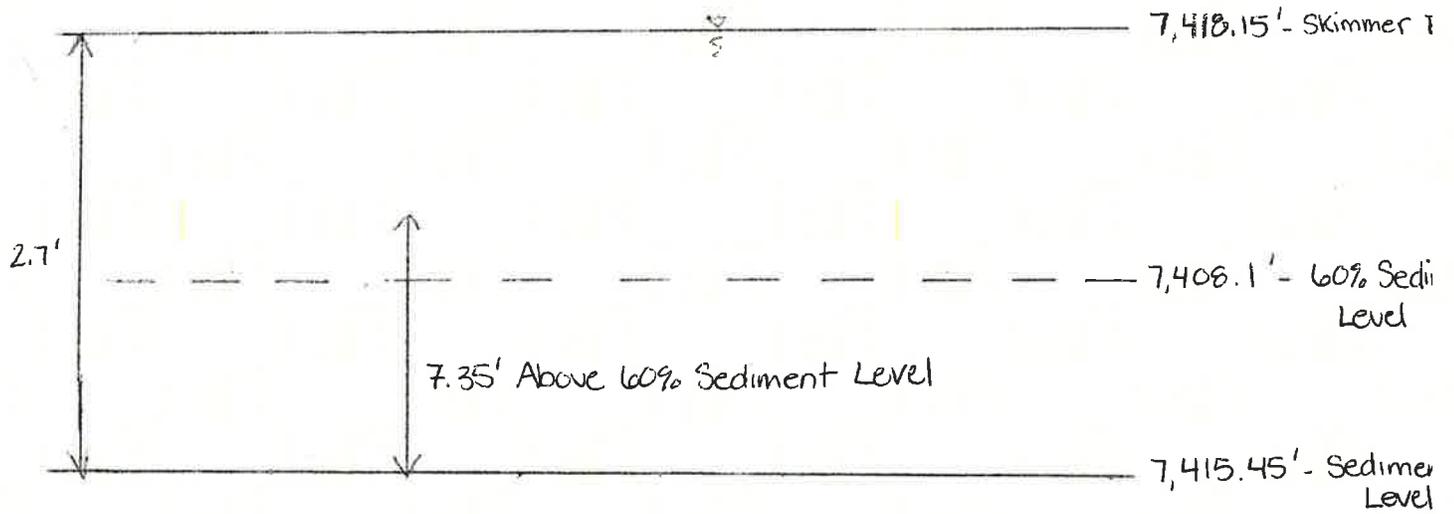
10. Drawing

The standpipe spillway in the pond is at an elevation of 7,418.15 feet. The water elevation is at 7,418.15 feet. Approximately an additional 0.29 acre-ft. of storage volume was available in the pond above the current standpipe spillway level. The sediment level in the pond just north of the decant structure was at 7,415.45 feet. This elevation is approximately 7.35 feet above the 60% sediment level.

Everything appears to be in normal operating condition. The pond is decanting currently to clean out the sediment.

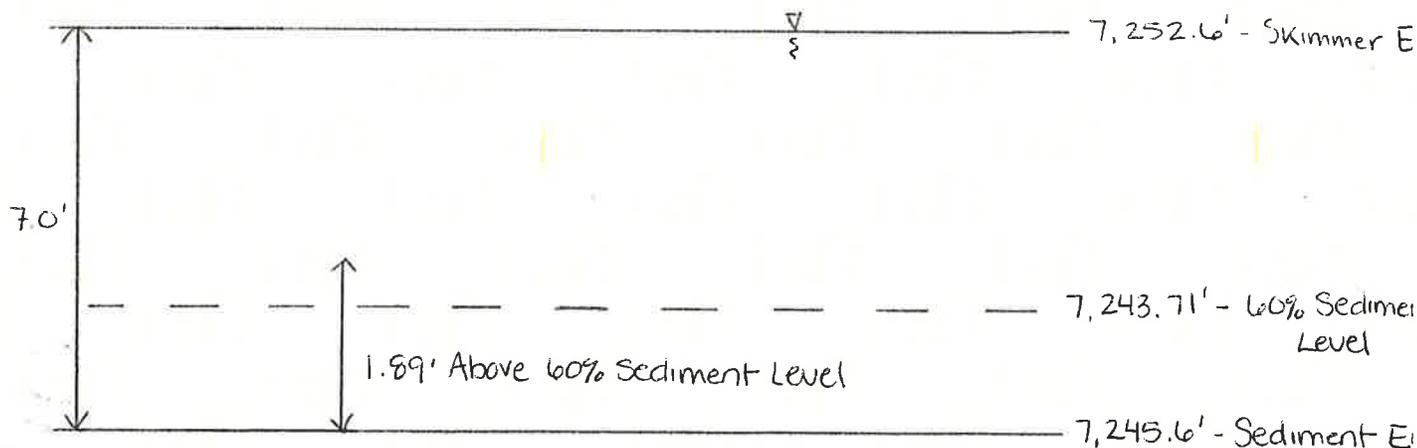
10. Drawing

The water in the pond was at an elevation of 7,252.6 feet, which is at the standpipe spillway elevation. The sediment level in the pond just north of the decant structure was at 7,245.6 feet. This elevation is 1.89 feet above the 60% sediment level.

Everything appears to be in normal operating condition. The overflow pond will be cleaned out in 2020.

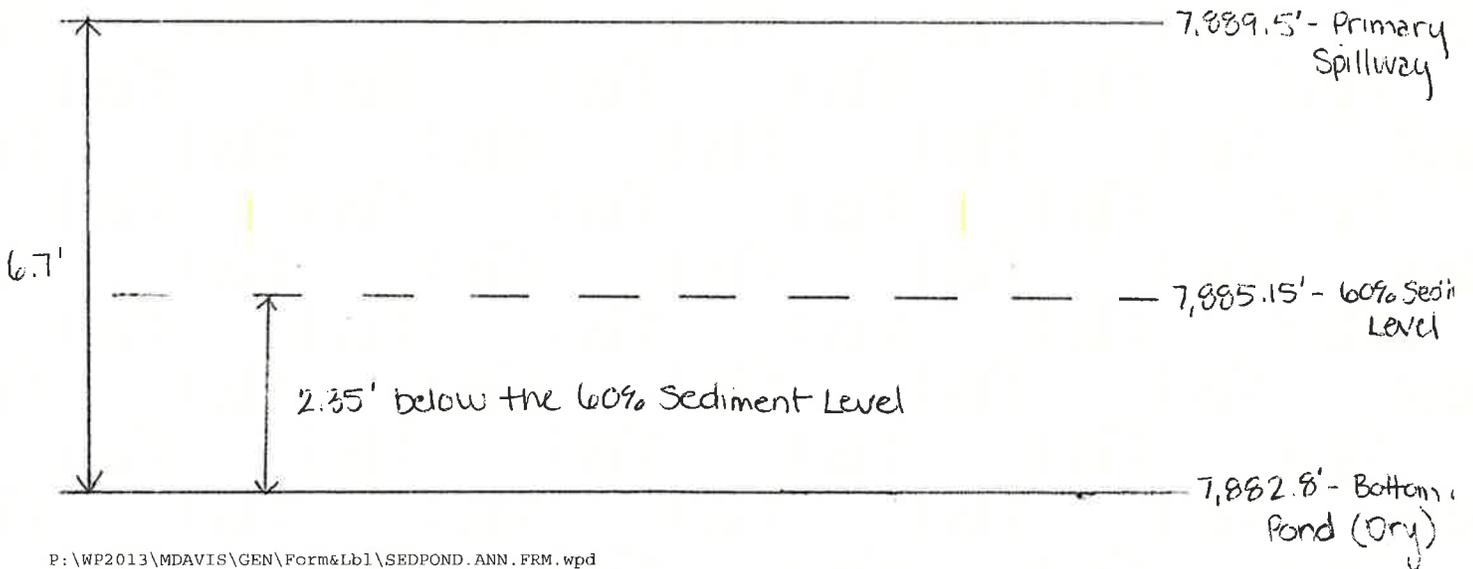
10. Drawing

The primary spillway elevation is 7,889.5 feet. The 60% sediment level for the pond is at 7885.15 feet. The pond is currently dry with a bottom elevation of 7,882.8 feet. Therefore, the pond has approximately 2.35 feet of sediment storage available before cleaning will be required.

Everything appears to be in normal operating condition.

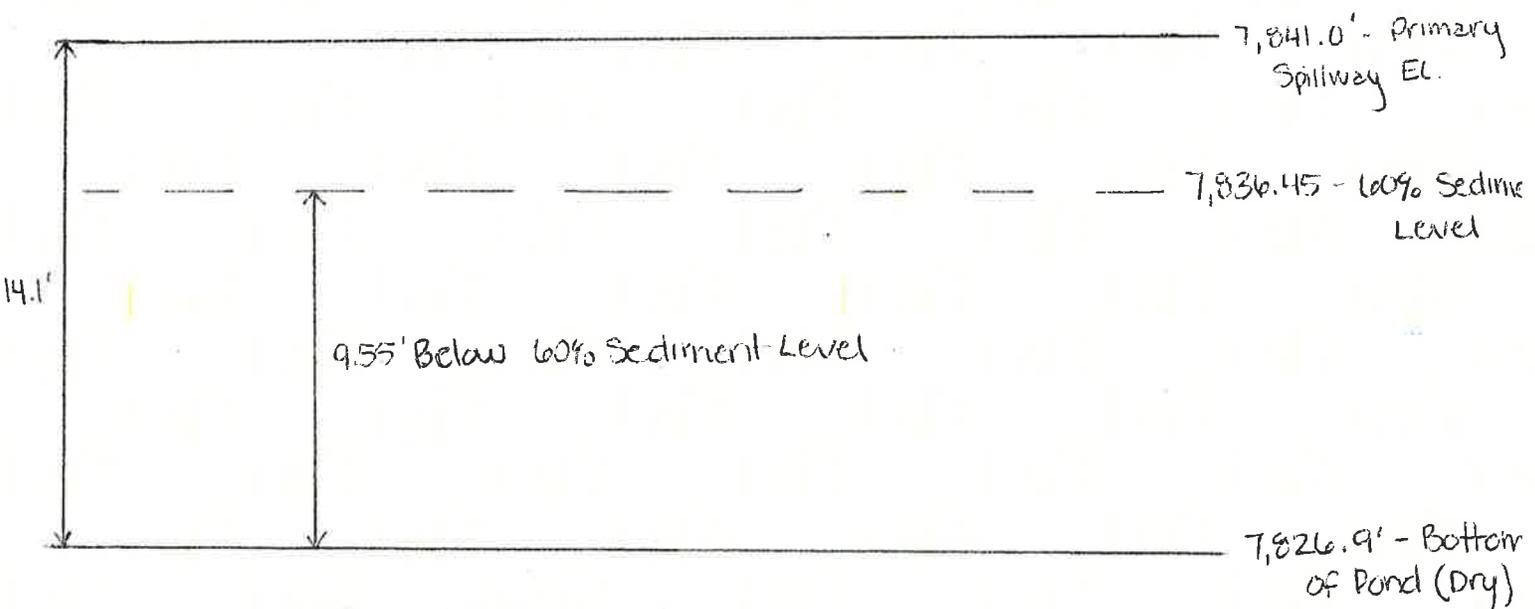
10. Drawing

The primary spillway elevation is 7,841.0 feet. The 60% sediment level for the pond is at 7,836.45 feet. The pond is currently dry with a bottom elevation of 7,827.0 feet. Therefore, the pond has approximately 9.5 feet of sediment storage available before cleaning will be required.

Everything appears to be in normal operating condition.
